Rail Accident Investigation Branch

# Rail Accident Report

## Runaway incidents on Blackpool Transport Services Tramway, 21 November, 3 and 10 December 2005

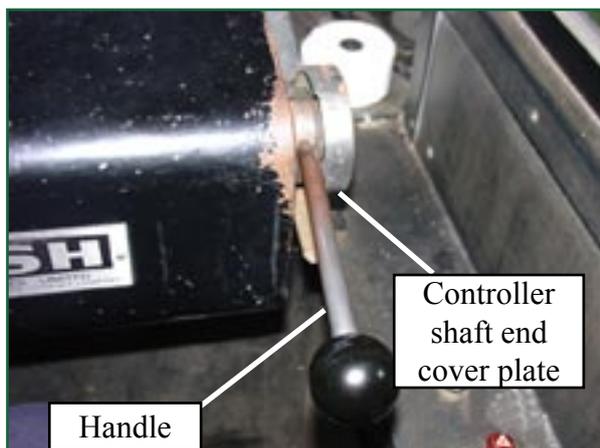
*Figure 7: Controller with handle in place*

22 The photographs below (Figures 7 and 8) show the controller with and without the handle in position. The handle is pushed fully forward to apply power, and pulled back to brake. A foot pedal must also be depressed to obtain power, but release of this pedal does not apply the brake. The controller has a central neutral position. It is possible to withdraw the controller handle in such a way that in disengaging from the shaft it ‘flips’ the controller shaft from the brake to the neutral position (see diagrams, Figure 9). If this happens it is impossible for the driver to replace the handle. A special fork tool must be used to reset the shaft position. This tool is carried by operating supervisors and fitters, but not by drivers.

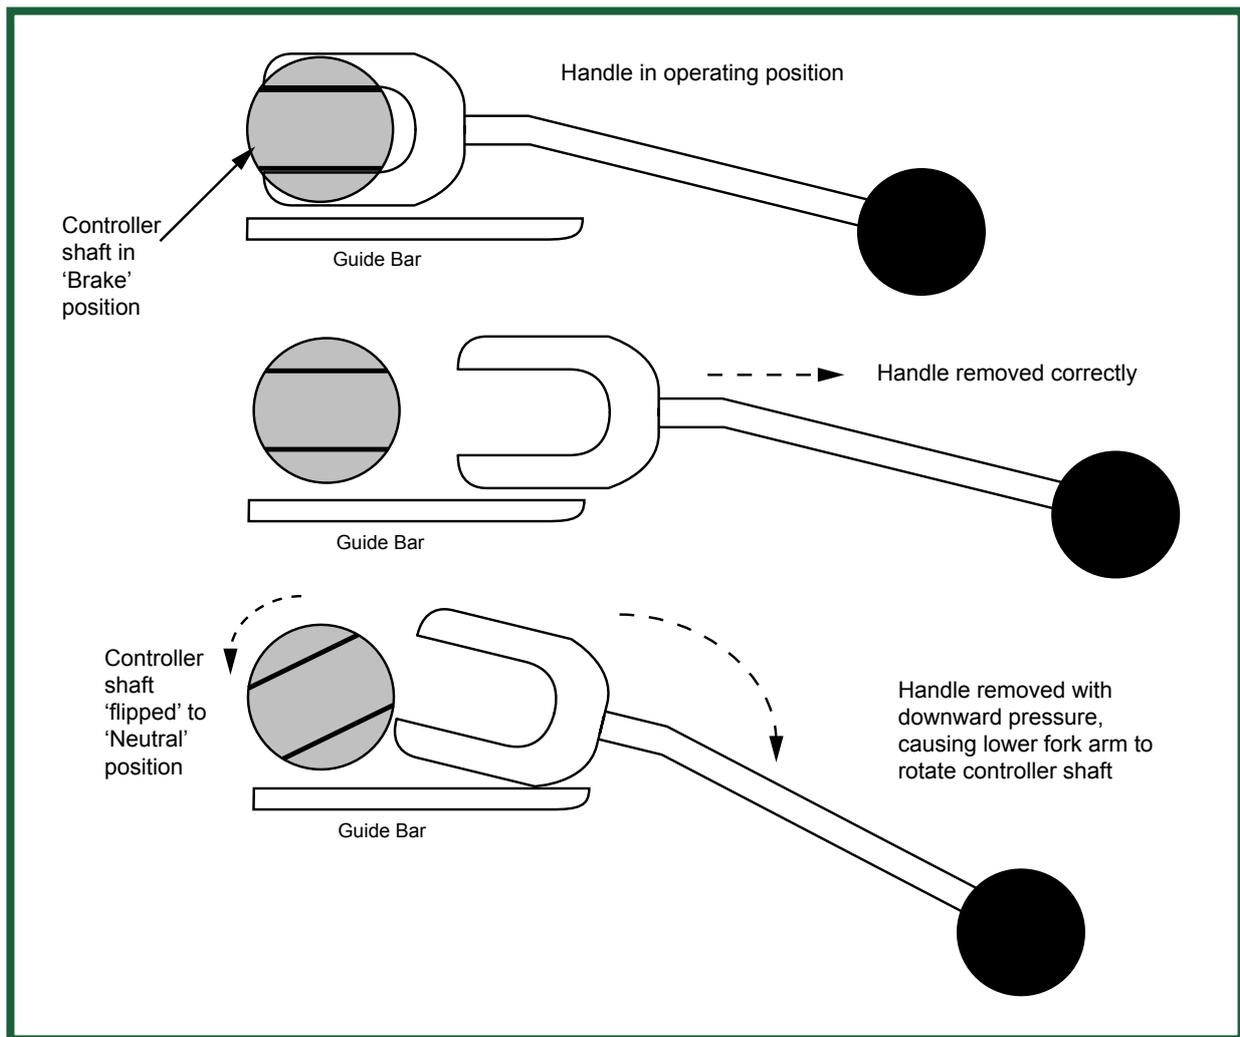
Figure 9: Removal of handle and 'flipping' of controller shaft

- 13 The immediate cause of the second and third incidents was the design of the tram controller housing. This permitted the controller shaft to move as the control handle was removed by the driver and consequently released the *service brake* without the driver being aware that this had occurred.

- 39 The second and third incidents had in common the ‘flipping’ of the controller shaft when the handle was withdrawn, as shown in Figure 9. Tests showed that this can be done relatively easily if the driver leans on the handle while getting up from the seat and at the same time pulling the handle out of the controller - a combination of actions which is quite normal for a heavily built person in easing themselves from the driver’s seat.

- 45 The immediate cause of the second and third incidents was the inadvertent 'flipping' of the controller shaft by the drivers as the control handle was removed.

- 3 After the second incident, BTS designed a modification to the controller end cover which prevents the shaft from turning while the handle is being removed. A prototype was inspected during the RAIB's investigation. A production version has since been fitted to all ten trams with this type of controller.
