Rail Accident Report

Passenger train collision with a road vehicle at Swainsthorpe level crossing, Norfolk

13 November 2005

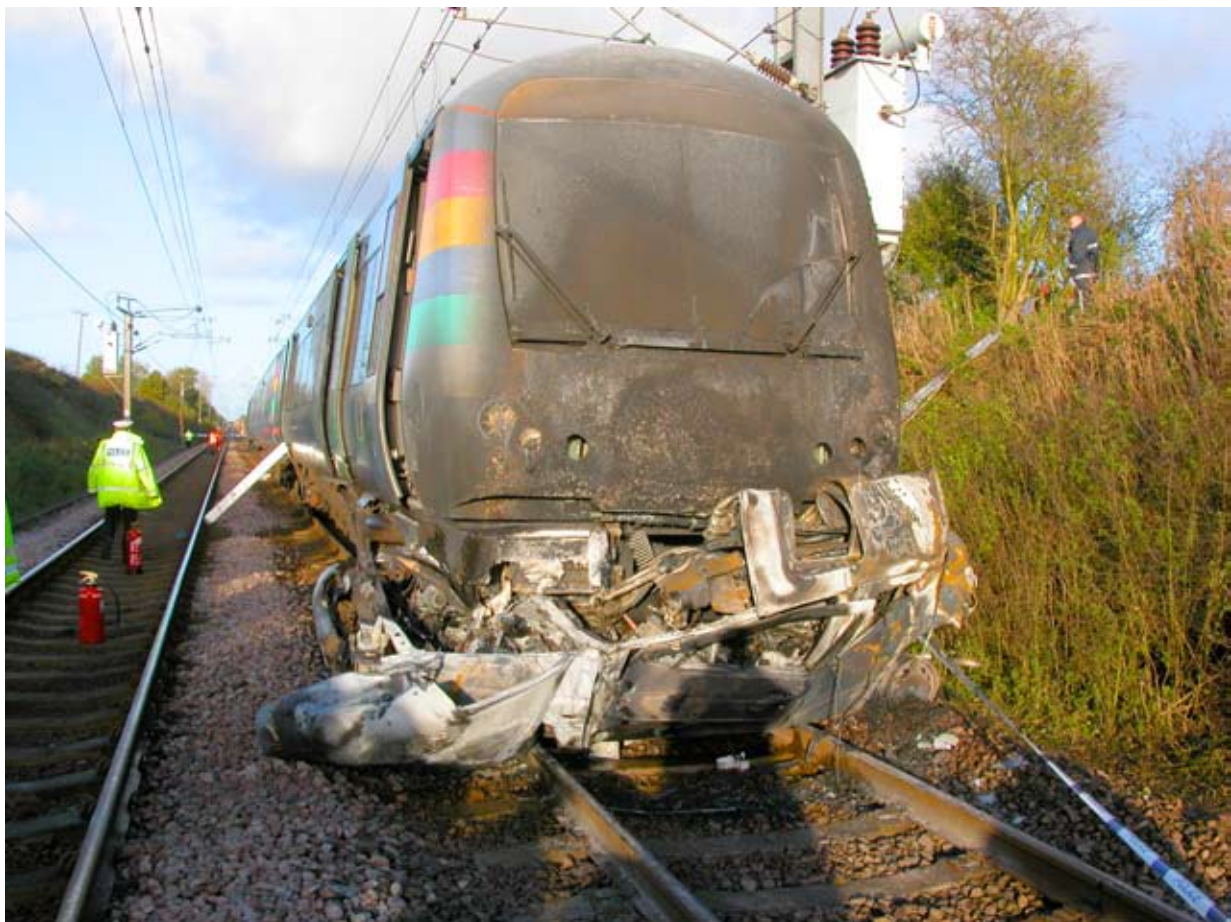
Figure 2: Damage caused to class 170 170207 as a result of the collision (courtesy of Norfolk Police)

26. The car was trapped under the front of the unit after it was struck by the train. It appears that the obstacle deflector prevented the wrecked car from reaching the wheels of the train and greatly reduced the risk of the train derailing. Subsequent examination of the

train showed that most of the damage occurred to the driver's side cab area of the leading vehicle due to the fire. There was no distortion of the bodyshell structure, and little other mechanical damage – the trailing vehicle suffered some minor bodyside and body structure damage, as well as damage to the power bogie. This is thought to be impact damage from components of the car that became detached as a result of the collision.

27. After the impact, the car caught fire. The fire burnt fiercely as the petrol in the car's petrol tank ignited. As well as the considerable exterior fire damage to the train driving cab and body structure forward of the leading wheelset, the fire penetrated the cab back wall cubicle containing electrical wiring behind the driver's seat, causing significant damage. This issue was examined by AEA Technology on behalf of the vehicle manufacturer, Bombardier, who concluded that the wiring in the cab back wall cubicle probably ignited due to the fact the self-ignition temperature of the insulation was 330 C, whereas temperatures close by had exceeded 660 C – the melting point of aluminium. The performance of wiring insulation is covered by British Standards BS4066 and BS7622, and the fire experienced gave rise to temperatures well in excess of the performance required.

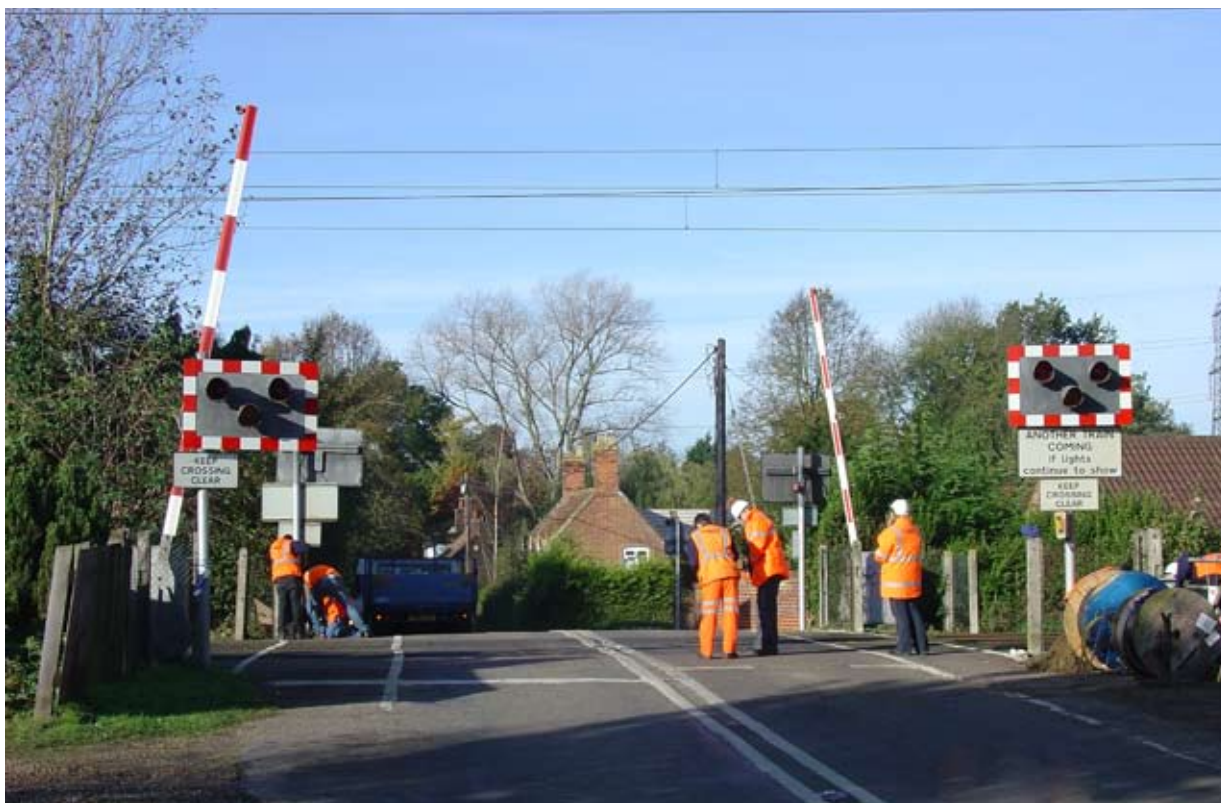
20. The railway between Norwich and Diss consists of double track and is signalled with colour light signals and continuous *track circuiting* controlled from the signal box at Colchester. The AHB level crossing (shown in Figure 3) is located at 109 miles 54 chains from Liverpool Street Station and comprises standard flashing road traffic light signals, audible alarms and lifting booms that close off the nearside half of the carriageway width in each direction. Assuming normal operation, for trains running at the maximum permitted speed of 100 mph (161 km/h), the lights illuminate at least 27 seconds before a train's arrival, and the booms are fully lowered at least eight seconds before a train's arrival. Emergency telephones are fitted on the offside of the crossing on both sides that connect to Colchester signal box. An 'Instead' 64 datalogger is fitted which monitors and records the operation of the level crossing. Located 183 m before the crossing on the *Up* line, there is a *two-aspect colour light signal* which the level crossing datalogger indicates was showing green as the train approached it

Figure 3: General view of the eastern (*Up* side) approach to Swainsthorpe level crossing

25. The level crossing datalogger was downloaded under the control of the RAIB, and this confirmed that the road traffic light signals and *crossing booms* had been working correctly as reported by the witness interviewed by the BTP. The RAIB Lead Inspector considered that full *wrongside failure testing* was not necessary given the clear witness evidence and agreed the scope of more limited *functional testing* of the level crossing equipment, prior to re-opening, with Network Rail. This acted as a further confirmation that the crossing had worked correctly. The testing was carried out during the night following the collision, and the key elements of the test were witnessed by the RAIB. As a result of the testing, Network Rail renewed three cables that were found with resistance values lower than those specified in maintenance documentation. The datalogger records showed that the low resistance values had no effect on the operation of the level crossing before the collision occurred. The operation of the crossing was neither a causal nor a contributory factor in the collision.

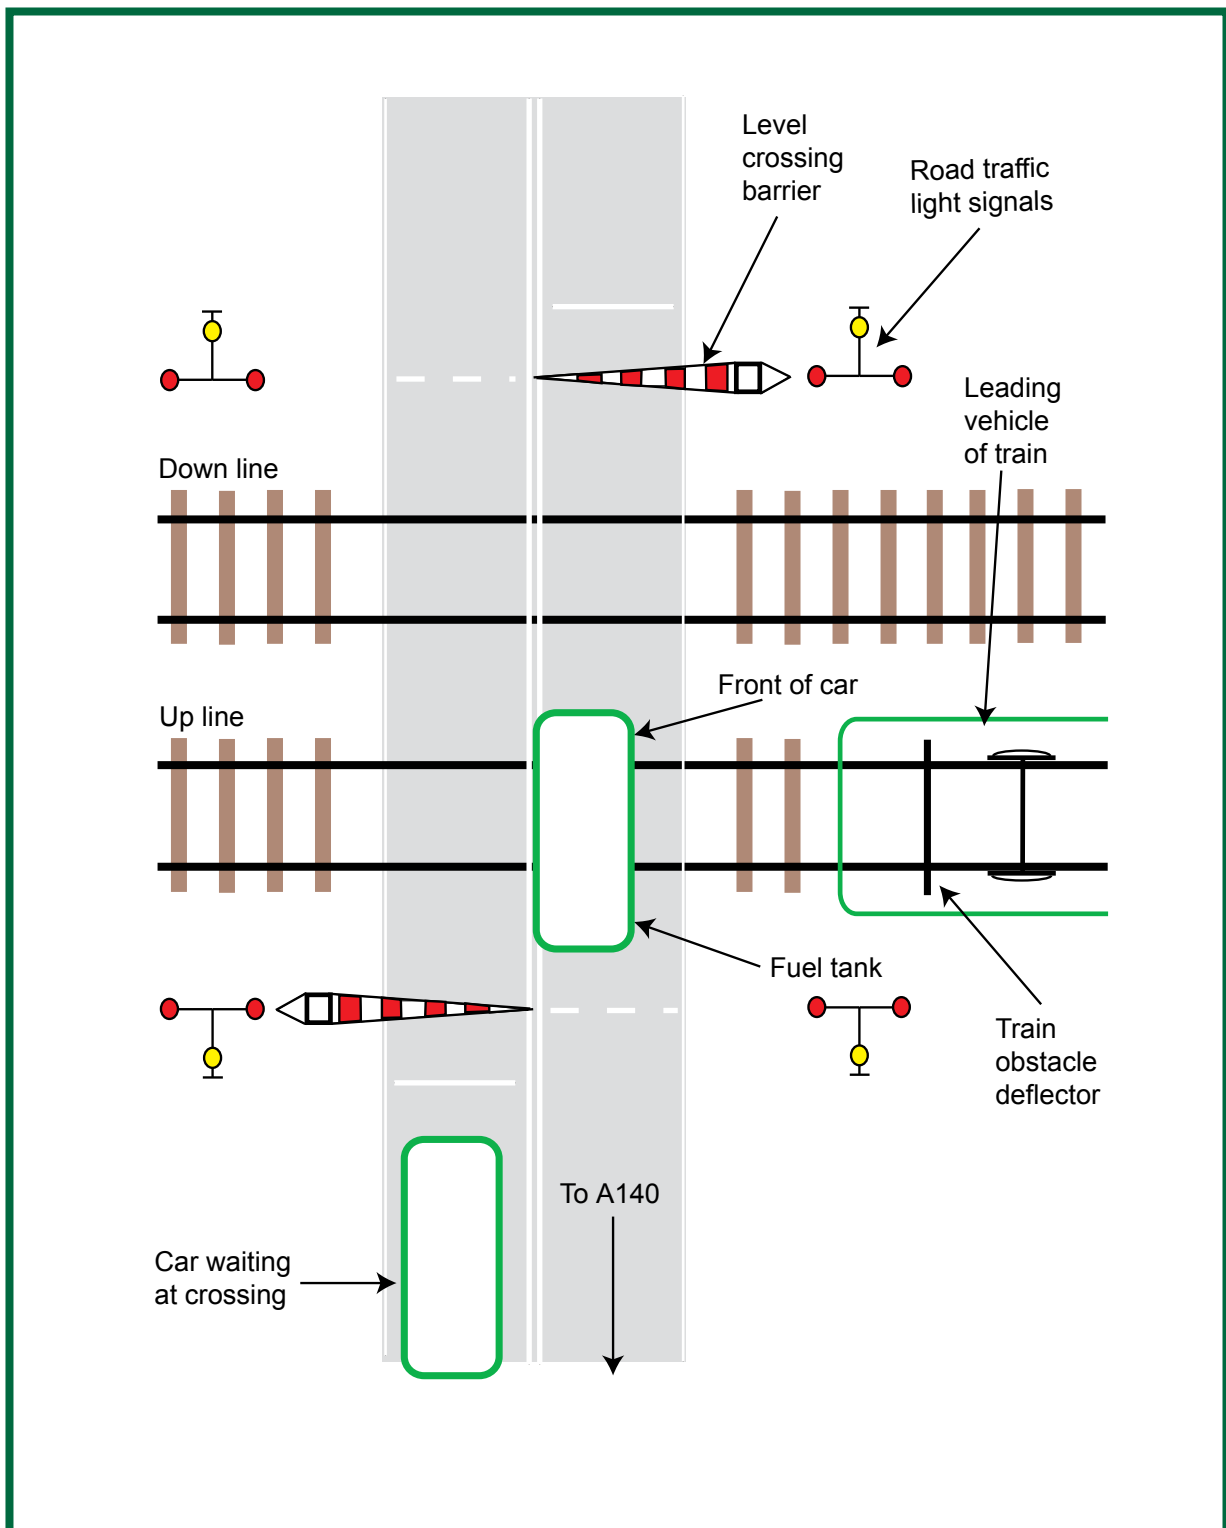
16. Appendix B Figure 4 shows the relative positions of the car that was positioned on the crossing and the car that was correctly waiting before the flashing road lights on the east side of the crossing just before the collision occurred.

Figure 4: Diagrammatic representation of relative positions of train and cars at impact

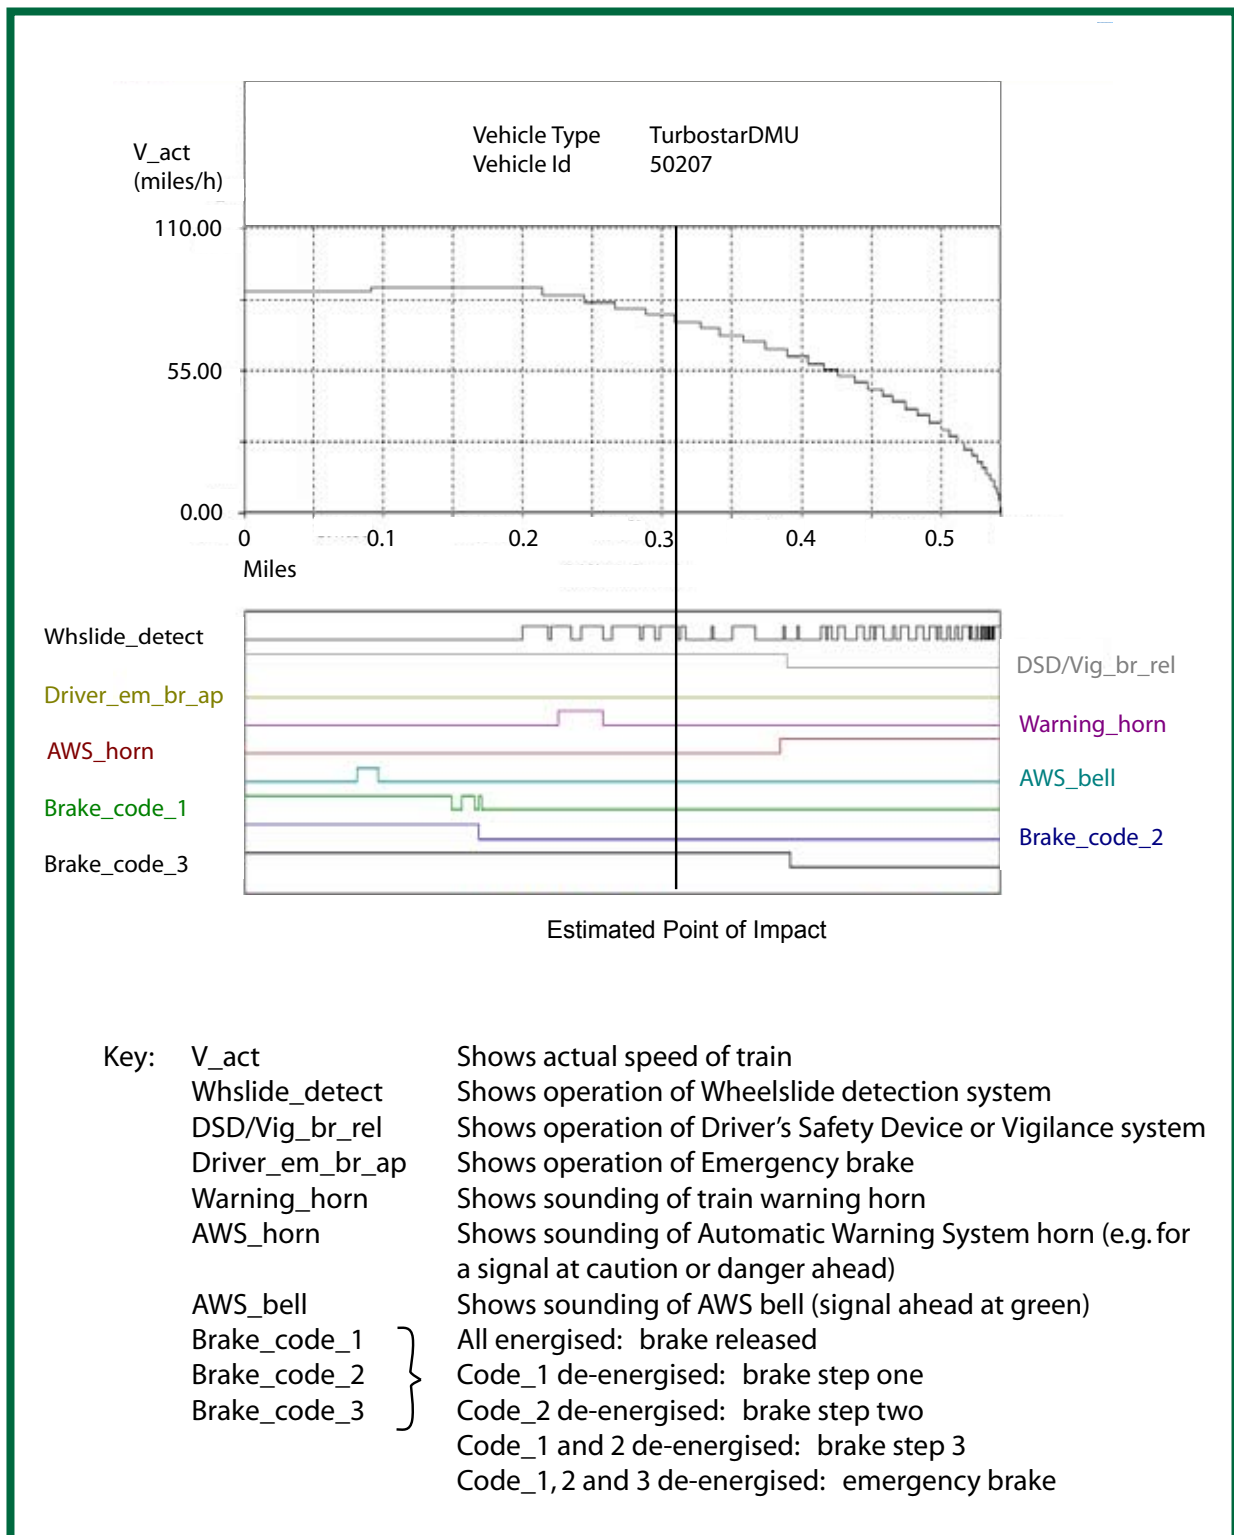
23. The RAIB oversaw the downloading of the train data recorder, and this shows that from the point the driver first made a continuous brake application, the train took 602 m to stop. The data recorder also indicates that the continuous brake application was made 226 m from the crossing following which the horn was sounded 131m from the crossing. From the results of the train data recorder, it is estimated that the train hit the car at a speed of 77 mph (124 km/h).

24. Before the collision occurred, the train driver thought that he had applied the brake into the emergency position, whereas the data recorder indicates that he initially applied the brake into the 'Step 1' position, released it and then made a 'Step 3' full service brake application. The emergency position provides an enhanced braking capability. However, given the time for the brakes to apply following operation of the driver's brake handle, and the distance the train was from the crossing, calculation shows that an emergency brake application would have further reduced the speed of the train by less than 5 mph. It is unlikely therefore that this would have made any difference to the outcome of this collision. A copy of the data recorder download is in Appendix C, Figure 5.

Figure 5: Data Recorder download trace from the leading vehicle no. 50207 of train 1G33
