# Rail Accident Report

**The fatality at Barratt's Lane No.1 footpath  
crossing  
21 November 2005**

# The fatality at Barratt's Lane No.1 footpath crossing, 21 November 2005.

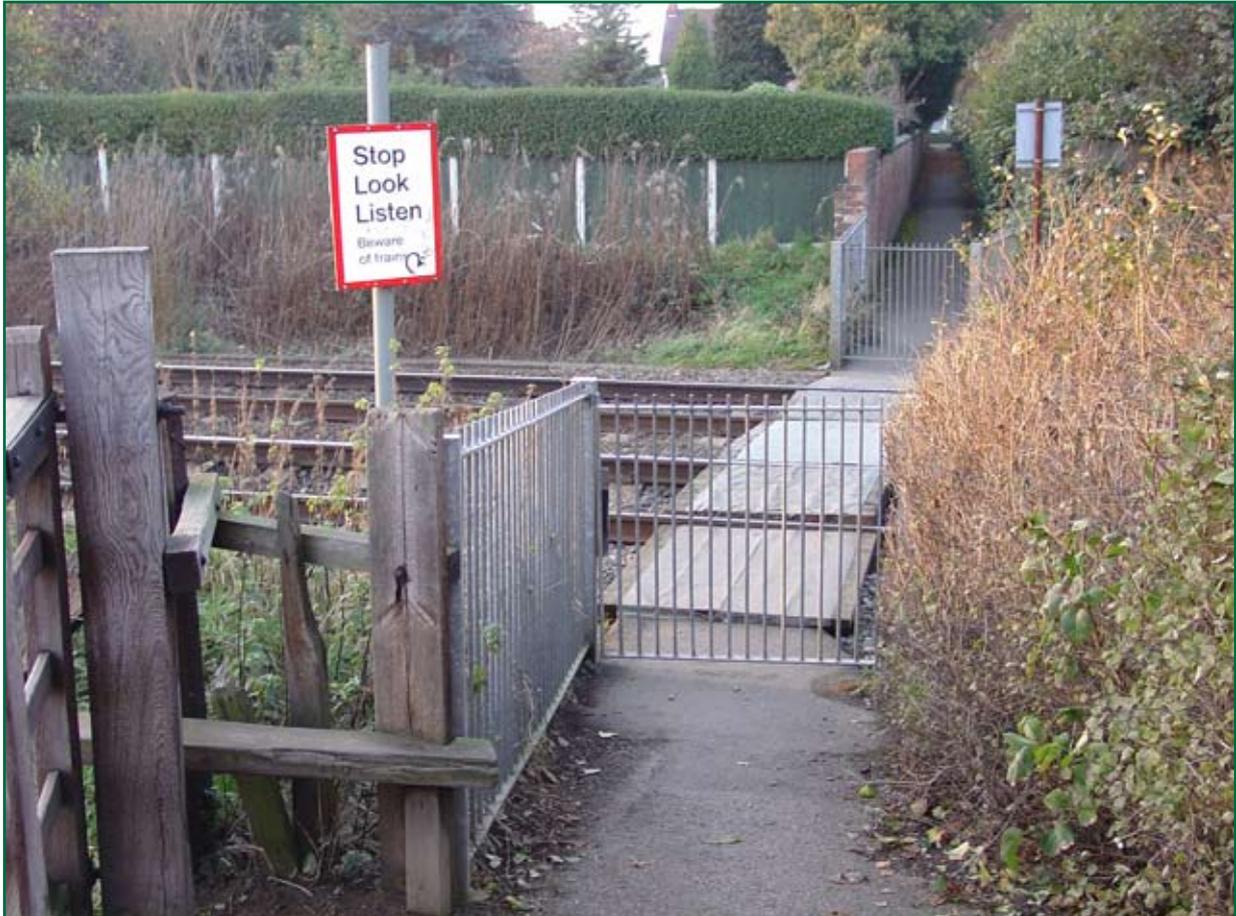
*Figure 3: Barratt's Lane No.1 crossing as seen from the approach from the St Mary's Close side, as used by the pedestrian.*

- 25 Figure 3 shows the footpath to Barratt Lane leading away from the far side of the crossing. The train that struck the pedestrian travelled from the left to the right on the far track (the down line) as seen in Figure 3 and Figure 4.

- 84 The maintenance records showed repairs to the non-slip surface were requested in late August 2005. These were completed before the date of the accident. No other issues were raised by the inspection report bar graffiti on one of the warning signs. A visual inspection of the crossing by the RAIB on 23 November 2005 found it to be in excellent working order with all of the required facilities and furniture provided. The graffiti mark found on the sign on the approach side used by the pedestrian did not make it illegible (see Figure 3).

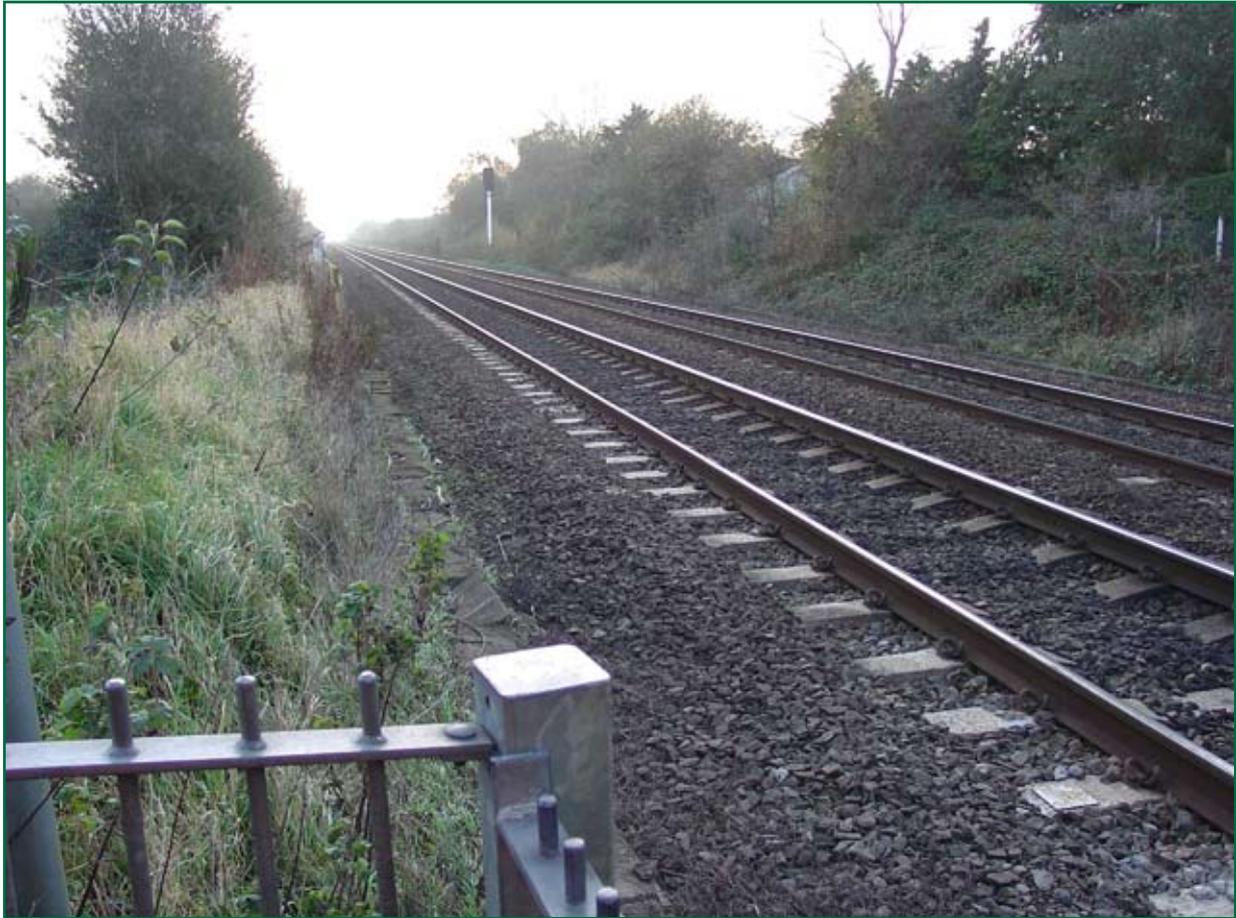
Figure 4: View from inside the wicket gate at Barratt's Lane No.1 footpath crossing looking towards London from the side the pedestrian crossed from (St Mary's Close)

- 26 Figure 4 shows the view the pedestrian would have had to the southwest when making a final decision whether to cross or not, except it was foggy on the day. The nearest track is the up line to London; the furthest is the down line on which train 1 approached. The signal is located 66 metres from the crossing.

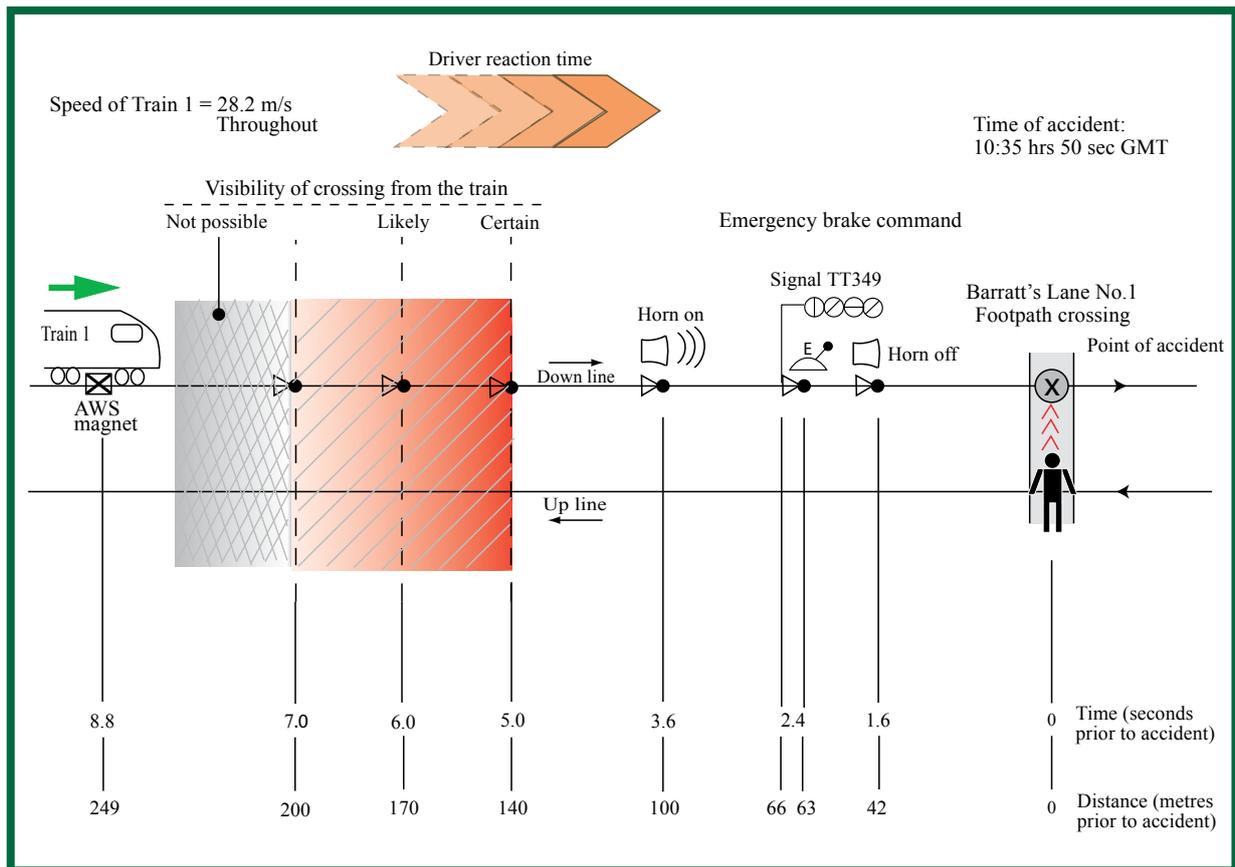
- 62 Figure 5 gives a schematic representation of the sequence of events derived from data records starting with Train 1 passing the AWS magnet for Signal TT349 (and therefore at that point still in fog and invisible to anyone looking from Barratt's Lane No. 1 crossing) to the moment of impact on the crossing. These events are described in more detail in the paragraphs that follow.

Figure 5: Schematic representation of the sequence of events leading up to the accident derived from the data records

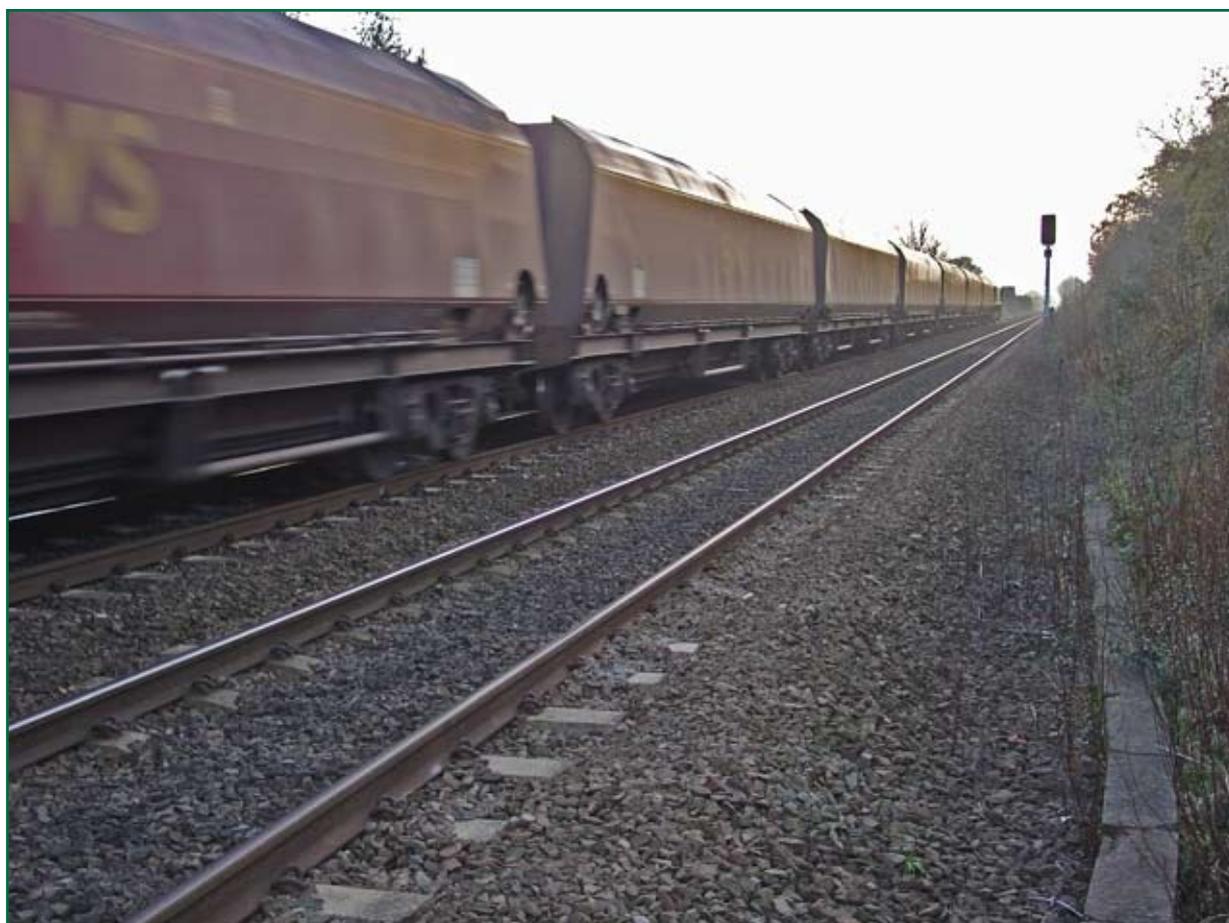
*Figure 6: View from inside the wicket gate at Barratt's Lane No.1 footpath crossing looking towards London from the side the pedestrian crossed towards (Barratt Lane)*

- 69 The coal train in Figure 6 on the up line provides a mobile scale – each wagon is 17.75 metres between coupler centres. The first wagon visible on the left has its coupler over the footpath crossing and acts as a zero datum. The locomotive at the head of the train is seven wagons distant, or 124 metres to its near end and 146 metres to its leading end. This is 6 metres more than the minimum calculated visibility distance in the fog at the time of the accident. The maximum calculated visibility is a further three wagons distant.
