Rail Accident Investigation Branch

Rail Accident Report

**The fatality at Barratt's Lane No.1 footpath
crossing
21 November 2005**

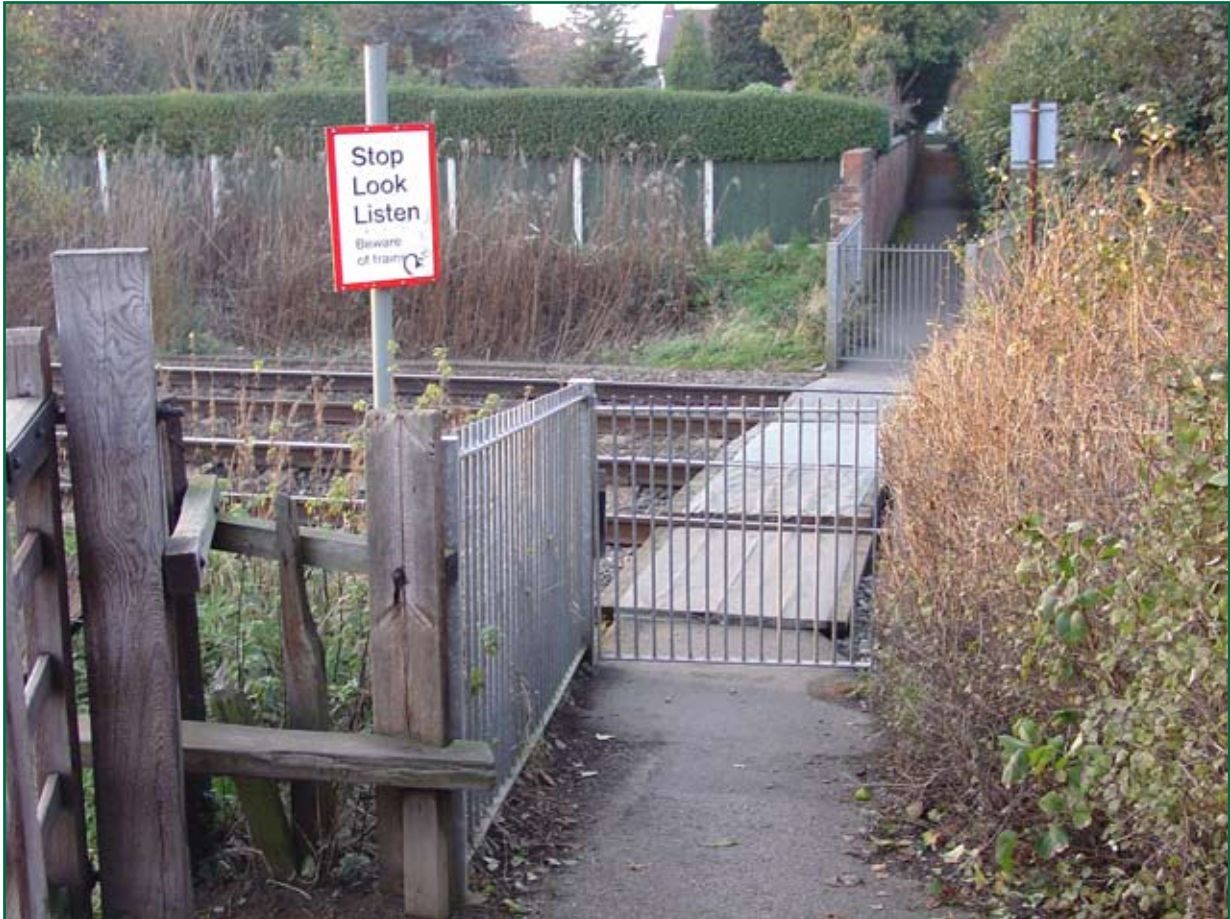
Figure 3: Barratt's Lane No.1 crossing as seen from the approach from the St Mary's Close side, as used by the pedestrian.

- 25 Figure 3 shows the footpath to Barratt Lane leading away from the far side of the crossing. The train that struck the pedestrian travelled from the left to the right on the far track (the down line) as seen in Figure 3 and Figure 4.

- 84 The maintenance records showed repairs to the non-slip surface were requested in late August 2005. These were completed before the date of the accident. No other issues were raised by the inspection report bar graffiti on one of the warning signs. A visual inspection of the crossing by the RAIB on 23 November 2005 found it to be in excellent working order with all of the required facilities and furniture provided. The graffiti mark found on the sign on the approach side used by the pedestrian did not make it illegible (see Figure 3).

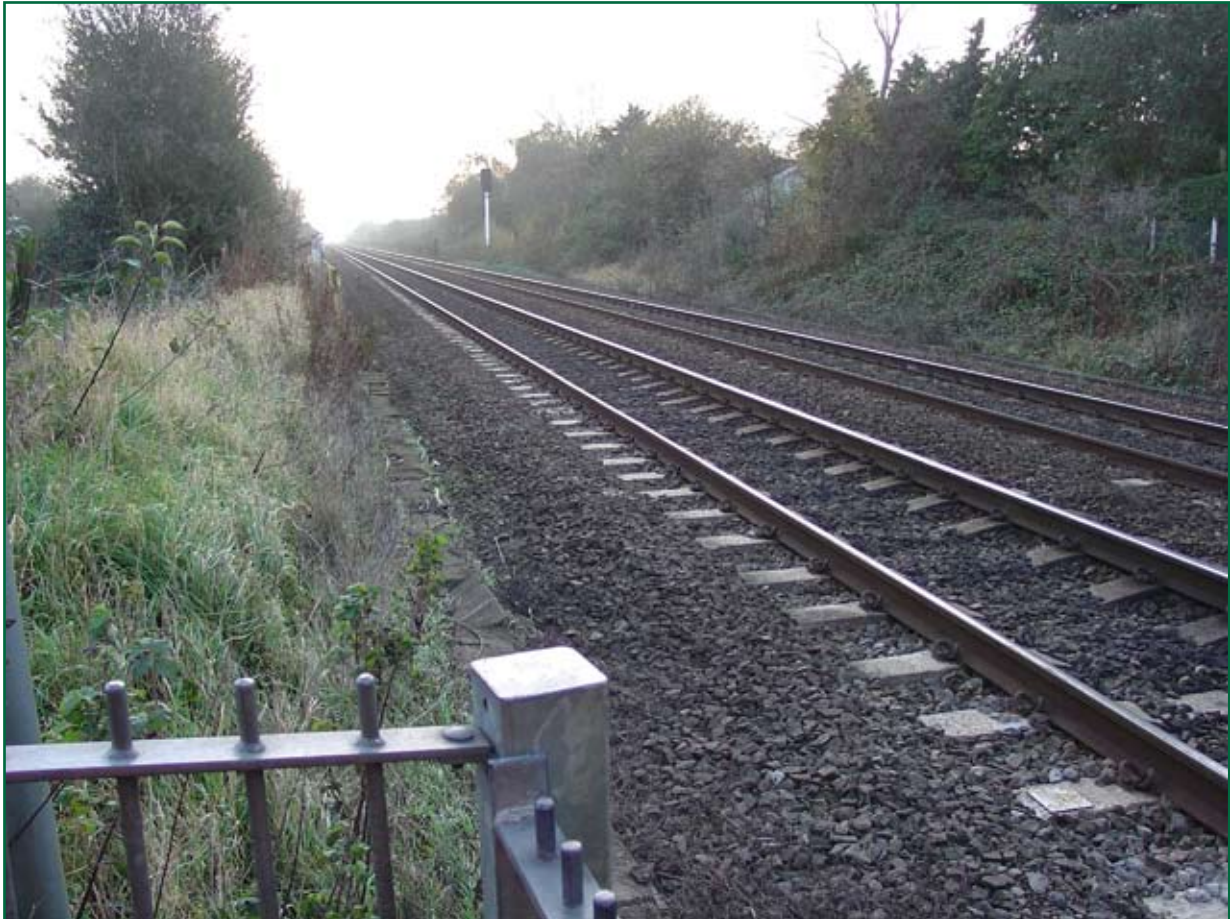
Figure 4: View from inside the wicket gate at Barratt's Lane No.1 footpath crossing looking towards London from the side the pedestrian crossed from (St Mary's Close)

- 26 Figure 4 shows the view the pedestrian would have had to the southwest when making a final decision whether to cross or not, except it was foggy on the day. The nearest track is the up line to London; the furthest is the down line on which train 1 approached. The signal is located 66 metres from the crossing.

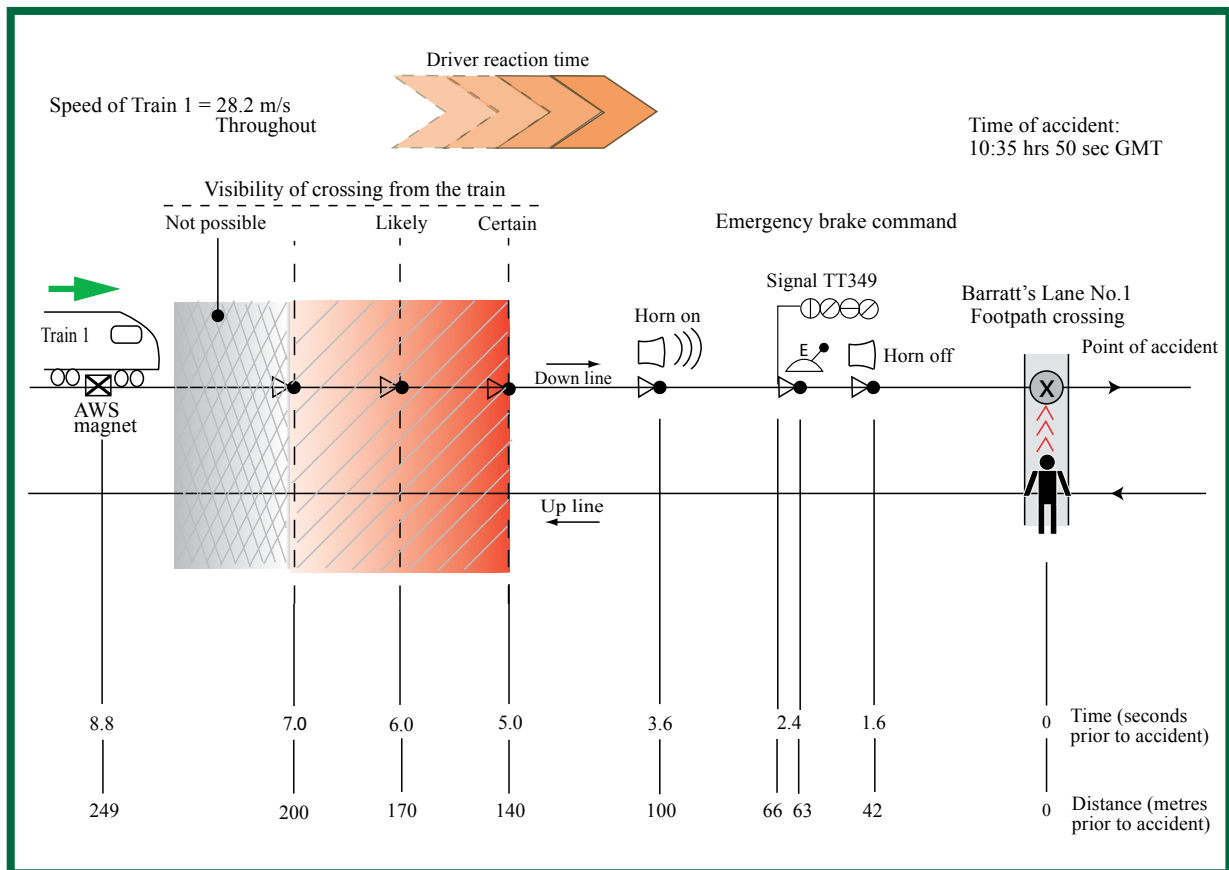
Figure 5: Schematic representation of the sequence of events leading up to the accident derived from the data records

- 62 Figure 5 gives a schematic representation of the sequence of events derived from data records starting with Train 1 passing the AWS magnet for Signal TT349 (and therefore at that point still in fog and invisible to anyone looking from Barratt's Lane No. 1 crossing) to the moment of impact on the crossing. These events are described in more detail in the paragraphs that follow.

- 64 At 10:35 hrs and 46.4 seconds the driver started sounding the warning horn after observing the person on the crossing. At 47.1 seconds he started to move the power brake controller from notch 3 throttle (maximum power) into emergency brake. At 47.6 seconds the emergency brake demand was activated. It took a further 3.5 seconds for the brake system to respond and generate a significant part of the full brake effort.

- 65 It is estimated from the train data recorder information cross-correlated with the distance between the *AWS magnet* and the footpath crossing that the pedestrian was struck 2.4 seconds after the emergency brake demand was made by the driver (that is, at 10:35 hrs 50 seconds GMT which is registered as 10:38 hrs and 17.2 seconds by the train data recorder of train 1). Due to the brake system response time, the brakes did not reduce the speed of the train by the time of the impact.

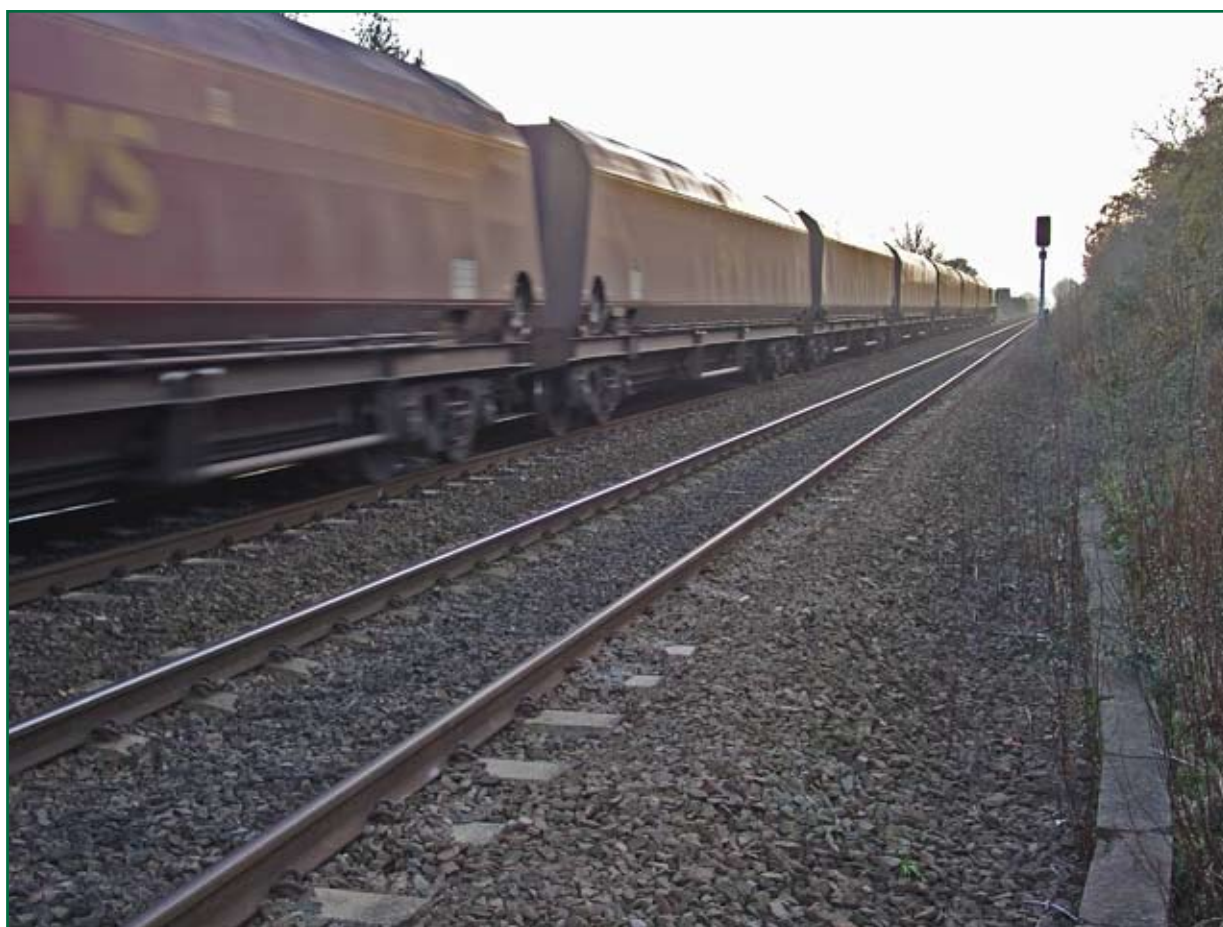
Figure 6: View from inside the wicket gate at Barratt's Lane No.1 footpath crossing looking towards London from the side the pedestrian crossed towards (Barratt Lane)

- 69 The coal train in Figure 6 on the up line provides a mobile scale – each wagon is 17.75 metres between coupler centres. The first wagon visible on the left has its coupler over the footpath crossing and acts as a zero datum. The locomotive at the head of the train is seven wagons distant, or 124 metres to its near end and 146 metres to its leading end. This is 6 metres more than the minimum calculated visibility distance in the fog at the time of the accident. The maximum calculated visibility is a further three wagons distant.
