Rail Accident Investigation Branch

# Rail Accident Report

**Near miss of two track persons by a tram on  
the Manchester Metrolink, Radcliffe  
8 November 2005**

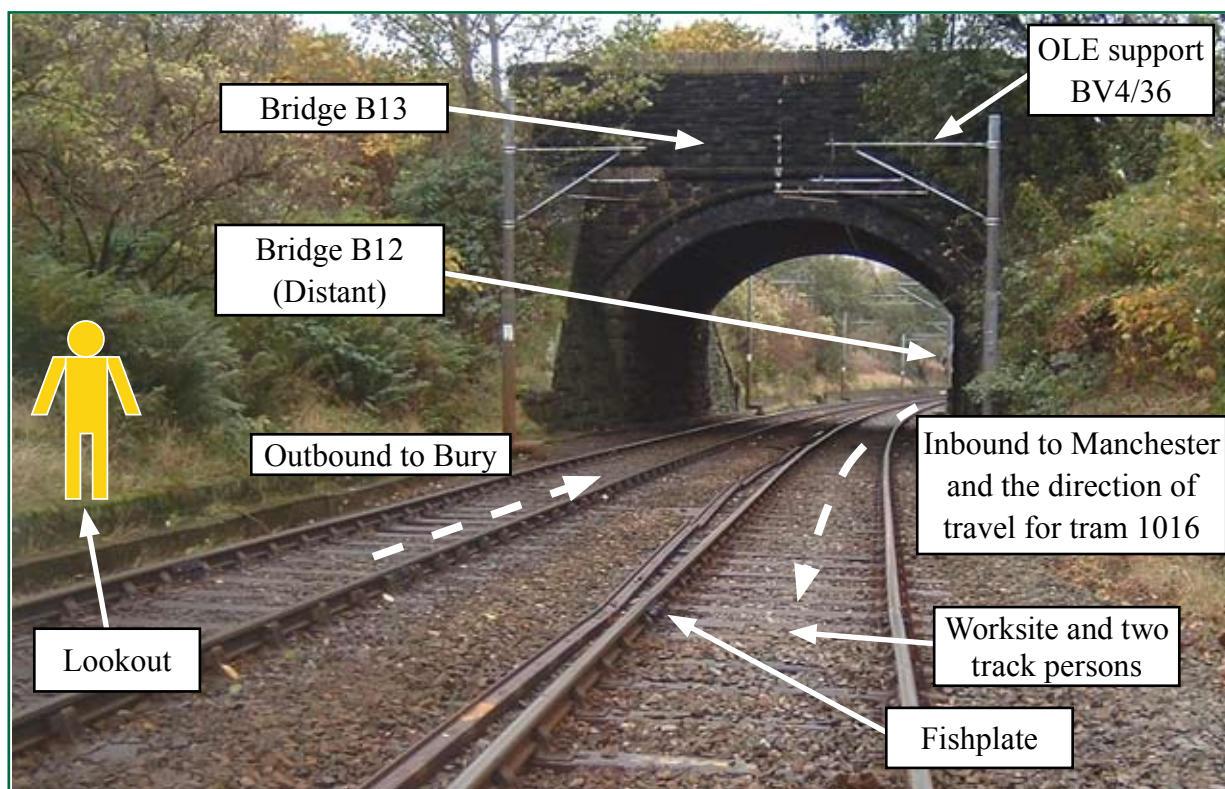
Figure 2: Photograph of the location

20 The incident occurred in the segregated section south of Bury, between Radcliffe and Whitefield tram stops. The location was the inbound running line beyond OLE support BV4/36. It is shown in the photograph (Figure 2) and the site plan (Figure 1). Events following the incident extended the incident site to the operational area bounded by Radcliffe and Whitefield stations.

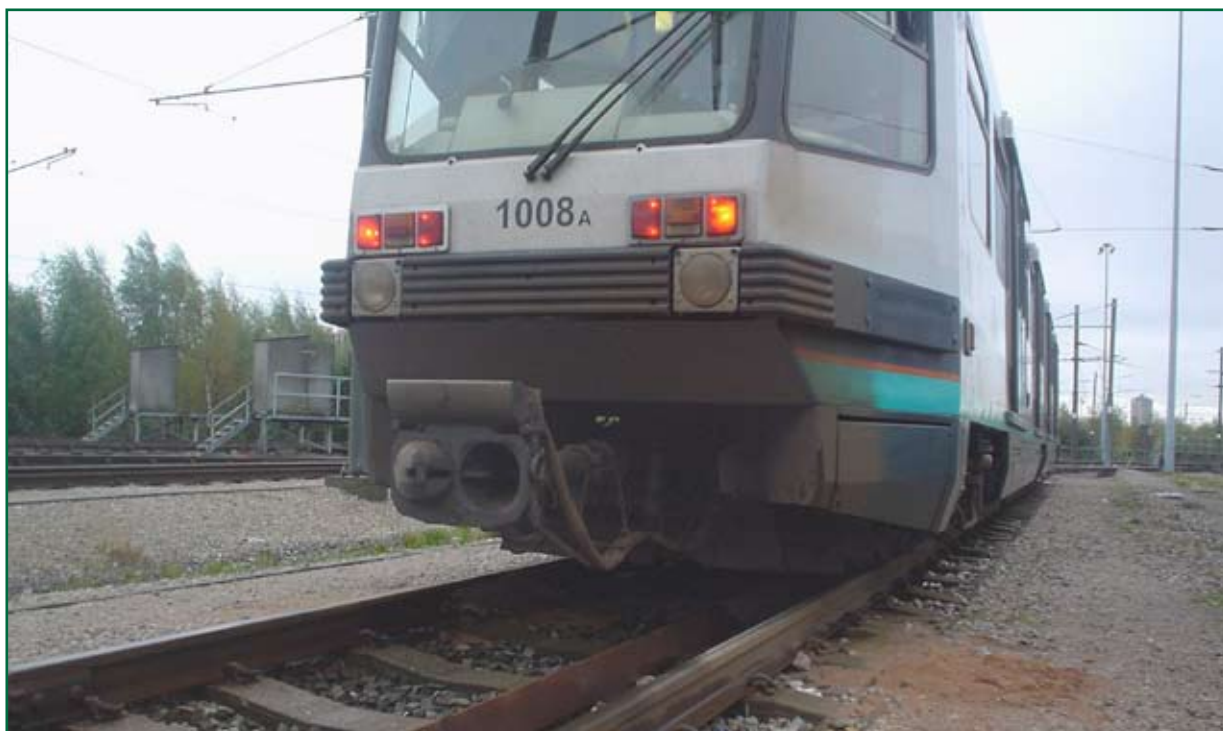
Figure 4: Photograph of the lower aspect of a phase 1 tram

35 There were neither fatalities nor injuries among the tram driver, passengers or track persons. The tram sustained minor damage to brake rigging adjacent to the leading axle, the Vehicle Recognition System (VRS) coils and an Automatic Tram Stop (ATS) beacon. Inspection, repairs and functional testing were carried out during the day of the incident and the tram was back in service by early evening. Photographs of the lower aspect of a phase 1 tram and the irreparably damaged Bance are shown in Figures 4 and 5.

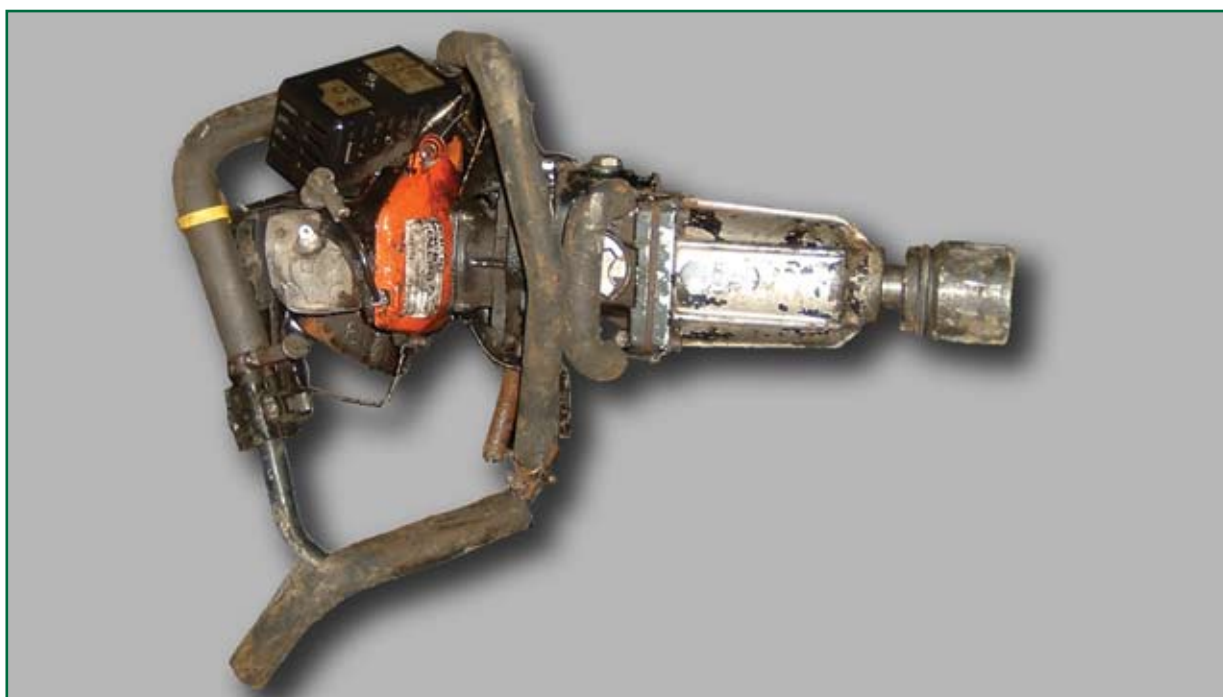
Figure 5: Photograph of the irreparably damaged Bance

- 34 The tram struck the Bance that neither PIC 1 nor contractor A had the opportunity to take to a position of safety. The tram stopped with its rear car 40 metres from the worksite. The actions of the driver and the response of the tram can be seen in the context of time, distance and location in the diagram in Appendix C.

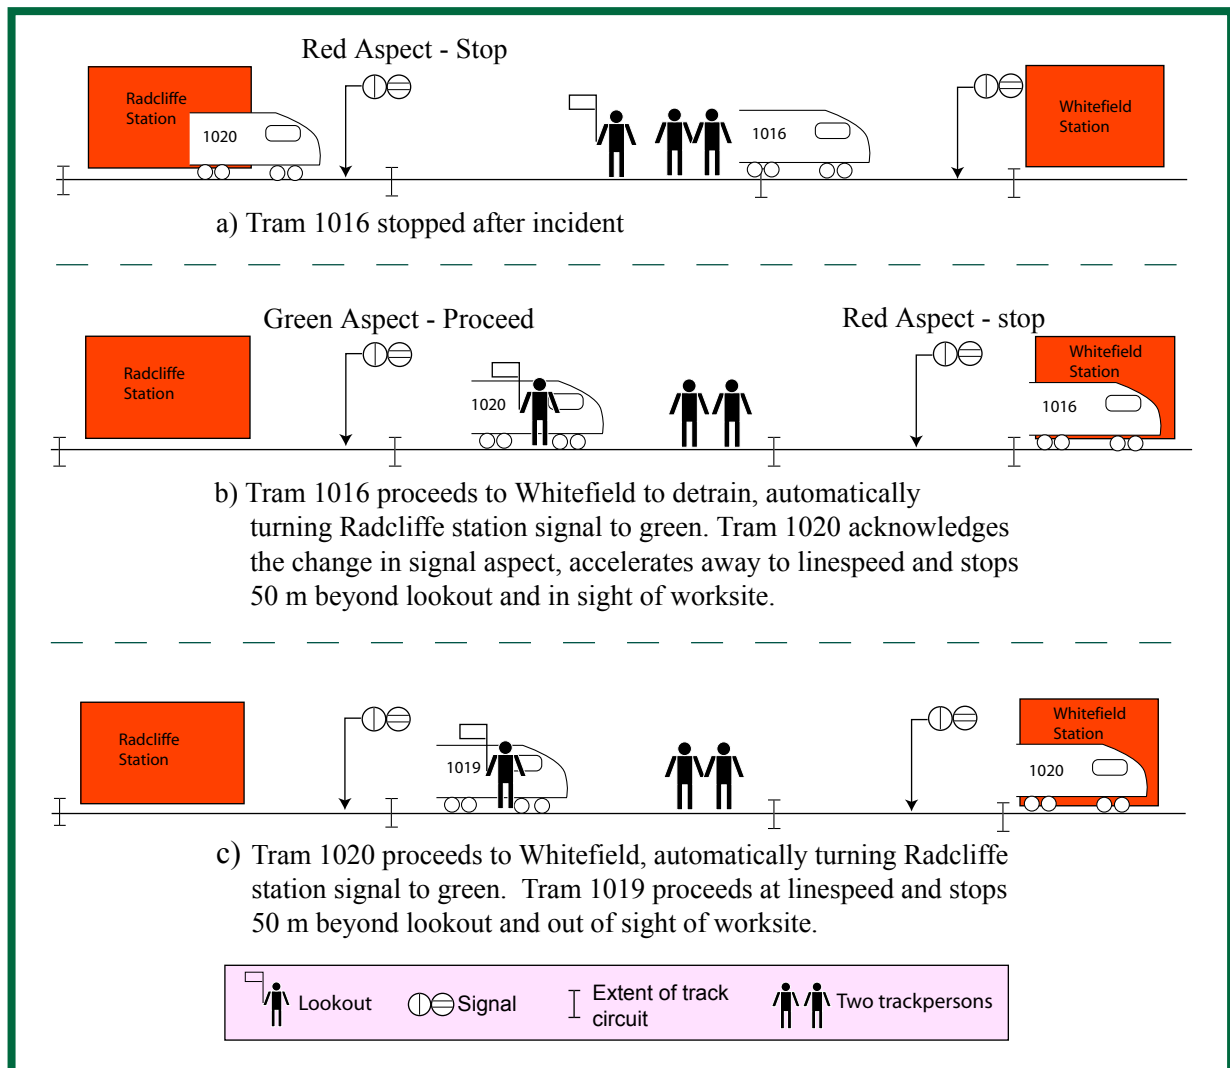
Figure 6: Sequence of events following the incident

39 PIC 1 contacted control via mobile telephone after speaking with the tram driver and was answered by controller C. PIC 1 asked for trams to be stopped while work was completed and stated that the lookout was walking outbound to stop trams with the red flag. No clear understanding was reached between PIC 1 and controller C, and trams were not stopped.

- 40 The call between PIC 1 and controller C remained open although PIC 1 believed the call was concluded. At this time the driver of inbound tram 1020 called control and was answered by controller B. The driver questioned being stopped at Radcliffe station by a signal with a red aspect. The signal changed to a green aspect immediately contact was made with controller B who advised the driver that the previous tram had been involved in an incident at a worksite but was now on the move. The driver was advised that normal running had resumed and he accelerated away from Radcliffe as normal.

- 41 The driver of tram 1020 sighted the lookout displaying the red flag and braked to a stop approximately 50 metres beyond the lookout and in sight of the worksite. PIC 1 used hand signals to instruct the tram to move towards him and pass the worksite at slow speed as the replacement fishplates had not yet been secured. Tram 1020 passed the worksite and continued normally.

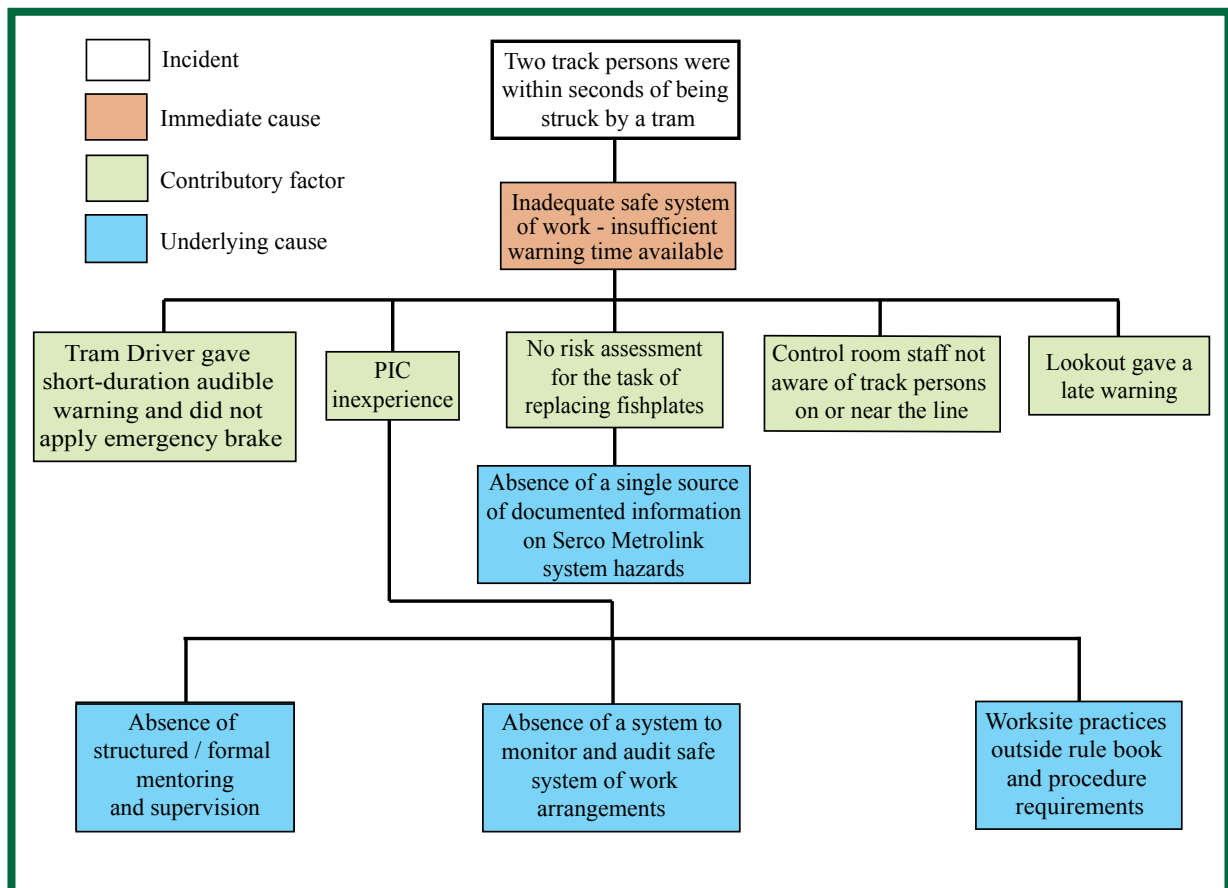
Figure 7: Summary of causal analysis

74 The immediate cause of the incident was the inadequate *safe system of work* that was adopted. Particularly, there was insufficient time available for a *lookout* to sight an approaching tram and give warning to the track persons.
