Rail Accident Investigation Branch

# Rail Accident Report

## Derailment at Oubeck North near Lancaster 4 November 2005

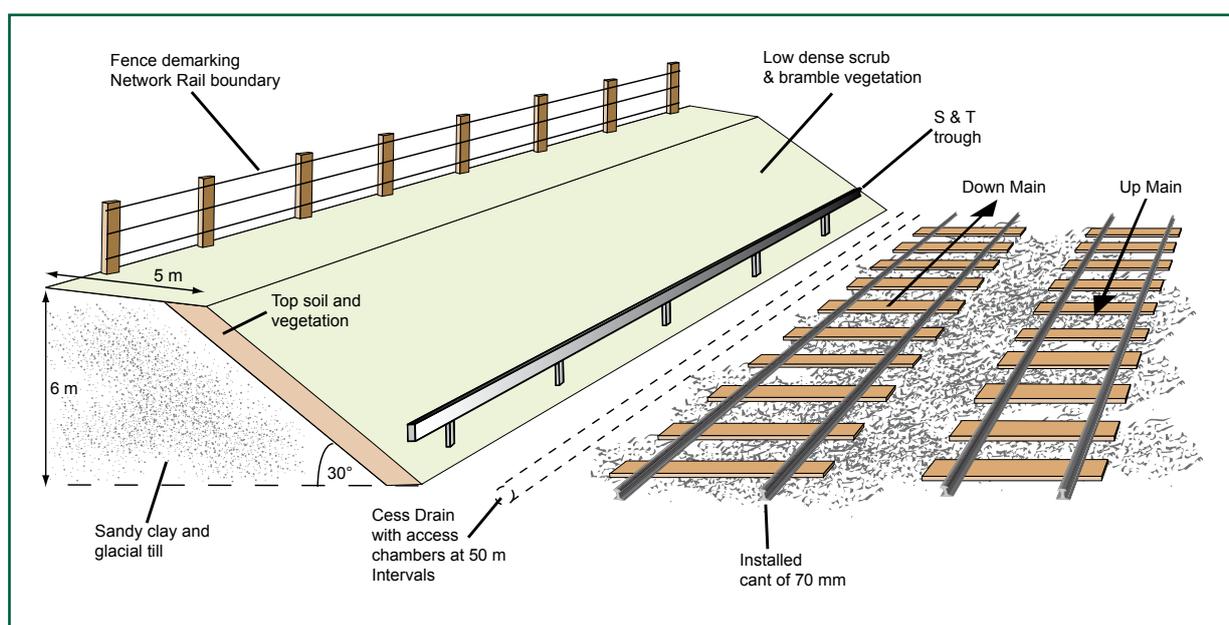
- 29 There is a *cess drain*, but no *crest drain* or surface drainage on the cutting. At this location and to the south of the failure site the cess drain is a piped system, containing several chambers at approximately 50 m intervals.

- 30 There is a *signalling and telecommunication (S&T)* trough route supported on stub concrete posts at 1.5 m centres set into the *slope toe*.

Figure 2: Diagrammatic presentation of the cutting slope prior to failure

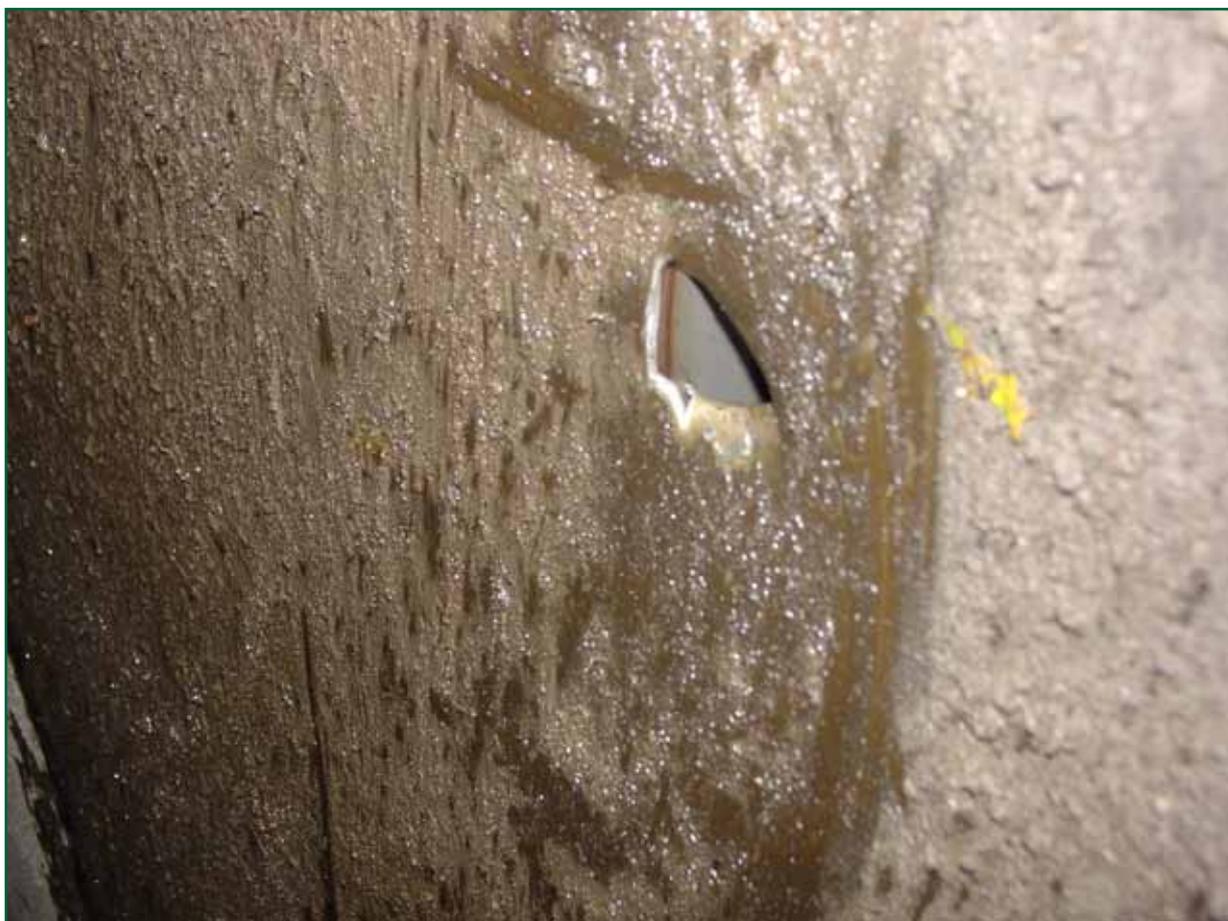
- 35 At approximately 13:56 hrs the train ran into a landslip at Oubeck North. The trailing wheelset on the leading bogie on the leading car derailed to the six foot. No other wheels were derailed. The train came to rest in an upright position after travelling a further 1430 m.
- 36 There were no injuries, although one passenger was airlifted to hospital with a suspected angina attack.
- 37 There was no collision with structures or other trains. A freight train on the up main line was stopped by emergency hand signals given by the driver of train 1C62. This prompt action by the driver prevented the consequences being more serious.
- 38 Two coupler lateral bump stops were dislodged from the leading vehicle and came to rest 200 m after the landslip. They caused damage to the underframe including holing the fuel tank on the leading vehicle as shown in Figure 3.

Figure 3: Hole in fuel tank

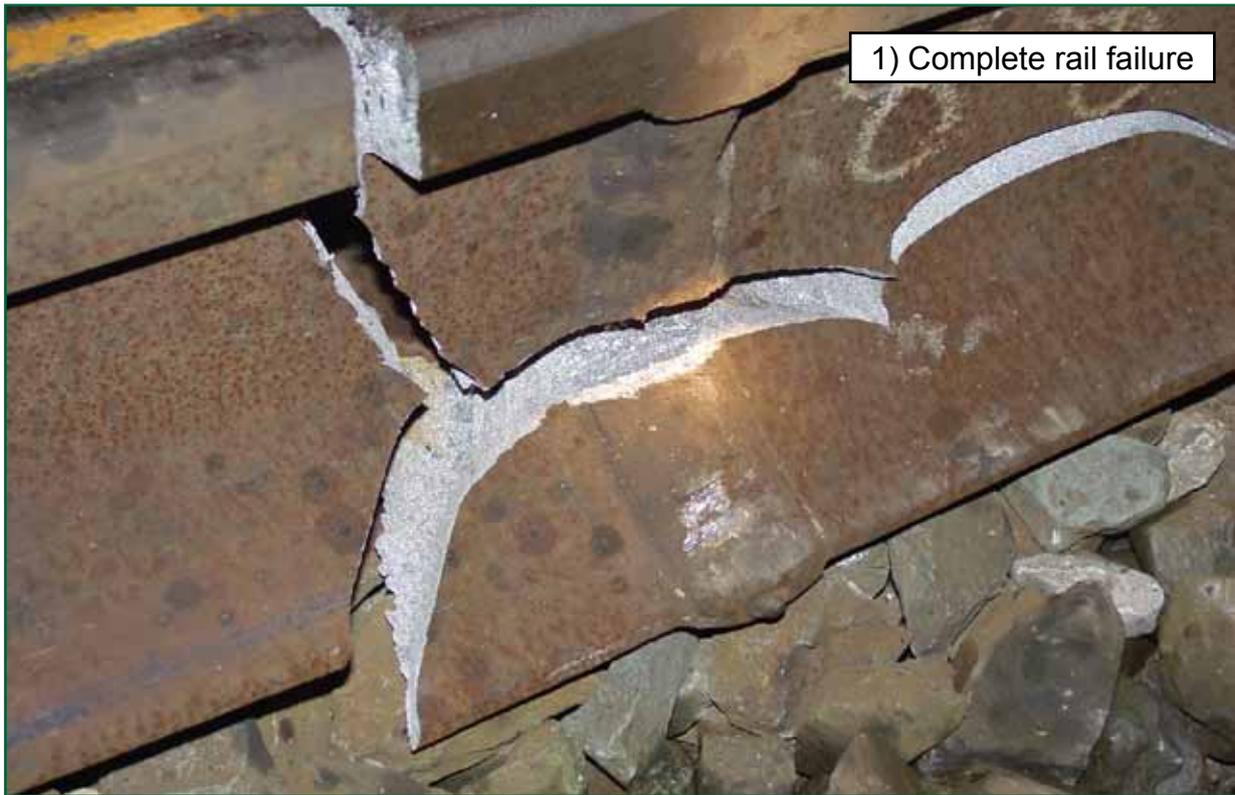
1) Complete rail failure

Figure 4: Examples of three different types of rail fractures observed

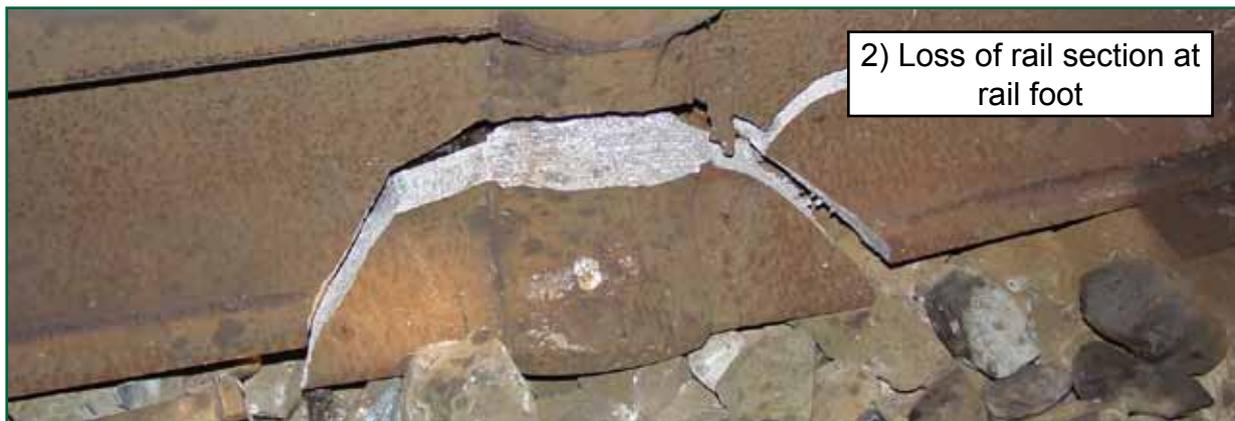
2) Loss of rail section at rail foot

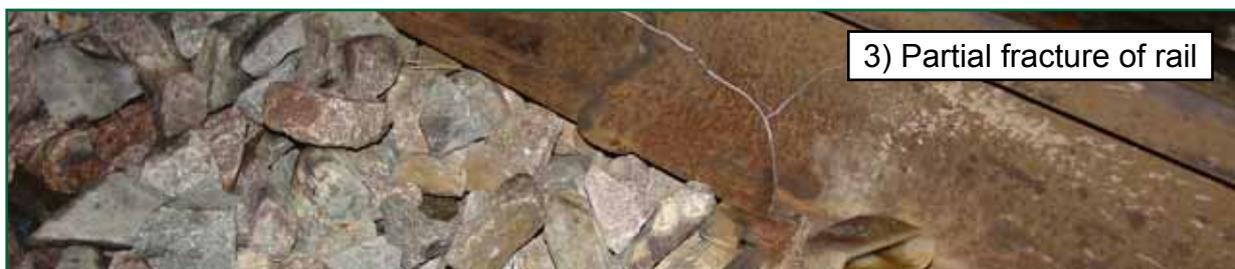
3) Partial fracture of rail

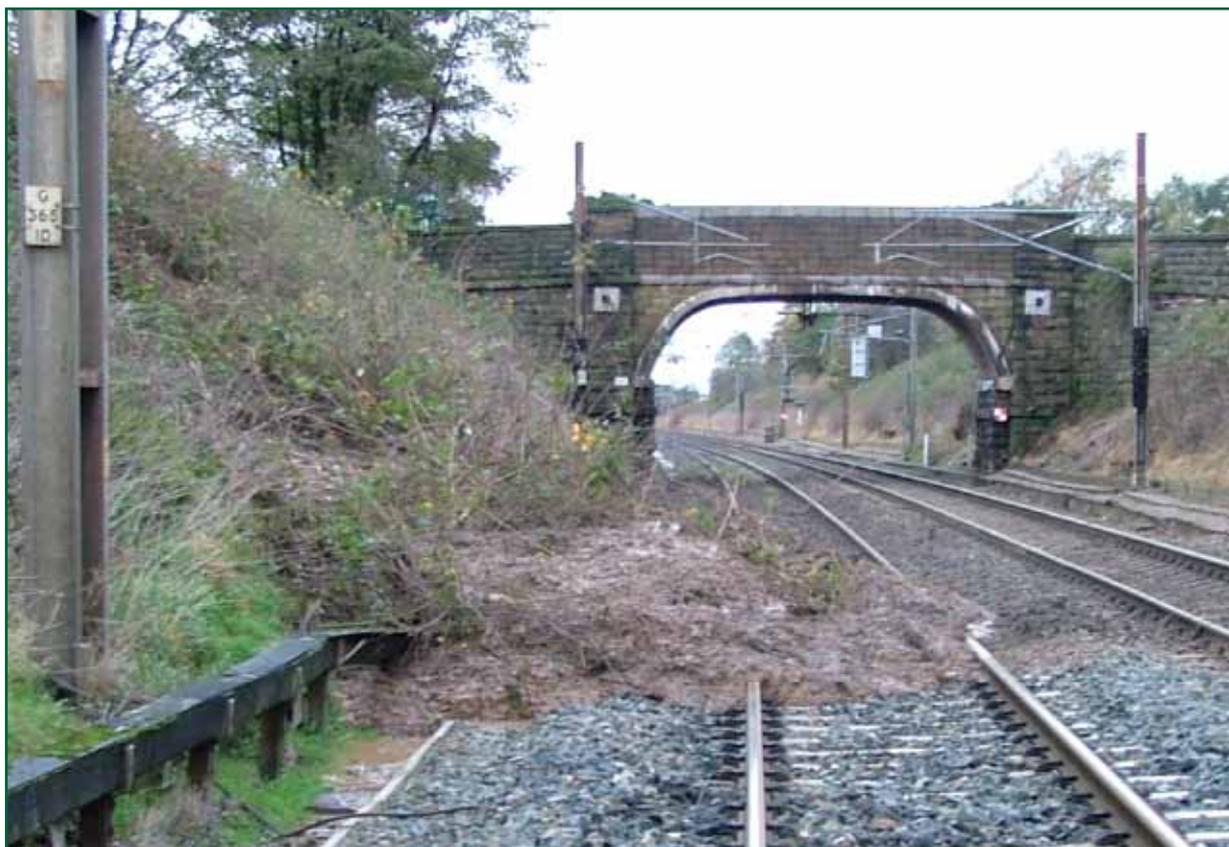
49 Post incident site investigations revealed that the landslip left a *scar face* approximately 10 m long and 2.5 m high on the cutting slope.

Figure 5: Landslip at Oubeck North looking in the direction of traffic

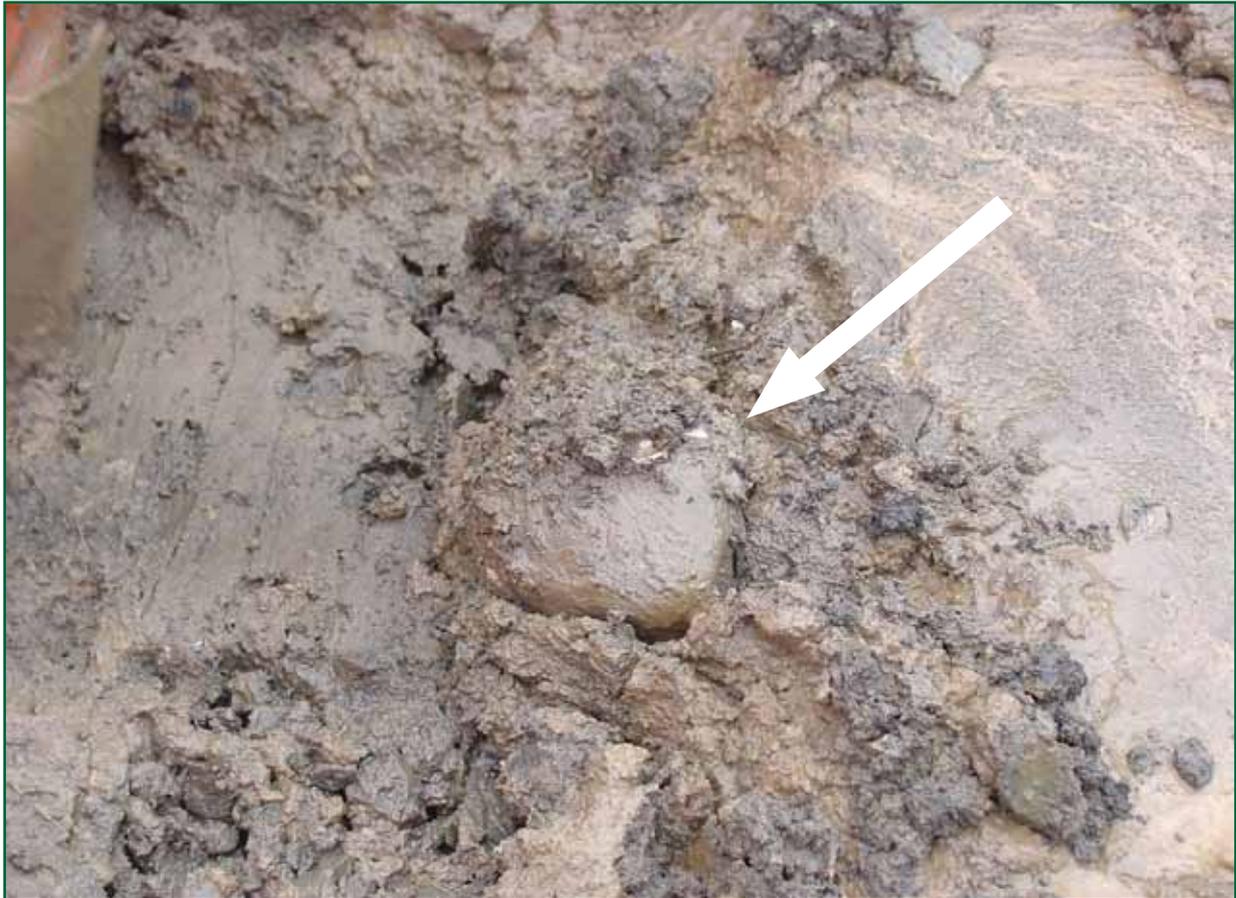
51 The landslip material comprised slabs of turf with saturated flow deposits behind. The material on the track was supersaturated and mainly consisted of soil and clay material, but also contained a number of large boulders, several of which were reported as being in excess of 500 mm in diameter. Figure 6 gives an indication of the consistency and shows a boulder of the order of 200 mm diameter in the landslip, indicated by the arrow. This photograph was taken during the digging out process on the day following the derailment.

Figure 6: Indication of consistency and boulders in the landslide material

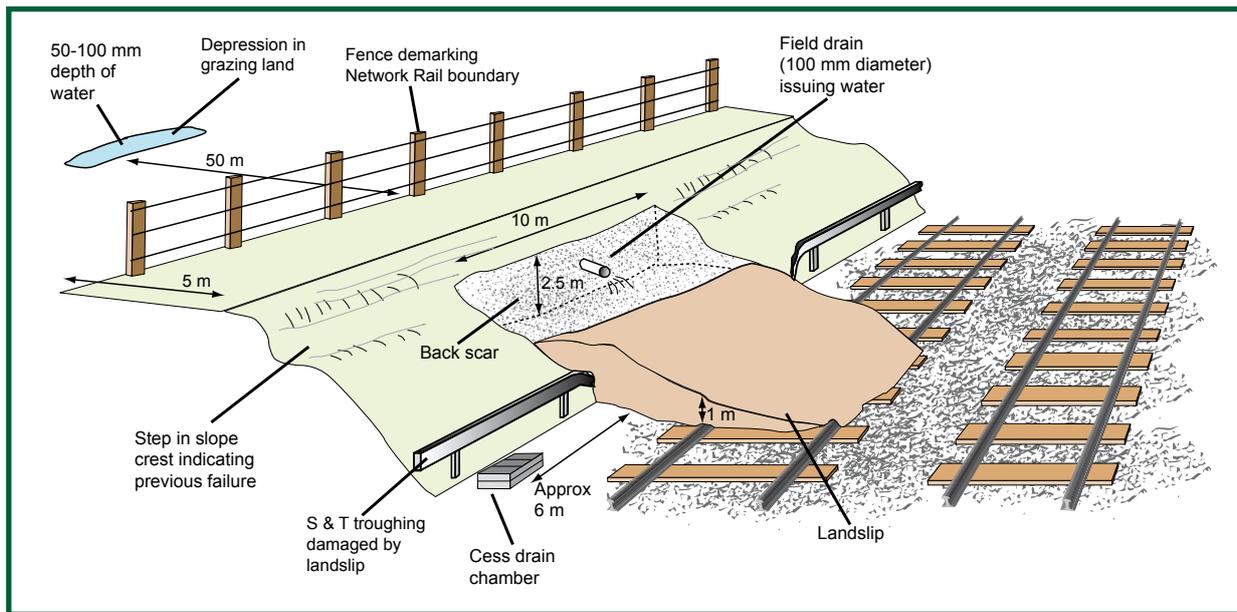
- 54 During the remedial work the vegetation was cleared from the top of the cutting for a distance of approximately 25 m north and south of the landslide location. This revealed an obvious step in the slope crest. This may have been an indication that there had been a previous failure at this location. The step was very rounded and buried by deep vegetation. Additionally, a site of possible previous *toe heave* was identified.

- 55 The cess drain at this location and to the south of the failure site was a piped system, containing several chambers at approximately 50 m intervals. The cover of the nearest chamber to the derailment site was removed to reveal that the drain was free flowing. Each of the chambers contained inlet pipes of about 100 mm diameter coming from the direction of the slope. One of these chambers was roughly in line with the outflow from the field drain. It is uncertain whether the pipes in the chambers are connected to *carrier drains* connecting the field drains to the cess drain. No records were made of any discovery of the remains of any pipes connecting the exposed field drain to the cess drain during the excavation and repair of the slope. The site findings are shown in Figure 7.

Figure 7: Cutting slope after landslide

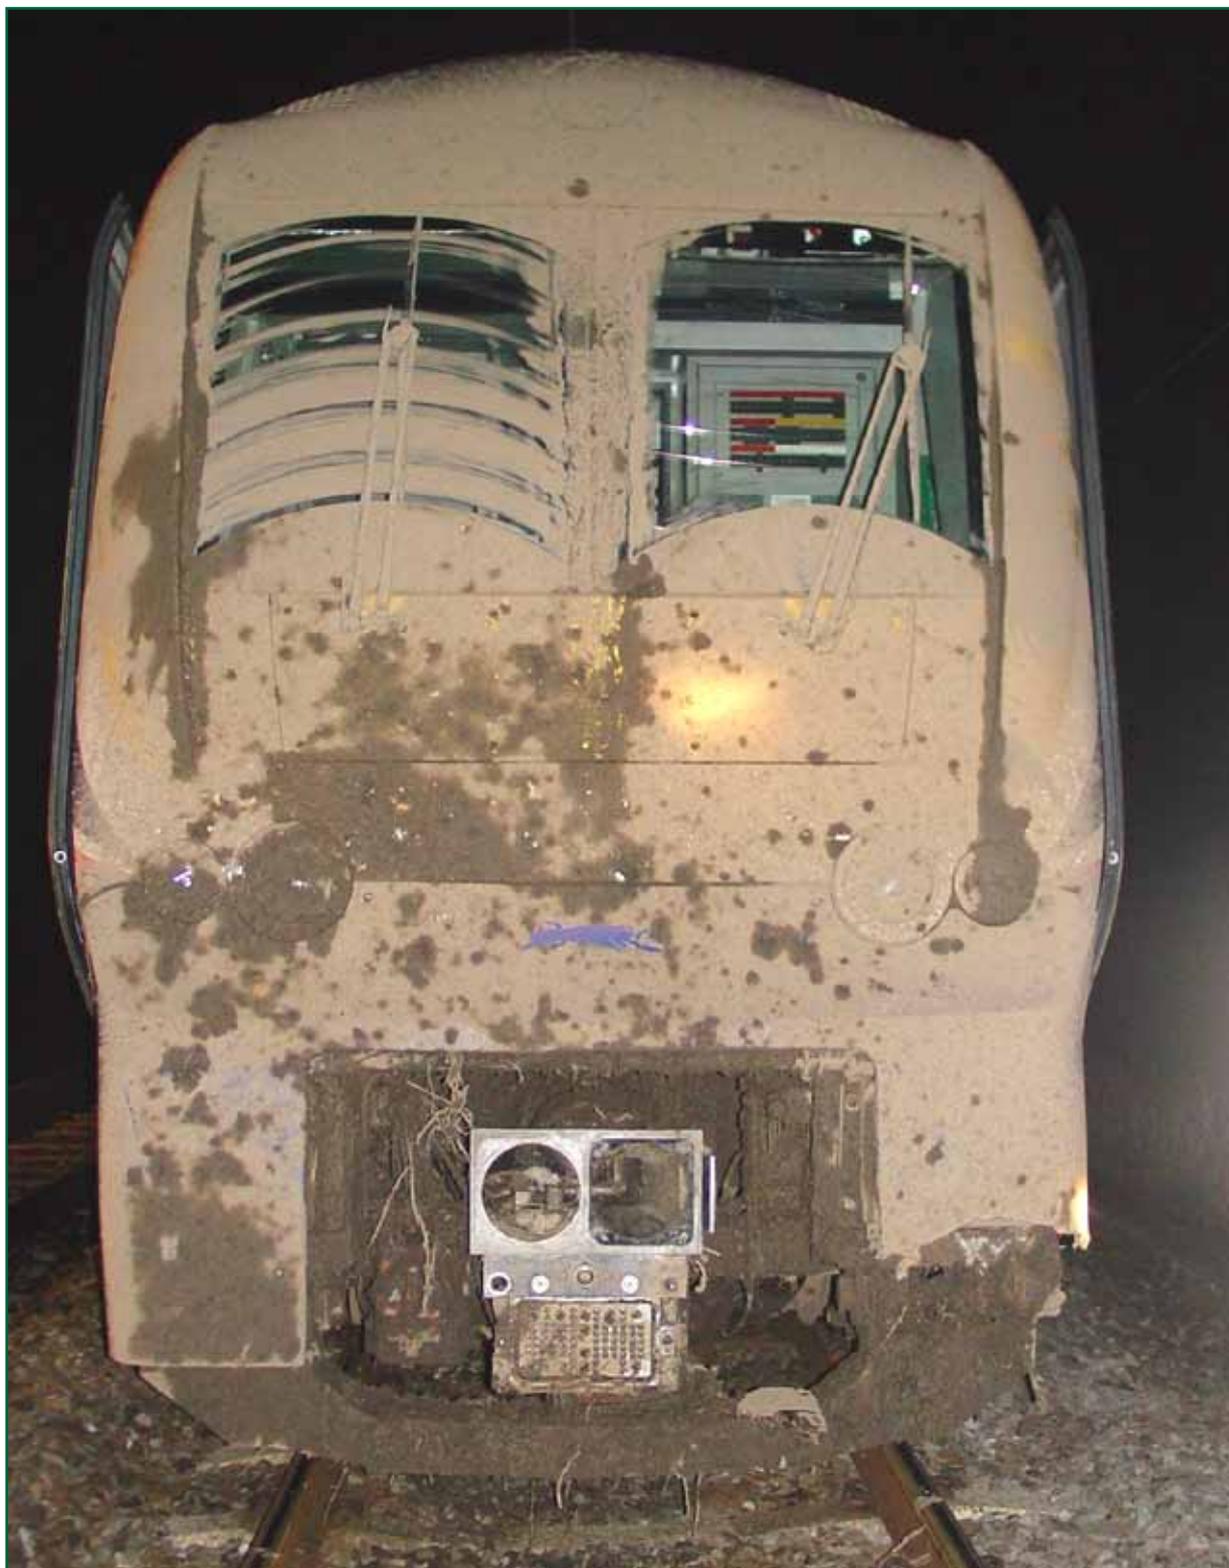
65 The train was examined at the site of the derailment prior to re-railing (see Figure 8), at Carnforth on 16 November 2005 and at Alstom Trainline Services, Wolverton on 30 November 2005 (before cleaning) and 9 December 2005 (after cleaning). The key findings are summarised in the following paragraphs (left and right hand sides are relative to the direction of travel when the train hit the landslip).

*Figure 8: Exterior of the vehicle following derailment*

- 85 There may have been a previous failure of the cutting slope at this location, evident by the step at the slope crest, corroborated by comments made by a local person (see paragraph 62). The vegetation coverage of the slope was such that the evidence of the previous failure was not visible from the track or slope crest. Additionally, there was evidence of a site of possible toe heave. There was however no evidence (eg *survey targets*) of specific monitoring at the site prior to this incident.

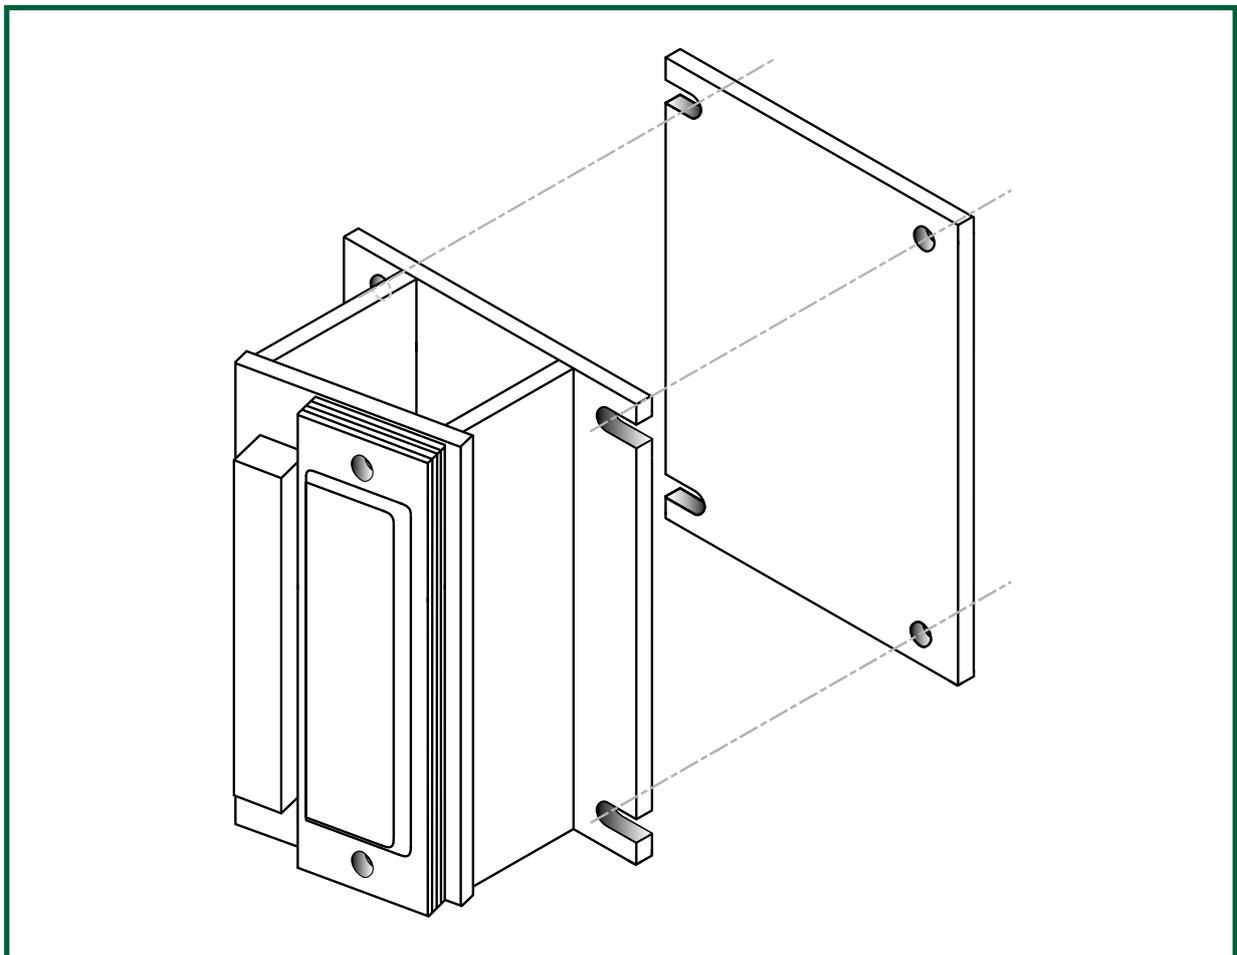
77 The coupler lateral bump stops are bolted onto plates mounted onto the *cab structure*, as shown in Figure 9. The lower edge of the coupler lateral bump stops is 787.5 mm above rail height.

Figure 9: Class 175 coupler lateral bump stops

- 78 The holes are slotted on the leading edge of the coupler lateral bump stop plate and on the trailing edge of the headstock, all other holes are drilled. Alstom, the train manufacturer, has advised that this arrangement is to ensure that the coupler lateral bump stops do not prevent the coupler retracting in a significant collision, thereby avoiding 'bridging out' the crashworthiness performance of the train structure.

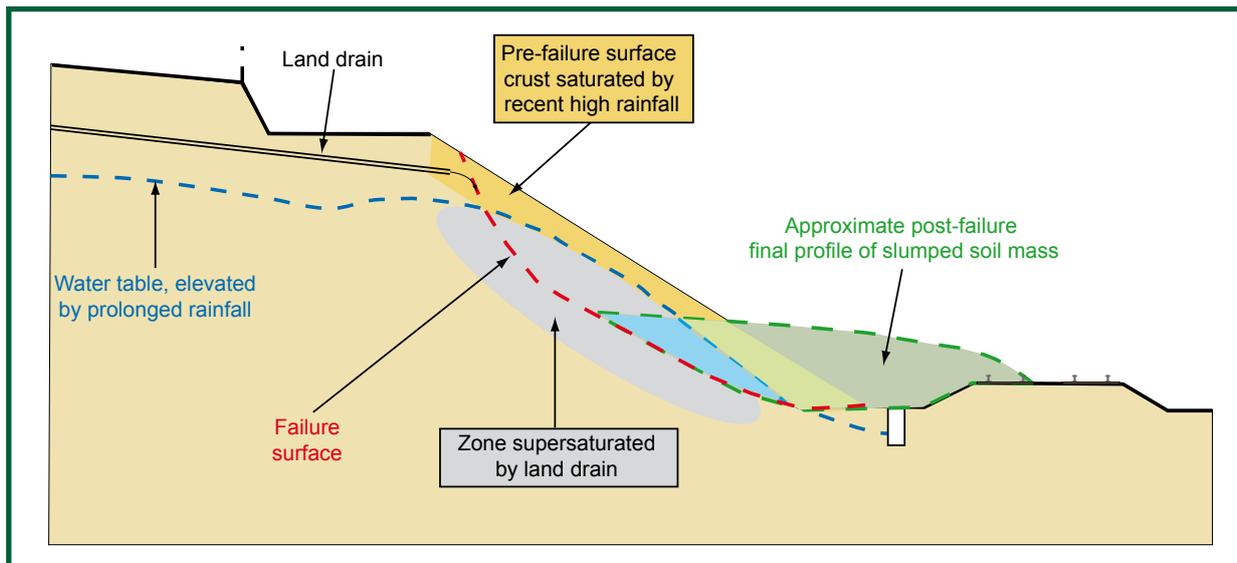
113 Whether as a result of failure in a carrier drain from the field drain, or because the field drain was installed without an outfall, water was flowing into the body of the slope, locally elevating groundwater levels that were already high as a result of the prolonged wet period.

114 The heavy rainfall immediately prior to the incident saturated the topsoil and vegetation layer on the cutting slope surface. The resulting weight increase caused the upper 300 to 500 mm soil layer to slide down the bank (a *translational failure*).

115 The loss of the constraint on the underlying glacial till allowed it to flow. The liquefied soils flowed down to the south covering both rails and pushed the top soil to the north and further onto the track.

116 This earthwork failure is described as earthflow and is shown diagrammatically in Figure 10.

Figure 10: Sketch section through the failed cutting slope

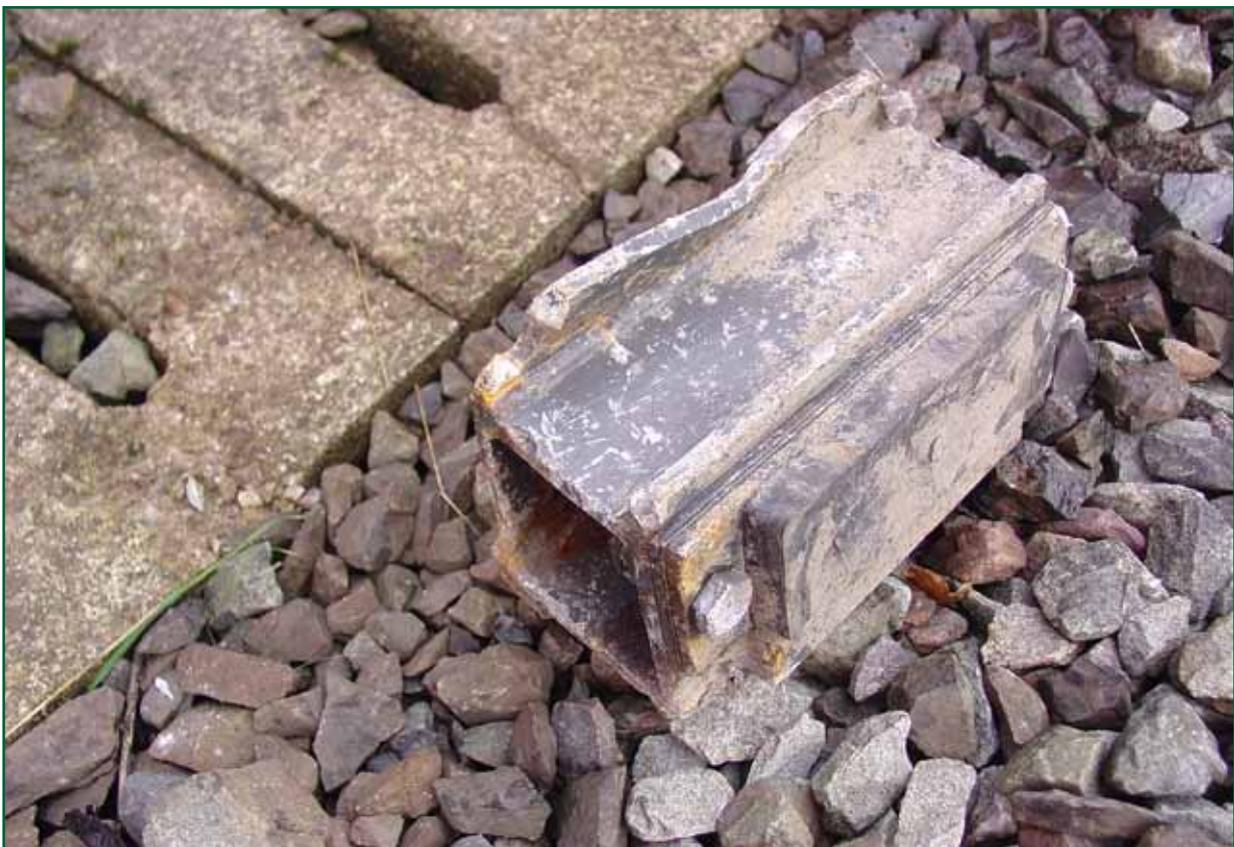
- 133 The coupler lateral bump stops were found in a relatively clean condition (see Figure 11) when compared with the rest of the front of the vehicle (see Figure 8) and especially considering the state of the equipment and surfaces within the coupler pocket (see Figure 12). This suggests that the coupler lateral bump stops were dislodged early in the incident, before the train ploughed through the debris, however it is not conclusive.

*Figure 11: Coupler lateral bump stop in the 'as found' condition*

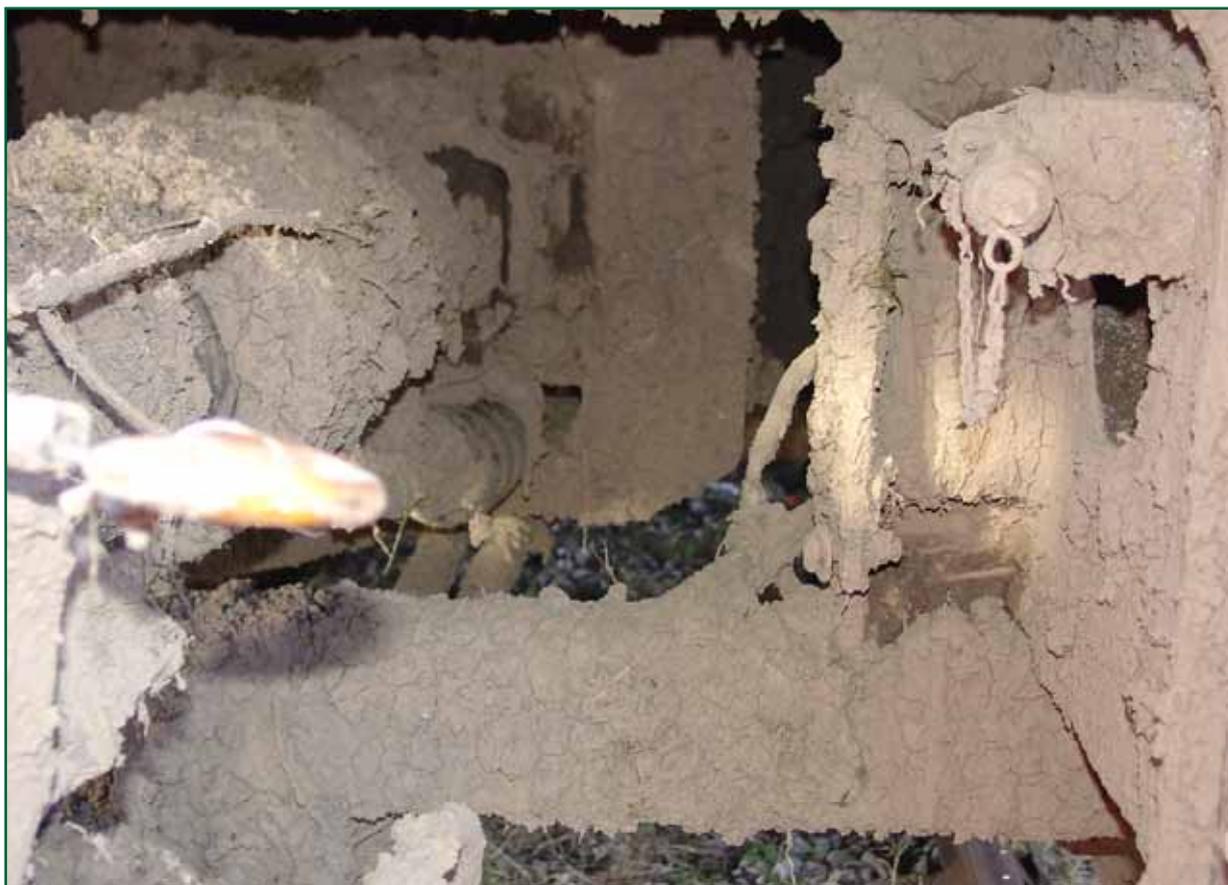
- 134 **Coupler impacting the coupler lateral bump stops** either as a result of the train body receiving a lateral acceleration due to the asymmetric impact with the landslip and in turn exciting the coupler to accelerate in the lateral direction or as a result of an input force causing the coupler to swing from side to side.
- 135 The body would have been deflected laterally by the obstacle deflector and the GRP valance hitting the landslip debris mound. The dynamics of this situation made it possible that the coupler oscillated from side to side in the coupler pocket at least once.

Figure 12: Coupler pocket following passage through landslide
