Rail Accident Investigation Branch

Rail Accident Report

Derailment at Watford Junction Yard

28 October 2005

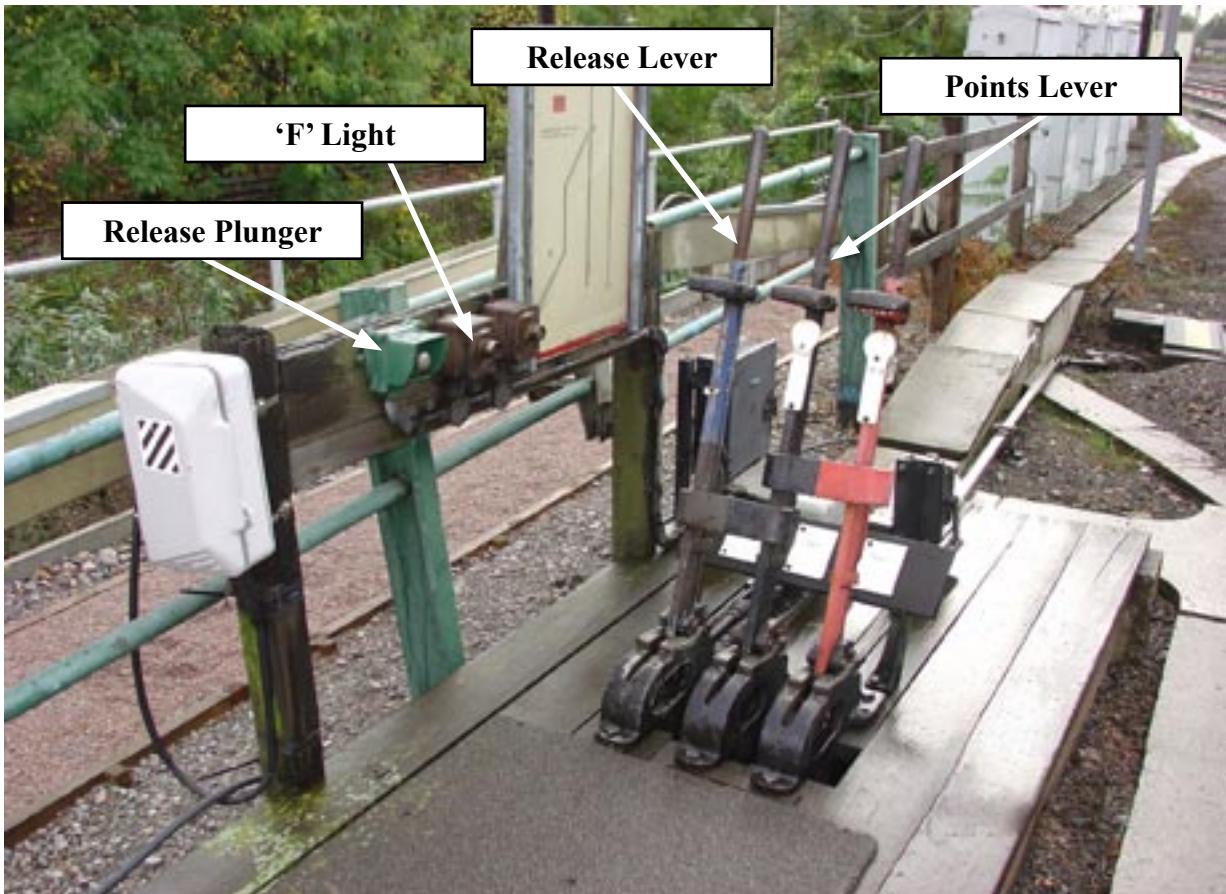
Figure 2: Watford Yard Ground Frame

- 12 The *ground frame* is shown in Figure 2. When it is *released* by the signaller, a white light with a black letter 'F' on a panel adjacent to the *ground frame* is illuminated. To obtain control of the *ground frame*, the operator presses a plunger when the light is illuminated and simultaneously pulls a *release* lever on the Frame. The points accessing the Branch are then under the control of the *ground frame* until the *release* lever is returned to its original position.

- 30 Once the *release* lever on the *ground frame* has been pulled, the associated lever which controls the movement of the points is free to operate until the *release* lever has been returned to its original position, regardless of the state of *track circuit* ZA, the position of the signaller's switch or the state of the 'F' light.

- 37 Had the DSM been prevented from moving the points while a train was passing over them, either by being unable to reach the point lever, or because it was locked, or by some other means, the derailment would not have occurred. Recommendation 2 refers.

- 2 Silverlink should issue instructions immediately that operators stand away from Watford Yard *ground frame* and observe the completion of a movement over the points before returning to the *ground frame* to move the points or give up the *release* (paragraphs 34, 36 & 37)

- 4 In the longer term, consideration should be given by Network Rail to the provision of a locking arrangement on the Watford Yard *ground frame* points when any alterations are made to the yard or the signalling in the Watford area (paragraph 38)

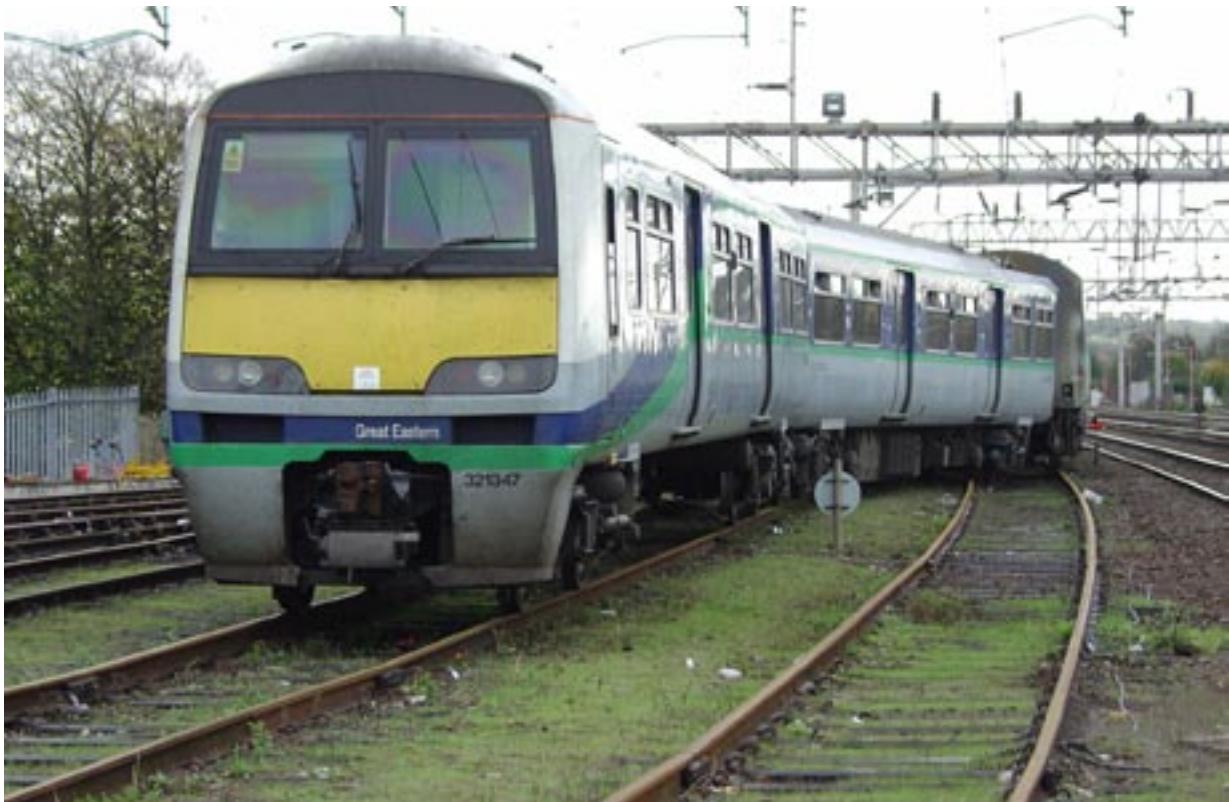
Figure 3: Immediate aftermath of the derailment

- 18 The driver moved the unit onto the Branch at a speed estimated as being approximately 3 mph, the maximum permitted shunting speed being 5 mph, and, on becoming aware that the unit was not moving normally, brought the train to a stand. The speed of the movement was established from recordings made by a CCTV monitor mounted on the end of a class 313 unit berthed on the adjacent No 3 siding.
- 19 As the second vehicle of the unit passed over the points, the DSM moved the point operating lever thereby changing the points under the moving train. As a consequence the fourth and subsequent bogies of the unit were directed to No. 1 siding instead of the Branch. The fourth bogie (the trailing bogie of the second vehicle, number 63105) became derailed at the crossing of the points. The train came to rest as shown in Figure 3.

- 20 The signaller, who had become aware of the derailment by the unusual noise of the movement, prevented further train movements on both Slow Lines as a precaution and advised the driver via the Cab Secure Radio of the derailment. In fact the unit was not foul of the *Up* Slow line.
- 21 No injuries occurred. Damage was confined to lateral distortion of the track and limited damage to the derailed bogie and the bodies of the second and third vehicles.
- 22 The unit was rerailed by EWS breakdown staff and the track repaired to enable the service on the Branch to be resumed by 16.00 hrs that day. The unit was subsequently moved to Bletchley Depot for inspection and minor repairs.

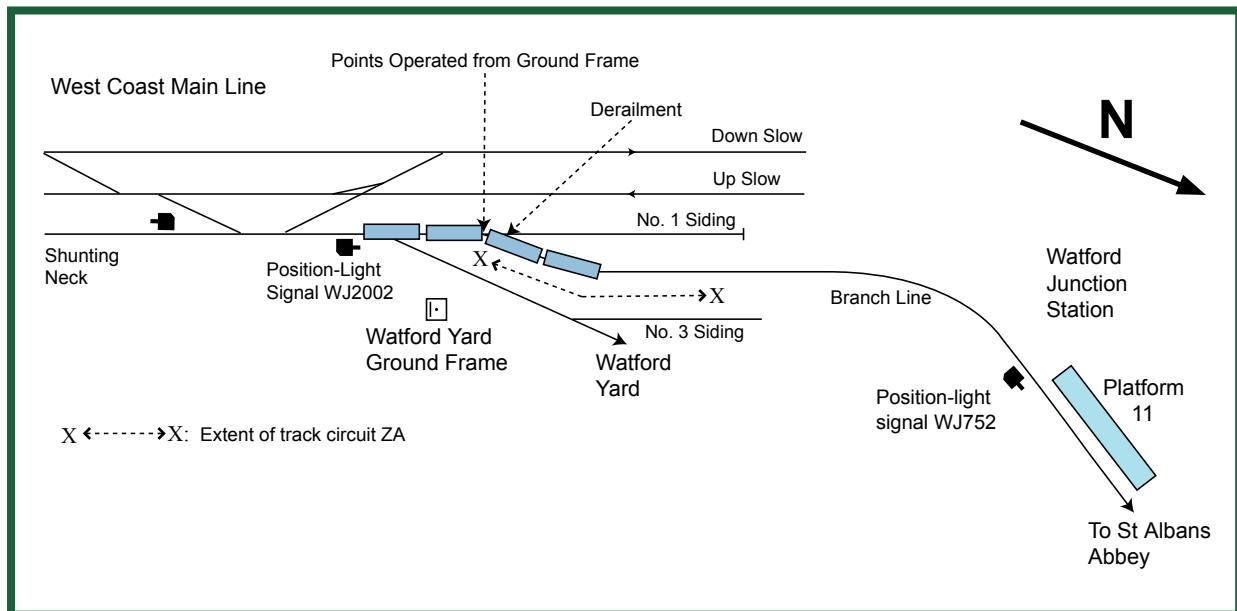
Figure 4: Track layout and associated signalling adjacent to Watford Yard Ground Frame

- 26 The DSM would not usually operate the *ground frame* more than once in a shift.
- 27 When a train passes onto the St Albans Abbey Branch from the shunting neck, it occupies *track circuit* ZA when the leading end has reached a position 7.4 metres from the *toe* of the points accessing the Branch (see Appendix C). Occupation of this *track circuit* removes the electrical *release* of the *ground frame* and consequently the 'F' light is extinguished. Thus, the occupation of *track circuit* ZA has exactly the same effect as the signaller removing the *release* of the *ground frame*. The purpose of this feature is to prevent the *release* of the *ground frame* when another train is standing between the points it controls and Platform 11.

- 29 An electrical *release* of the *ground frame* can only be obtained when both the signaller has placed the switch in the signal box to 'Free' and *track circuit* ZA is unoccupied. When an electrical *release* is given, the *release* lever is freed to operate when the plunger is simultaneously depressed.
