# Rail Accident Report

## Trackworker fatality at Trafford Park 26 October 2005

## 26 October 2005

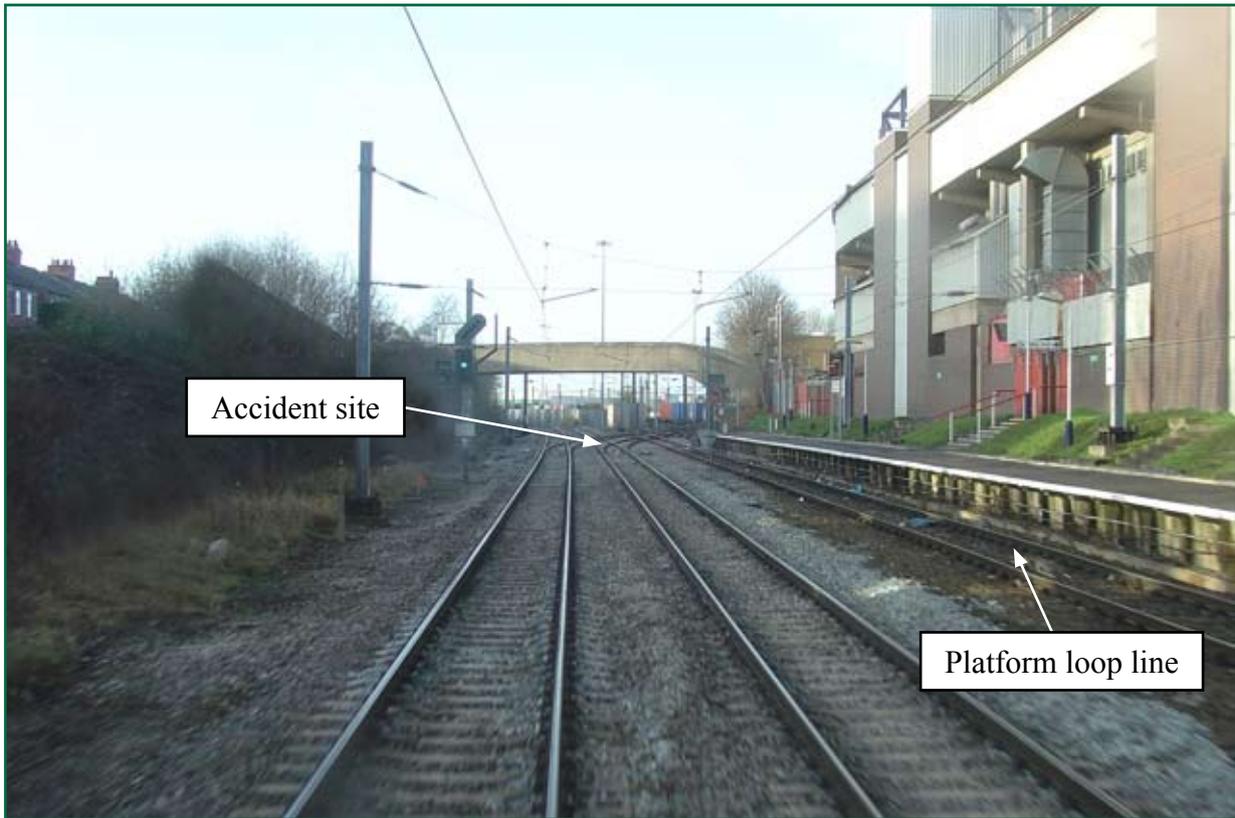
Figure 5: The accident site from the east

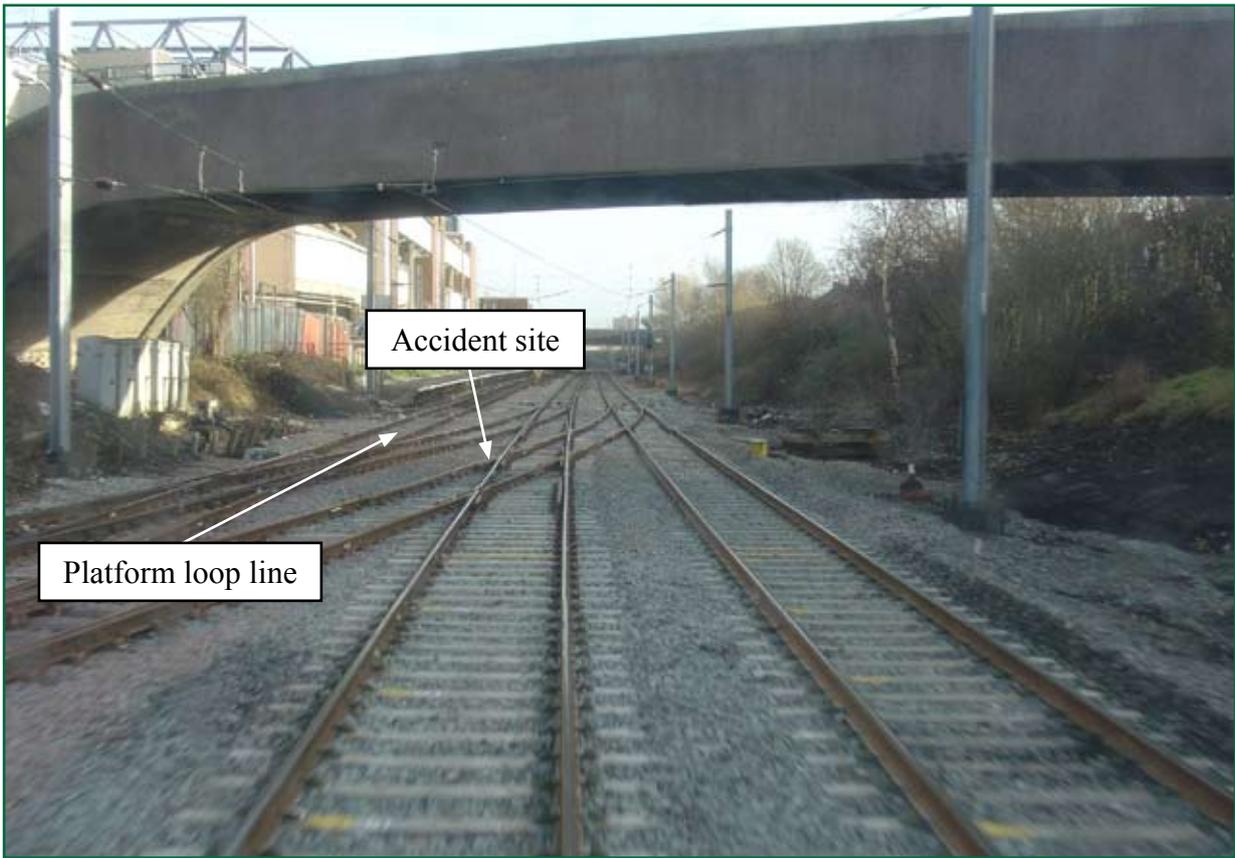
Figure 7: The accident site from west

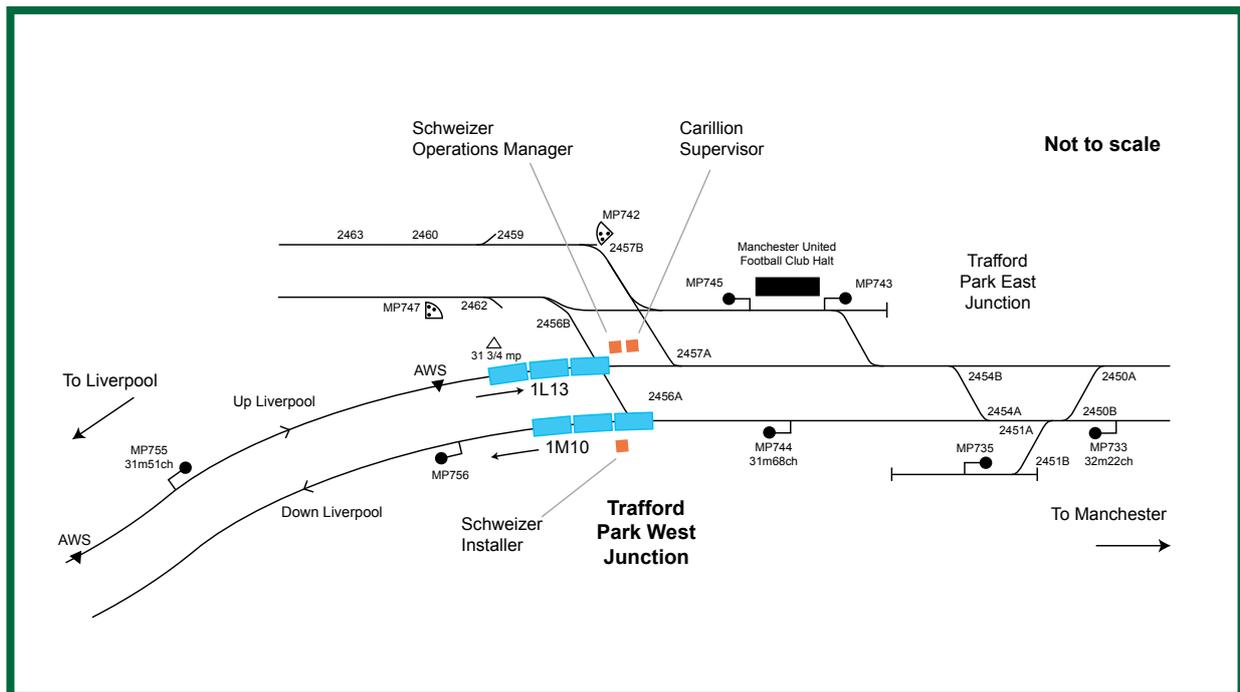
Figure 9: The location of people and trains during the incident

- 103 As train 1M10 travelled along the straight section of line towards Trafford Park East Junction, the Driver observed men in the four foot of his line ahead, in the vicinity of Trafford Park West Junction. One of the men moved into the Down cess. At a distance estimated by the Driver to be 300 metres to 400 metres from the group, the Driver sounded the warning horn. There was no acknowledgement from any of the three men. The two men standing in the *four-foot* moved from the Down line, across the Up line and stood in the space between the Up line and the platform loop, as shown in Figure 9. They were however still close to the cess rail of the Up line.

- 104 As train 1M10 reached Trafford Park West Junction it's speed was approximately 65 mph (104 km/h). The Driver noted that the two men on the up side were facing each other, in conversation, side-on to the line, and the larger man was holding a clipboard, drawing or similar item.

- 109 At this point train 1L13 was travelling at a speed of 82 mph (135 km/h), as determined from the *On Train Monitoring Recorder (OTMR)* data.
- 110 As the Driver completed these tasks and looked forward, he immediately saw the two men ahead close to his left hand side. He sounded the horn briefly and immediately applied the brake. He noted that the man with his back to the train was a large man and that there was a smaller man who was initially obscured by him. The Driver had not observed any lookout(s).
- 111 Train 1L13 struck the larger man with a glancing blow. The larger man bowled the smaller man over and both ended up a distance from the Up Line close to the nearest rail of the Platform loop line.
- 112 The brake application brought train 1L13 to a stand within 650 metres: the train stopping close to MP732 signal.
