Rail Accident Investigation Branch

Rail Accident Report

Derailment near Liverpool Central underground station 26 October 2005

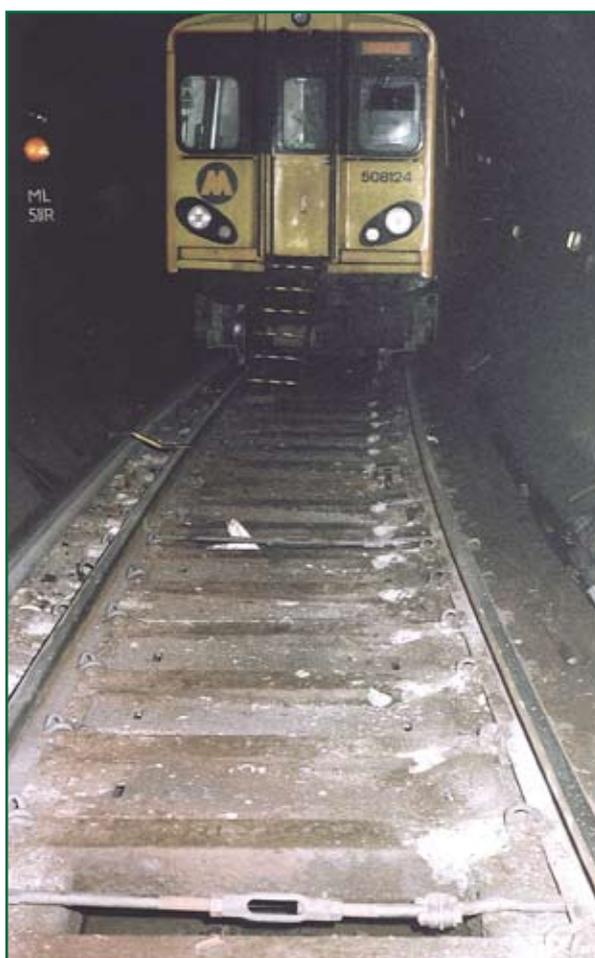
Figure 2: View of the rear of train 2W43 following its derailment (courtesy of British Transport Police)

- 38 None of the passengers were injured as a result of the derailment. The driver was also uninjured; however, the guard attended hospital during the night following the derailment but was not detained.
- 39 Damage to the train, as a result of the derailment, was limited and consisted of damage to wheel surfaces, a damaged *gearcase* and *tripcock*.
- 40 The damage to the track was also limited and consisted of damage to sleepers and fastenings over a 30 m distance.

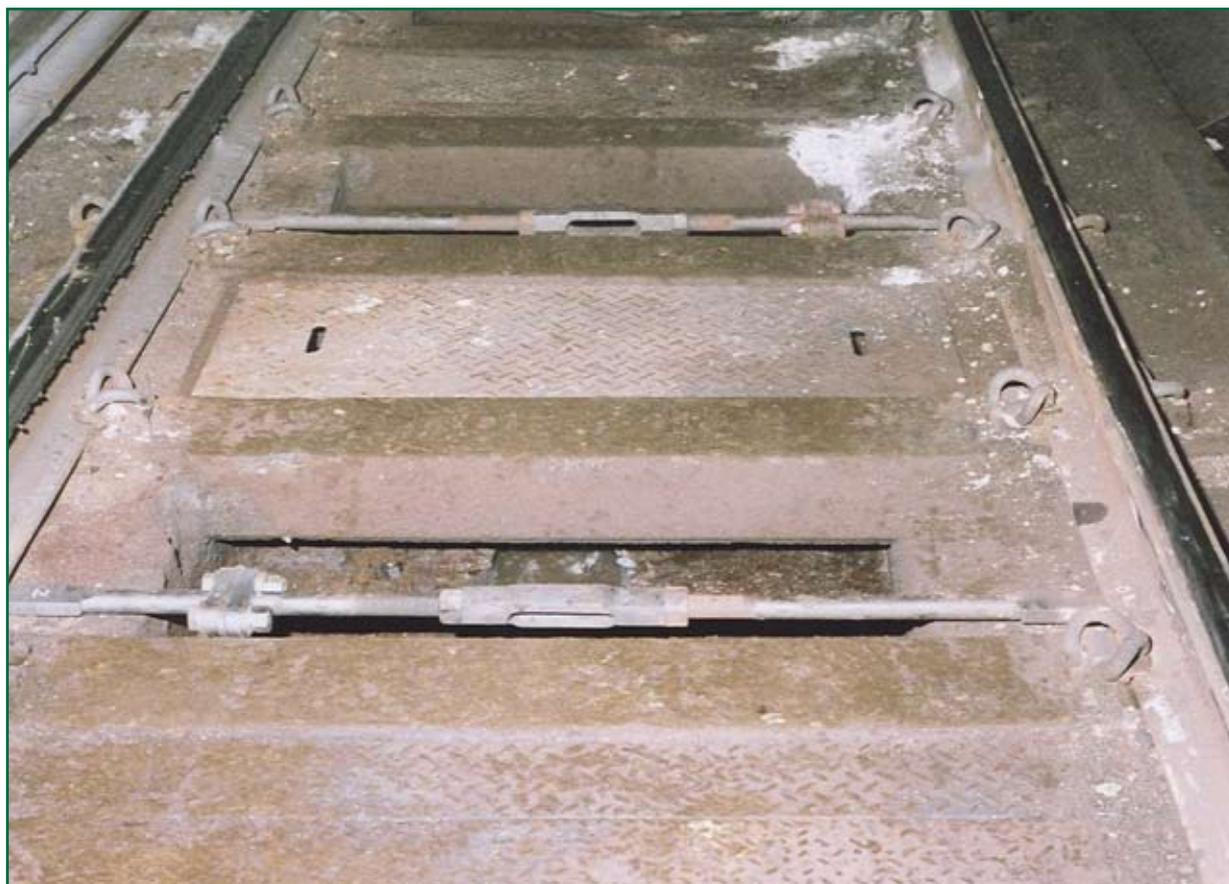
- 51 The *Point of Derailment* (POD) was measured at 392 m (429 yards) from the *headwall* of Lime Street station, located at 1 mile 204 yards. The POD was therefore at 1 mile 633 yards. Both before and after the POD, the track condition was found to be poor, with loose Pandrol clips due to corrosion or wear, and broken or missing *insulators*. There were many tie-bars fitted, including five that had broken. At the POD, a tie-bar had previously failed at the left hand end retaining lug. Figure 3 shows the track in the vicinity of the derailment and tie-bars that had been fitted just after the POD.

Figure 3: Tie-bars fitted to the track close to where the derailment occurred (courtesy of British Transport Police)

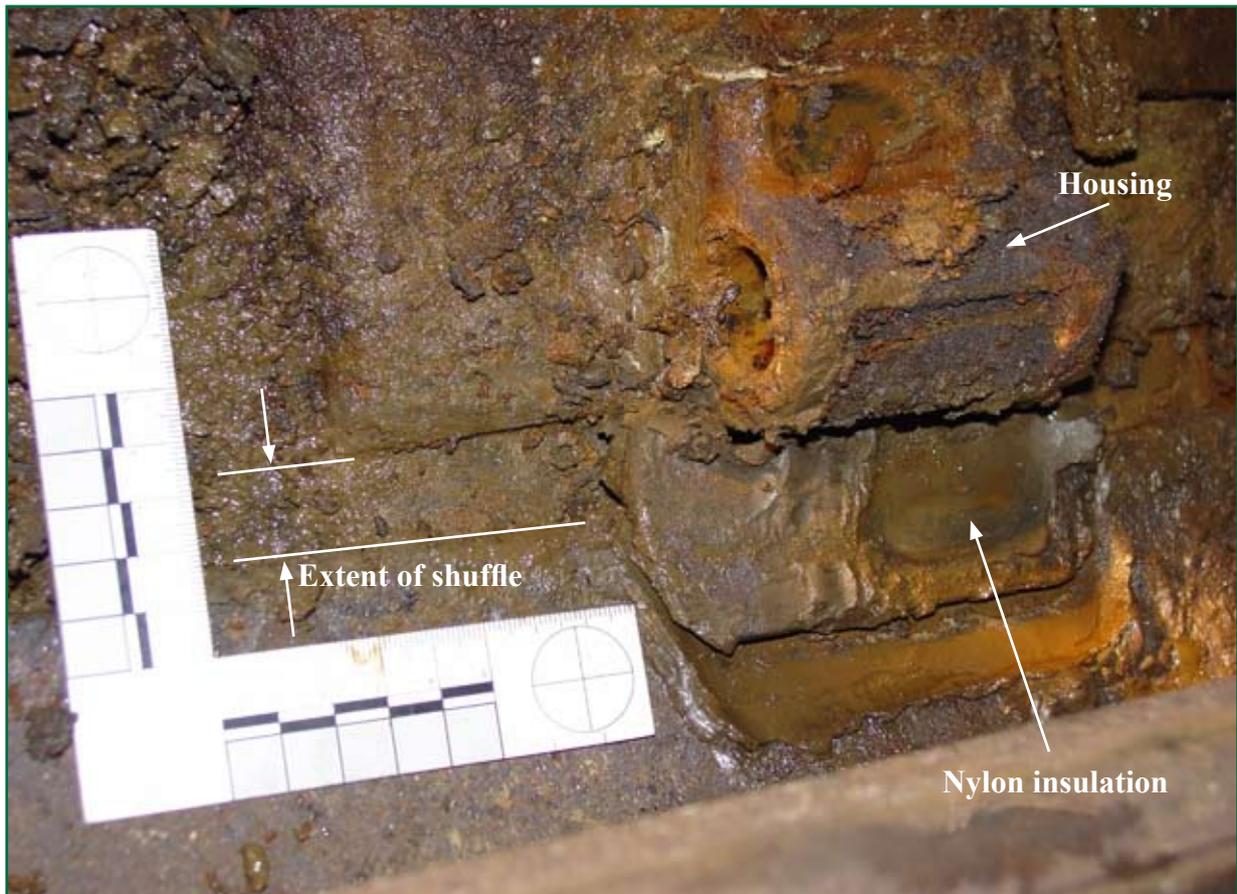
- 52 Both the right hand rail (the low rail) and left hand rail (the high rail) showed evidence of movement ('shuffling') away from the track centre-line (see Figure 4). This was greatest where rail insulators were either broken or missing.

Figure 4: Sleeper 105 showing the degree of rail shuffle that had taken place (note the missing Pandrol clip)

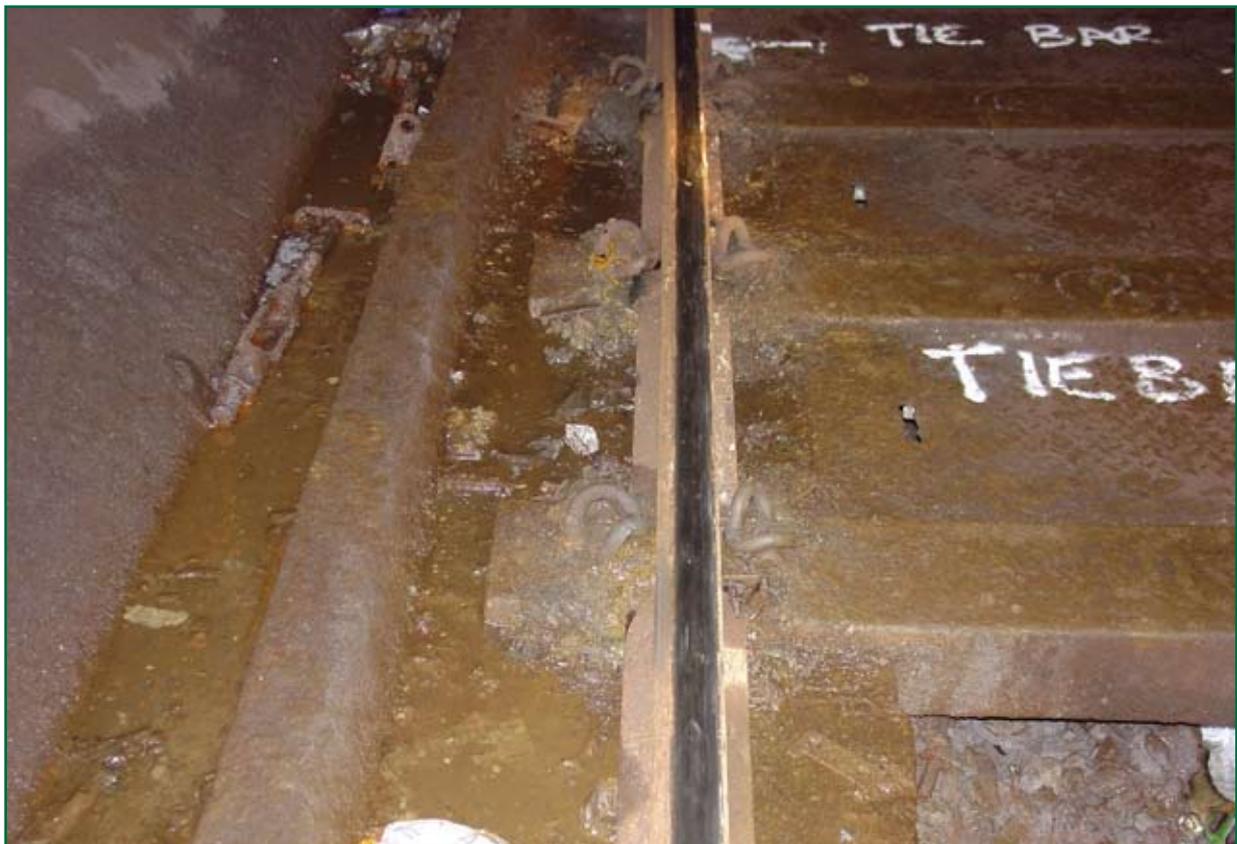
- 54 The trackbed around the rail foot and the housings for the Pandrol clips was heavily contaminated with detritus, causing corrosion of the rail foot over time, resulting in loss of width and depth as well as corrosion of the housings. Figure 5 shows the degree of contamination and also areas of track marked up by the maintainer for further tie-bar fitment, which was not carried out before the derailment occurred.

Figure 5: Showing the degree of contamination around housings and locations marked for further fitment of tie-bars

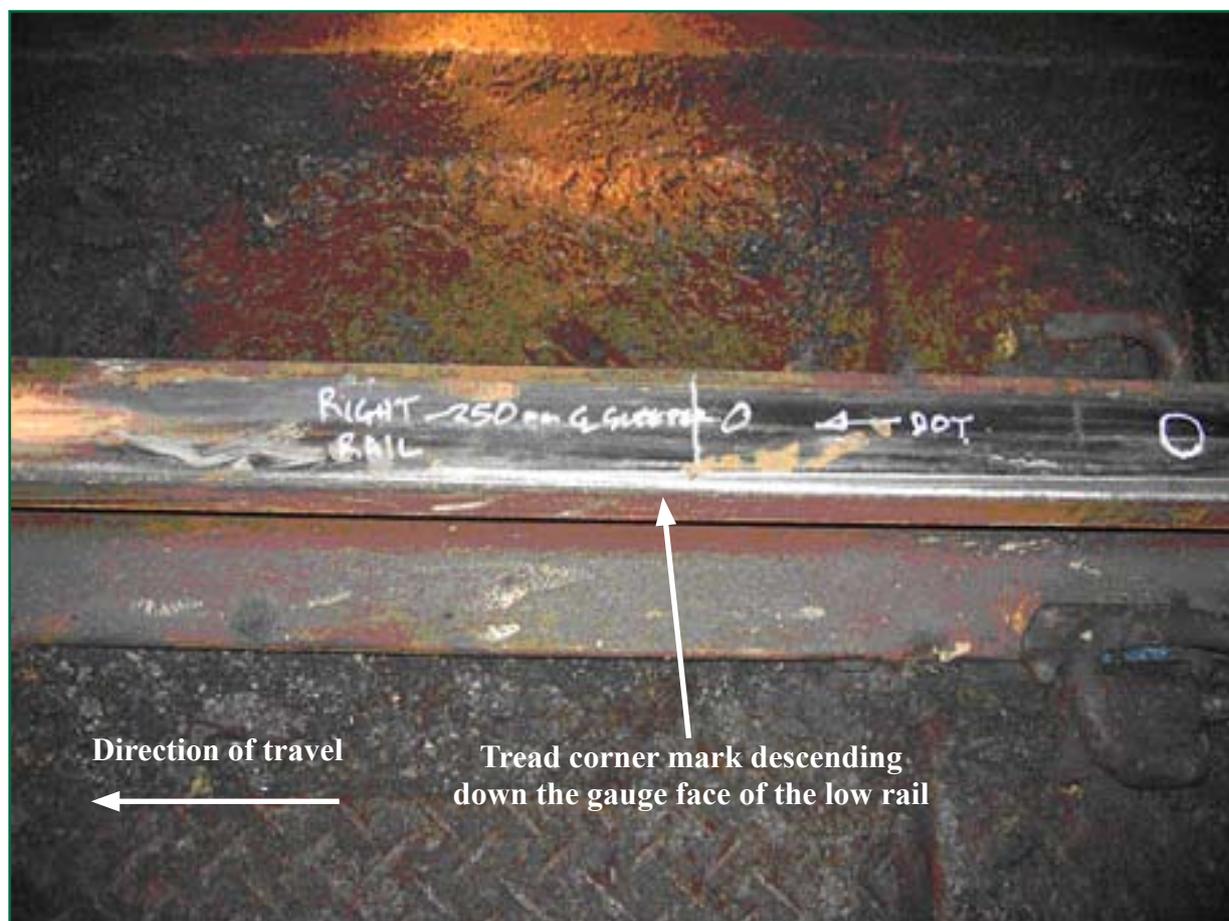
79 The derailment occurred when the leading right hand wheel of the last bogie of the train partially descended down the gauge face of the low rail at a location where a tie-bar had previously broken. Initially, the lateral restraint provided by the track prevented the wheel from wholly dropping onto the trackbed or the track fastenings, and the left hand wheel remained in its normal running position, but with its flange in hard contact with the gauge face of the left hand high rail. Figure 7 shows the *tread corner* mark where the right hand wheel descended the gauge face.

Figure 7: Tread corner marks descending down the gauge face of the right hand rail head

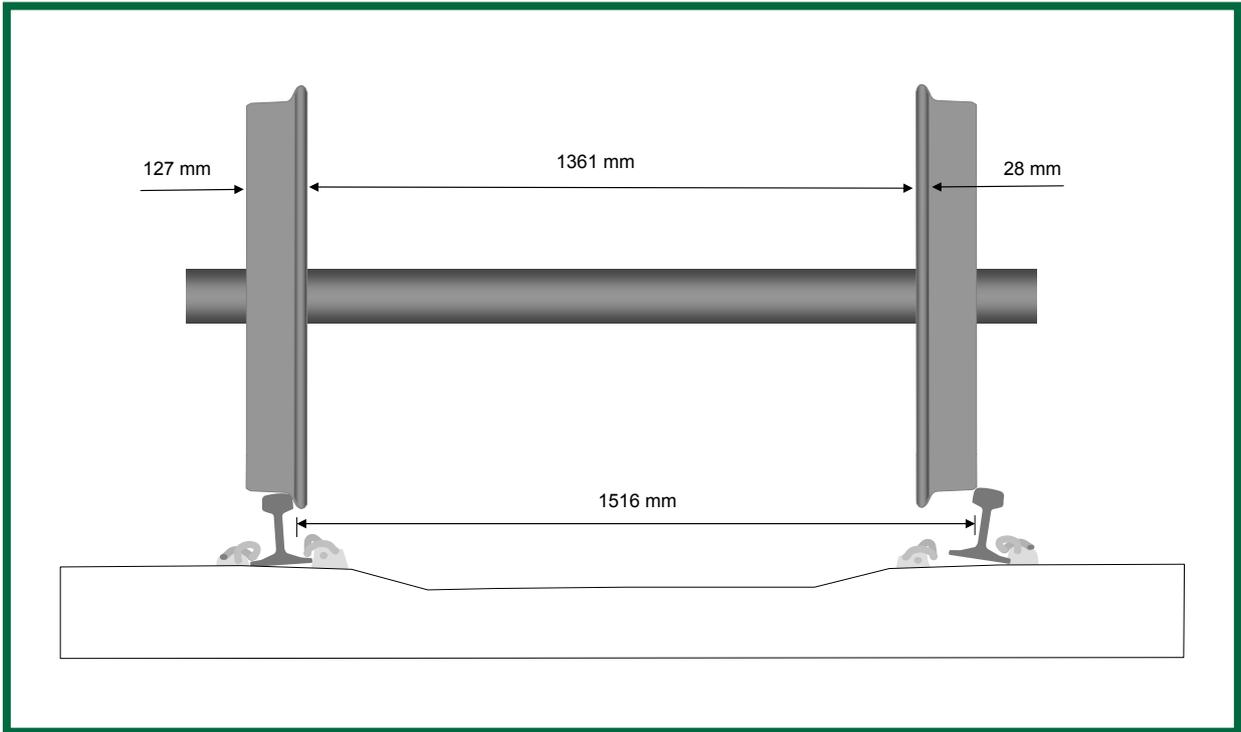
- 80 Figure 8 shows the situation that existed just as the derailment occurred. From the measurement of static gauge at the POD (1465 mm), and the wheelset dimensions that were measured, the gauge faces of the rails displaced by a further 51 mm (1516 mm – 1465 mm) as a result of the gauge spreading forces arising from the train.
- 81 Between the second and third sleepers beyond the initial POD, the flange of the left hand leading wheel of the trailing bogie climbed the gauge face of the high rail and, in doing so, relieved the high lateral *gauge spreading forces*. This allowed the leading right wheel of the trailing bogie to continue its descent down the gauge face of the low rail into full derailment between the third and fourth sleepers from the initial POD. Figure 9 shows the flange climb marks and Figure 10 shows the derailment of the right hand wheel.

Figure 8: Diagram of critical gauge spread dimensions to cause derailment

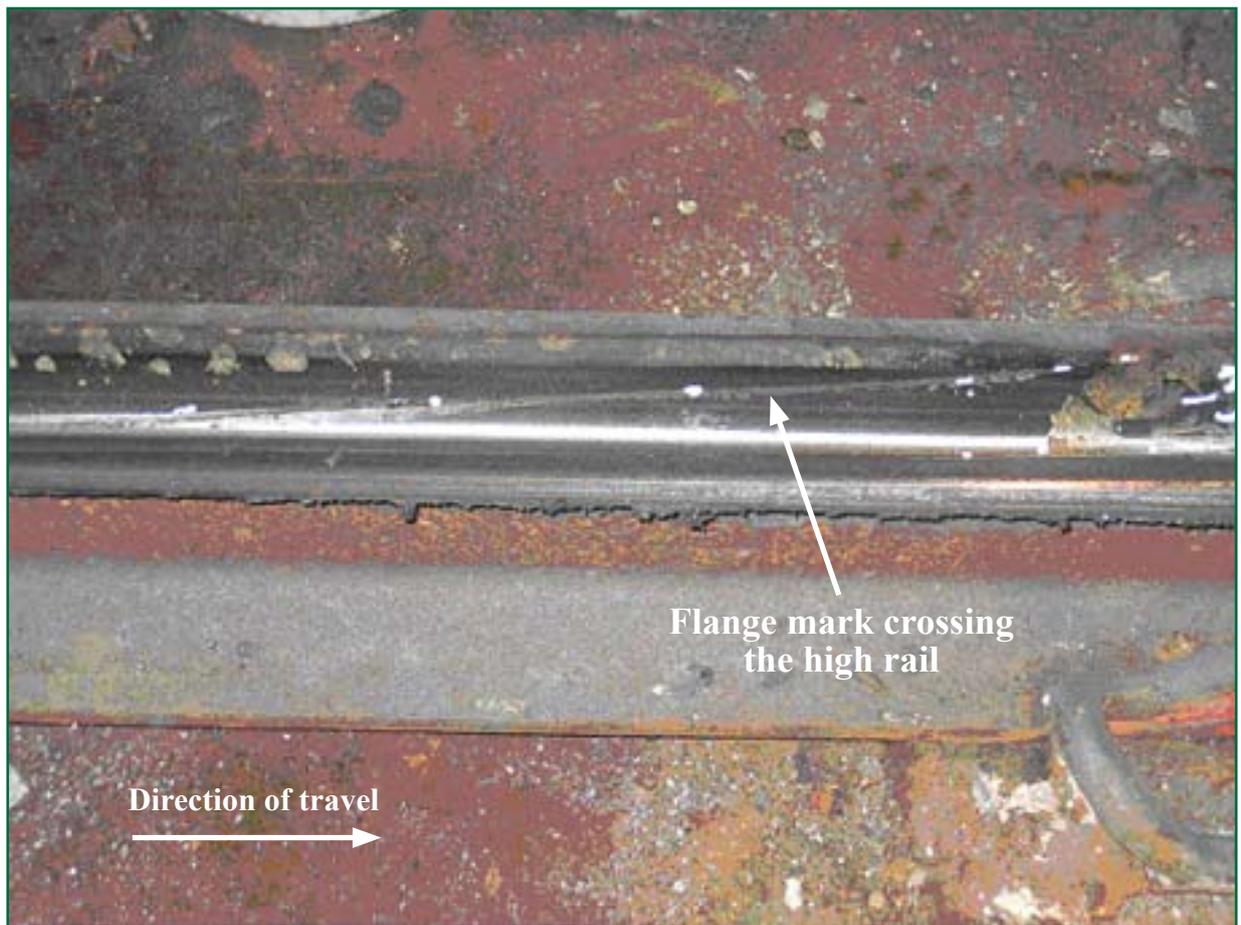
Figure 9: Flange climb mark up the gauge face of the high rail between the second and third sleepers

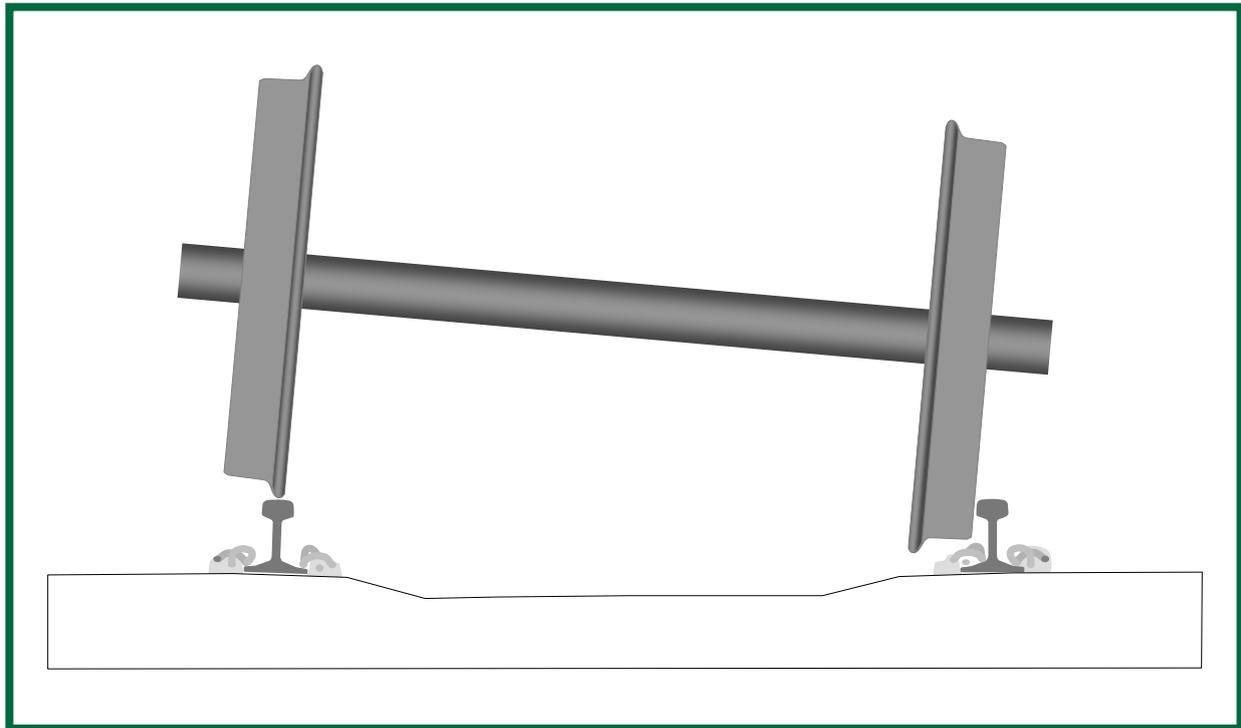
Figure 10: Diagram of wheelset showing how the left hand wheel has flange climbed onto the rail head allowing the right hand wheel to fully derail

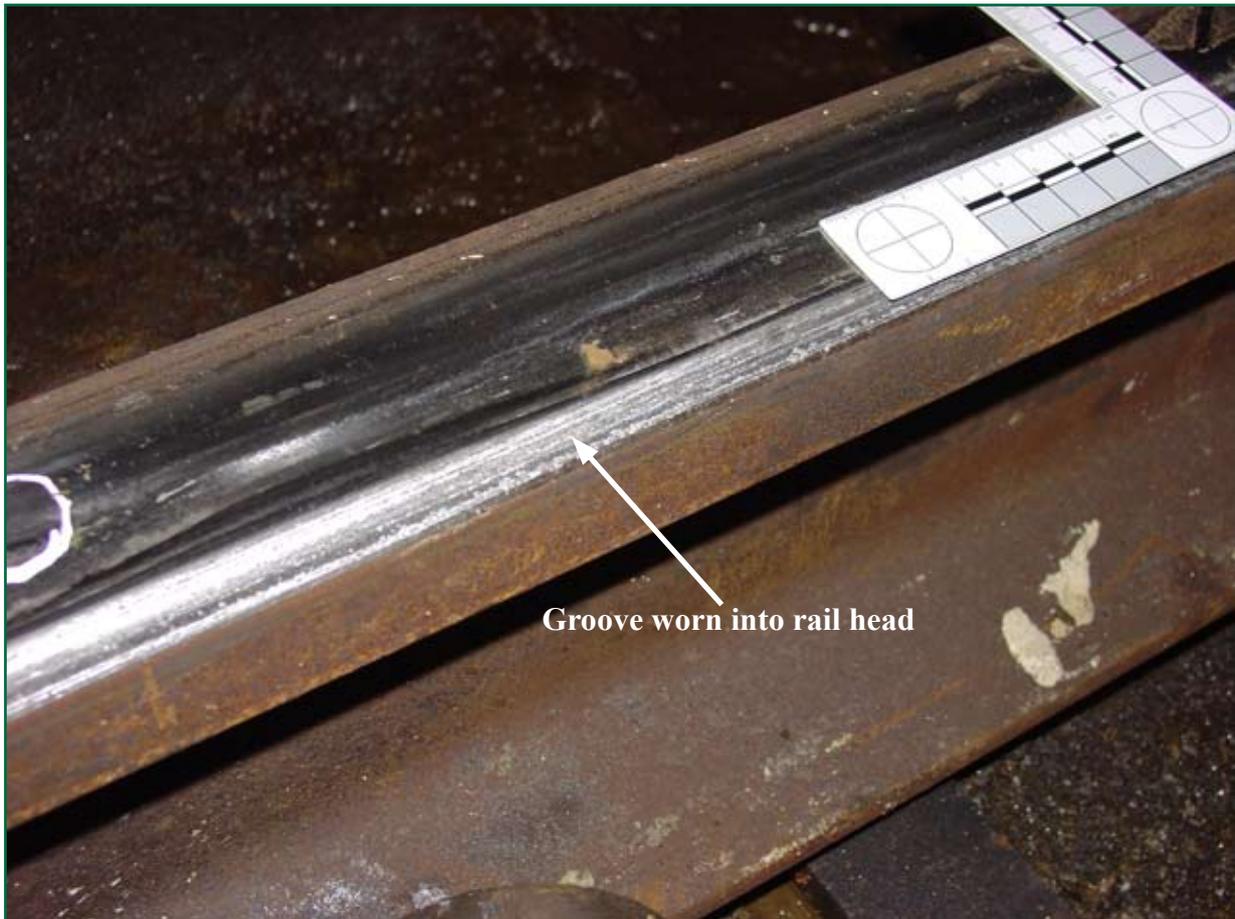
- 86 It was found that a significant groove had developed on the head of the low rail in the vicinity of the POD. It commenced about two sleepers before the POD, approximately 15 mm from the gauge face and, as the groove progressed towards the POD, it migrated towards the gauge face such that, at the POD, it had reached the *gauge corner*. Beyond the POD, the groove migrated back across towards the *field side* so that, by two sleepers beyond the POD, it was 10 mm away from the gauge face. This *witness mark* was typical of that formed by the tread corners of wheels running on track that was wide to gauge. The groove, just before where the leading right wheel of the last bogie descended down the gauge face, is shown in Figure 11.

Figure 11: Groove on the low rail just before the point of derailment

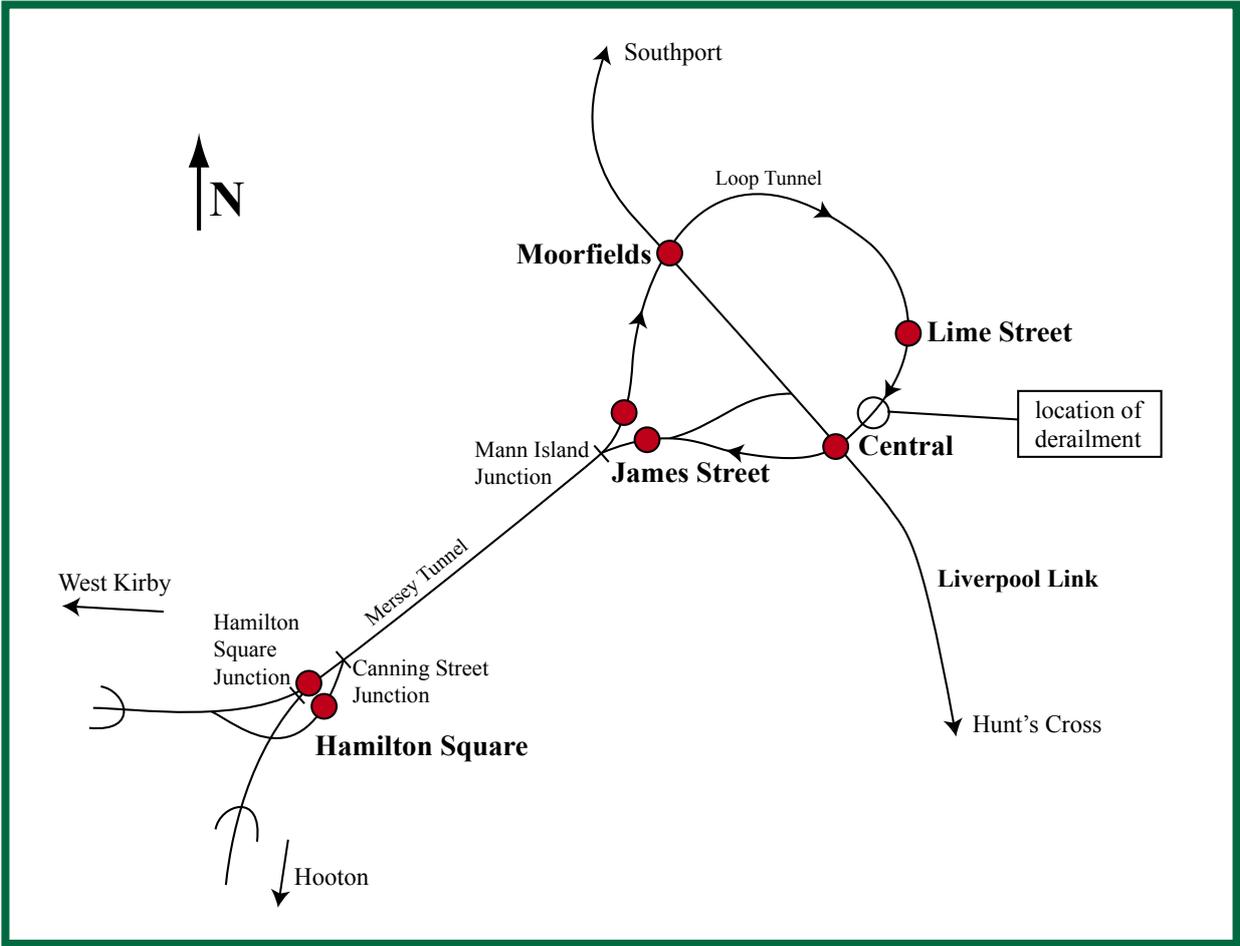
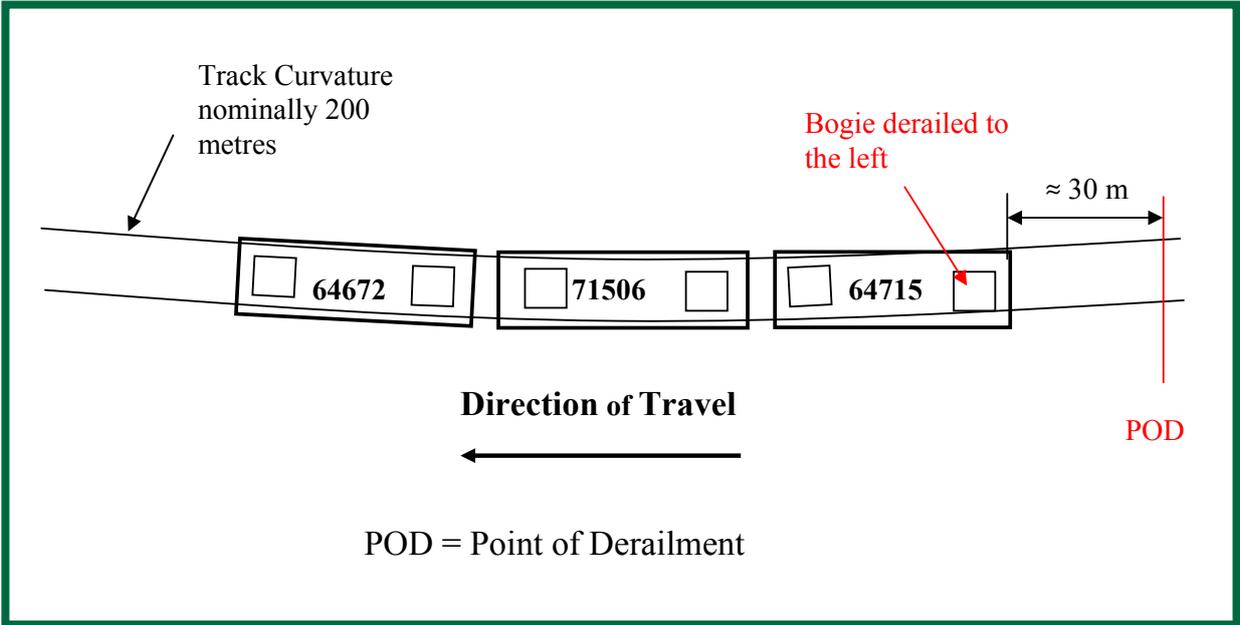
Left and right hand profiles at the POD

- 53 There was evidence of sidewear of the high rail, and this was found to be 6 mm at the point of derailment. Although significant, the sidewear was within maintenance limits. The degree of sidewear of the high rail at the POD can be seen in Appendix E.

Note: the red outlines are the rail profiles as measured at the derailment site

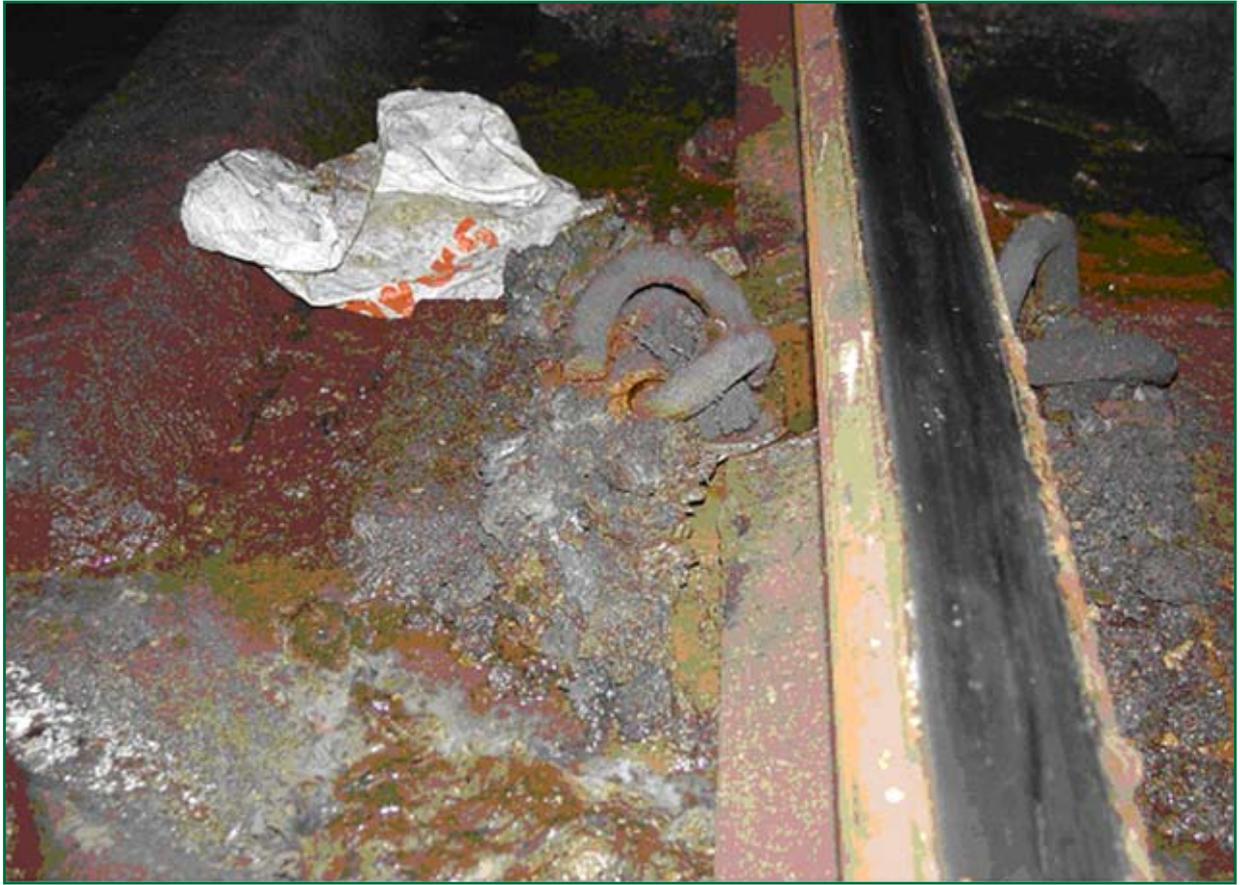
Photo attached to Urgent Safety Advice

2. URGENT SAFETY ADVICE	
USA DATE:	27 October 2005
TITLE:	Gauge widening
SYSTEM / EQUIPMENT:	Pre-stressed concrete-sleepered track part embedded in concrete base. Tie bars fitted but with varying quality and effect.
SAFETY ISSUE DESCRIPTION:	Insulators pushed out and rails cut into housings combined with extensive side-wear, permitting track gauge to widen, thus allowing potential for derailment.
CIRCUMSTANCES:	Sharp curved track in aggressive tunnel environment
CONSEQUENCES:	Gauge widening allowing derailment
SOURCE:	RAIB site investigations
REGULATING ISSUES:	No issues
REASON FOR ISSUE	So that duty holders with similar track forms may check for potential similar details
