Rail Accident Report

Derailment at Phipps Bridge, Croydon Tramlink 21 October 2005

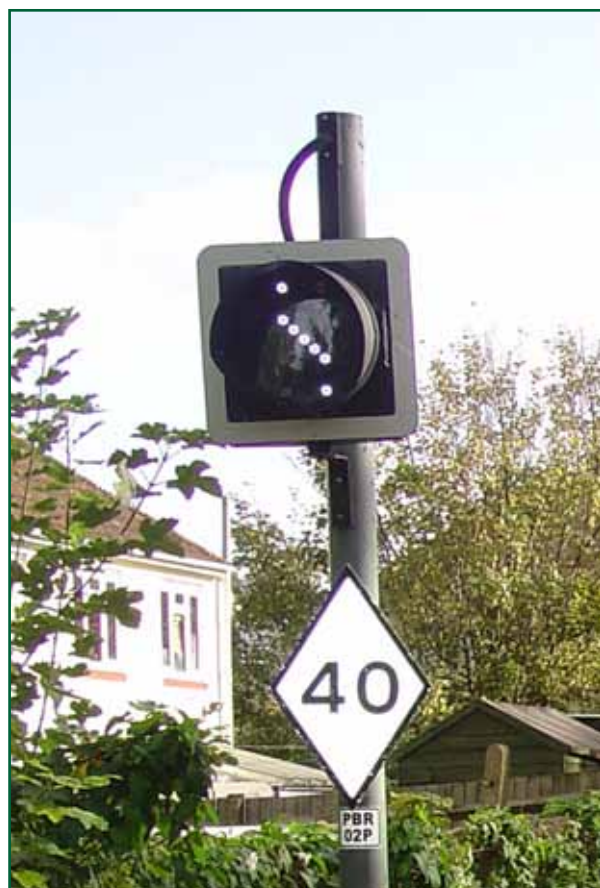
Figure 2 : Points position indicator - points correctly set

- 13 The track on the *single line* section consists of flat-bottomed rail on concrete sleepers. The points at Phipps Bridge are carried on timber *bearers*, and are fitted with a Hanning & Kahl HW 40 operating mechanism. The mechanism is not power operated, but the points are sprung to lie *normally* towards the eastbound line. There is a points position indicator (PPI) located 4m before reaching the points, at drivers' eye level on a post to the left of the line. When the points are correctly set and detected in this position, the PPI shows a pattern of white lights indicating the left-hand route (see figure 2). If the points are not correctly set, only the central white light of the PPI is lit (see figure 3).

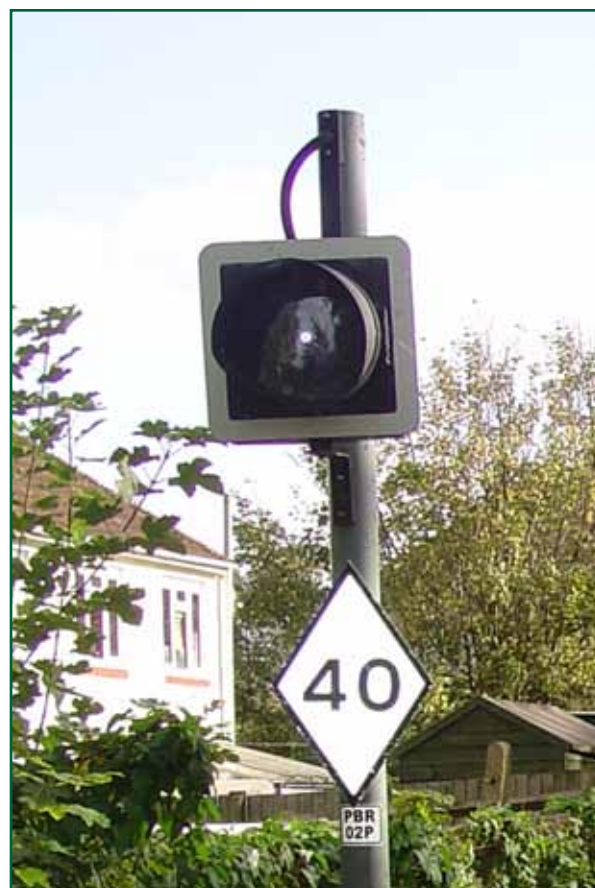
Figure 3: Points position indicator - points not correctly set

29 The tram driver had encountered indications of incorrectly set points before but in his experience this was extremely infrequent compared to the number of times the PPI showed that points were correctly set. The driver was concentrating on the tram speedometer while reducing the speed of the tram for the speed restriction over the points. The PPI becomes visible from a distance of about 200 m, and the investigation into this accident confirmed that the pattern of lights forming the “points set” indication (see figure 2) is not easily distinguishable from a single light at this range; only as the tram comes within about 100 m of the PPI does the form of the indication become clear. The single white light shown by the PPI is less conspicuous than the “points set” indication, and does not stand out as an indication requiring a response from the driver in the same way that a horizontal bar or red light would do.

- 31 Human factors research indicates that an “abnormal” indication should be easily distinguished from a “normal” indication, and be at least as conspicuous. Conspicuity can be improved by increasing the number of lights in the display and arranging them in a distinct pattern (recommendation 1).

- 1 The conspicuity of the PPI 'abnormal' indication should be assessed and improved by an appropriate means, such as display of a horizontal white bar when the points are not correctly set (para. 31).

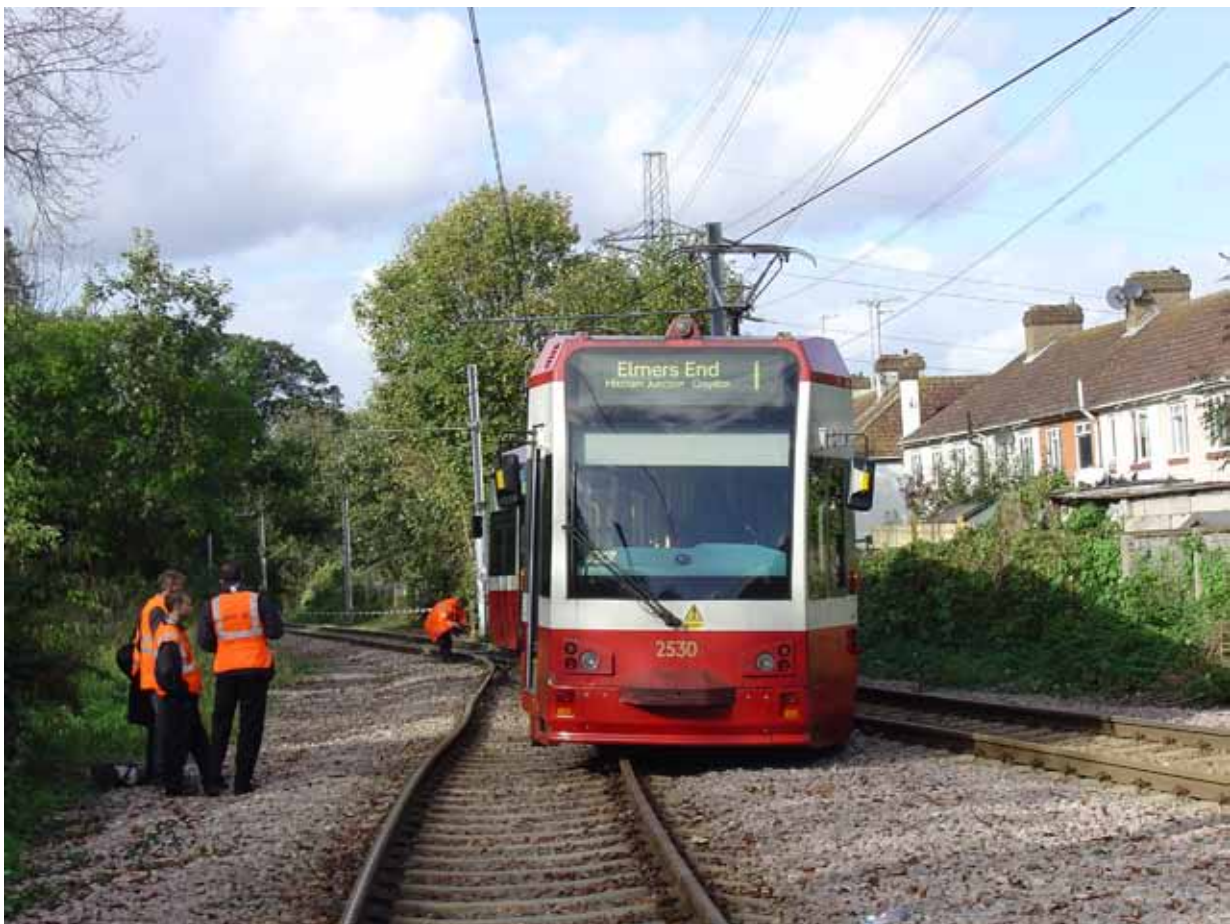
- 19 The leading bogie of the tram became derailed at the points. The left-hand wheels, facing the direction of travel, passed between the *switch blade* and *stock rail*. The right-hand wheels then dropped into the *four foot*. The tram then slid as its traction motors and other underbody equipment rode on the rail head over the crossing of the points until the inside of the right hand leading wheels came into contact with the rail head. The left hand wheels then rode over the right hand running rail and dropped into the *ballast*, and the tram came to a stop. The front of the tram came to rest 25m from the point of derailment, and 37m from the tips of the *switch blades* (see the photographs, figure 4 and 5). Following the accident, the driver made an emergency radio call to the control room and appropriate steps were taken to deal with the situation.

Figure 4: The derailed tram from the front, showing distortion of the track

- 22 The lateral forces involved in the derailment were sufficient to cause minor displacement of both tracks. These required realignment and minor repairs before the line was reopened for normal services at 21.10 hrs the same day. There was no damage to the points mechanism.

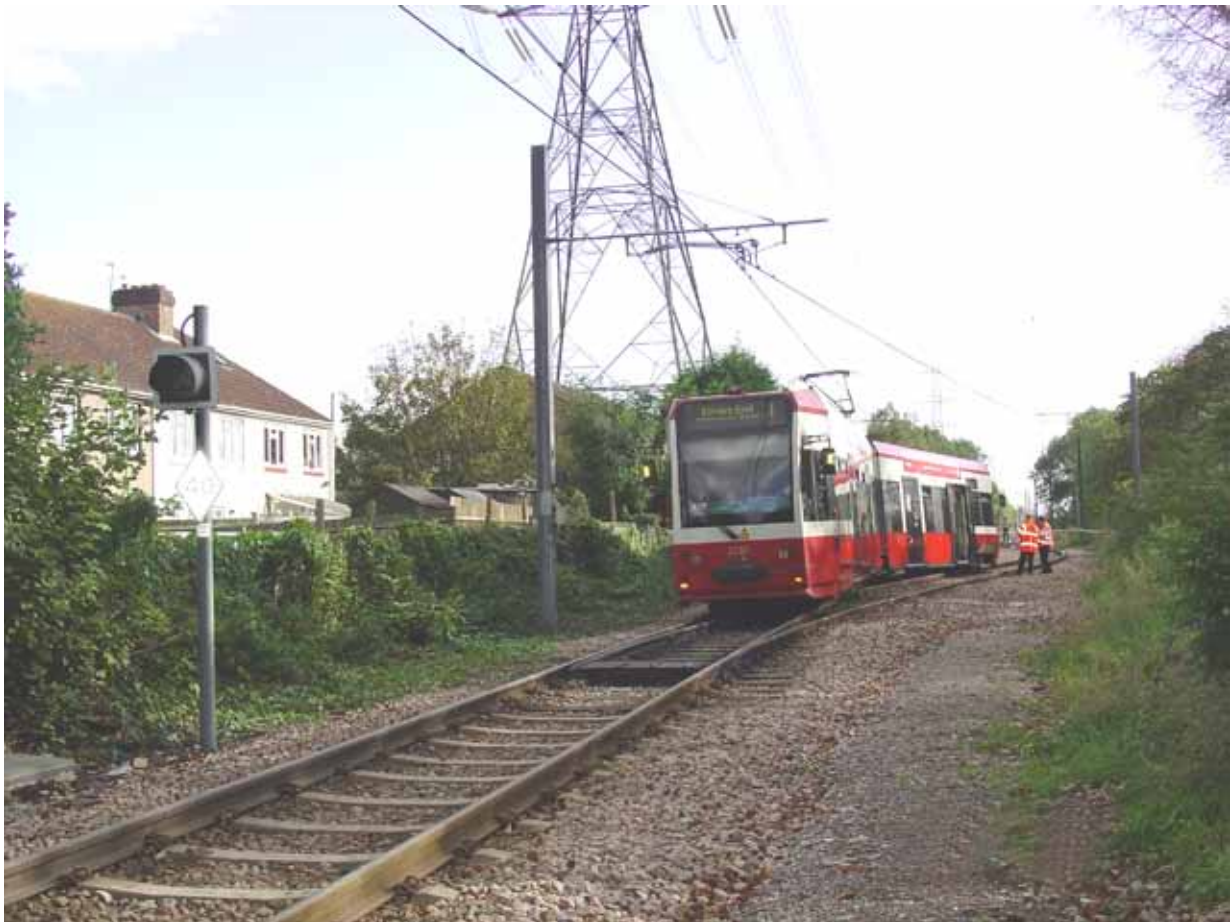
Figure 5: The derailed tram from the rear, showing the points position indicator and speed restriction sign

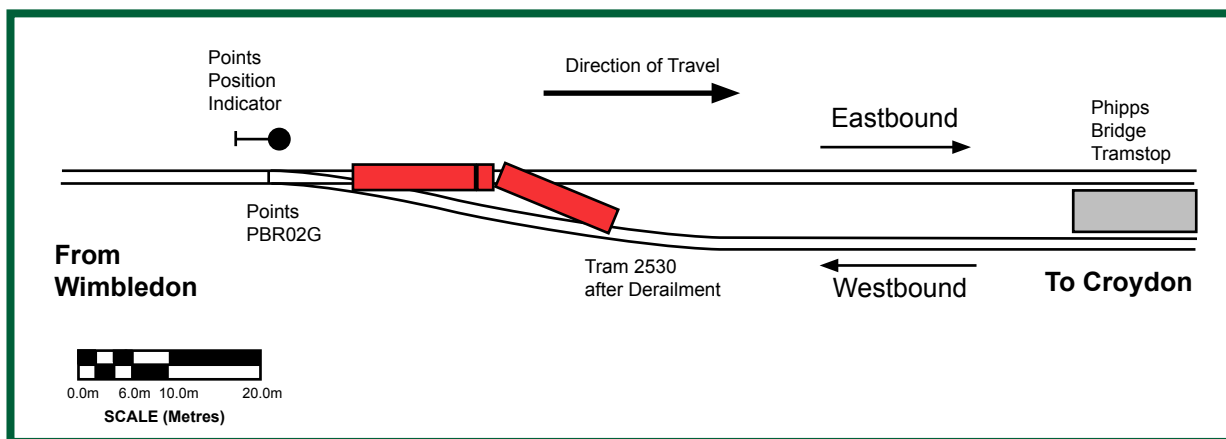
Figure 6: Site plan of the derailment

28 The evidence of the control room alarms and the CCTV on the tram shows that at about 10:32hrs, when the previous westbound tram passed over them in the *trailing direction*, the points at Phipps Bridge failed to self-restore to *normal* and remained stuck, lying for the right-hand, westbound, route. The PPI therefore showed a single white light to the driver of tram 2530 as it approached eastbound. The driver did not react to this warning until the tram was about to pass the PPI, and by the time he applied the emergency brake the tram was passing over the points. The shock of the tram passing over caused the points to spring back to their *normal* position, lying for the *normal* route, where they were found after the accident. Consequently the leading bogie was derailed, and the centre and trailing bogies of the tram were diverted to the left. The tram stopped 37m after reaching the points. It is notable that although this derailment occurred at almost the maximum speed permitted for trams passing over spring-operated points, there were no injuries to passengers or crew and relatively little damage to the tram and the track.
