RAIB Bulletin 02/2008

Container door struck by a passenger train in January 2008

Description of the incident and the findings of the RAIB

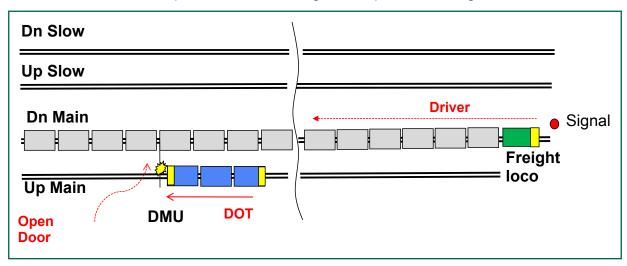
Figure 1 – position of trains

- 1. In January 2008 a passenger train running on a four-track railway struck the open door of a container on its right-hand (non-driver's) side. This container formed part of the load of a freight train which was stopped at a signal on an adjacent line. The train was travelling at approximately 45 mph (72 km/h) when the collision occurred.
- 2. At the time of the collision the freight train had been stopped by the controlling signaller in order to investigate a report of an open door on the train. This report had been made to a signaller on another panel by the driver of a third train, who had observed the open door as the freight train passed through a station.

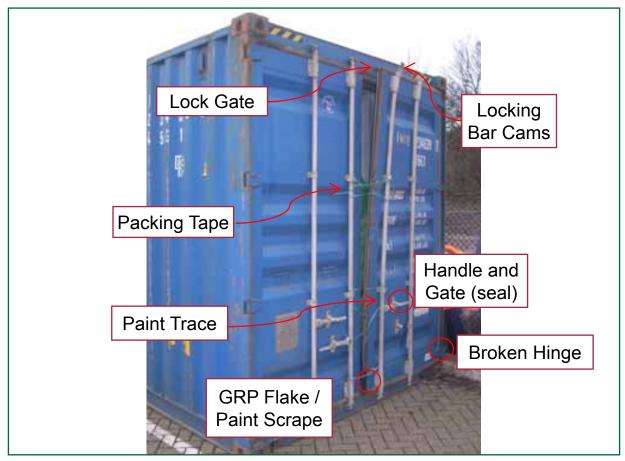
Figure 2 – damage to container

- 3. No-one was injured as a result of the collision. The multiple unit forming the passenger service sustained damage to the front cab area including damage to paintwork and minor damage to the fibre glass body shell. A front light unit also needed replacement. The container involved sustained severe damage to its right hand side door and is thought to be beyond economic repair. The cargo inside the container was undamaged.
- 4. The likely explanation for the door of the incident container being open was that it was tampered with whilst the freight train was stationary in a siding for 30 minutes in order to allow for a crew change.

- 6. Following the collision the container door was secured with nylon packing band by the driver of the freight train, who then informed the signaller that the train was safe for forward movement to its destination without restriction. This type of banding is not suitable for securing loads and could break. Its use to secure the container door in this way therefore created a risk that the door could once again come open and strike another train, a trackside object, a passenger standing on a station platform or a track worker.

- The need to brief drivers about ensuring that loads are safely secured after an incident.
- The possibility of obtaining suitable securing equipment which could be placed in locomotive cabs for use in similar situations (note this would also require that drivers become competent in making such loads safe to travel).
- Reporting all tampering incidents to the BTP, as some are currently being reported only to port police forces. This effectively under-reports route crime and diminishes the ability of the BTP to target preventative action against tampering. In addition BTP can advise on the security of sidings and steps that might be taken to reduce the risk to trains in transit.
- 11. The RAIB has written to the freight operator concerned with its conclusions and decision
