# RAIB Bulletin 02/2008

## Container door struck by a passenger train in January 2008

### Description of the incident and the findings of the RAIB

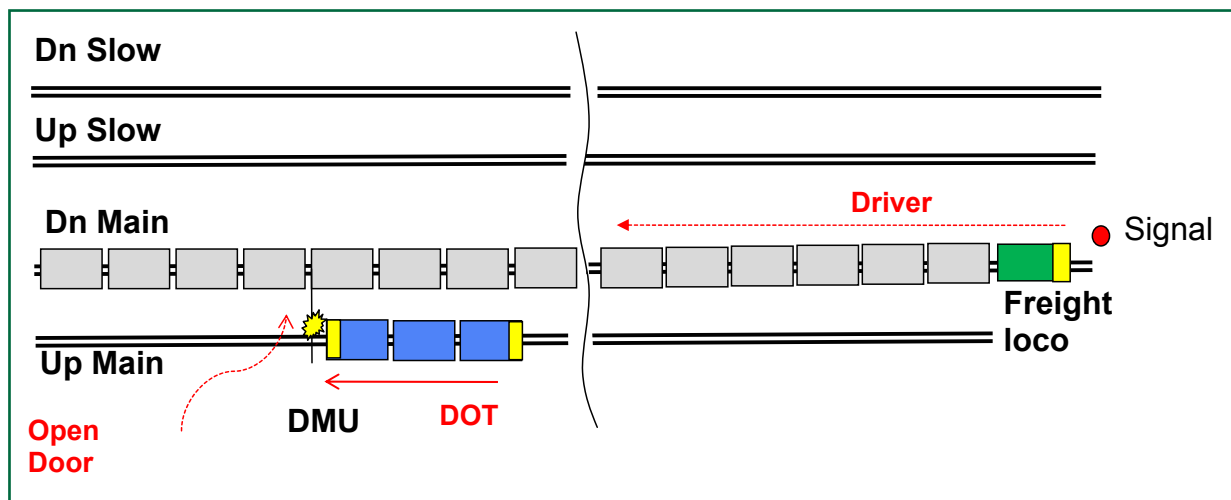
1. In January 2008 a passenger train running on a four-track railway struck the open door of a container on its right-hand (non-driver's) side. This container formed part of the load of a freight train which was stopped at a signal on an adjacent line. The train was travelling at approximately 45 mph (72 km/h) when the collision occurred.
2. At the time of the collision the freight train had been stopped by the controlling signaller in order to investigate a report of an open door on the train. This report had been made to a signaller on another panel by the driver of a third train, who had observed the open door as the freight train passed through a station.

Figure 1 – position of trains

5. The line adjacent to the freight train was open because the signaller receiving the report of the open door did not reach a clear understanding with the reporting driver as to its position. This signaller made an incorrect assumption as to which side of the train was affected because of the location of the reporting train, and subsequently passed incorrect information on to the controlling signaller.

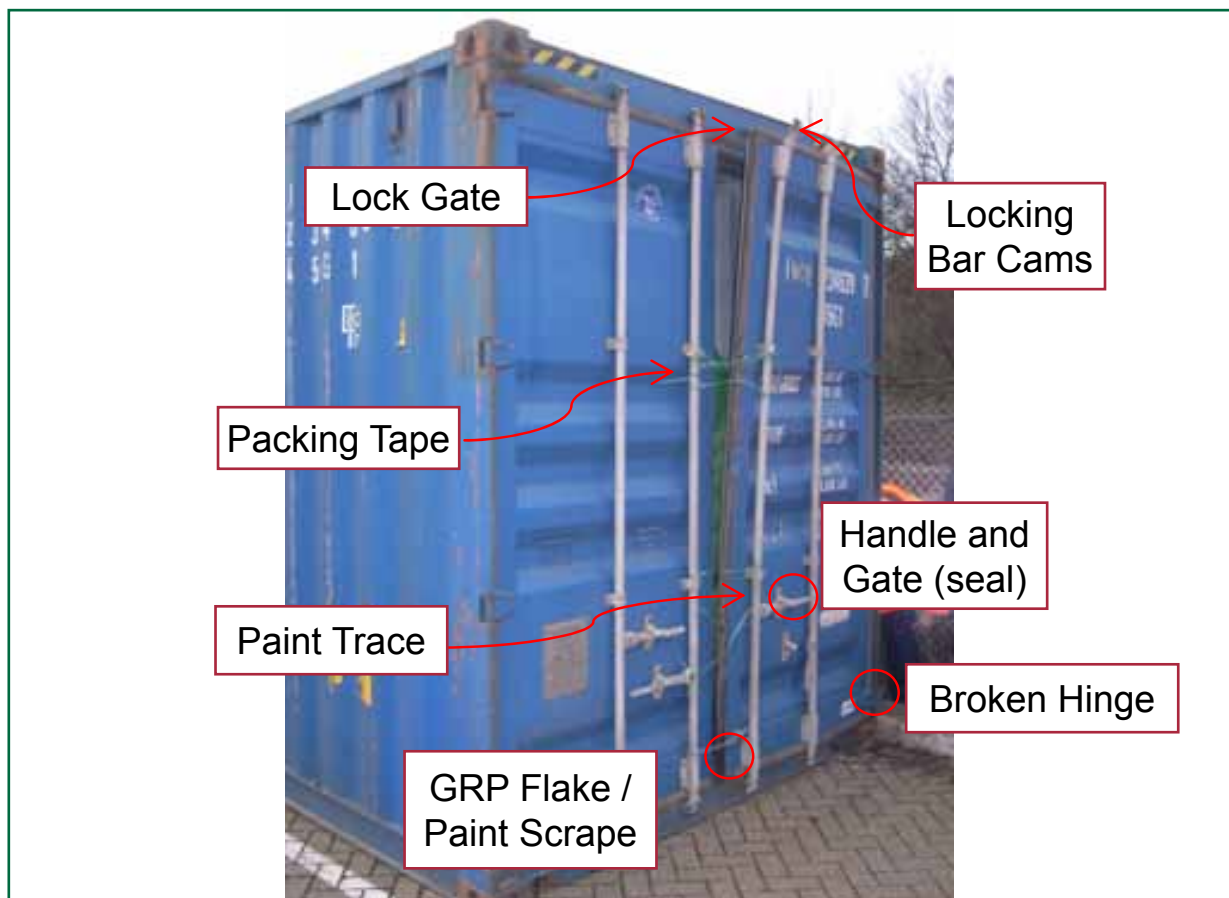
3. No-one was injured as a result of the collision. The multiple unit forming the passenger service sustained damage to the front cab area including damage to paintwork and minor damage to the fibre glass body shell. A front light unit also needed replacement. The container involved sustained severe damage to its right hand side door and is thought to be beyond economic repair. The cargo inside the container was undamaged.
4. The likely explanation for the door of the incident container being open was that it was tampered with whilst the freight train was stationary in a siding for 30 minutes in order to allow for a crew change.

6. Following the collision the container door was secured with nylon packing band by the driver of the freight train, who then informed the signaller that the train was safe for forward movement to its destination without restriction. This type of banding is not suitable for securing loads and could break. Its use to secure the container door in this way therefore created a risk that the door could once again come open and strike another train, a trackside object, a passenger standing on a station platform or a track worker.

Figure 2 – damage to container

10. These are:
  - The need to brief drivers about ensuring that loads are safely secured after an incident.
  - The possibility of obtaining suitable securing equipment which could be placed in locomotive cabs for use in similar situations (note - this would also require that drivers become competent in making such loads safe to travel).
