# RAIB Bulletin 01/2008

## Shunter struck by train in August 2007

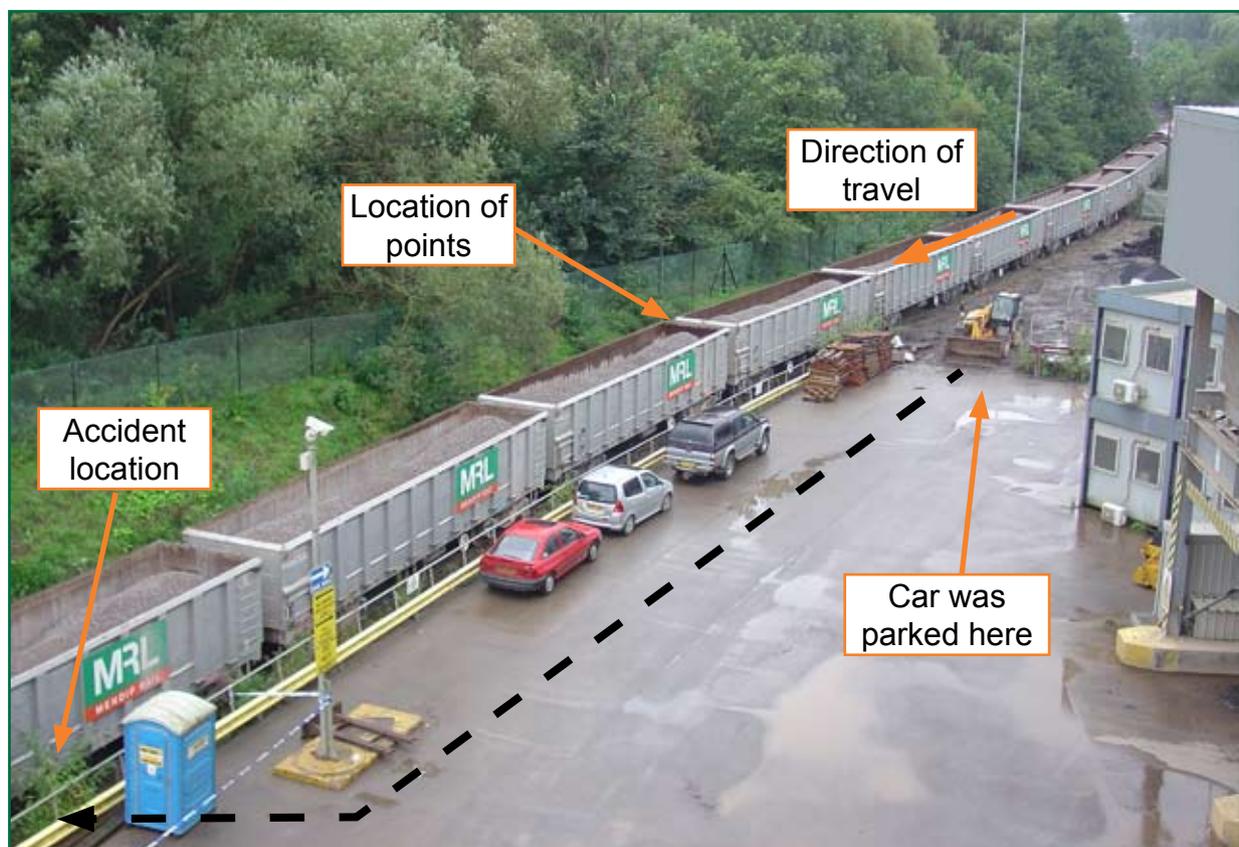
Figure 1: site of accident

6. Study of the times of the phone call and the movement of the train indicates that the shunter only had a period of some 34 seconds to move the distance of 68 metres from his car to cross in front of the approaching train so that he was in a position to carry out his next duties. This movement included climbing over a barrier, and descending a low embankment.

8. It is probable that the shunter tripped as he hurried to cross the track, fell with his legs across the rails as the train approached, and did not have time to get clear.

11. The lack of a clear, safe, and well lit walking route from the cabin to the sidings may have influenced the shunter in his decision to drive between the locations. Managerial and supervisory checks did not identify the conditions in the yard, or the fact that an unauthorised procedure was taking place.

- the necessity of allowing adequate time when carrying out safety critical duties;
- the necessity of never leaving, or planning to leave, a place of safety in front of an approaching train;
- the necessity of not dealing with mobile phone calls when carrying out safety critical duties;
- the necessity of stopping a train if verbal contact between shunter and driver is lost; and
- the necessity of adequate managerial or supervisory checks at remote locations, which should cover the method of working employed and the physical conditions at the site.
