SERIOUS INCIDENT

Aircraft Type and Registration:	Boeing 737-300, VP-CKY	
No & Type of Engines:	2 CFM56-3B2 turbofan engines	
Year of Manufacture:	1992 (Serial no: 26282)	
Date & Time (UTC):	15 January 2014 at 2249 hrs (local Grand Cayman time)	
Location:	Owen Roberts International Airport, Grand Cayman	
Type of Flight:	Commercial Air Transport (Passenger)	
Persons on Board:	Crew - 2	Passengers - 64
Injuries:	Crew - None	Passengers - None
Nature of Damage:	None	
Commander's Licence:	Airline Transport Pilot's Licence	
Commander's Age:	52 years	
Commander's Flying Experience:	18,450 hours (of which 13,800 were on type) Last 90 days - 65 hours Last 28 days - 42 hours	
Information Source:	AAIB Field Investigation

Synopsis

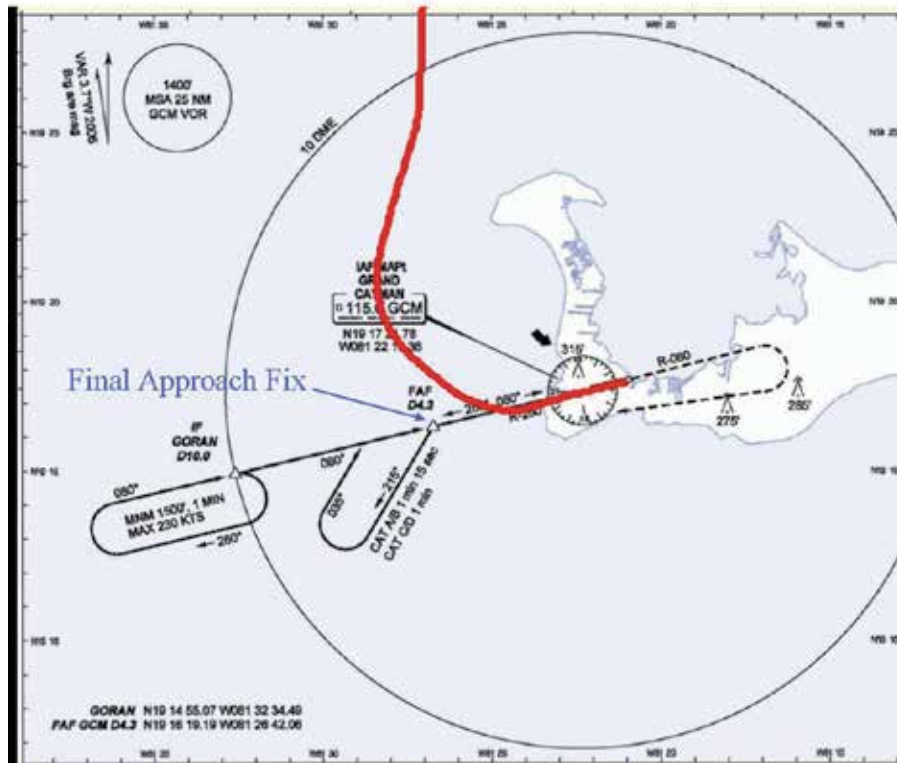
Figure 1

Extract from the Cayman Islands AIP showing the track flown by VP-CKY on its approach to Runway 08 at Owen Roberts International Airport

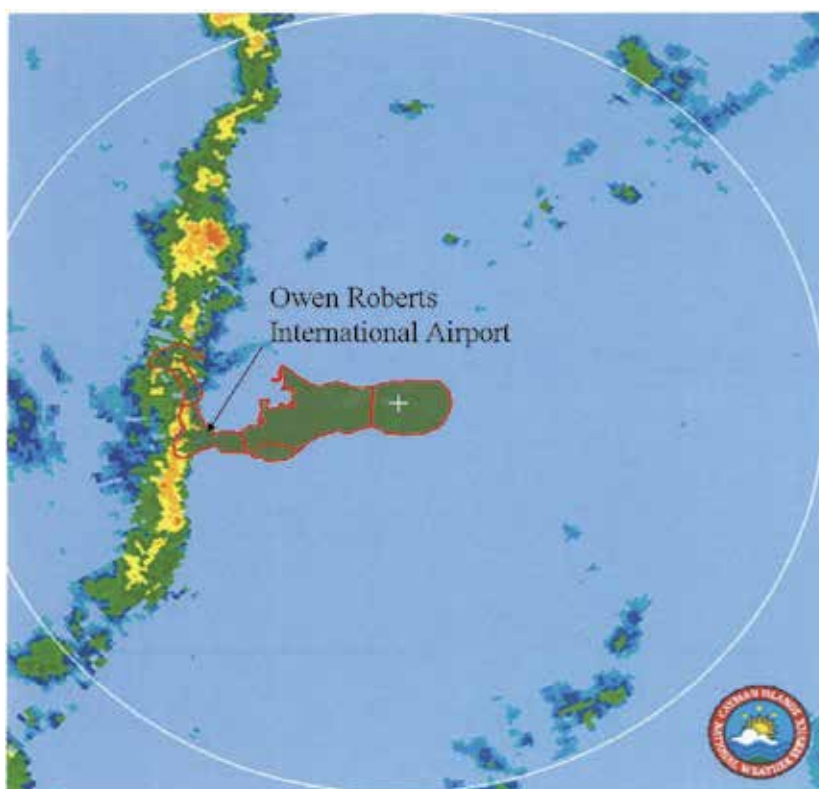
Figure 2

Weather image at 2230 hrs provided by the Cayman Islands National Weather Service showing the line of showers referred to by the commander of VP-CKY

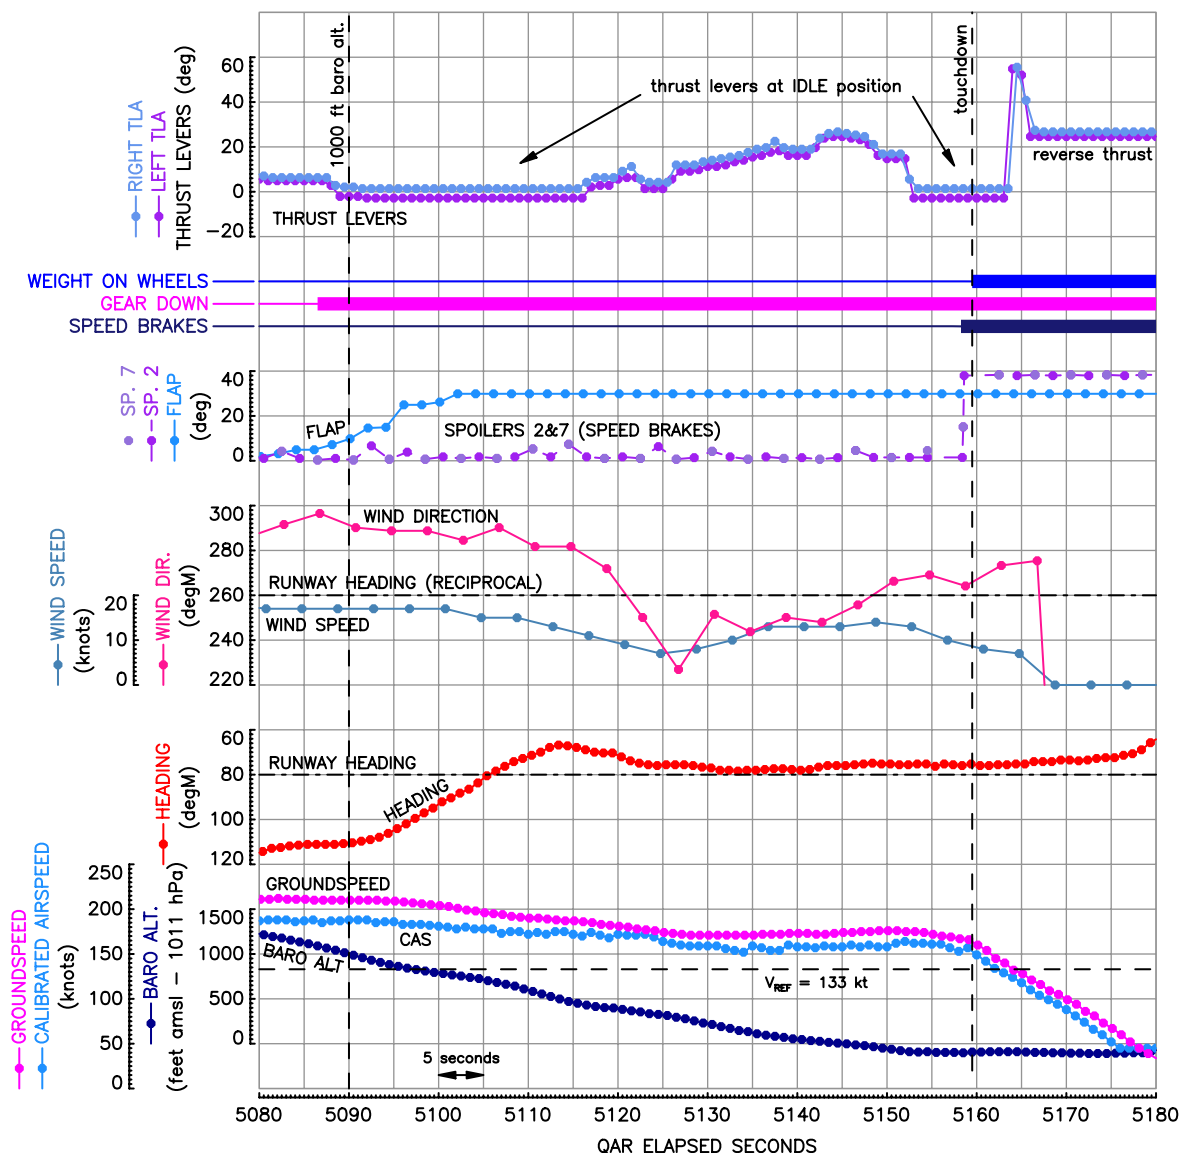
Figure 3 starts with the aircraft at 1,300 ft amsl on the approach to Runway 08. At 1,000 ft amsl (992 ft aal), the landing gear was down, the flap was passing the Flap 15 position in transit to a final flap setting of Flap 30, and the calibrated airspeed (CAS⁵) was 188 kt. The engines were set at idle thrust during the descent from 1,100 ft to 550 ft amsl, during which the average rate of descent was 1,200 ft/min.

Recorded flight data during the approach

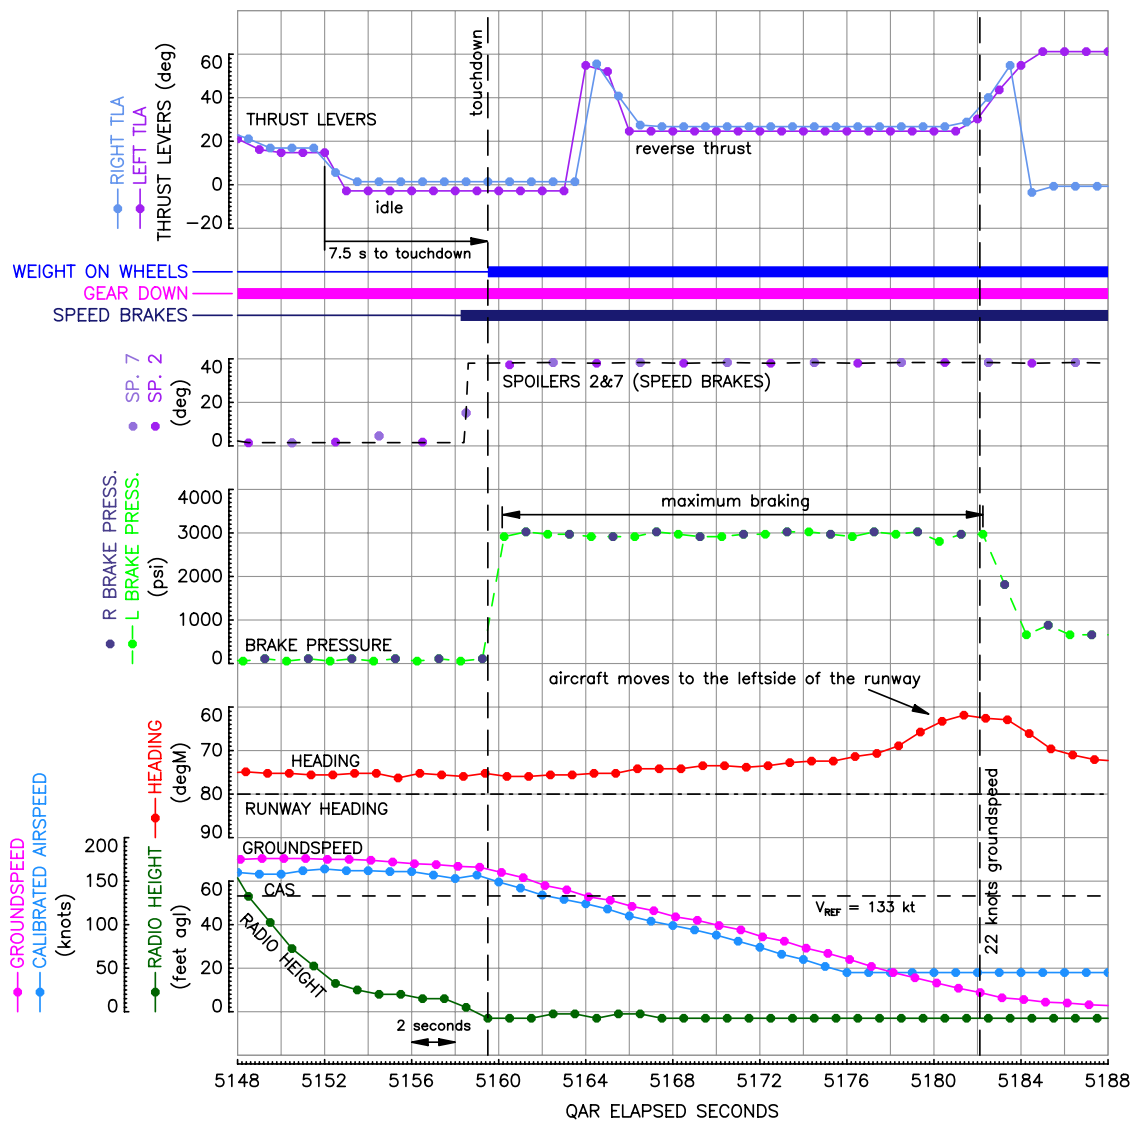
Figure 4 starts with the aircraft at 60 ft agl, a little under 12 seconds before touchdown. At 50 ft agl, the aircraft was flying at 160 kt CAS but had a groundspeed of 175 kt. At about 3 ft agl, approximately six seconds after the thrust levers were set to the IDLE position, the speed brakes were deployed and the aircraft touched down approximately one second later at 157 kt CAS (166 kt groundspeed). Maximum braking was then applied, followed four seconds later by the selection of reverse thrust, both of which were maintained until the aircraft slowed to approximately 22 kt groundspeed, by which time the aircraft was being positioned to the left side of the runway. The distance from touchdown to the point that reverse thrust was cancelled was 1,027 m (derived from recorded groundspeed).

Recorded flight data during the landing

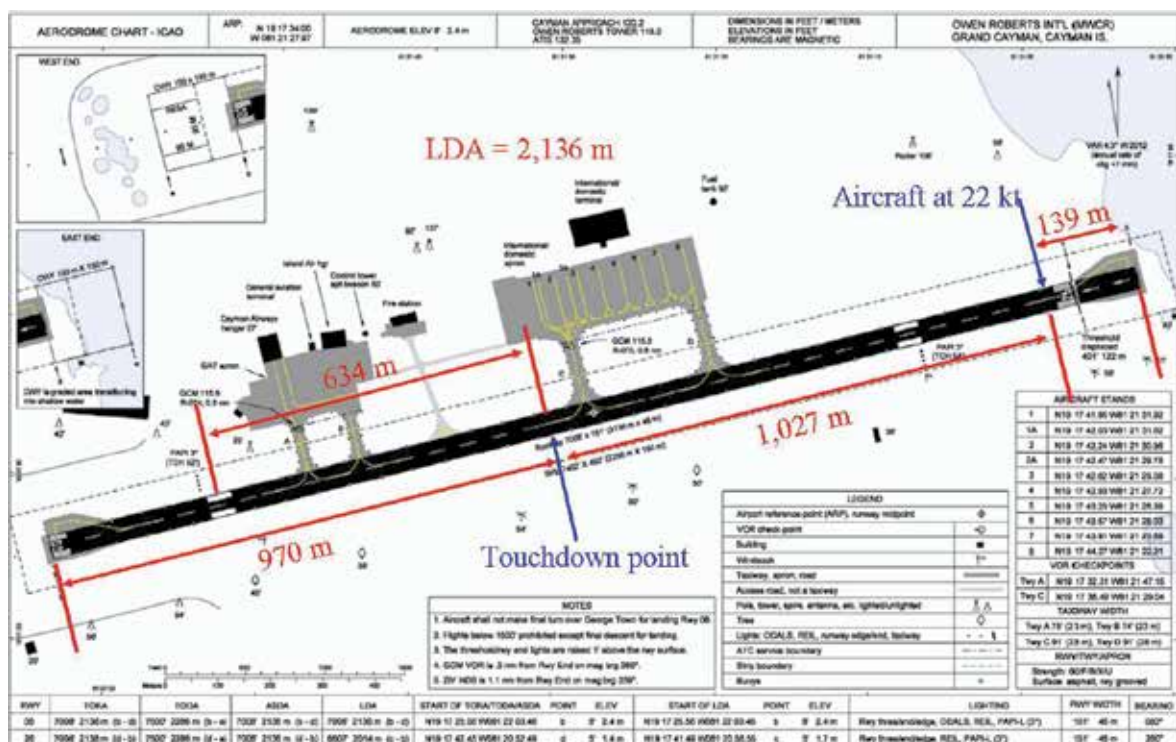
Figure 5 shows information on the landing derived from recorded flight data and depicted on a plan of the airport (all distances are approximate). The aircraft touched down 634 m beyond the touchdown zone markers. When reverse thrust was cancelled at 22 kt, there was 139 m remaining of the landing distance available (LDA). The aircraft began to turn around when the groundspeed was 6 kt, 95 m from the end of the LDA.

Information on the landing derived from recorded flight data
