# URGENT FIELD SAFETY NOTICE ALL HOSPIRA PLUM™ A+ FAMILY OF INFUSERS Broken Distal Occlusion Pressure Pin

Product name: Plum A+ Family of Infusers

EMEA FA ID: Q.FA.EMEA.2013.004

**Date:** 24 January 2013

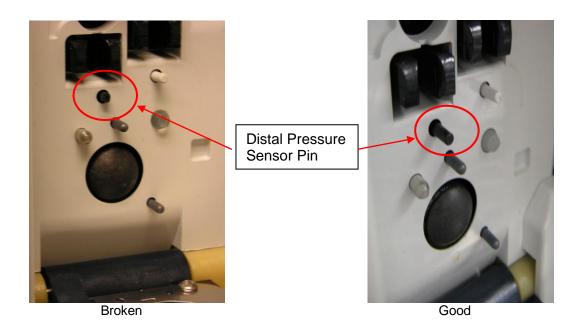
Hospira, Inc. is issuing this Field Safety Notice to inform you about the potential for the distal pressure sensor pin to break on Plum A+ infusers.

Hospira has identified the potential root cause of this issue to be improper loading of the cassette into the pump cassette chamber. The distal pressure sensor measures the pressure within the distal line of the administration set and indicates the presence of a full or partial distal occlusion. This issue can only be detected via a visual inspection of the device or by performing a Performance Verification Test (PVT) of the Distal Occlusion Test.

A broken distal pressure pin could result in incorrect distal pressure readings, undetected distal occlusions and/or undetected cassette failures. These situations could result in delay/interruption of therapy, overdose or underdose, which have a worst case potential to result in significant injury or death.

- Unlatch the cassette door from the opener handle assembly by pushing on the door release tab and open the door fully.
- Visually inspect the distal pressure pin for any evidence of breakage. See picture below

To further address this issue, Hospira is in the process of redesigning the distal pressure sensor pin to improve its strength and reduce the potential for breakage. The enhanced pin design will be released into manufacturing at the end of May 2013. During routine cleaning and each time a pump is returned to the Biomed department for service, please visually inspect the distal pressure pin assembly using the steps below:

In addition to a visual inspection, performing the Performance Verification Testing (PVT) Distal Occlusion Test as described in Section 5 of the Technical Service Manual (430-95552-005, Rev. 03/10), can be used to determine if the distal pressure sensor is performing correctly.

Upon the identification of a broken distal pressure pin, remove the device from service and contact your local Hospira office to report the issue.
