Helmond, 1 July 2013

Safety warning Ibis comfort wheelchair

1016040B | Replacing the upper hinge block

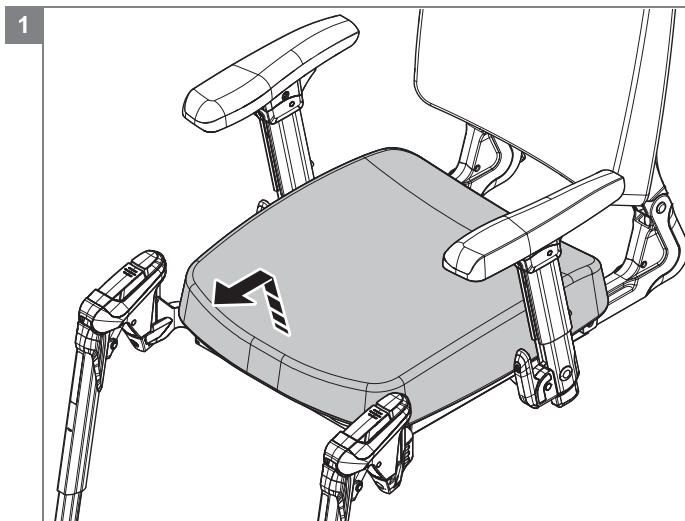
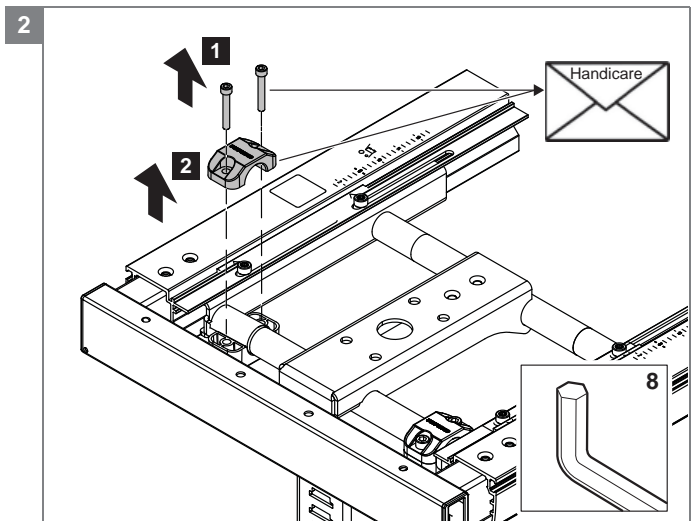
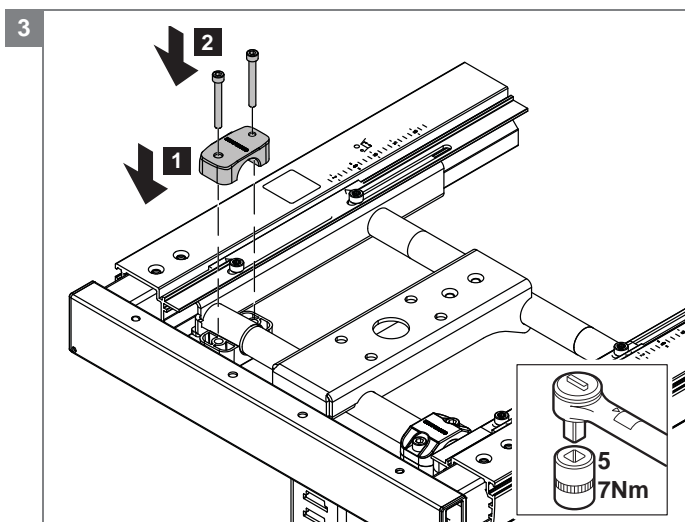
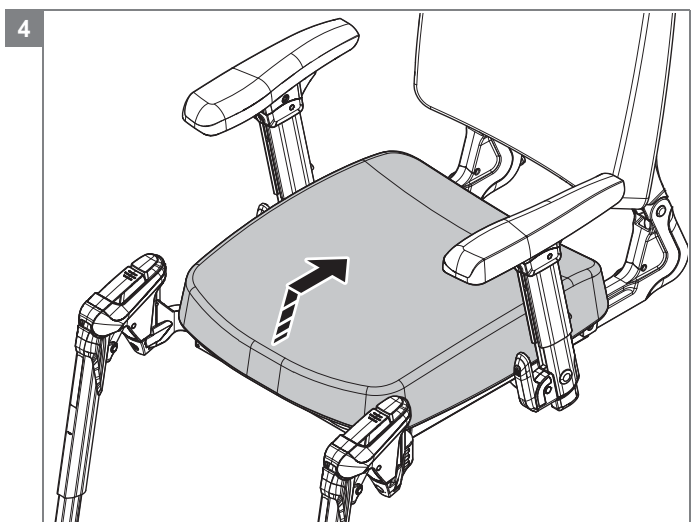
I am writing to tell you that Handicare has discovered a potential quality issue with the tilt adjustment on a limited number of Ibis comfort wheelchairs, delivered between 29 January and 12 April 2013. In extreme situations, a component used in the tilt mechanism may break, which could cause the seat unit to tip backwards. No injuries have been reported. As the safety of the people using our products is our first priority, Handicare has decided to replace all components from the affected batch as a precautionary measure. This action is effected in cooperation with the MHRA. For the execution of this action we ask your assistance.

- Remove the upper hinge block 22 mm (with sloping sides)
- Place the new upper hinge block (same as the lower hinge block)
- Place and screw the both 55 mm socket head screws (5 mm longer than original screws)
- Repeat same steps for the other hinge block
- Put back the seat
- Send exchanged upper hinge blocks and socket head screws back to Handicare (please use the Handicare return form)

Note! Tighten the socket head screws of the hinge block with 7 Nm!
