## **Urgent Field Safety Notice**

### **Harrier Range Technical Manual**

**Invacare Ref: FSN 043**

## Drive Wheels.

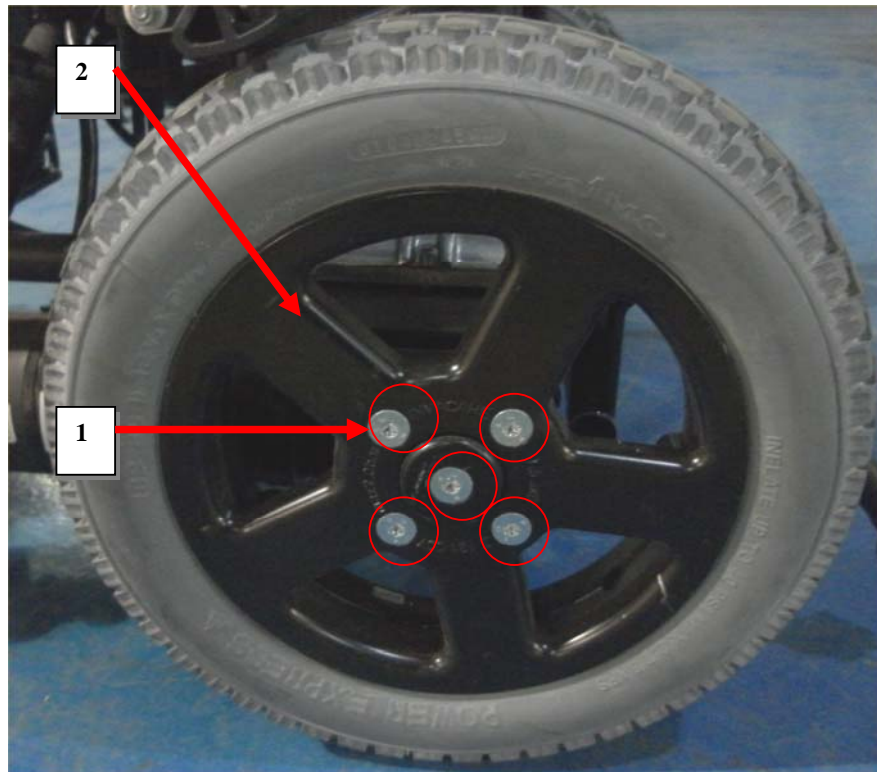
Note: The drive wheel is fixed to the hub by means of five Torx Screws.

- Lift the mobility aid up on one side and get a second person to place a suitably sized wooden block underneath it so that the drive wheel is suspended freely.
- Loosen the five T40 Torx Screws (1).

- Take the wheel (2) off the hub.
