# Medical Device Alert

Ref: MDA/2012/046 Issued: 16 July 2012 at 15:30

Non CE-marked portable dental X-ray units.

Including the Tianjie Dental 'Falcon'.

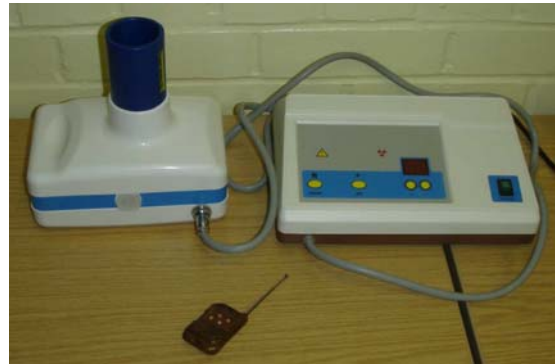
Testing by the Health Protection Agency (HPA) has revealed that the Tianjie Dental Falcon device lacks sufficient shielding in the X-ray tube, which could give rise to high patient doses and under typical high radiographic workloads result in operator doses in excess of the Ionising Radiation Regulations 1999 annual dose limits. This could give rise to adverse health effects caused by radiation.

The Tianjie Dental Falcon is not CE-marked as a medical device.

- Identify and stop using this and similar non CE-marked devices.
- Replace the device with a suitable CE-marked alternative.
- Be aware of the NRPB (HPA) [Guidance Notes for Dental Practitioners on the Safe Use of X-Ray Equipment](#) or the [Medical & Dental Guidance Notes](#) published by IPEM.
- Be aware of the general requirement to consult a suitable radiation protection adviser with regard to the use of X-ray equipment.
- Be aware of [MHRA advice on the use of non-CE marked devices](#).
- Report any suspected devices to [MHRA Adverse Incident Centre](#).

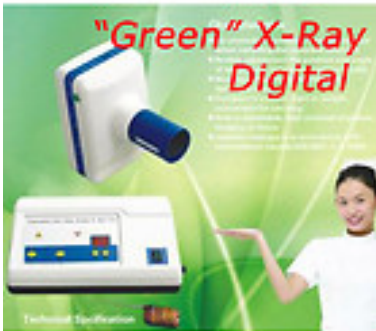
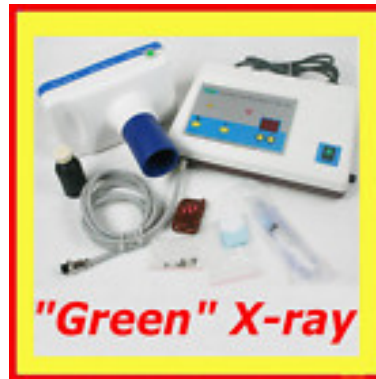
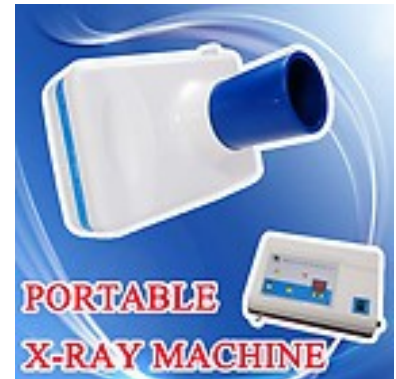
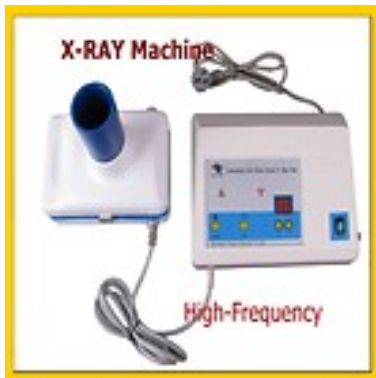
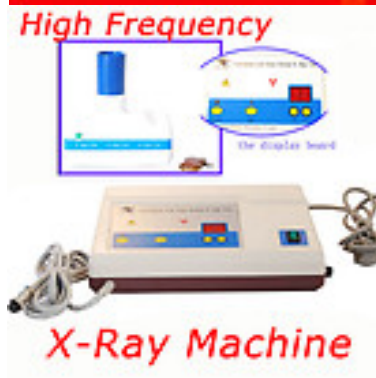
The Tianjie Dental Falcon portable X-ray unit is not CE-marked as a medical device and was purchased on eBay. It is identical in appearance to a number of other non CE-marked devices that are available on the internet:

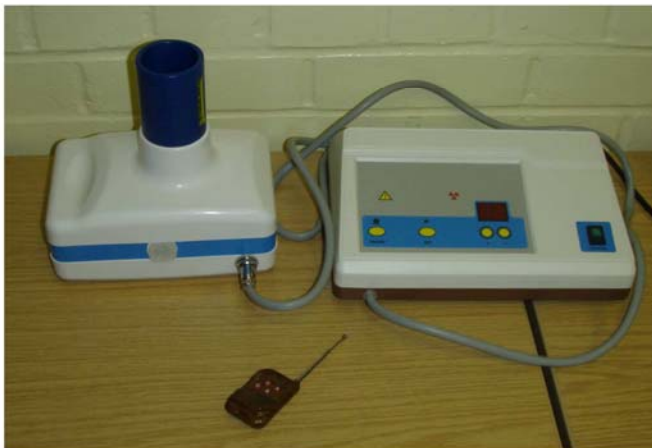
HPA's Dental X-ray Protection Service (DXPS) has recently obtained an example of a hand held dental X-ray unit available for purchase in the UK via the eBay website. There are other X-ray units of identical appearance being sold under different names on the internet. This particular unit was sold from China and was priced at £205, a fraction of the cost of other dental hand held X-ray sets available for sale in the UK, which can be over £4,000. The unit is not CE marked and there was no identifiable information provided about the supplier or manufacturer. DXPS is aware of one UK dentist who has purchased this type of X-ray set and has received several other enquiries from dentists who are considering purchasing one. The X-ray set obtained is pictured below.

DXPS has made an assessment of the operating parameters of the X-ray set and measurements of scattered and leakage radiation at positions representative of the operator's hand and body position when holding the X-ray set in the hands. **These results give cause for concern** and are summarised overleaf.

Maximum dose at the operator body position for a typical exposure <sup>1</sup> :	<b>5.6 µGy</b>
Maximum dose at the operator hand position for the same exposure:	<b>7592 µGy</b>
Assessed operating potential:	<b>49 kVp</b>
Focal spot to end of cone distance:	<b>100 mm</b>
Beam size:	<b>55 mm circular<sup>2</sup></b>

These operating parameters do not meet the requirements specified in the Guidance Notes for Dental Practitioners on the Safe Use of X-ray Equipment and the measurements of scattered and leakage radiation raise serious concerns (see below).

The example tested demonstrates a number of serious deficiencies, the most worrying of which is a lack of sufficient shielding in the X-ray tube which could (under circumstances of high but realistic radiographic workloads) give rise to operator doses in excess of the IRR99 annual dose limits and could even lead to localised deterministic effects. The X-ray set also fails to meet a number of the standards recommended in the Dental GNs, and is not CE marked. In addition, an assessment conducted by HPA CRCE's Technology Development Group concluded that the X-ray unit did not meet the expected standards of construction and electrical safety.

HPA recommends that regulators give consideration to prohibiting the use of this model of X-ray unit. Furthermore, professional bodies within the dental community may wish to inform potential users of the risks of using this X-ray unit.
