## URGENT FIELD SAFETY NOTICE

Dual Chamber Models of Pacemakers:  
Kappa 600, 700, 800, 900, EnPulse, Adapta, Versa, Sensia, Relia,  
Vitatron Models E50A1, E60A1, and G70A1

**Medtronic Reference: FA507**

### Dual Chamber Pacemakers with Measurement Lock-up ERI

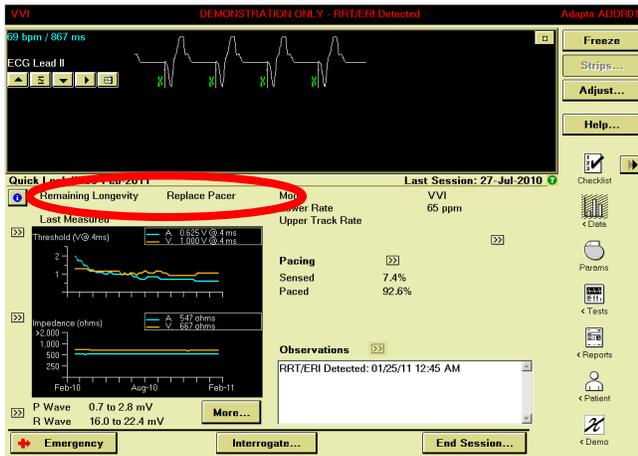
Example 1 – Programmer Screen for Typical Pacemaker at ERI

Two examples of images from the Medtronic 2090 programmer are shown below. Example 1 shows what a normal ERI condition looks like. Example 2 shows what will be displayed if the ERI is triggered due to the measurement lock-up condition.

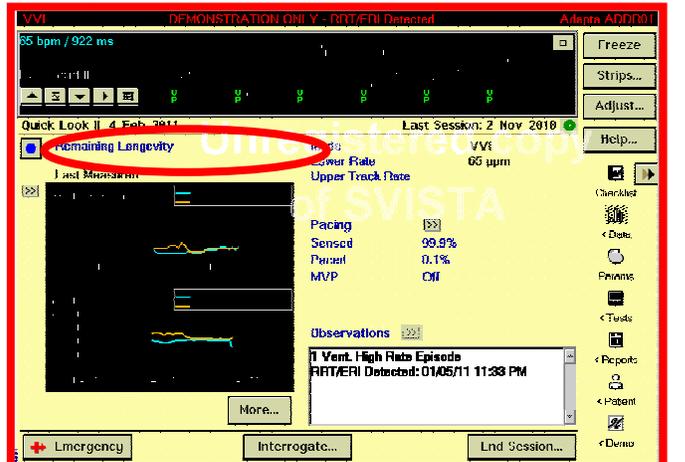
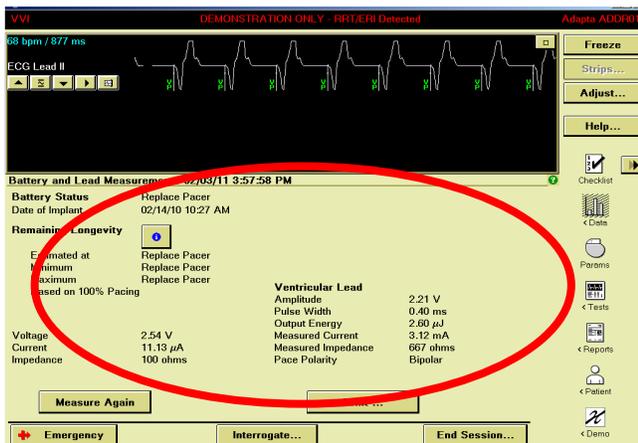
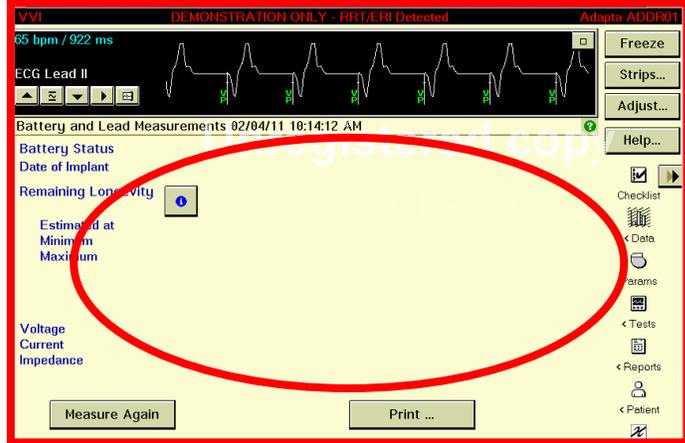
Example 2 – Programmer Screen for Measurement Lock-up ERI

A device that has experienced a measurement lock-up ERI will present ALL of the following symptoms:

- Device declaring ERI/RRT
- Remaining Longevity = <Blank> on the programmer (and CareLink where available)
- Battery Voltage = <Blank> on the programmer (and CareLink where available)
- If the user attempts to take a Battery and Lead Measurement, a pop up window will indicate that it cannot estimate remaining battery life.

This condition can be reset and does not require device explant. If this measurement lock-up occurs, obtain a save-to-disk file and contact your local Technical Consultant or Medtronic Technical Services on 01923 212 213 for assistance. Reset devices are no more likely to experience a recurrence of this issue.
