URGENT FIELD SAFETY NOTICE

Dual Chamber Models of Pacemakers:
Kappa 600, 700, 800, 900, EnPulse, Adapta, Versa, Sensia, Relia,
Vitatron Models E50A1, E60A1, and G70A1

Medtronic Reference: FA507

Dual Chamber Pacemakers with Measurement Lock-up ERI

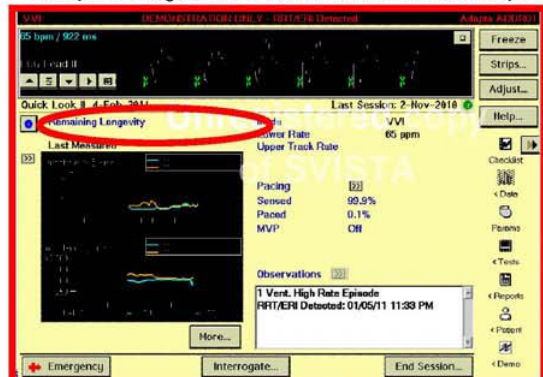
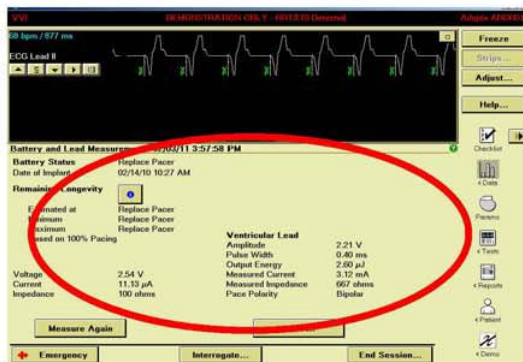
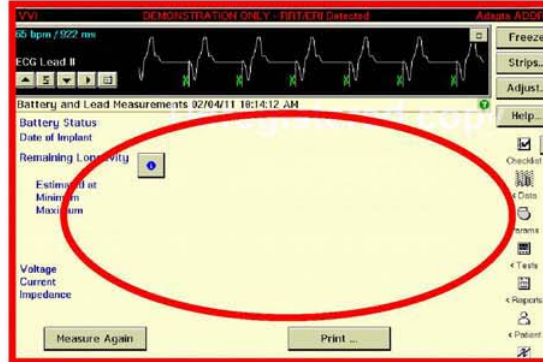
Example 2 – Programmer Screen for Measurement Lock-up ERI

If this rare measurement lock-up occurs in the pacemaker, it causes the device to read a value of zero for battery voltage. After four measurements of zero, the device will trigger ERI and revert to a VVI pacing mode at 65 bpm. There is no loss of ventricular pacing and the output voltage will remain the same.

The issue can be uniquely identified using the programmer or via CareLink transmission; the battery voltage measurements and remaining longevity will appear as blank values. Medtronic has developed a method for clearing the ERI condition through the use of a specially configured programmer. There is no impact to the device functionality or longevity after this reset is complete.

A device that has experienced a measurement lock-up ERI will present ALL of the following symptoms:

- Device declaring ERI/RRT
- Remaining Longevity = <Blank> on the programmer (and CareLink where available)
- Battery Voltage = <Blank> on the programmer (and CareLink where available)
- If the user attempts to take a Battery and Lead Measurement, a pop up window will indicate that it cannot estimate remaining battery life.

This condition can be reset and does not require device explant. If this measurement lock-up occurs, obtain a save-to-disk file and contact your local Technical Consultant or Medtronic Technical Services on 01923 212 213 for assistance. Reset devices are no more likely to experience a recurrence of this issue.
