INTERSTATE AVIATION COMMITTEE

FINAL REPORT

| Aircraft type | Airplane, Boeing 737-505 |
| Registration | VP-BKO (Bermuda) |

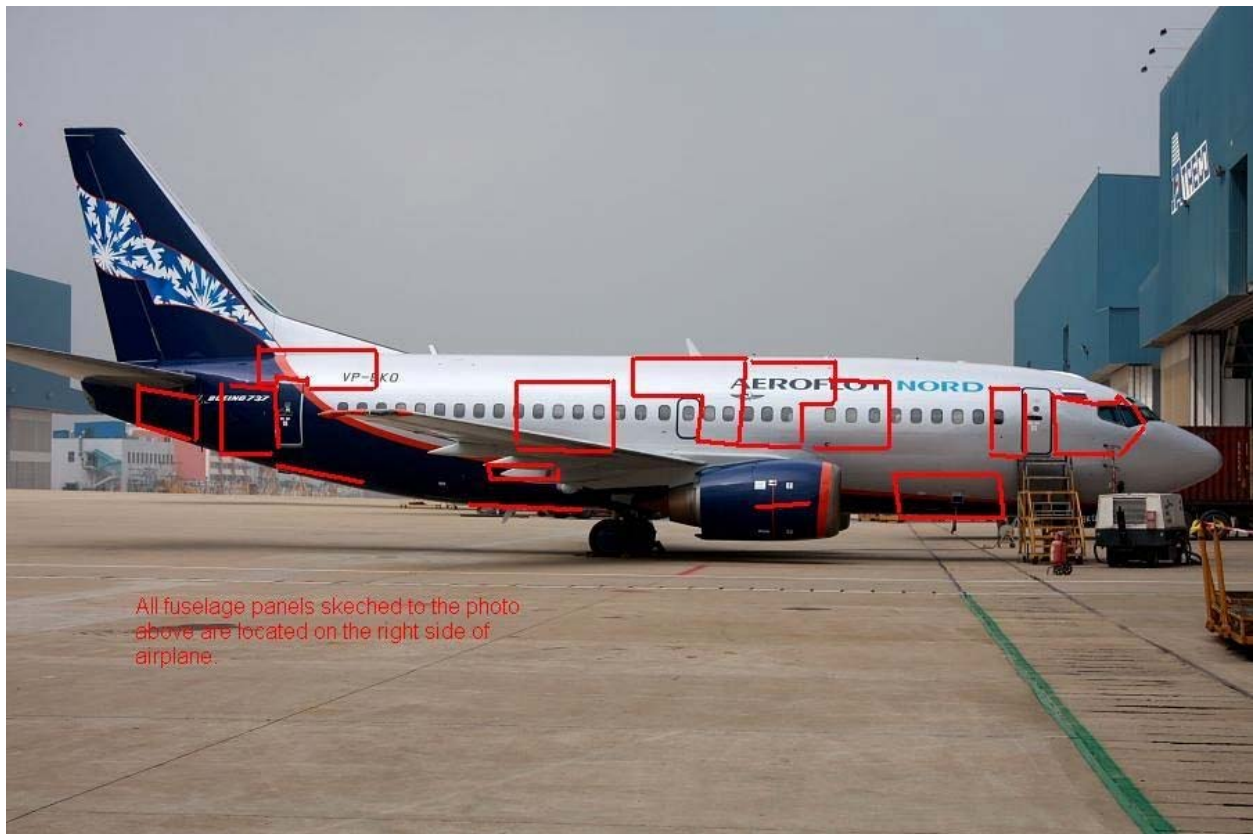
The fuselage was highly fragmented. There were 14 identifiable large fuselage skins and sections (see Picture below). Eleven of these panels are located on the right side of the airplane and three are lower (belly) panels. There were no identifiable fuselage structures found for the left side of the fuselage.

Remaining parts of the fuselage

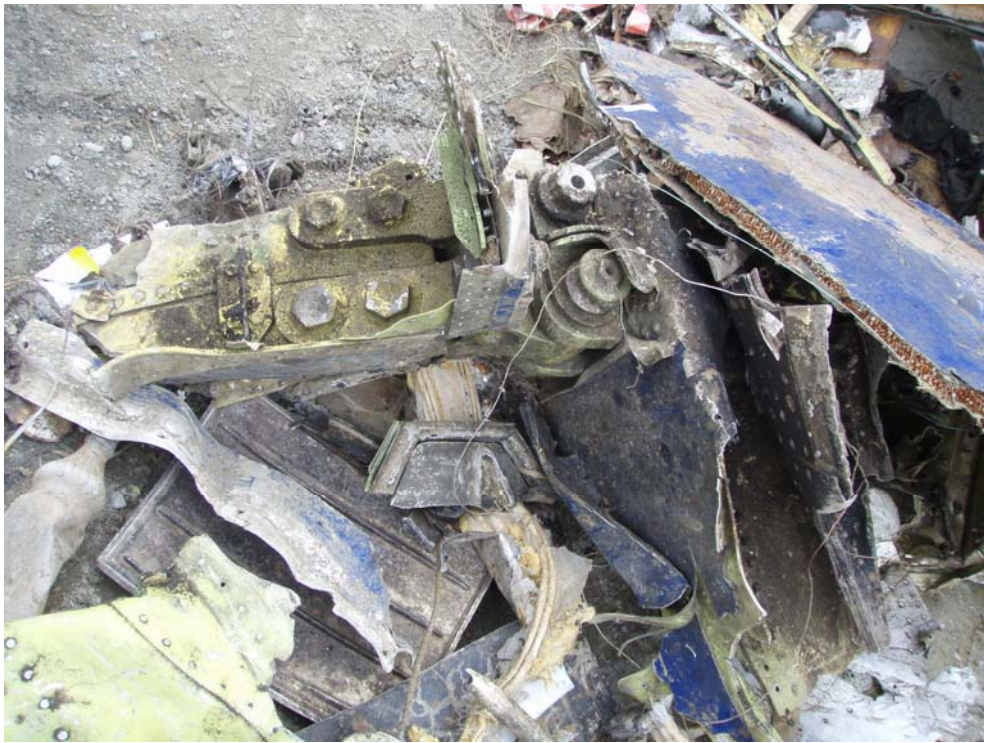
Left and right wing boxes and the center section were shattered and fragmented. Upper and lower wing surfaces, ribs, rear spar and front spar were broken into individual parts. Landing gear beams were separated from the airplane. The picture below shows the damage of right wing box to center section attachment.

Right wing box to center section attachment

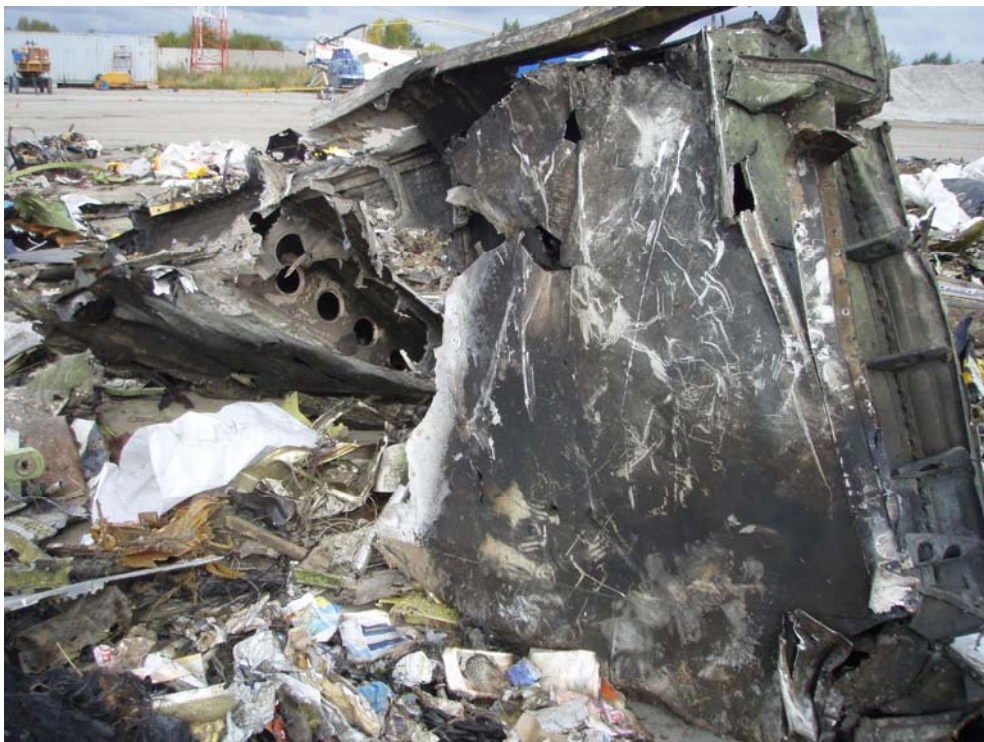
The lower 12 feet portion of vertical fin wreckage remained after the accident. The upper half was ripped and twisted almost 90 degrees to the right in relation to the lower half. All rudder hinges were ripped off except one on the upper portion. The vertical fin has evidences of severe burn in ground fire.

Remained portion of vertical fin

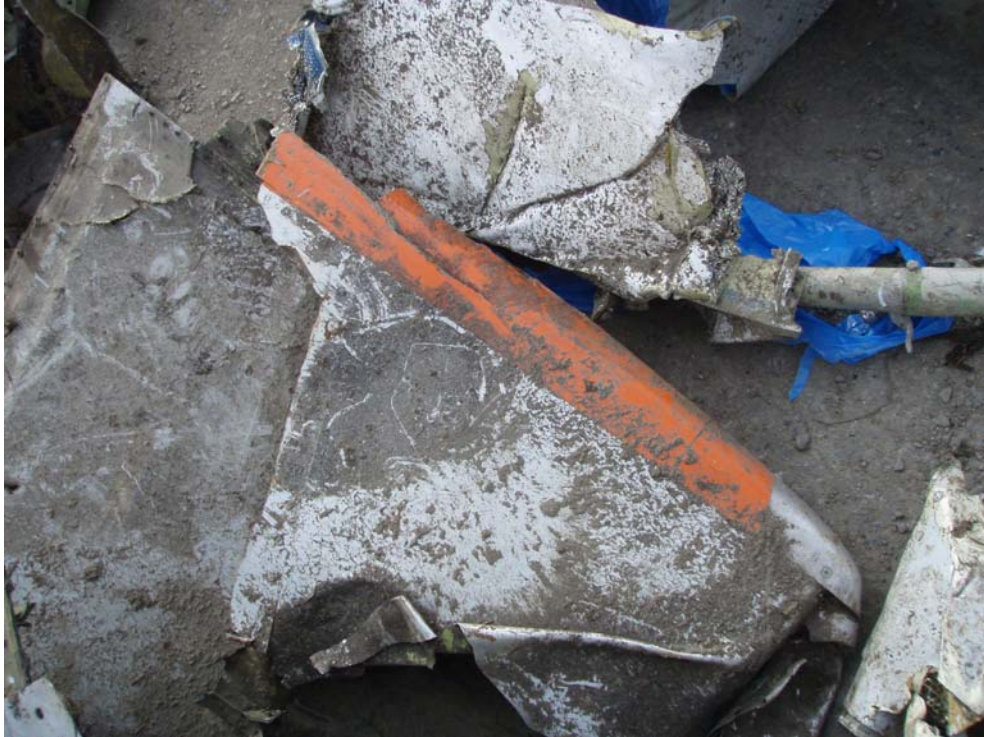
The only structure found on the left horizontal stabilizer was its tip.

Tip of left horizontal stabilizer

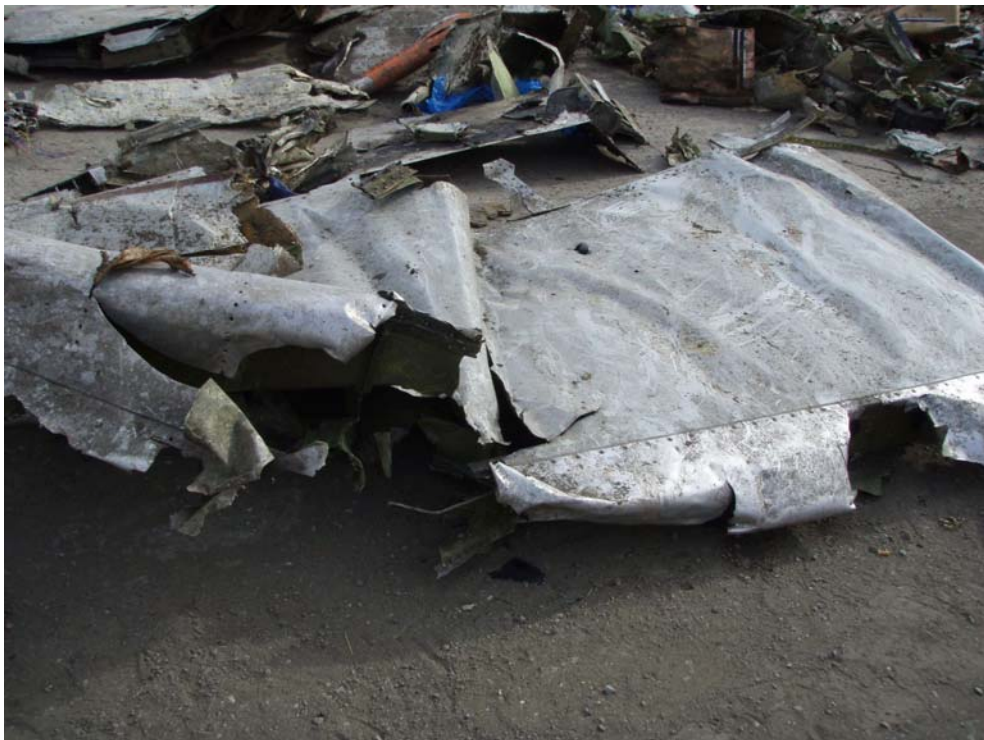
The right horizontal stabilizer was ripped in two pieces (see the pictures), which were twisted and crumbled from post-impact. Trailing edges were ripped off.

Inboard section of right horizontal stabilizer

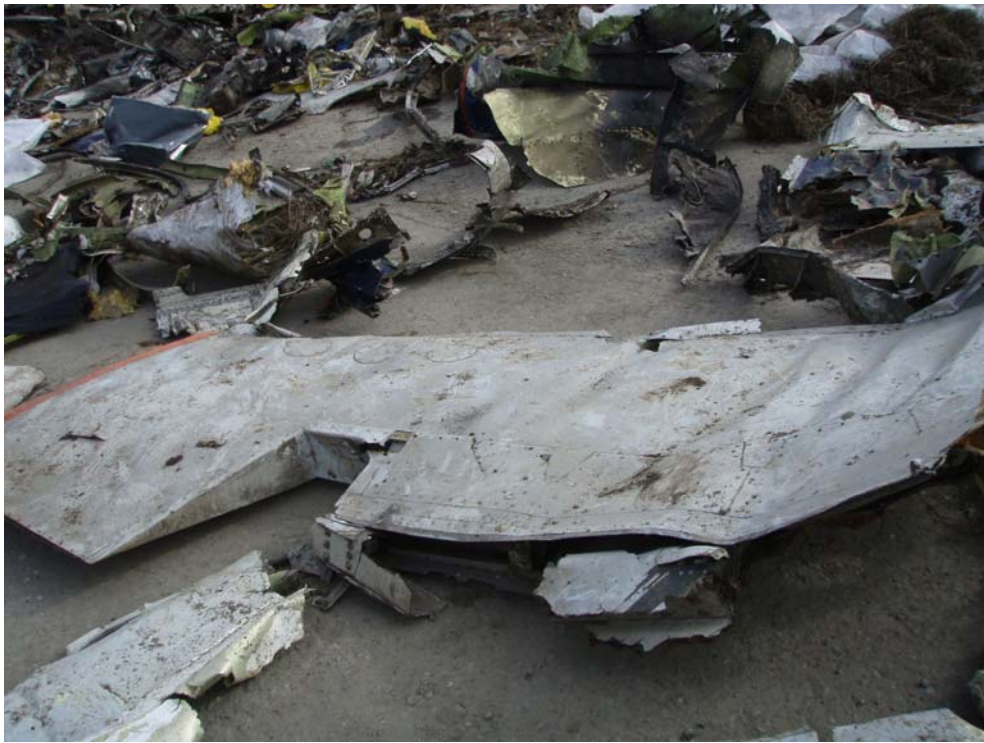
Outboard section of right horizontal stabilizer

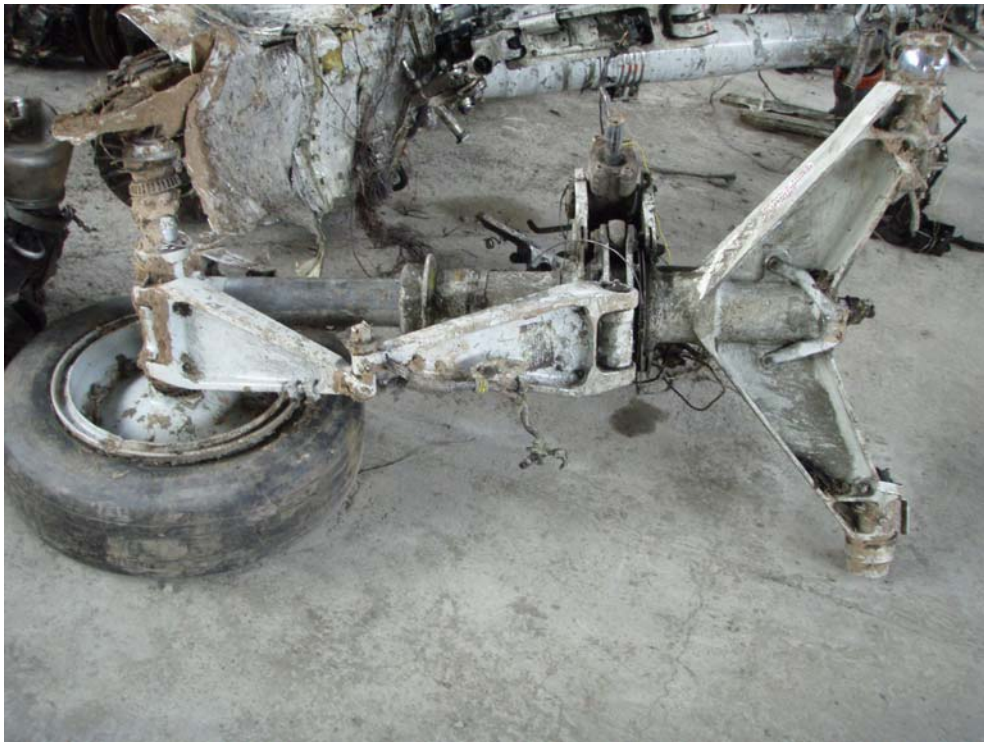
Nose gear assembly was separated from the fuselage. Left wheel was destroyed and ripped off the strut, the attaching nut was locked. Right main landing gear was deformed and had evidences of ground impact. The left wheel was separated; the right wheel had traces of ground fire. The left main landing gear was totally destroyed, the wheels and brakes ripped off, the shock strut inner cylinder was broken off in the lower portion, the damper is missing, the inclined strut was destroyed and ripped off. At the time of the impact the landing gears were extended.

Nose gear

All the damages of the landing gears resulted from the impact forces.

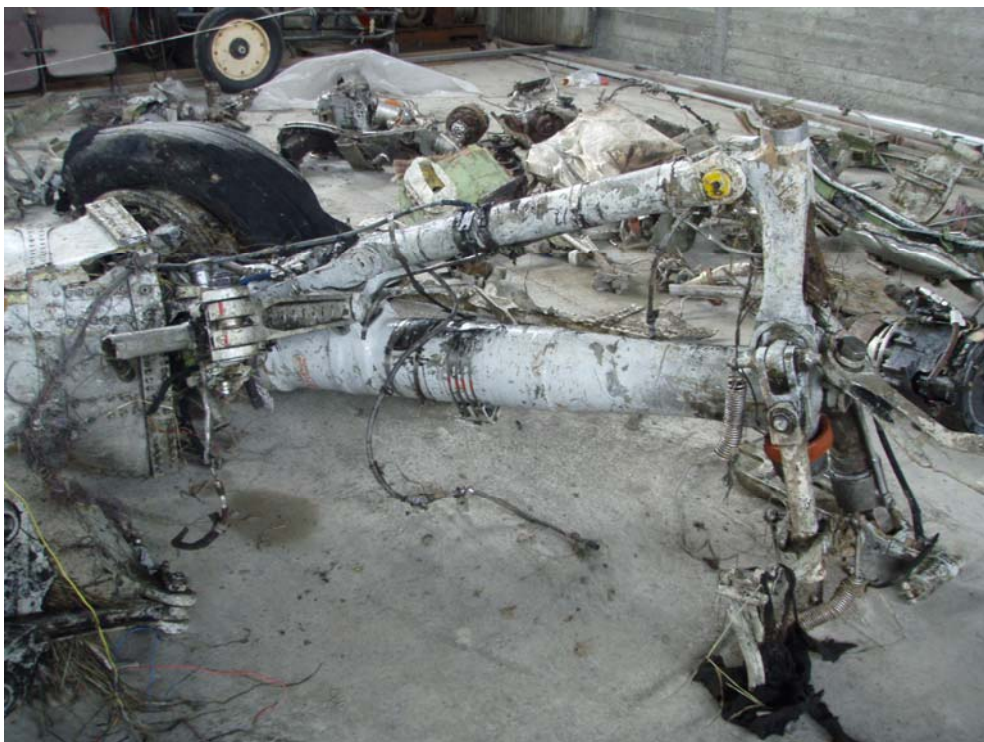
Right main gear

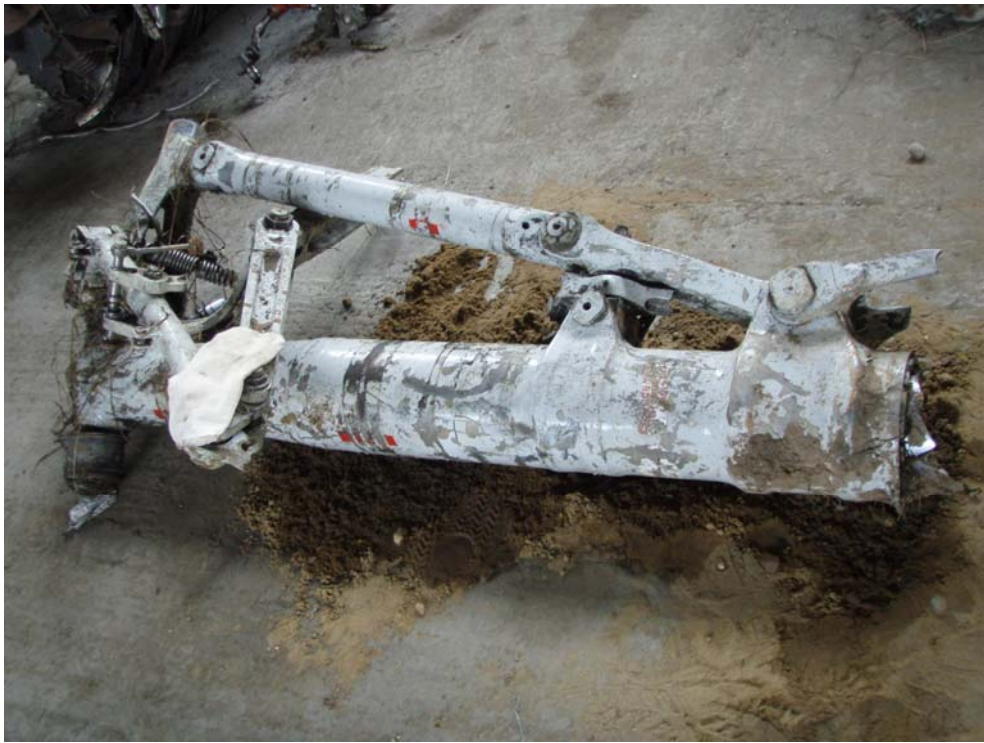
Left main gear

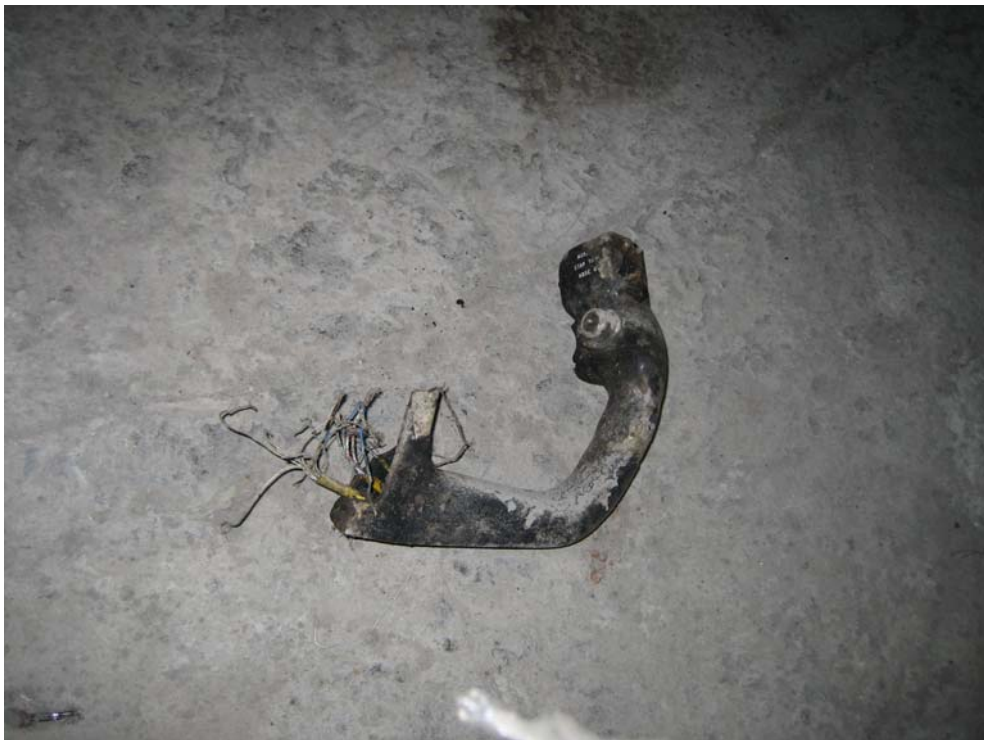
The flight controls and control linkages were totally destroyed; the central cockpit panel was damaged. The control wheels were destroyed.

Portion of a Control Wheel

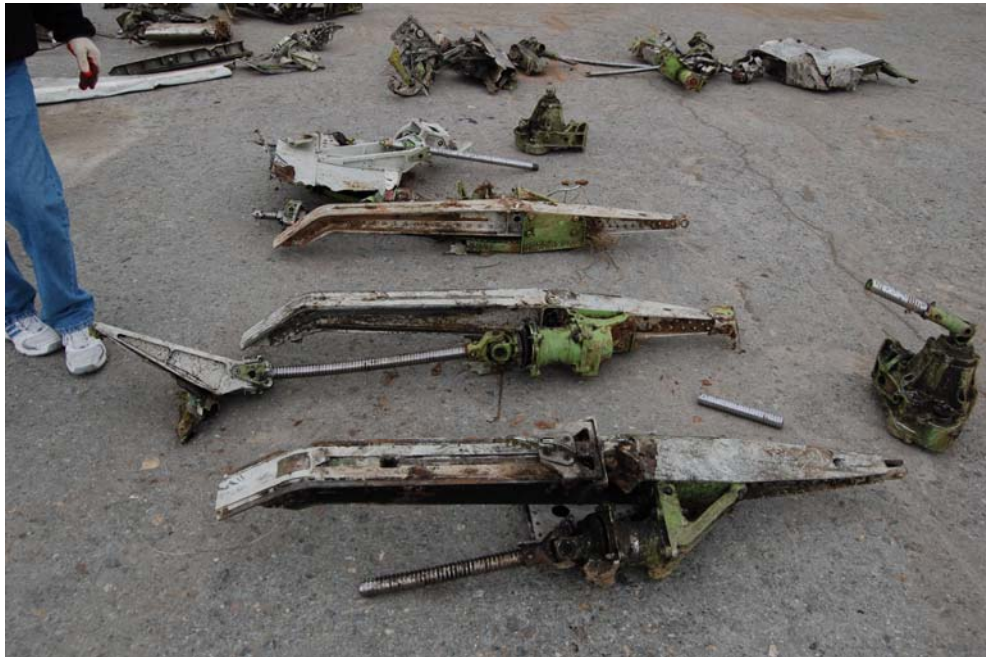
All four outboard flap drive screws as well as all four inboard flap transmission assemblies were identified. The distance from the up-stop to the top of the gimbal was measured for each, which showed the Flaps 30 position.

Outboard flap tracks

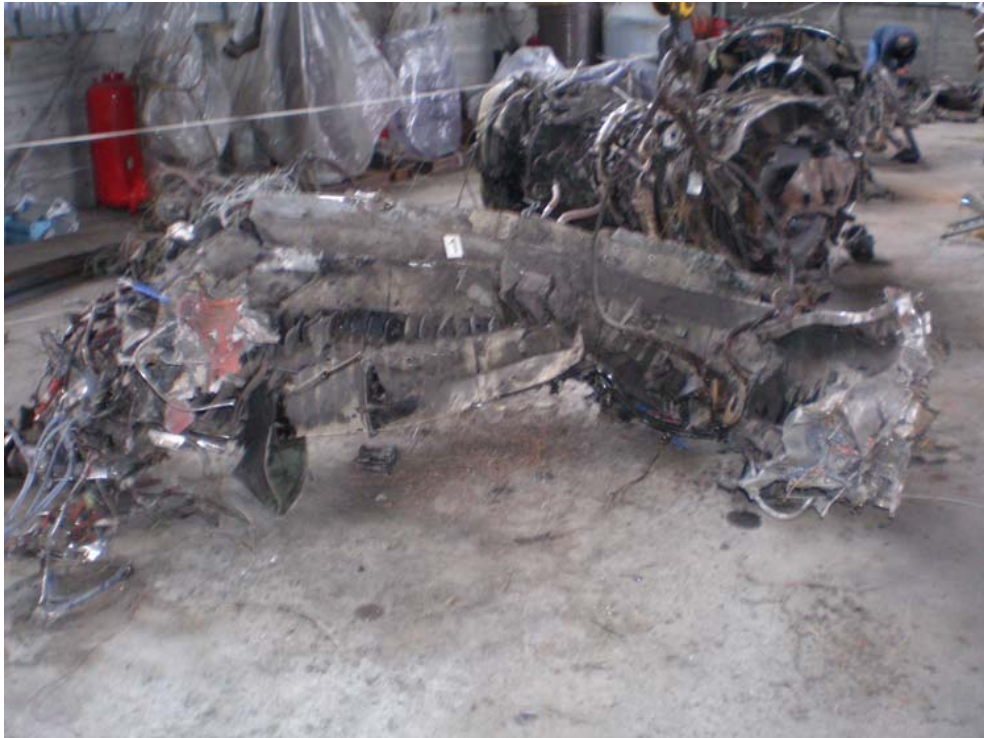
Left engine's fan case

The fan case was separated from the engine, broken into two portions, deformed, no traces of fire, the stator blades were fractured or missing and had soot from ground fire. The pipes were destroyed, but the wiring had no evidence of in-flight fire.

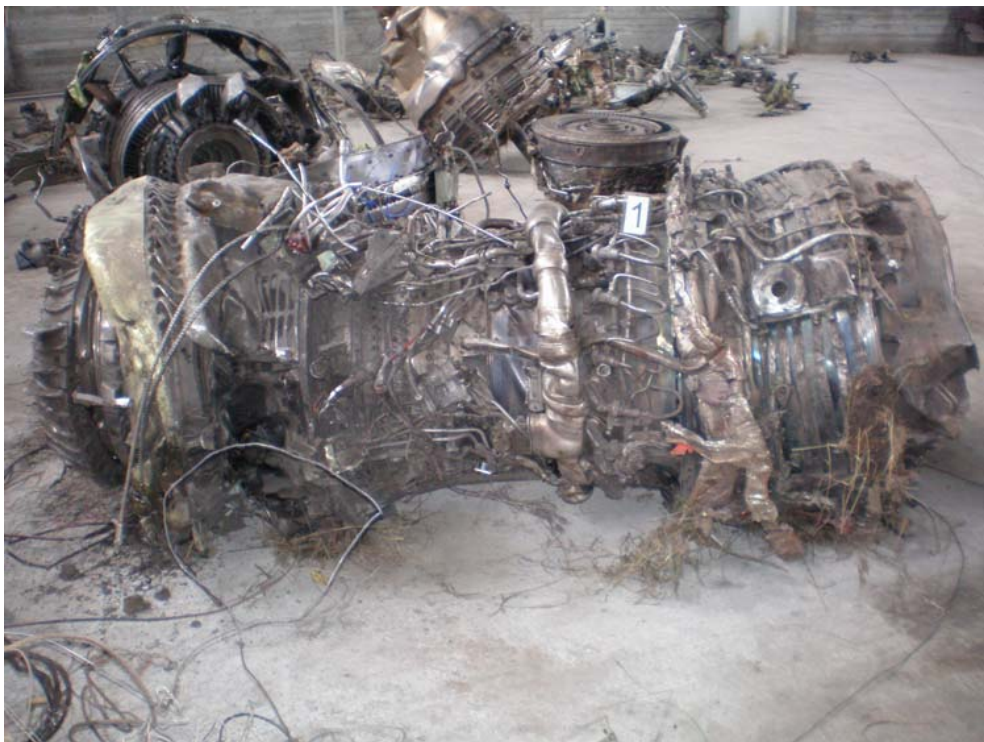
Left engine's core

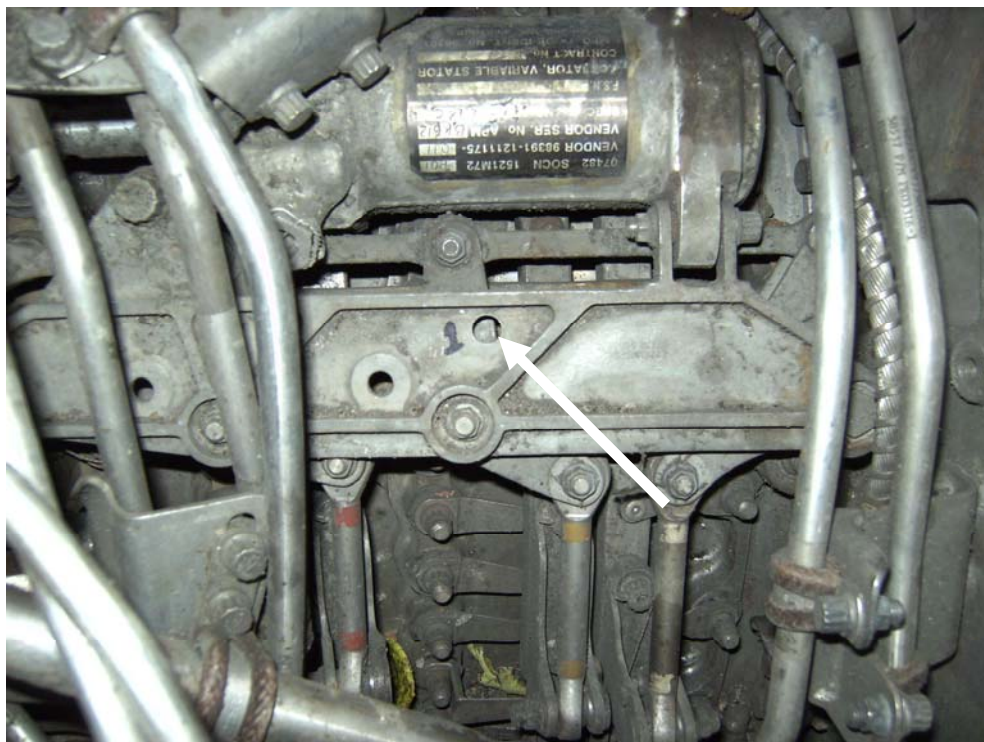
On the basis of the slight offset of the stator vane actuator lever arm rig pin hole and the inner rig pin hole in the synchronization rings, and also on the basis of the bypass valve in partly closed position (see pictures below) it can be assumed that this engine was operating at high power at the time of the impact.

Left engine - stator vane actuator lever arm rig pin hole

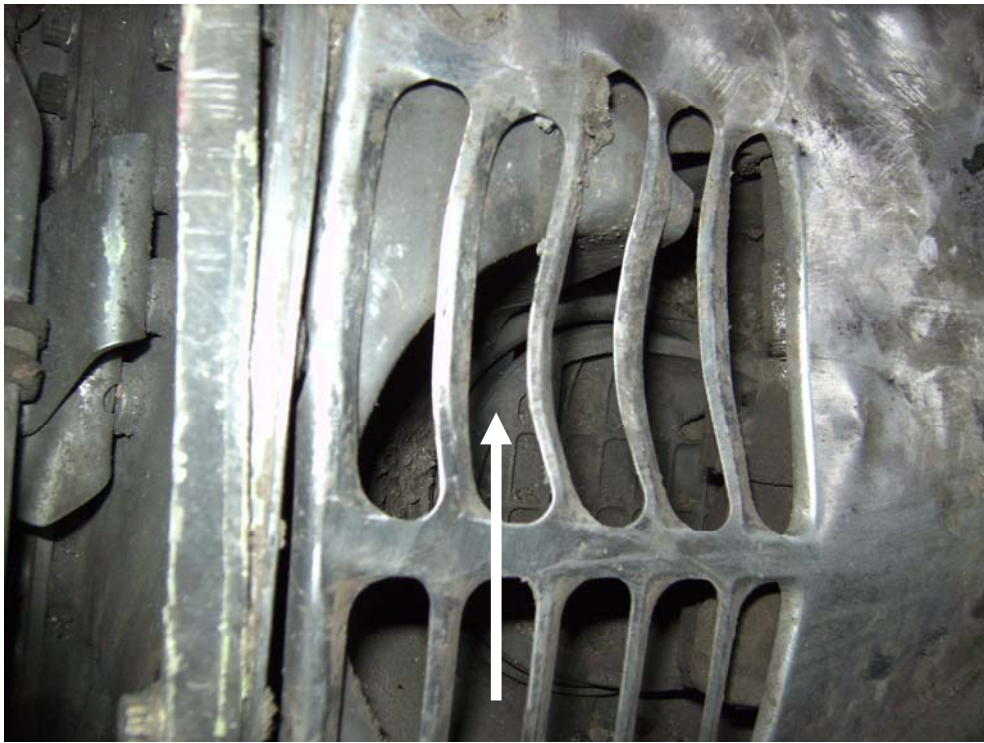
Left engine – bypass valve position

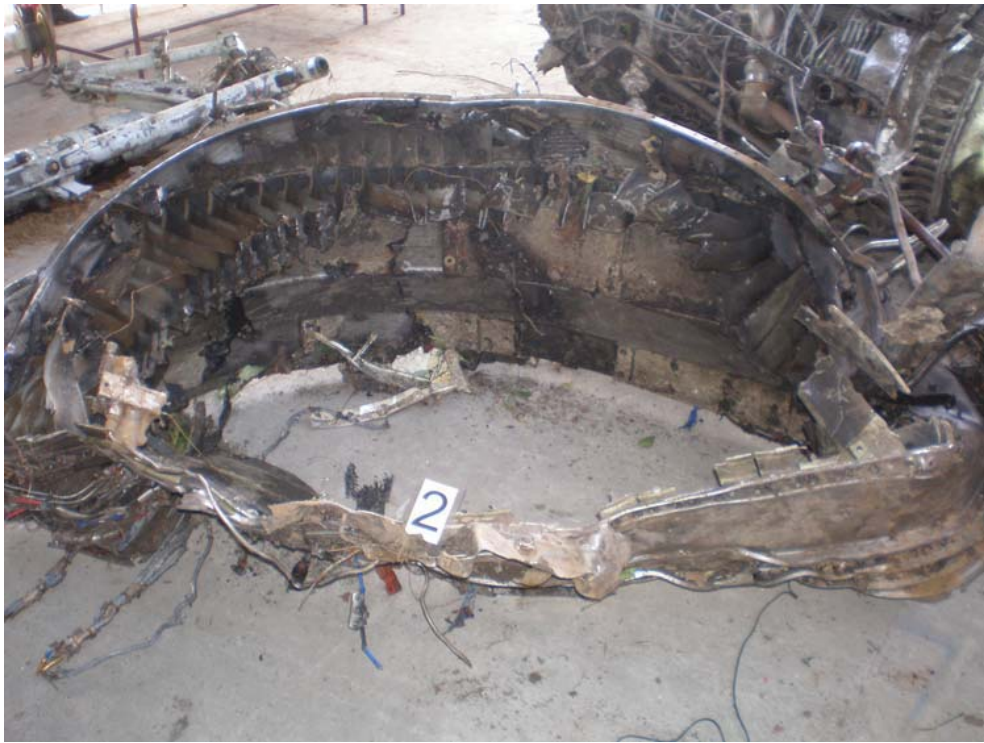
Right engine's fan case

The fan case was crushed and distorted. Twenty-two stator blades were separated. The remaining blades were deformed and some were sooted by the ground fire. There was evidence of thermal damages on fan acoustic panels, the fracture surfaces were also affected, which means they were burnt after the ground impact. The wiring insulation on the outside of the fan case did

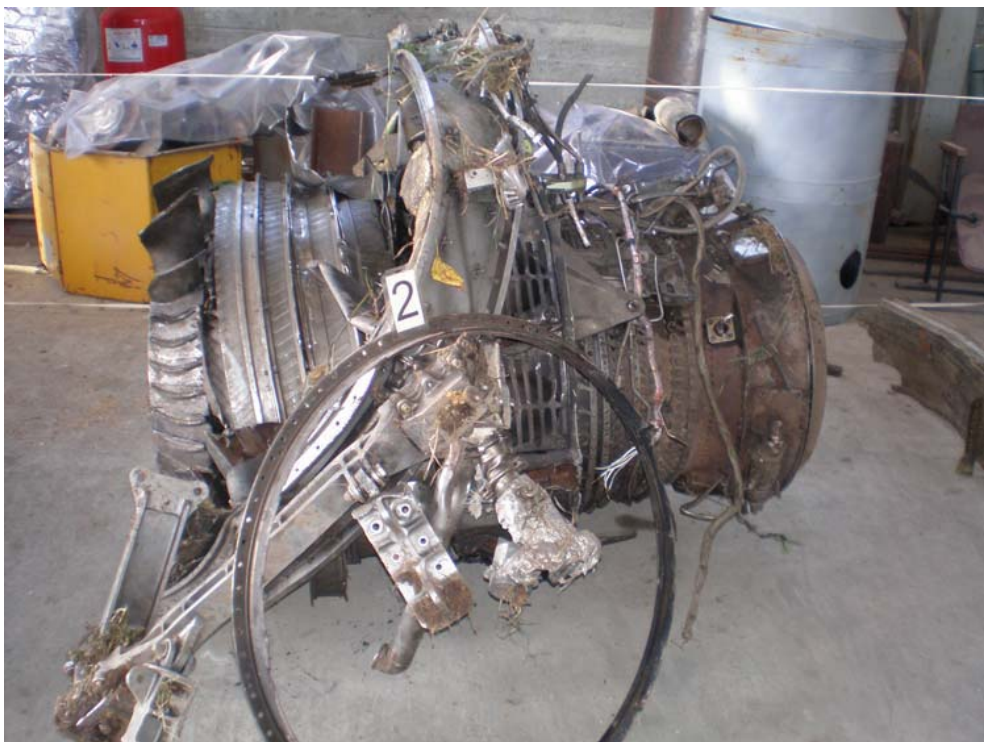
Right engine's fan and compressor

The fan and compressor were highly damaged. Thirteen fan blades are totally separated. The remaining 23 blades are either broken or crushed and bent in the same direction opposite to the engine rotation. The variable stator vane actuator arm rig pin hole was aligned with the other rig pin hole. On the basis of this alignment and also of the bypass valves position (fully closed – see pictured below), it can be concluded that at the time of the impact the right engine was operating at almost full thrust.

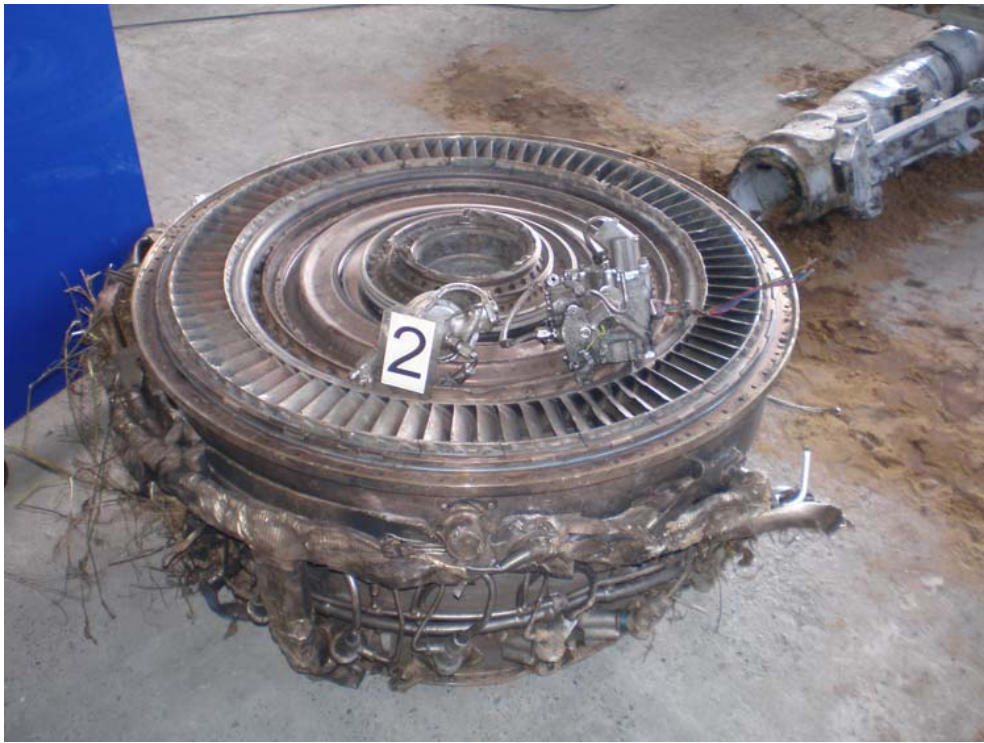
Right engine's combustor and high pressure turbine

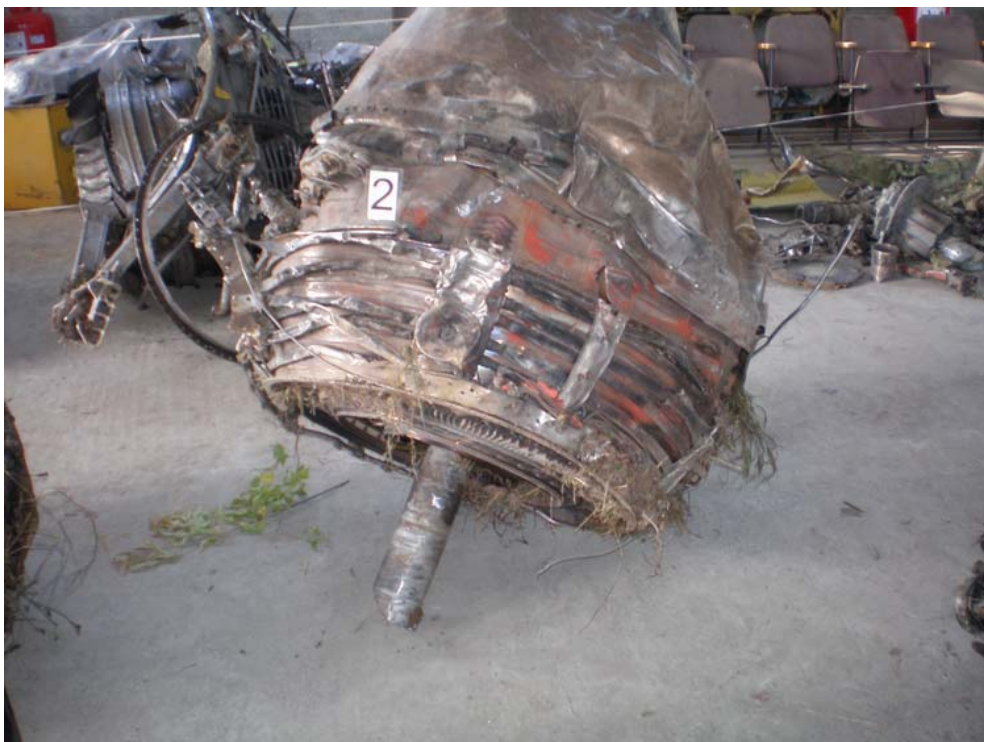
Right engine's low pressure turbine, exhaust duct and exhaust cone

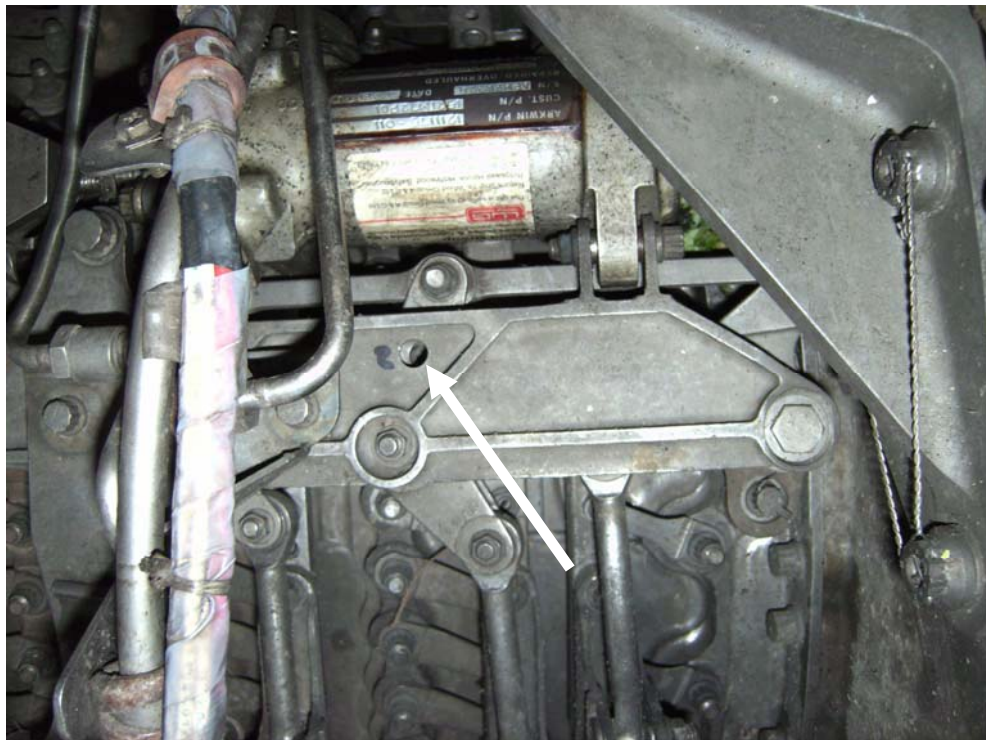
Right engine - stator vane actuator lever arm rig pin hole

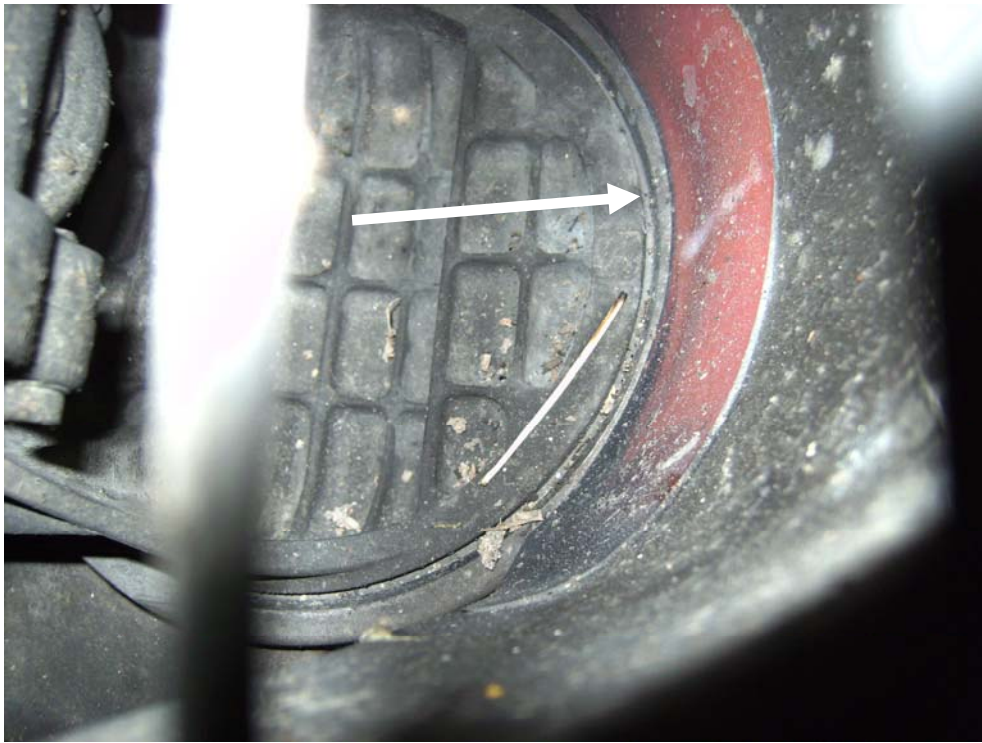
Right engine – bypass valve position

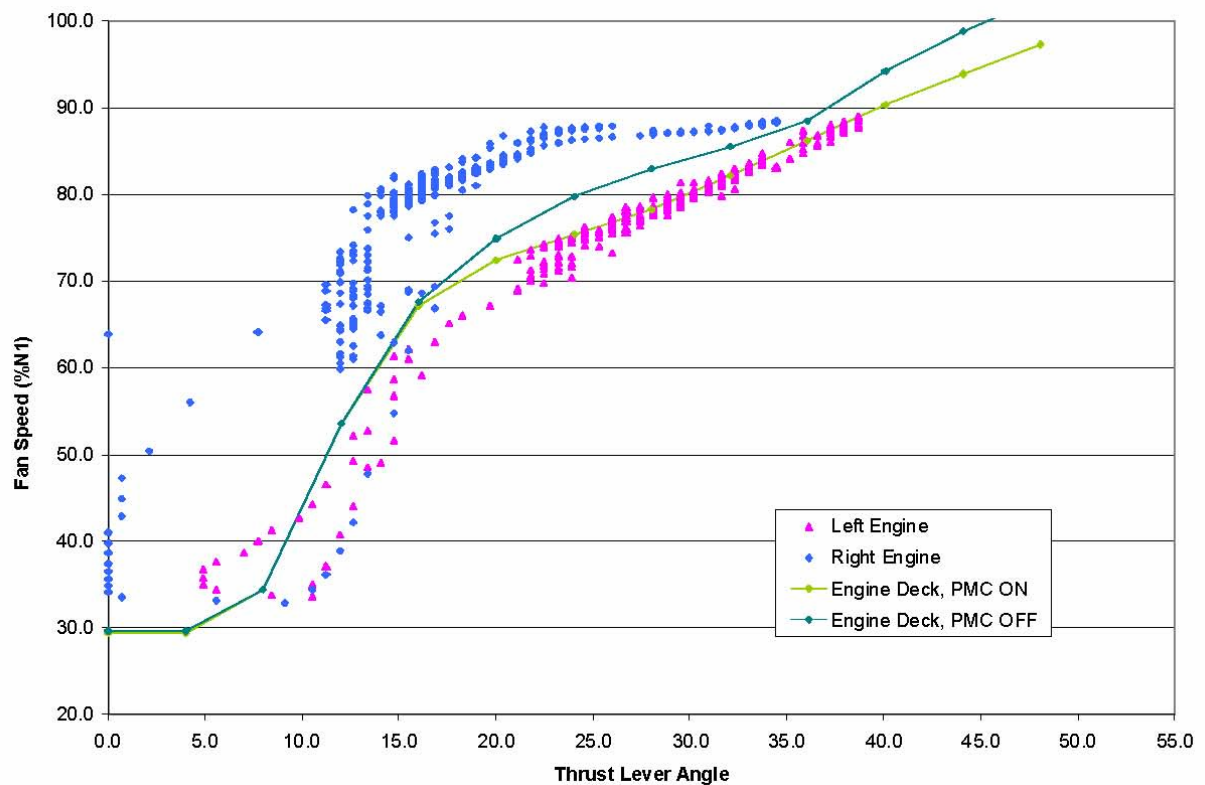
The chart below shows the nominal N1 to TLA function for the PMC ON and OFF, and also the actual values for the left and right engine. It is clear from the chart that the left engine was working within the operational limitations (compared to the nominal PMC ON), while the right engine N1 (and thrust) were significantly higher than standard for the part power TLA.

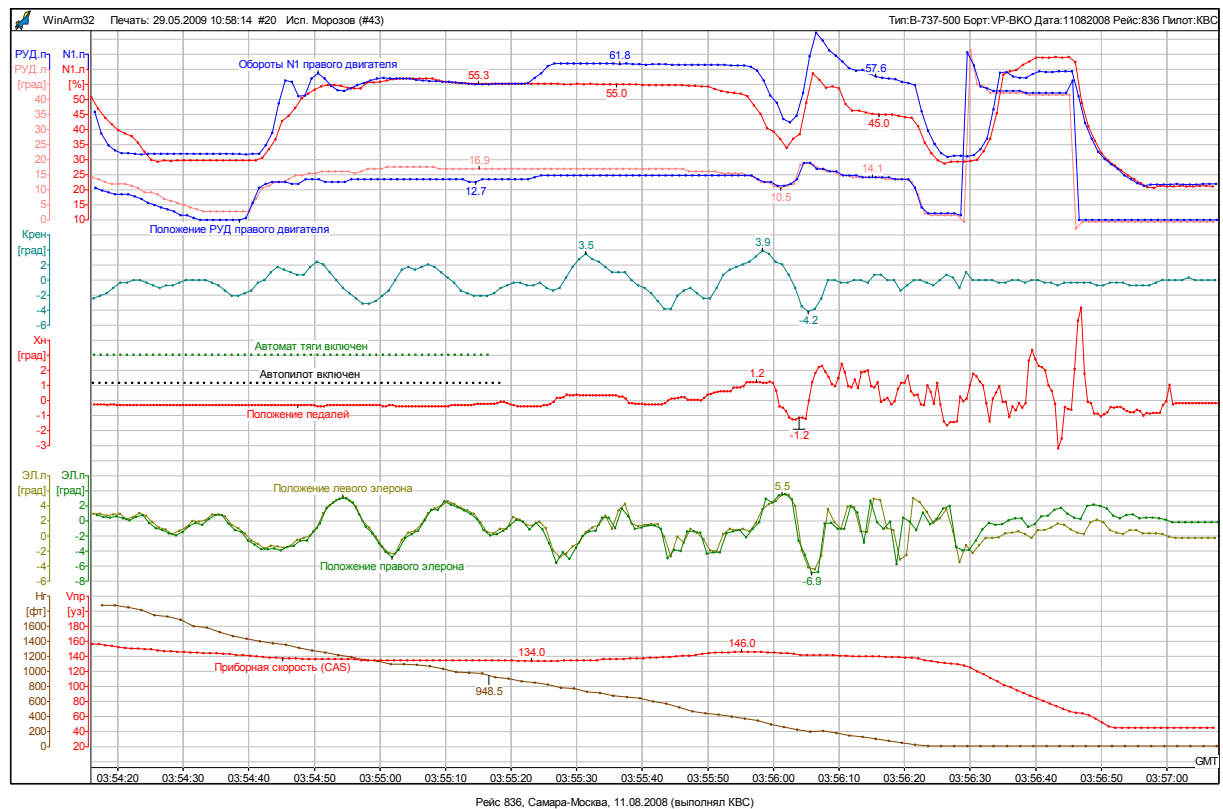
The record analysis showed that during the descent along the glideslope with the autothrottle engaged, the autothrottle maintained equal N1 on both engines. After the AT was disengaged, at about 950 ft (290 m), the pilot flying matched the throttles, which resulted in thrust split, initial increase in speed by 10 knots and a need to move the throttles intensively to maintain the required approach speed. The crew did not try to match the N1.

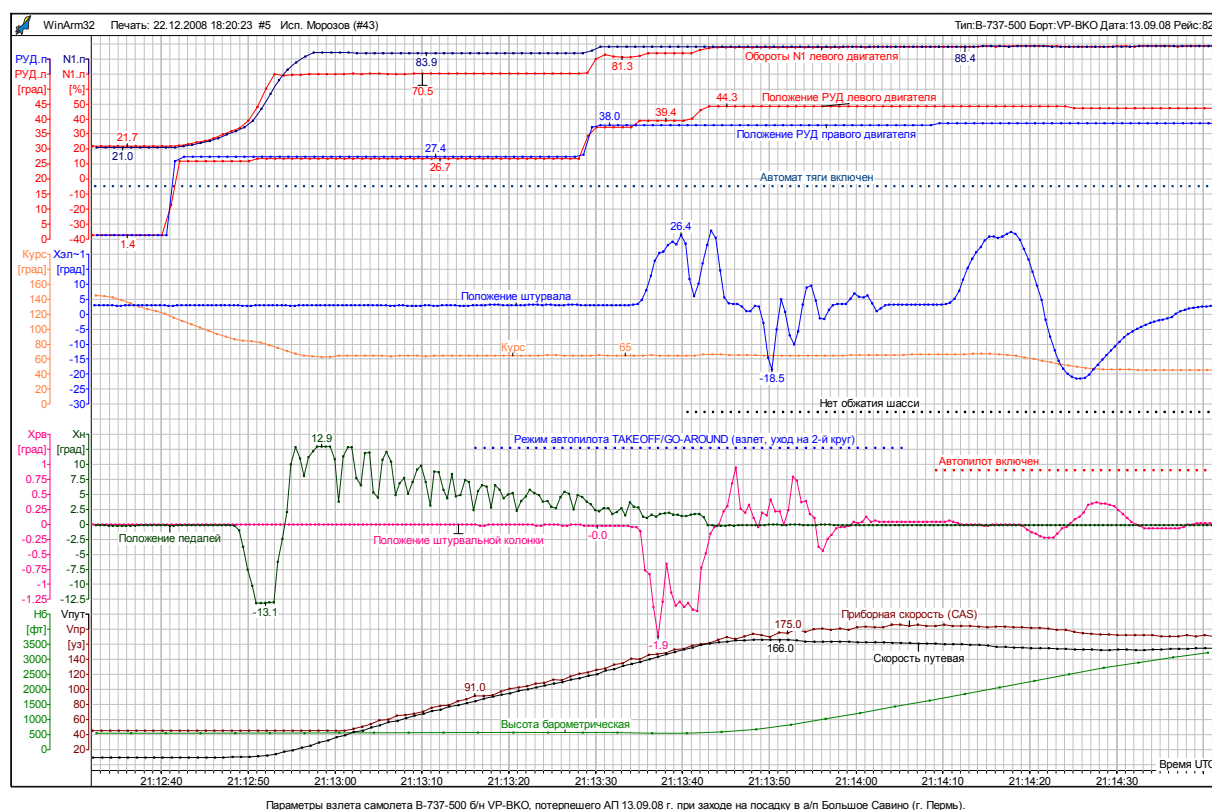
In fact the crew did not follow any of the SOP recommended procedures. The actual flight parameters are shown in the chart below.

The increase in thrust was done 55 degrees before lining up; the throttle position was matched at 27 degrees TLA within 2 seconds, which led to thrust increase up to 70.5 % N1 left and 84% N1 right within 17 seconds. The mentioned thrust split resulted from the right engine mistrim described above. It should be noted that such engine control method at takeoff is extremely dangerous, as if the mode is changed asymmetrically, a significant yaw moment appears due to a large split, which can lead to runway excursion if the runway friction factor is low (RWY is wet or slippery)⁴⁴.
