industry, and amongst the travelling public, it is considered appropriate to publish an update on the continuing investigation into this accident. This report is in addition to the Initial Report, published on 18 January 2008, a subsequent update published on 23 January 2008 and Special Bulletins published on 18 February 2008 and 12 May 2008.

History of the flight

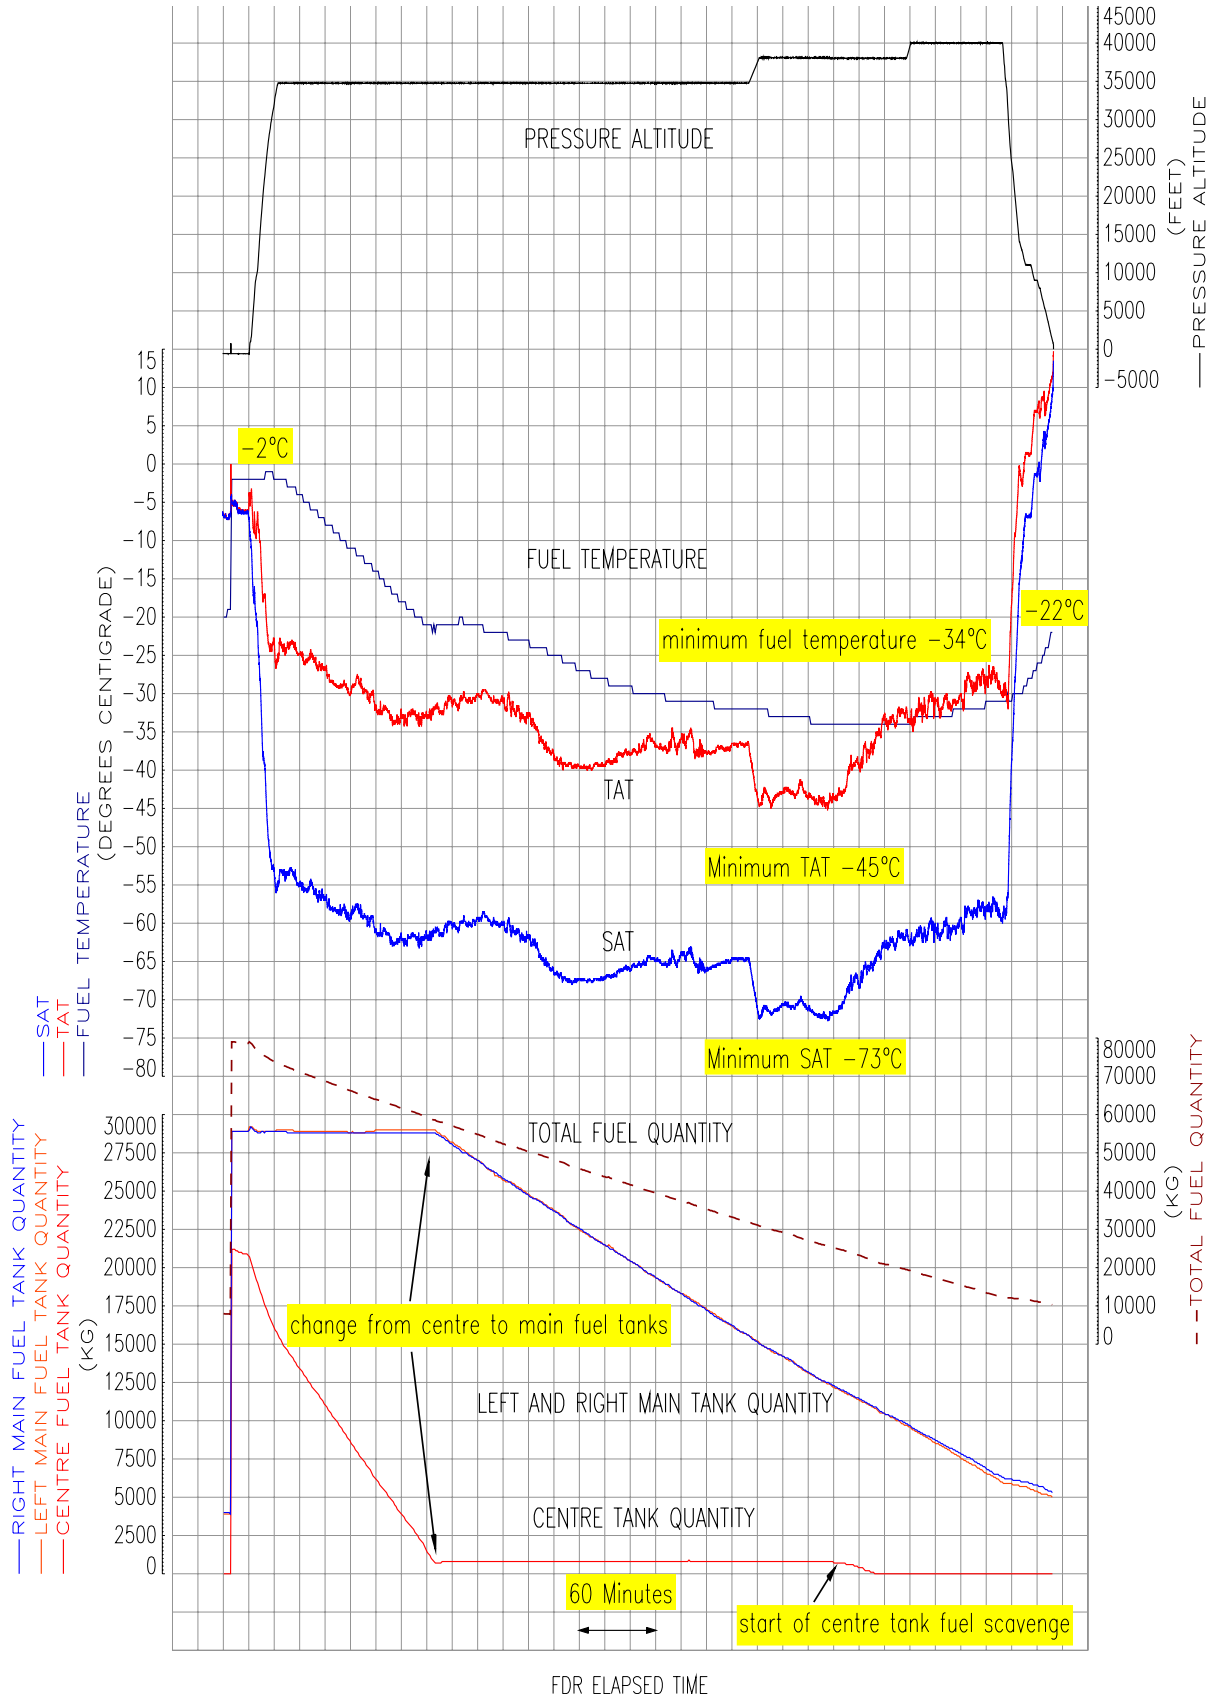
Figure 1
Temperatures

A time history of Total Air Temperature (TAT), Static Air Temperature (SAT), fuel temperature and other salient parameters during the accident flight are shown in Figure 1. Figure 2 shows a time history of the relevant parameters during the final approach and the accident sequence.

Whilst taxiing out at Beijing the TAT was -6°C (21°F), and the fuel temperature, measured in the left main fuel tank, was -2°C (28°F). The aircraft took off at 0209 hrs.

Two hours into the cruise the TAT had progressively reduced to -33°C (-27°F) and the left main tank fuel temperature was about -22°C (-8°F). At this point the engines fuel feed supply switched from the centre tank to their respective main fuel tanks; the total fuel quantity at this point was 58,600 kg, with fuel being distributed 29,000 kg, 800 kg and 28,800 kg across the left main, centre and right main fuel tanks respectively.

During the next three and a half hours the fuel temperature reduced further from -22°C (-8°F) to -32°C (-26°F), in line with further reductions in TAT.

At 0931 hrs, fuel temperature reduced to its lowest recorded value of -34°C (-29°F). It remained there for

about 80 minutes during which the lowest value of TAT of -45°C (-49°F) was recorded.

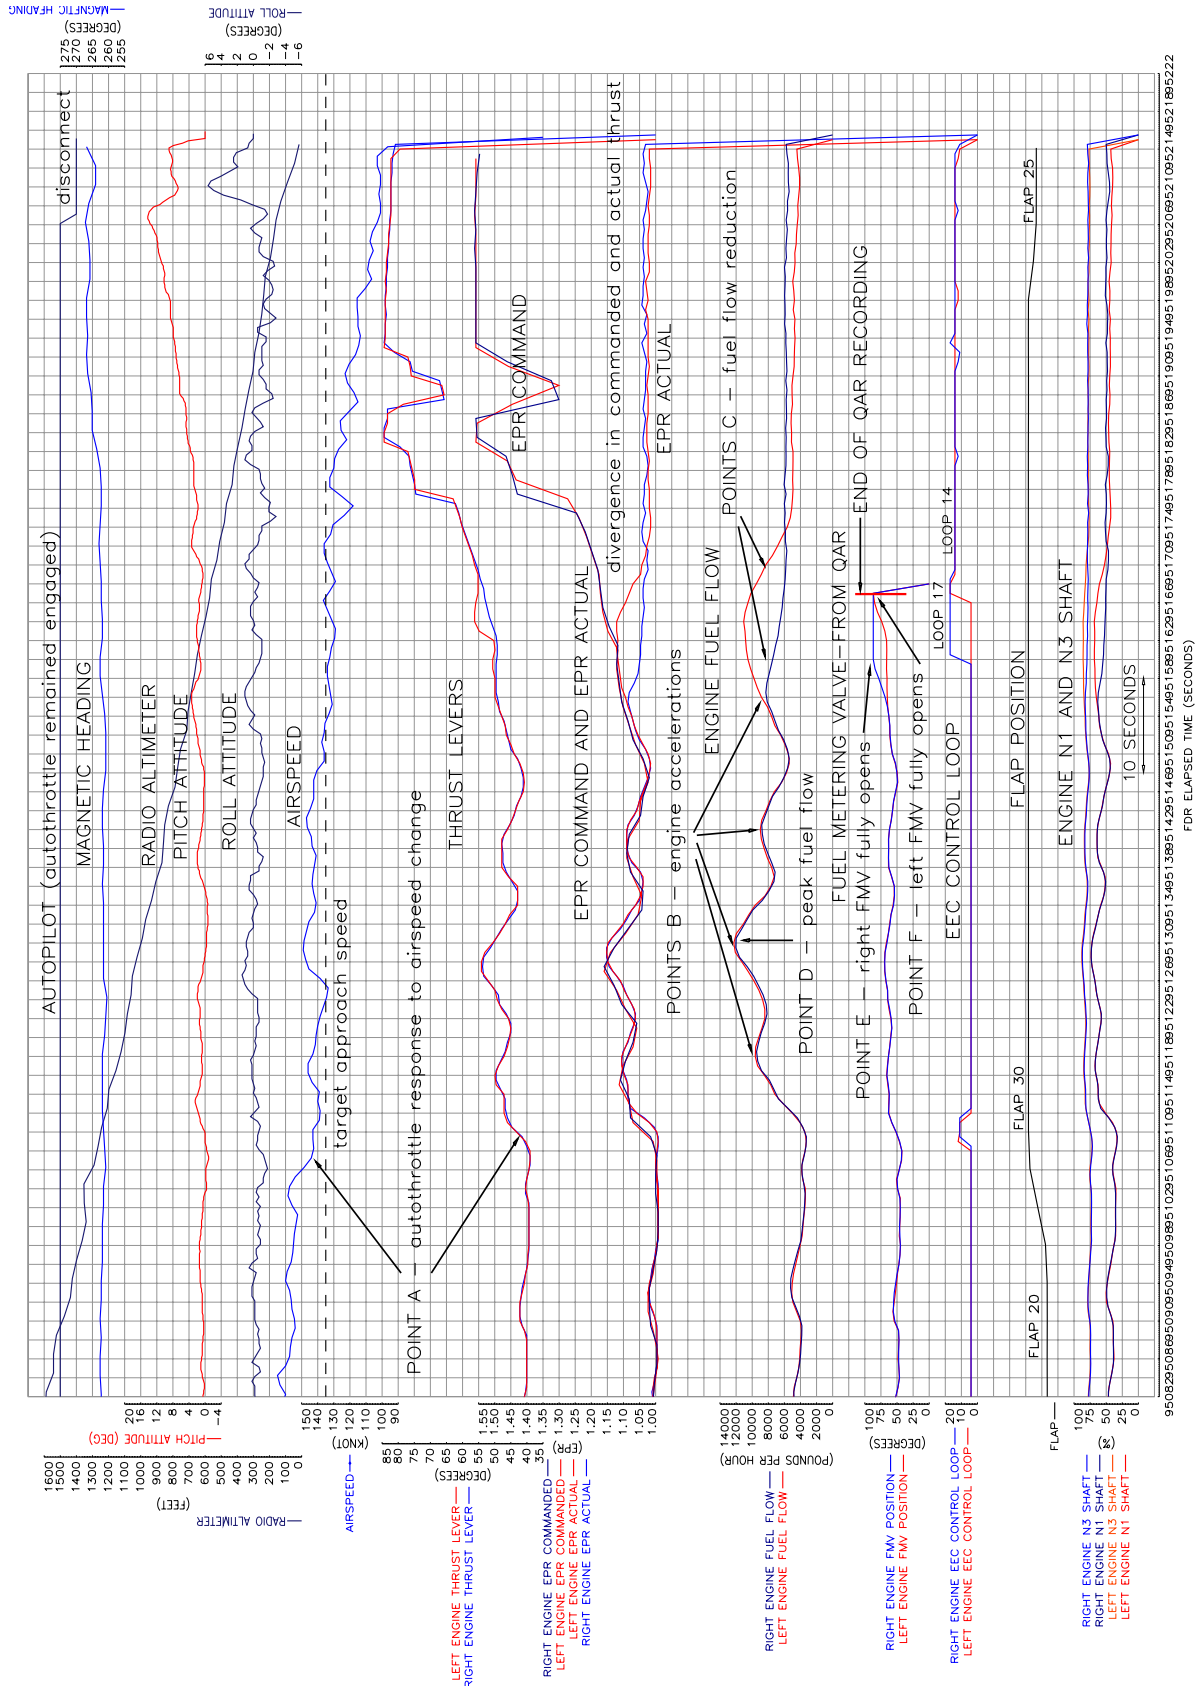
airspeed (Figure 2 Point A). In response to variations in the wind velocity and associated airspeed changes, there followed a series of four, almost cyclic, thrust commands by the autothrottle (Figure 2 Points B). It was during the fourth acceleration, and as additional thrust was being commanded, that the right engine, followed some seven seconds later by the left engine, experienced a reduction in fuel flow (Figure 2 Points C). The right engine fuel flow reduction occurred at a height of about 720 ft and the left engine at about 620 ft.

Of the four thrust commands it was the second that resulted in the highest delivery of fuel flow, reaching a peak of 12,288 pph for the left engine and 12,032 pph for the right (Figure 2 Point D). These peaks occurred about 26 seconds prior to the reduction in fuel flow to the right engine. Peak fuel flows during the first and third thrust commands were lower, at about 9,500 pph and 9,000 pph respectively.

During the fourth thrust increase, the right engine fuel flow had increased to 8,300 pph before gradually reducing. The recorded EPR then started to diverge from the commanded EPR and the right engine FMV was then fully opened (Figure 2 Point E). Some seven seconds later, the left engine fuel flow, which had increased to 11,056 pph, also started to reduce and the left engine FMV was also moved to its fully open position (Figure 2 Point F). Following the reduction in fuel flow, the left engine fuel flow stabilised at about 5,000 pph and the right at about 6,000 pph. Both engines continued to produce thrust above flight idle. The autothrottle and the flight crew commanded additional thrust, with both thrust levers ultimately being placed fully forward, but there was no increased thrust available from either engine. The actual fuel flows continued to remain significantly below that being commanded.

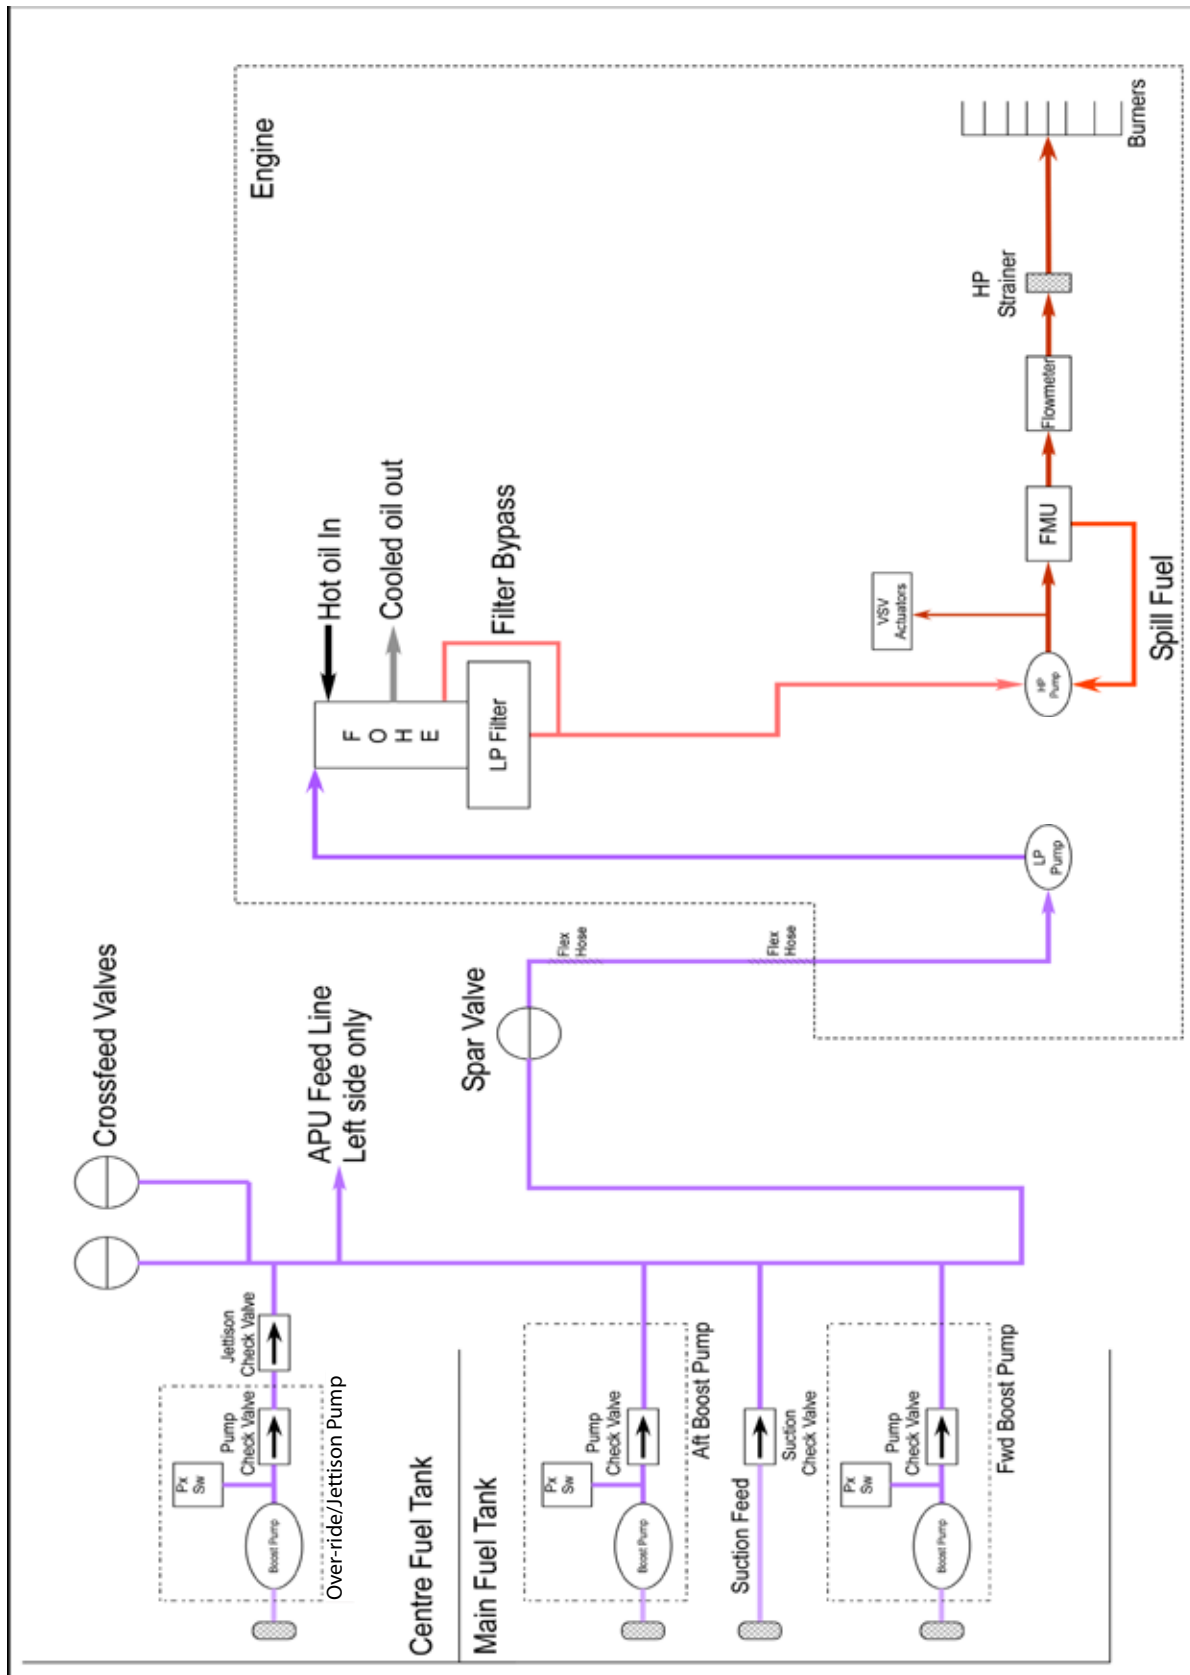
Figure 3

The fuel on the Boeing 777-200ER is stored in three fuel tanks: a centre tank, a left main tank and a right main tank; see Figure 3. The centre tank contains two override / jettison pumps (OJ) and each main fuel tank contains two boost pumps, identified as forward (fwd) and aft. Each of the pump inlets is protected by a mesh screen and the pumps are also equipped with a check valve fitted in the discharge port, to prevent fuel in the fuel feed manifold flowing back through the pump. A pressure switch, mounted between the pump's impellor and check valve, monitors the fuel pressure and triggers a warning in the flight deck if the pressure rise across the pump drops to a value between 4 and 7 psi.
