**SERIOUS INCIDENT**

| <b>Aircraft Type and Registration:</b> | ATR 72-202, EI-SLG | |
| <b>Location:</b> | Near Edinburgh Airport | |

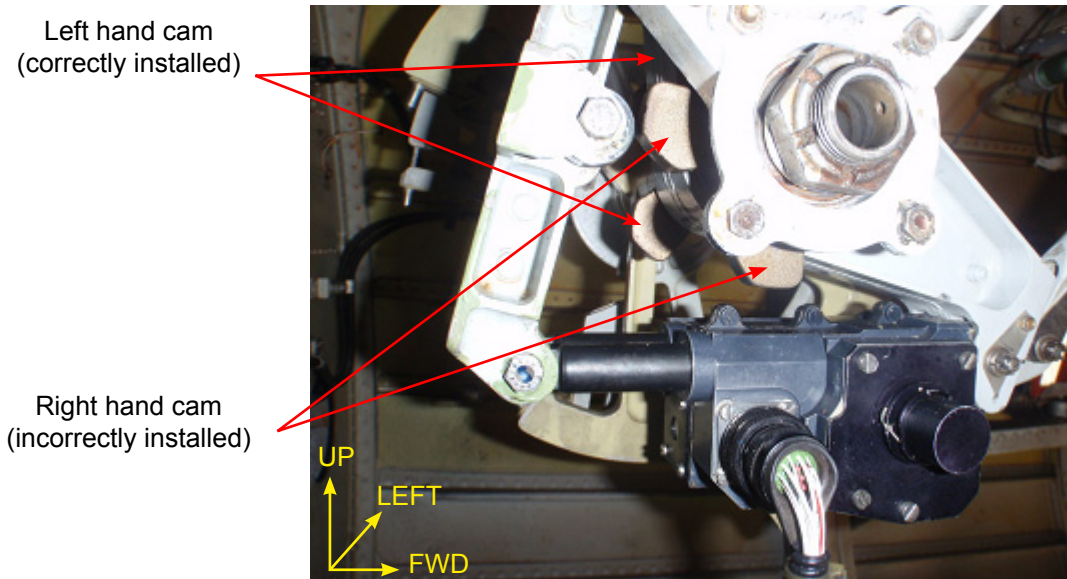
**Figure 3**

During reassembly, the right hand cam was installed in the incorrect orientation. Neither an independent inspection nor an operational test of the TLU system was performed. The incorrect assembly was not identified until the TLU mechanism was inspected by the maintenance organisation after the incident.

Travel Limitation Unit with right hand cam incorrectly installed – rudder in neutral position  
(Note that the lobes of the right hand cam are not aligned with the lobes of the left hand cam and that the right hand roller is facing the upper lobe of the right hand cam)

approximately 19° to one side, the incorrect installation of the right hand cam resulted in the right hand cam no longer being symmetrically aligned with the left hand cam (Figures 3 and 4).

It was demonstrated that with the right hand cam installed in the incorrect orientation, it presented a restriction to the travel of the corresponding roller. When the TLU was activated, this situation prevented both rollers from

engaging in the vee groove of the cams and caused an uncommanded rudder input and corresponding rudder deflection.

It is recommended that ATR immediately informs all operators of ATR aircraft equipped with a Travel Limitation Unit that it is possible to install the cams on the rear rudder quadrant shaft in the incorrect orientation.

It is recommended that ATR amends all relevant Aircraft Maintenance Manual tasks to include a warning to highlight that the cams on the rear rudder quadrant shaft can be installed incorrectly.

It is recommended that ATR amends the Aircraft Maintenance Manual task '*Operational Test of the Rudder Travel Limitation Unit*' to state that: (1) the test should be carried out for a minimum of 30 seconds and (2) should an asymmetric restriction of the rudder pedals be detected or if the FLT CTL light illuminates, further inspection of the TLU system should be conducted.

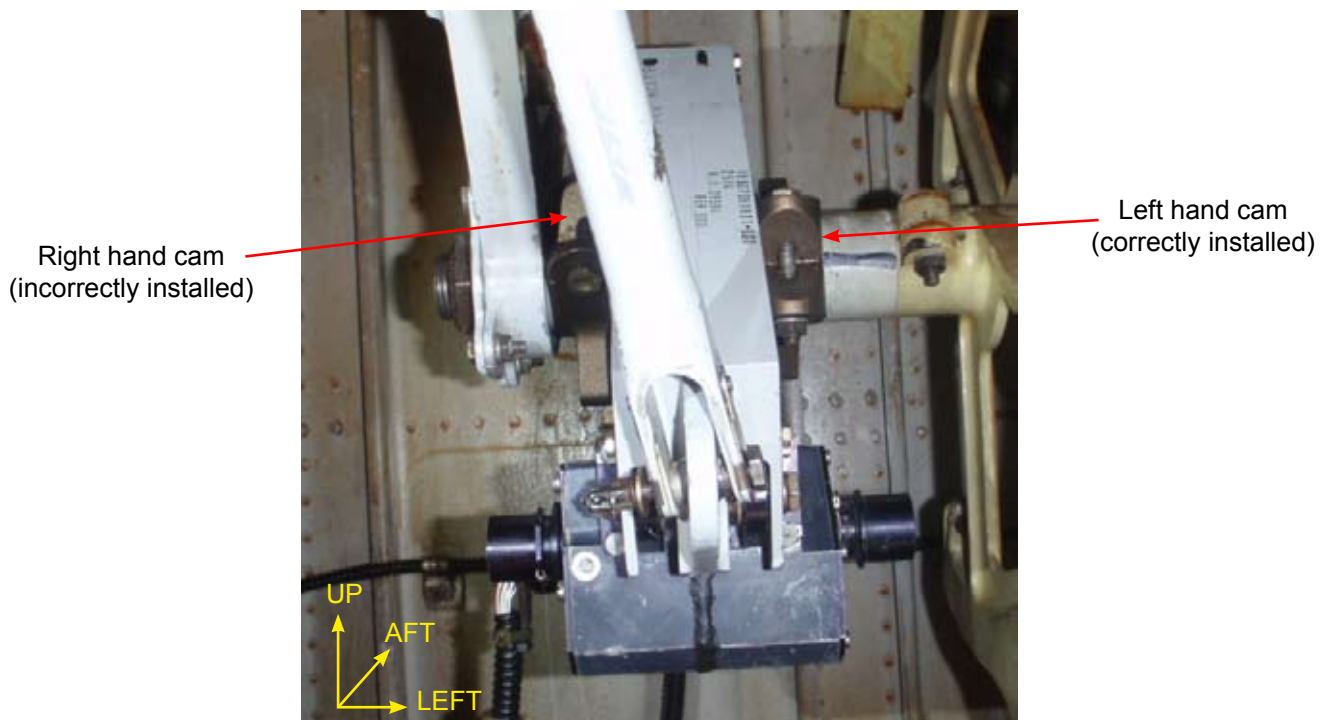
**Figure 4**

View looking aft on Travel Limitation Unit with right hand cam incorrectly installed - rudder in neutral position
