AAIB Bulletin S7/2012

SPECIAL

ACCIDENT

Aircraft Type and Registration:	EC225 LP Super Puma, G-CHCN
No & Type of Engines:	2 Turbomeca Makila 2A1 turboshaft engines
Year of Manufacture:	2007 (Serial no: 2679)
Date & Time (UTC):	22 October 2012 at 1418 hrs
Location:	In the North Sea, approximately 32 nm southwest of Sumburgh, Shetland Islands
Type of Flight:	Commercial Air Transport (Passenger)
Persons on Board:	Crew - 2 Passengers - 17
Injuries:	Crew - None Passengers - None
Nature of Damage:	Fracture of the Main Gear Box bevel gear vertical shaft
Commander's Licence:	Airline Transport Pilot's Licence
Commander's Age:	46 years
Commander's Flying Experience:	Approximately 12,000 hrs (approx 1,000 hrs on type)
Information Source:	AAIB Field Investigation

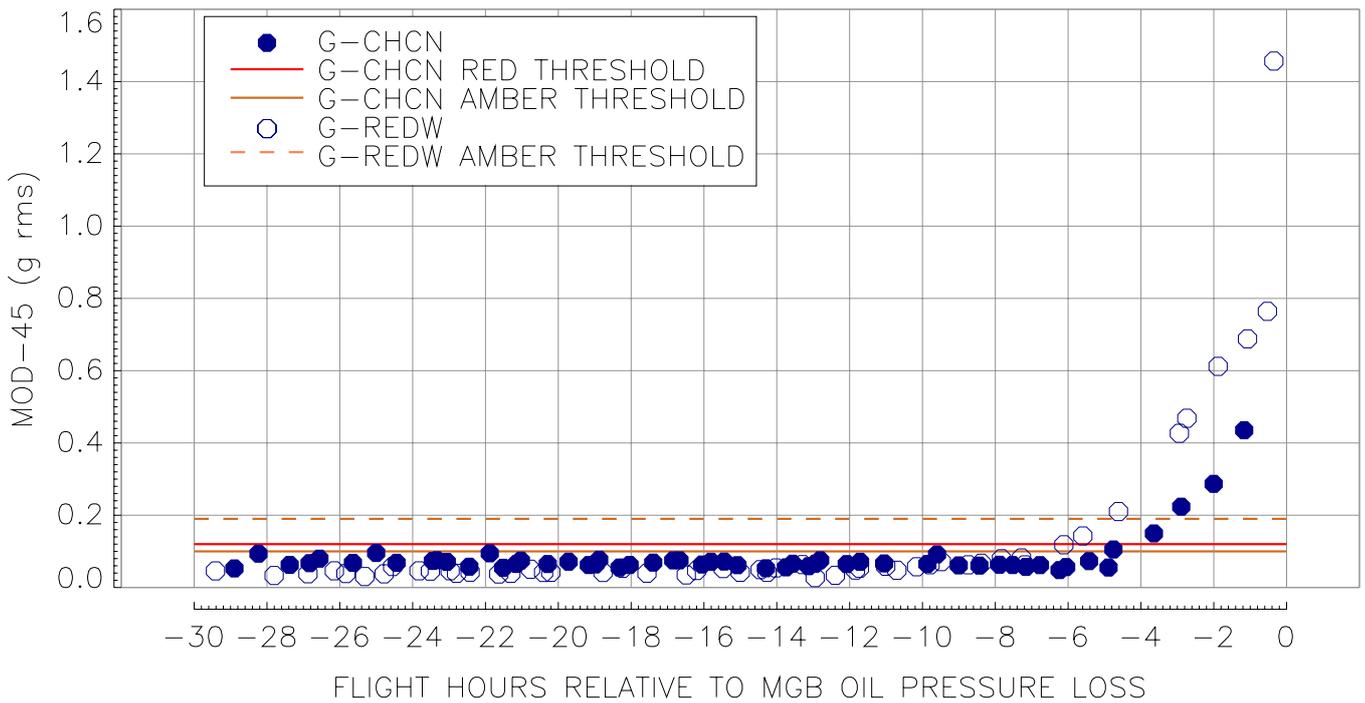
Figure 1
Comparison MOD-45 trend indications between G-CHCN and G-REDW

Figure 1 shows that the MOD-45 indicator for G-CHCN, exceeded its 'learned' amber threshold (0.10) 4.75 flying hours and its 'learned' red threshold (0.12) 3.63 flying hours prior to the loss of oil pressure. For G-REDW the MOD-45 indicator exceeded its 'learned' amber threshold (0.19) 4.62 flying hours before the loss of the MGB oil pressure.

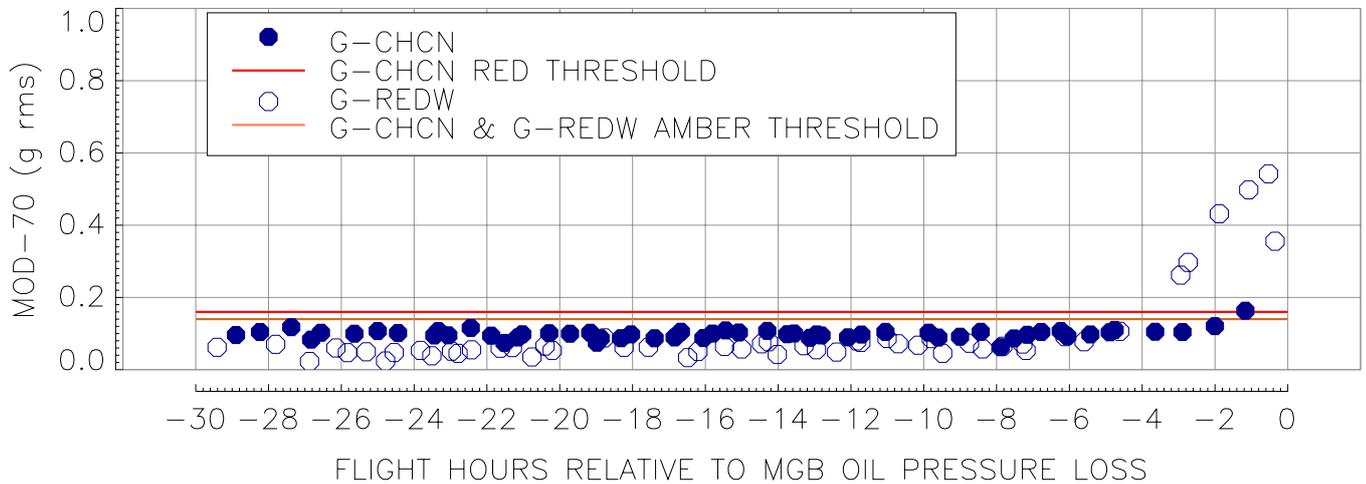
Figure 2
Comparison MOD-70 trend indications between G-CHCN and G-REDW

Figure 2 shows that for the MOD-70 indicator, the first instance that it exceeded the 'learned' amber threshold (0.14) for G-REDW was 2.95 flying hours before the loss of MGB oil pressure. However, for G-CHCN only the last recorded value of this indicator, which was captured 1.17 flying hours before the loss of the MGB oil pressure, exceeded both its amber (0.14) and red (0.16) 'learned' thresholds.

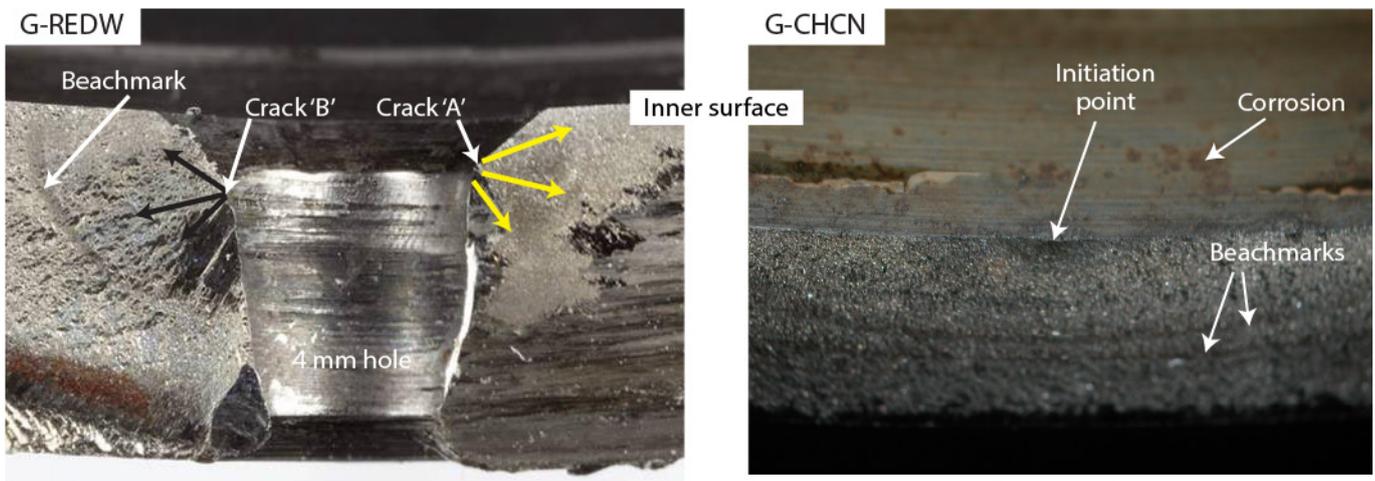
Figure 3

Location of crack initiation on G-REDW and G-CHCN

On G-REDW, the first crack to develop was identified as Crack ‘A’, which initiated at a corrosion pit approximately 0.06 mm deep located in the inner countersink of the Ø 4 mm hole (Figure 3). The crack then propagated along the fusion line between the area of the weld which had been previously melted, and the heat affected zone in the parent material in the vertical shaft. A second crack, Crack ‘B’, initiated after Crack ‘A’ at a small scratch in the internal surface of the hole. Numerous corrosion pits that could only

On G-CHCN the fatigue crack initiated at an area of corrosion on the inner surface of the shaft (Figure 3), approximately 47° around the circumference from the Ø 4 mm hole (Figure 4). It has not yet been determined where the crack initiated in relation to the heat affected zone. Away from the initiation point, the crack propagated in both directions in the parent material in the vertical shaft. Small areas of corrosion were also visible in the machining marks around the inner flange that had been machined during manufacture to remove the root of the weld. The initial examination has not identified corrosion on any other part of the bevel gear vertical shaft.

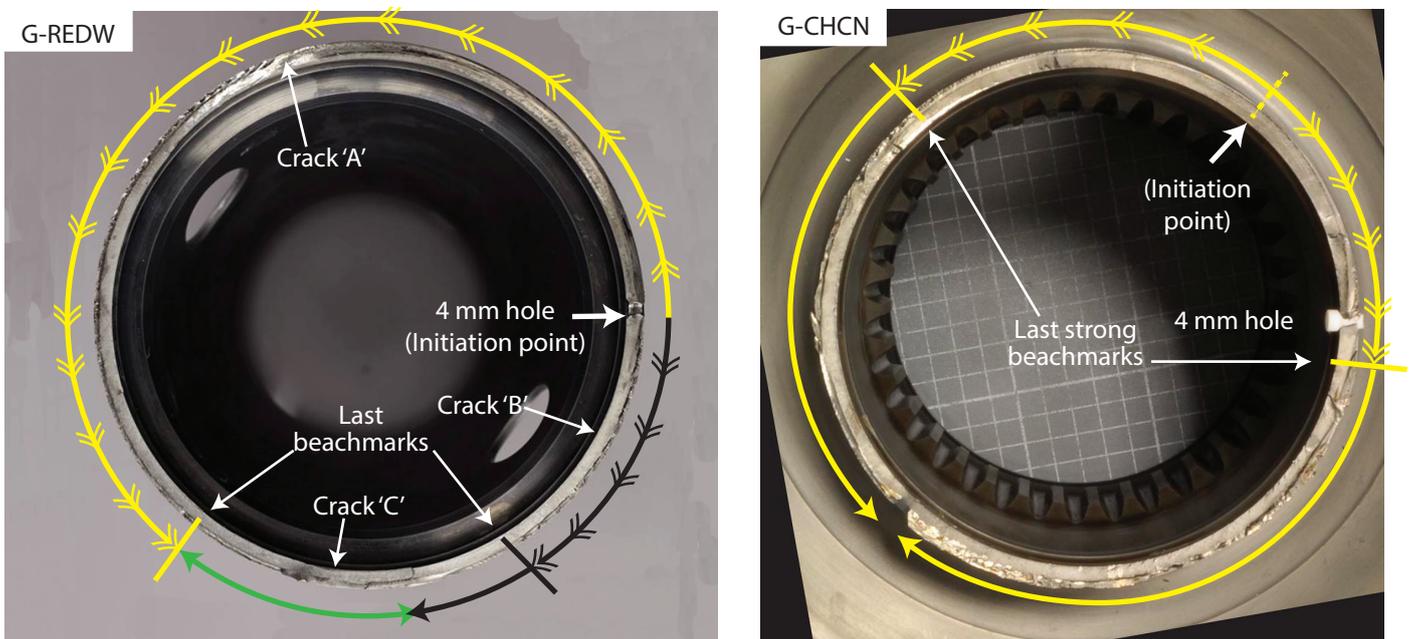
Figure 4

Location of beachmarks on G-REDW and G-CHCN

The fracture surfaces of the shafts on G-REDW and G-CHCN both displayed characteristic fatigue beachmarks, which can be formed when an event such as an engine start or significant change in torque has taken place (Figure 4). Beachmarks can be difficult to identify and can be interpreted in a number of ways.

For G-REDW the first beachmark was identified at 4 mm from the initiation point. Crack growth estimates are complicated by variations in engine torque and the changing stiffness of the shaft as the crack grows to failure. A number of different models are being considered, one of which suggests that the time for the crack to grow from the first beachmark to failure could be as low as 20 engine⁴ hours. From the recorded data this corresponds to approximately 15 flying⁵ hours. Another model has shown that the crack growth time could be as high as 31 flying hours. Detailed analysis of the beachmarks continues.

For G-CHCN, work continues to identify all the beachmarks on the fracture surface. The provisional examination and analysis indicates that the first beachmark was identified at 2 mm either side of the initiation point (giving a crack length of 4 mm). Early analysis shows that there is a possible close correlation in the crack propagation time in the shafts fitted to G-CHCN and G-REDW.
