Airport. The intention was to refuel the helicopter at Sumburgh, before returning to Aberdeen. The helicopter lifted from the Borgsten Dolphin platform at 1612 hrs, with the commander acting as the Pilot Flying (PF) and the co-pilot as the Pilot Not Flying (PNF)¹.

Aircraft information

Published 18 October 2013

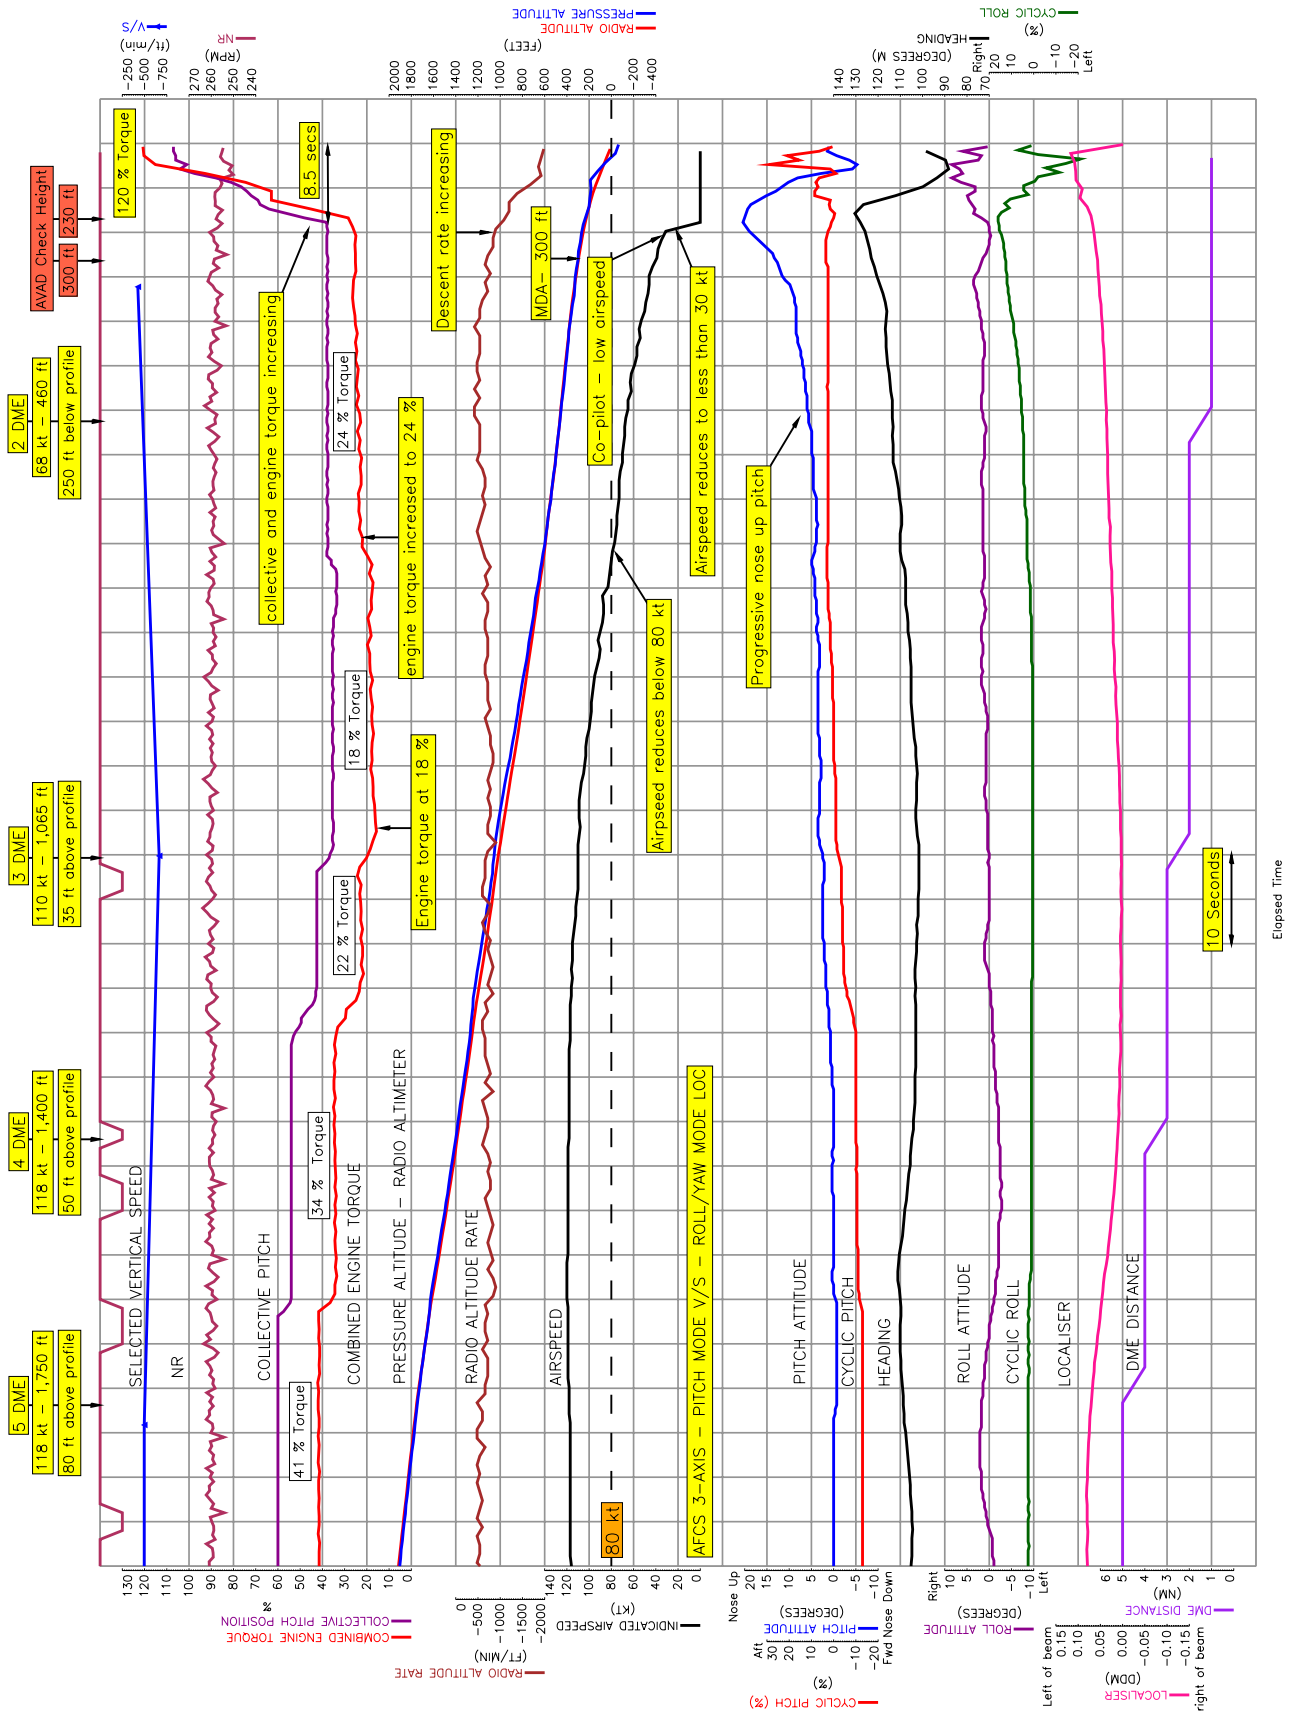
Figure 1 presents the salient recorded data for the final approach to Runway 09.

The recorded data show that the approach was conducted with the autopilot in 3-axes mode. At 6.4 nm, the commander advised that he was starting the descent and, with a selected vertical speed of 500 ft/min⁵, engaged the autopilot V/S mode. The autopilot ALT.A (Altitude Acquire)⁶ mode was not used for the approach.

At 3 nm, the collective pitch was reduced and the engine torque stabilised at 18%. The airspeed was reducing at a rate of about 1 kt per second.

At approximately 2.6 nm and an altitude of 800 ft, the co-pilot advised they had 500 ft to go to the MDA, which the commander acknowledged. The airspeed was 87 kt and the descent rate was about 700 ft/min. When the airspeed reached 80 kt the collective pitch was increased, with an accompanying increase in engine torque to 24%.

At 2.2 nm, the helicopter was at an altitude of 560 ft and the airspeed was 74 kt. The helicopter's pitch attitude started to increase slowly as the autopilot maintained the selected vertical speed, whilst the airspeed continued to decrease.

Recorded data parameters for the Final Approach

With the co-pilot having advised that the target altitude at 1 nm was 390 ft, the commander stated that he was reducing the rate of descent; the rate reduced from about 700 ft/min to about 500 ft/min. Several seconds later, the co-pilot advised they had 100 ft to go to their MDA and the commander acknowledged. The descent rate was being maintained at about 500 ft/min, but the airspeed had by then decreased to 54 kt and the pitch attitude was 8° nose-up with engine torque stabilised at about 24%.

The AVAD aural “CHECK HEIGHT” function activated at a height of 300 ft above the sea. The airspeed had reduced to 43 kt and the pitch attitude was now 12° nose-up. The co-pilot alerted the commander to the airspeed.

At a height of 240 ft, the helicopter’s pitch attitude was 20° nose up, the airspeed 32 kt and the rate of descent about 1,000 ft/min and increasing. There was then an increase in collective pitch and engine torque and the cyclic stick was moved forward. A second AVAD “CHECK HEIGHT” callout occurred at this time. The helicopter was at 230 ft and the airspeed had reduced to below 30 kt (airspeeds of less than 30 kt are not recorded on the CVFDR).

In response to the increase in collective pitch, engine torque increased at a rate of about 14% per second. The helicopter’s descent rate nevertheless continued to increase. As it descended through 100 ft, the AVAD 100 ft call was recorded. Engine torque was now at 115% and the descent rate was approximately 1,800 ft/min.

This initial analysis also showed that the combination of the nose-high attitude, low airspeed, high rate of descent and high power placed the helicopter in a vortex-ring state⁷ entry condition (VRS) during the final stages of the flight. The manufacturer’s modelling indicated that, in this condition, the reduced helicopter performance, together with the limited height available, meant that the impact with the sea was unavoidable.
