INCIDENT

Aircraft Type and Registration:	Airbus A319-111, G-EZAC
No & type of Engines:	2 CFM56-5B5/P turbofan engines
Year of Manufacture:	2006
Date & Time (UTC):	15 September 2006 at 1052 hrs
Location:	Near Nantes, France
Type of Flight:	Commercial Air Transport (Passenger)
Persons on Board:	Crew - 6 Passengers - 138
Injuries:	Crew - None Passengers - None
Nature of Damage:	None
Commander's Licence:	Airline Transport Pilot's Licence
Commander's Age:	42 years
Commander's Flying Experience:	8,782 hours (of which 394 were on type) Last 90 days - 211 hours Last 28 days - 77 hours
Information Source:	AAIB Field Investigation

Synopsis

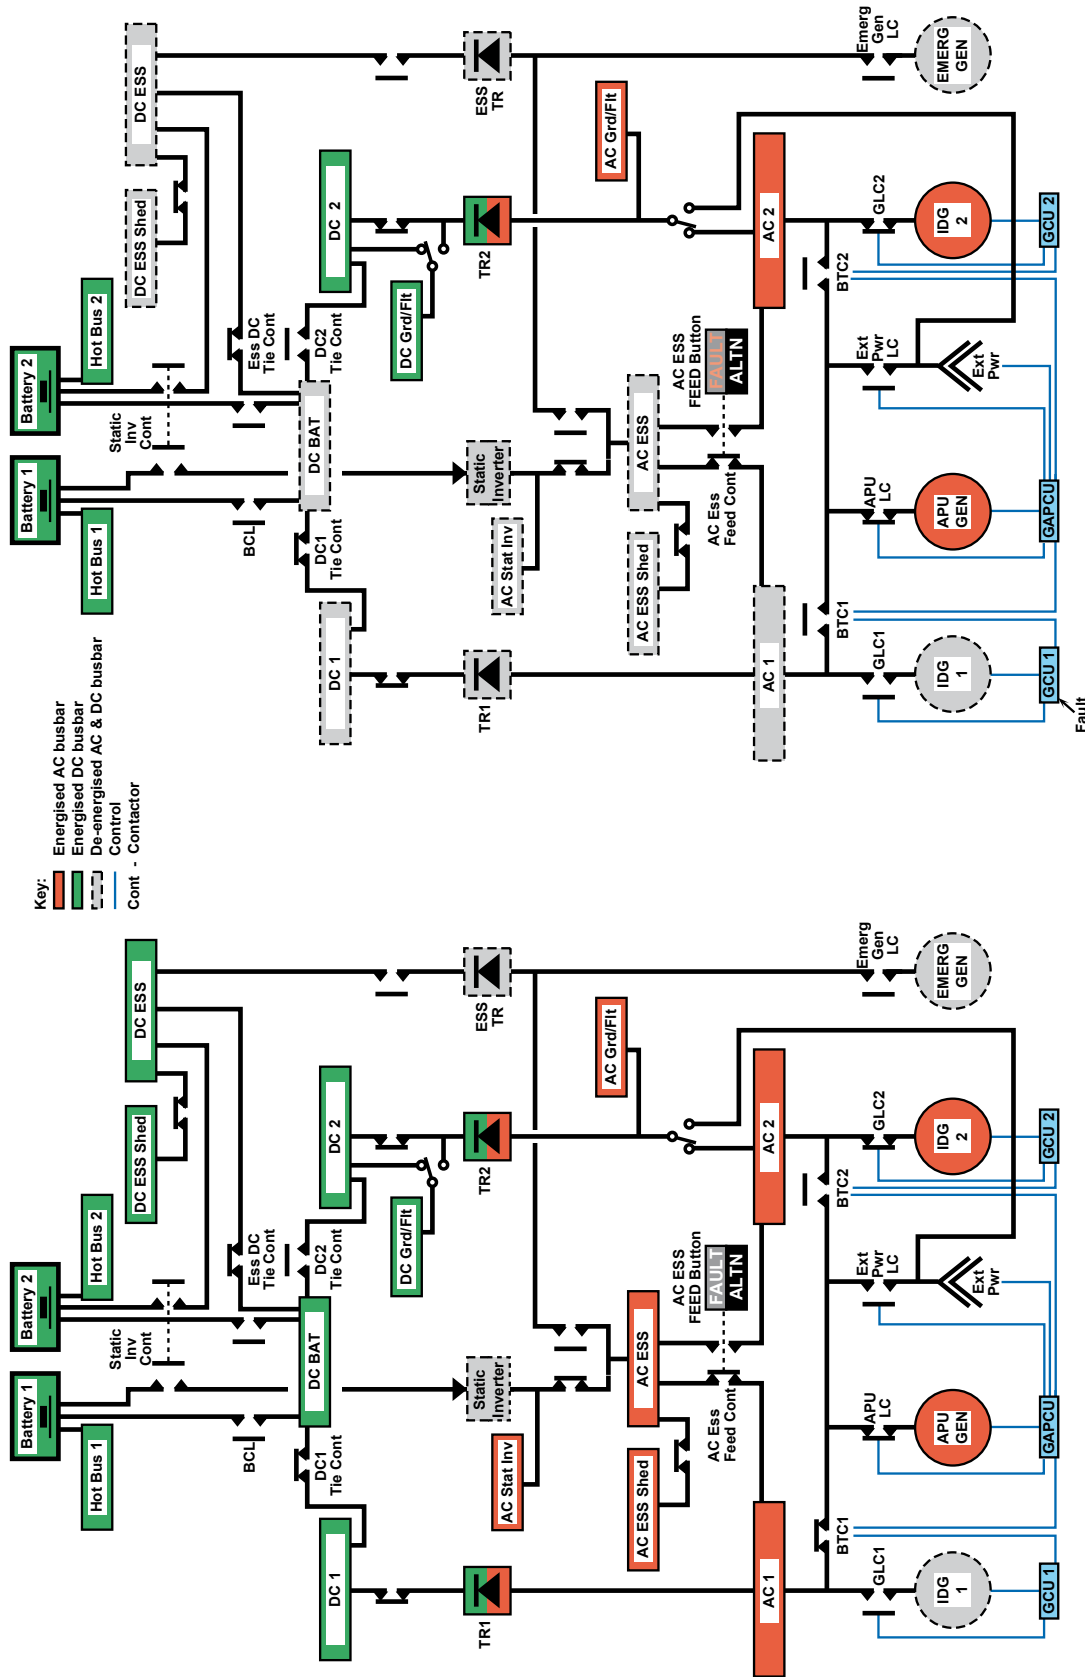
Figures 1.1 and 1.2

Figure 1.2 Configuration Immediately After Fault

Figure 1.1 Configuration On Dispatch

Electrical Distribution System Schematic

The evidence indicated that a monitoring system had incorrectly interpreted a fault in GCU1 as a GLC1 fault and opened BTC1 as a result. This had disconnected the APU generator from the AC1 busbar, leading to the loss of AC1 and a number of other busbars, including the AC ESS and DC ESS busbars. It was undesirable that the incorrect interpretation of a single fault should cause the loss of a main busbar. At this time the inappropriate action by the GCU appears to have been due to inadequate logic in the monitoring system. Therefore:
