No: 3/90

Ref: EW/C1122

Spitfire Mk 5C, G-MKVC

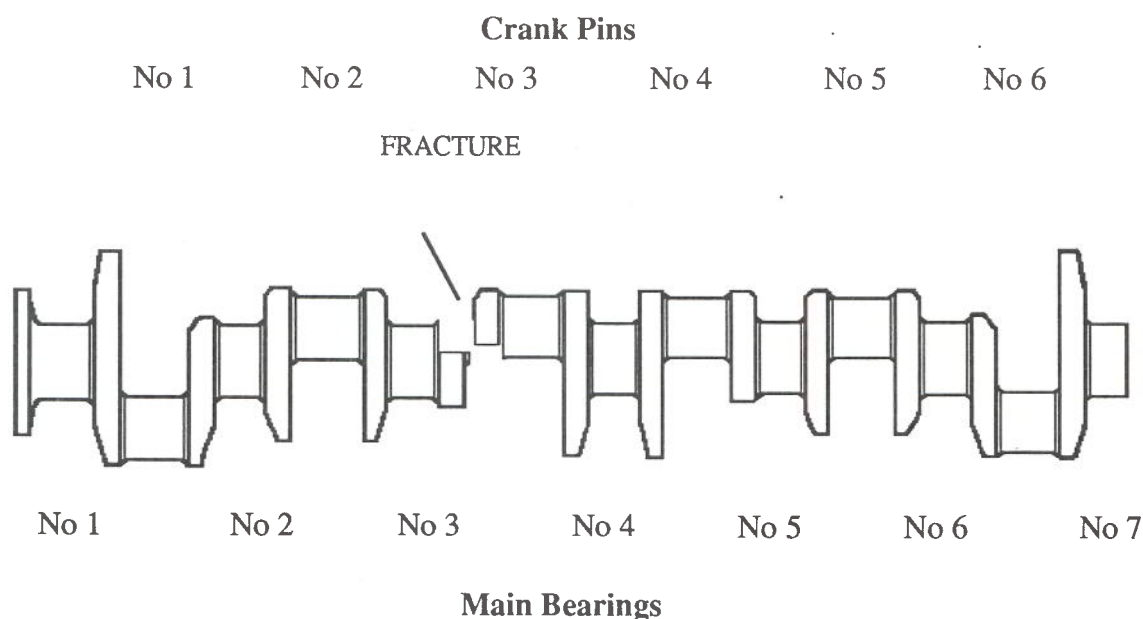
The Merlin has 12 cylinders disposed in two blocks mounted on the crankcase at an angle of 60 degrees in the form of an upright V. The connecting rods are in six pairs, plain and forked, working on a one piece, six throw crankshaft supported in seven main bearings within the crankcase.
