ACCIDENT

Aircraft Type and Registration:	Sikorsky S-76C, G-WIWI	
No & Type of Engines:	2 Turbomeca Arriel 2S2 turboshaft engines	
Year of Manufacture:	2007 (Serial No. 760684)	
Date & Time (UTC):	3 May 2012 at 2155 hrs	
Location:	Peasmarsh, East Sussex	
Type of Flight:	Public Transport	
Persons on Board:	Crew - 2	Passengers - 2
Injuries:	Crew - None	Passengers - None
Nature of Damage:	None	
Commander's Licence:	Airline Transport Pilot's Licence (Helicopters)	
Commander's Age:	55 years	
Commander's Flying Experience:	10,250 hours (of which 4,800 were on type) Last 90 days - 11 hours Last 28 days - 4 hours	
Information Source:	AAIB Field Investigation

Synopsis

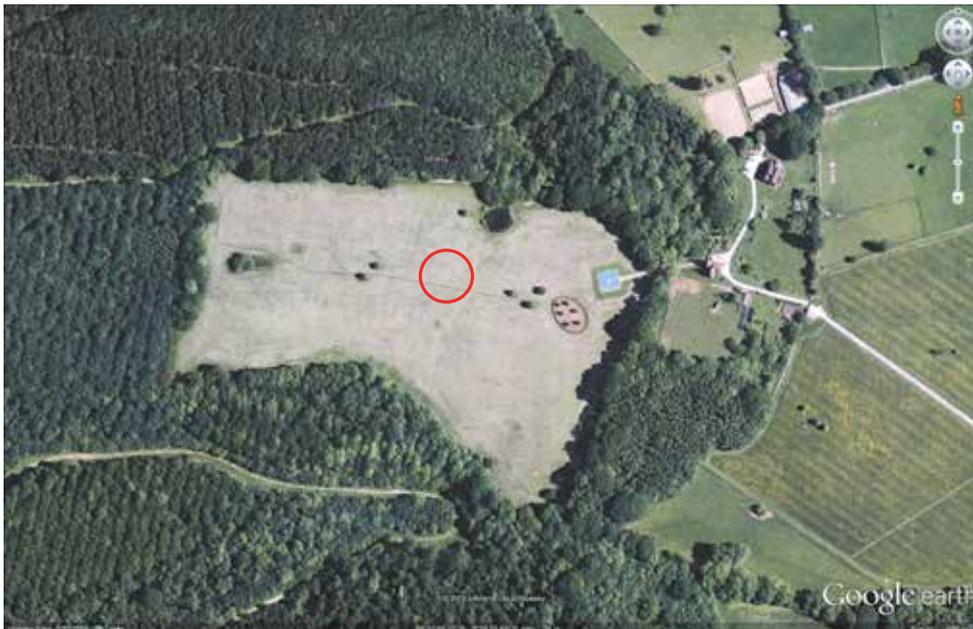
Figure 1

The field containing the landing site near Peasmarsh;
the red circle indicates the position of the triangle of lights

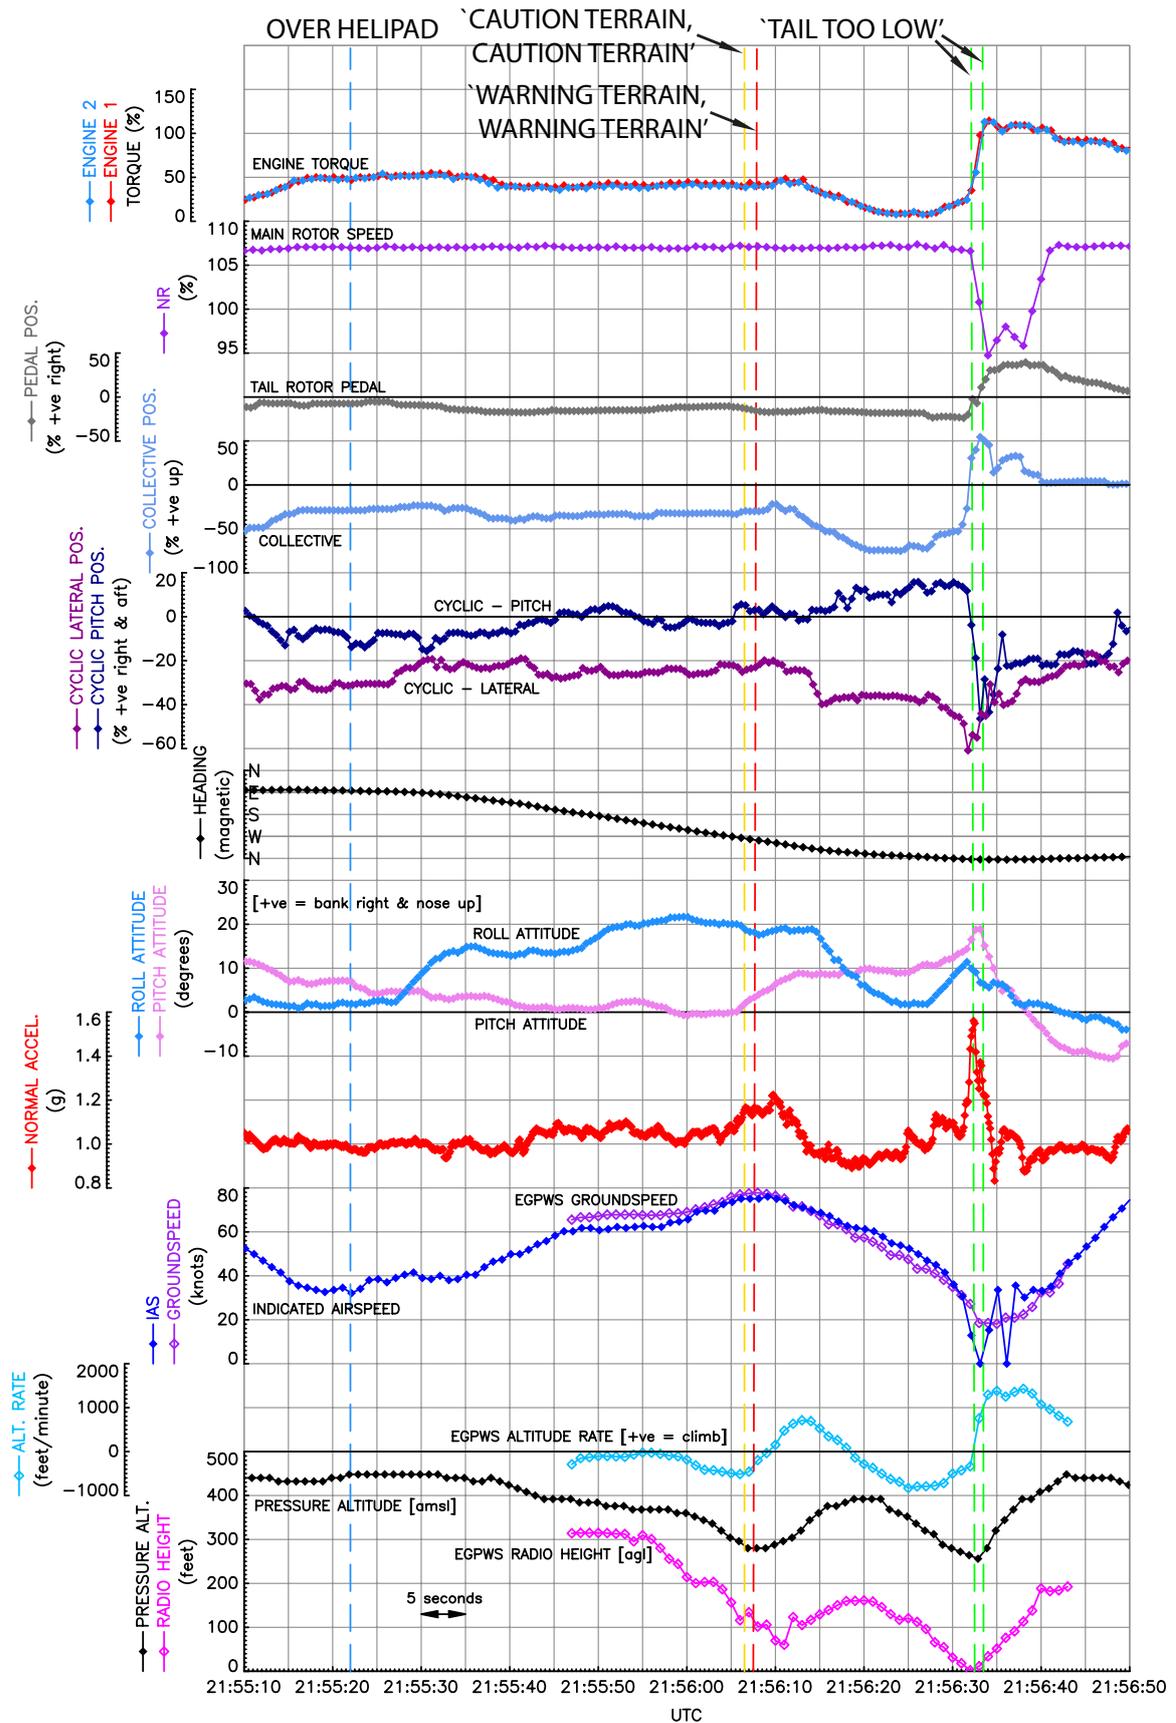
Figure 2

G-WIWI salient flight data from flight recorder and EGPWS

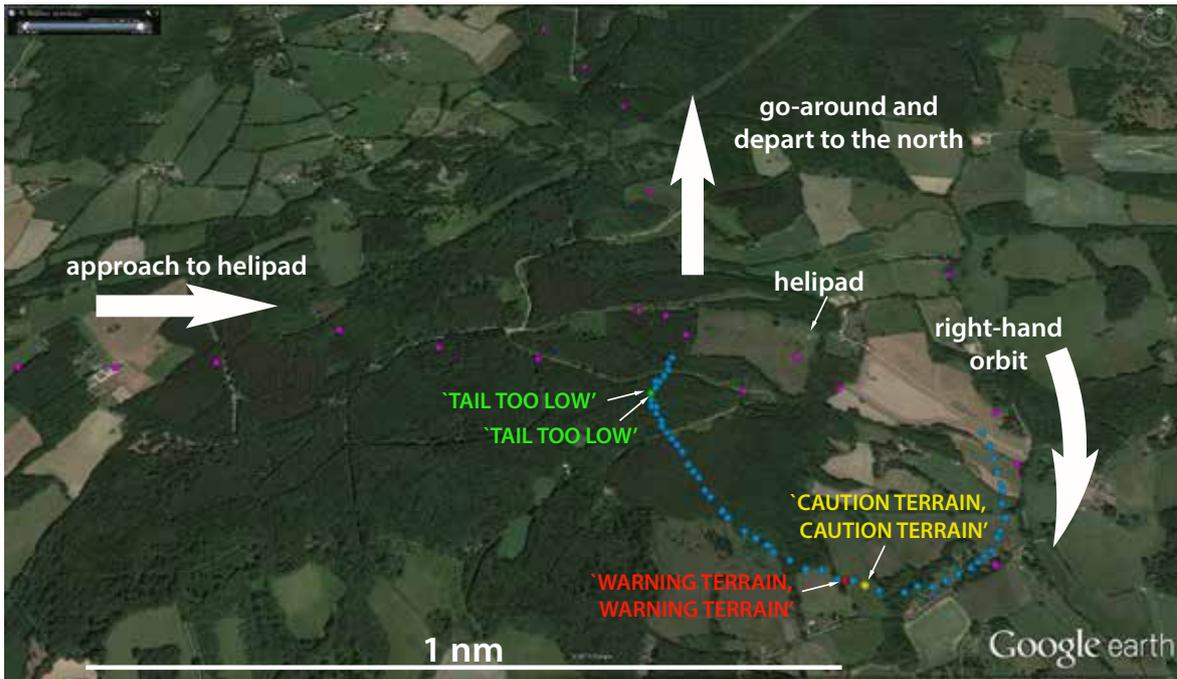
Figure 3

Radar ground track (dark pink) and EGPWS GPS ground track (light blue)

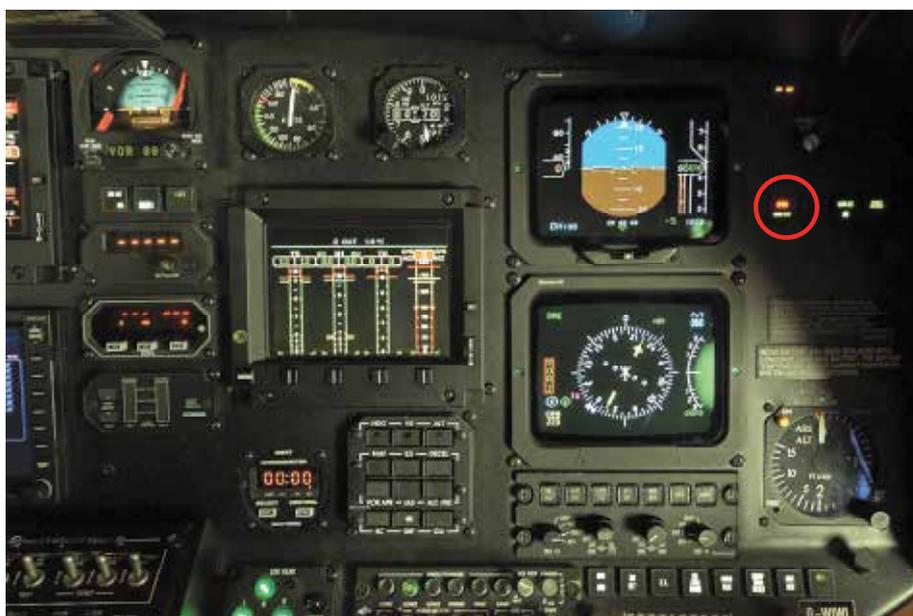
Figure 4

The right hand instrument panel in G-WIWI showing the 'GPWS visual alert (amber, right of the EADI - circled red)
