ACCIDENT

Aircraft Type and Registration:	Piper PA-28-161 Cadet, G-BXJJ
No & Type of Engines:	1 Lycoming O-320-D3G piston engine
Year of Manufacture:	1989 (Serial no: 2841200)
Date & Time (UTC):	17 October 2014 at 0820 hrs
Location:	Near White Waltham Aerodrome, Berkshire
Type of Flight:	Training
Persons on Board:	Crew - 2 Passengers - None
Injuries:	Crew - 2 (Minor) Passengers - N/A
Nature of Damage:	Substantial, both wings detached
Commander's Licence:	Commercial Pilot's Licence
Commander's Age:	33 years
Commander's Flying Experience:	2,890 hours (of which 1,200 were on type) Last 90 days - 180 hours Last 28 days - 56 hours
Information Source:	Aircraft Accident Report Form submitted by the pilot and information from the operator

Synopsis

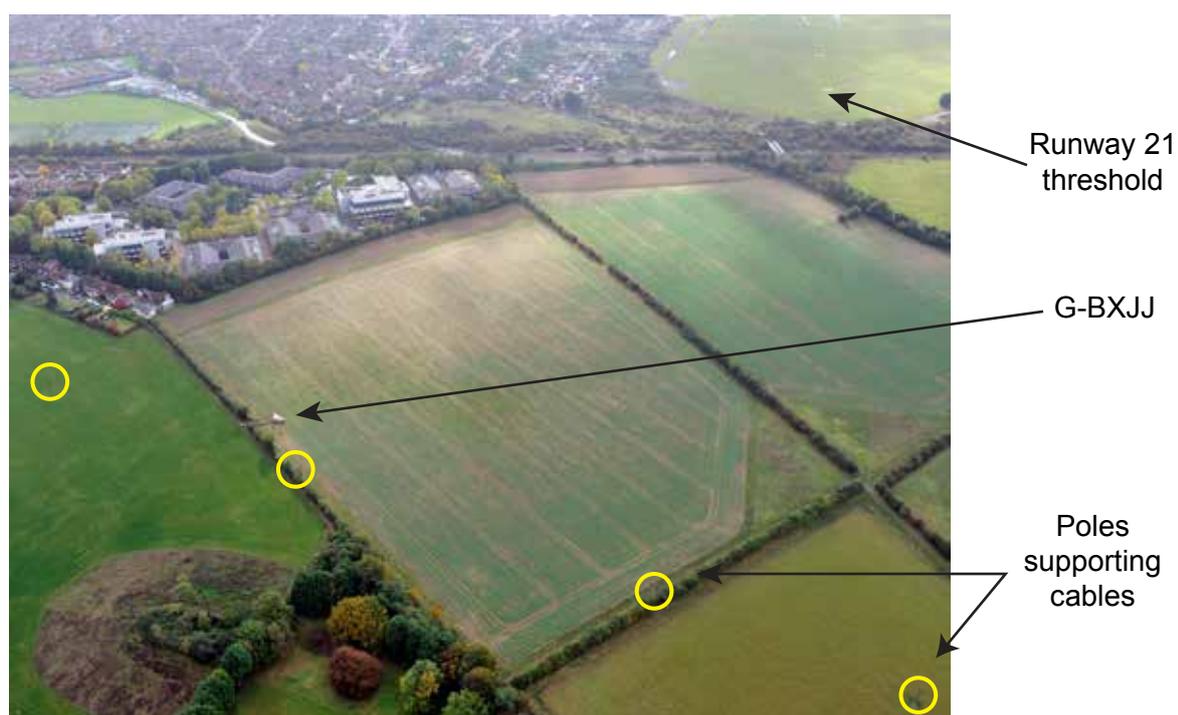
Figure 1

order to extend two stages of flap and commence the approach. The aircraft became lower than planned and when the throttle was advanced to add power, the engine did not respond. The instructor took control, declared a MAYDAY on the aerodrome frequency and then conducted emergency drills, which included changing the fuel selector to the other tank. The aircraft descended faster than anticipated and as the height reduced power cables became visible on the approach path. In order to avoid a potential stall by attempting to fly over the cables, the instructor decided to descend and fly under the cables. The aircraft landed short of the intended field (Figure 1) and it collided with a hedge and was severely damaged. The student selected the electrical master and other switches OFF.

Aerial view of the accident site
(courtesy National Police Air Service)

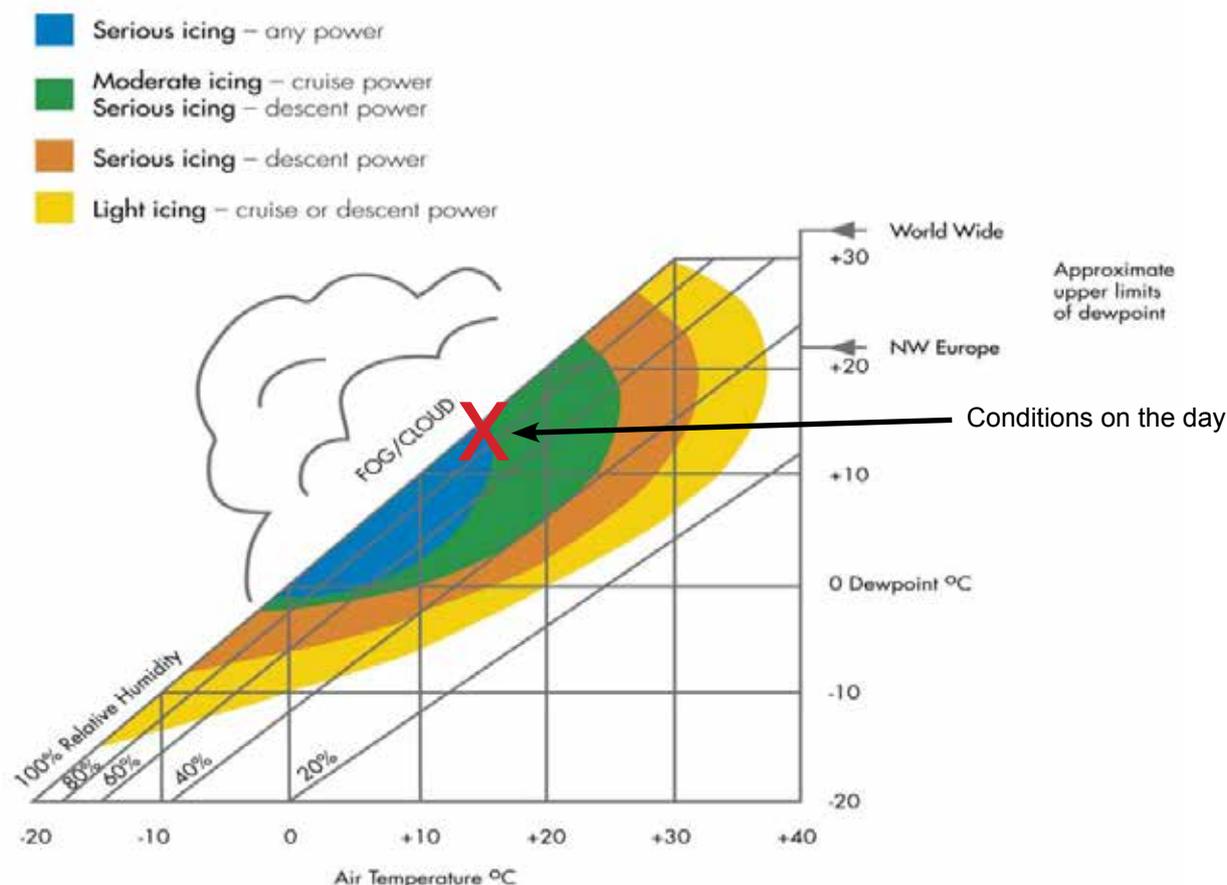
Figure 2

The leaflet also includes a chart, Figure 2, to show the atmospheric conditions most likely to cause carburettor icing. Plotting the temperature and dew point reported on the day of the accident onto this chart indicates that serious carburettor icing was likely to be present at any power setting.

Carburettor icing chart from CAA Safety Sense Leaflet 14, *Piston Engine Icing*

In the absence of any mechanical defects, it seems that carburettor icing is a likely cause of the power loss, given the number of risk factors present on the day. These included: high humidity, a low power setting and the engine was probably not up to full operating temperature. The CAA Safety Sense Leaflet No14, '*Piston Engine Icing*' discusses carburettor icing and its avoidance in more detail.

The operator has highlighted the CAA Safety Sense Leaflet 14, '*Piston Engine Icing*' to its members. It has also placed a laminated copy of the leaflet in their flight planning room for easy reference and included a link to the leaflet in the Pilot Information section of their website.
