ACCIDENT

Aircraft Type and Registration:	Piper PA-31-350, N66886	
No & Type of Engines:	2 Lycoming 540-J2B2 piston engines	
Year of Manufacture:	1974 (Serial no: 31-7405188)	
Date & Time (UTC):	9 April 2014 at 1447 hrs	
Location:	Field near Stonehaven, Aberdeenshire	
Type of Flight:	Private	
Persons on Board:	Crew - 1	Passengers - None
Injuries:	Crew - None	Passengers - N/A
Nature of Damage:	Damaged beyond economic repair	
Commander's Licence:	Airline Transport Pilot's Licence	
Commander's Age:	60 years	
Commander's Flying Experience:	3,188 hours (of which 19 were on type) Last 90 days - 16 hours Last 28 days - 1 hour	
Information Source:	AAIB Field Investigation

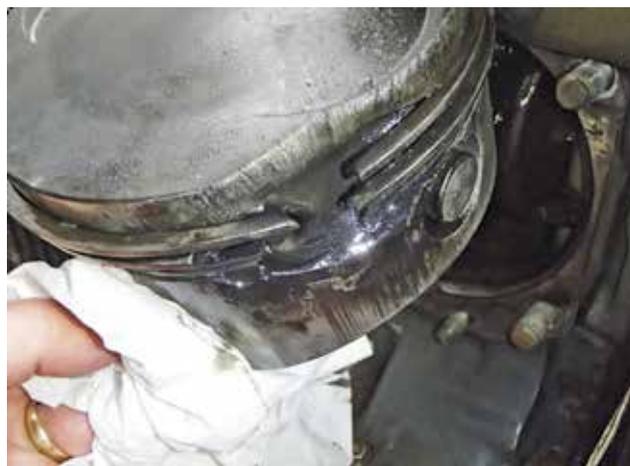
Figure 1

On removing the cylinders it was found that the No 6 piston (rear left) had sustained severe damage, in the form of burning and melting, around a portion of its circumference and this extended to the piston skirt and rings; see Figure 1. There were two compression rings and one oil scraper ring and it was apparent that the gaps in the rings were aligned, whereas normal practice is to install the rings such that the gaps are positioned well apart from each other around the piston circumference.

It was apparent that the ends of the rings had been eroded to the extent that the gaps had widened to between 0.5 and 1.0 in.

Left engine No 6 piston, showing damage to crown, skirt and rings

The damage was indicative of 'blow by', where the combustion gases find a

The condition of the No 6 piston on the left engine and the No 3 piston on the right engine appeared consistent with detonation (pre-ignition) damage. Lycoming's experience has shown that such damage can arise from a number of factors, including lean mixture setting, incorrect ignition timing, induction leaks, excessive oil consumption and incorrect or contaminated fuel. In their opinion, the extreme heat, leading to the extrusion of bearing material in the No 5 connecting rod bearing in the left engine, may have been caused by operating the engine with less than the minimum safe quantity of oil in the sump.

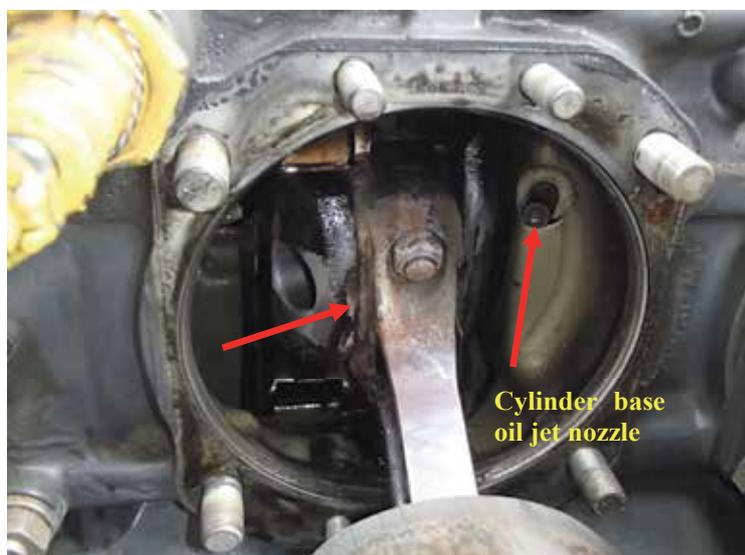
Figure 2

way past the piston and into the crankcase. After removing the piston it was found that the connecting rod, together with that of No 5 cylinder opposite, had been severely heat-affected. Removal of the No 5 cylinder revealed that the big end bearing shell material had become extruded onto the flanks of the connecting rod, where it had solidified into flakes; see Figure 2. Similar debris was also found in the oil filler shaft.

No 5 piston connecting rod showing flakes of extruded bearing shell material and oil jet nozzle

The connecting rod was stiff to rotate, indicating a partially seized big end bearing. The No 6 connecting rod rotated easily, but some radial play was noted, suggesting that much of the bearing shell material had disappeared from its associated bearing.

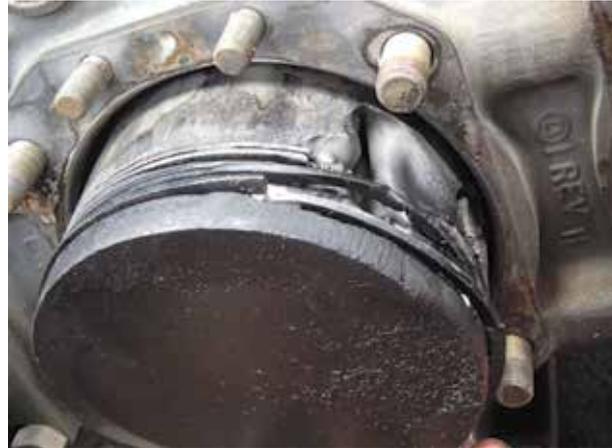
On removing the cylinders it was found that the No 3 piston had sustained almost identical damage to the No 6 cylinder from the left engine (see Figure 3).

The piston crown was perhaps less severely damaged in comparison with the left engine's No 6 piston, although the skirt appeared in worse condition, and the observed damage was again indicative of 'blow by' of the combustion gases. It was noted that, although the gaps in two of the rings had become aligned, this was away from the area of burn damage. It was also noted that the rings had broken into a number of segments, a likely consequence of the piston damage.

Figure 3
Damaged No 3 piston
on right-hand engine
