ACCIDENT

Aircraft Type and Registration:	Cessna 525A Citation CJ2+, N380CR	
No & Type of Engines:	2 Williams FJ44-3A-24 turbofan engines	
Year of Manufacture:	2010 (Serial no: 525A0465)	
Date & Time (UTC):	31 December 2013 at 1100 hrs	
Location:	5.7 nm north-west of Coventry, Warwickshire	
Type of Flight:	Private	
Persons on Board:	Crew - 1	Passengers - 1
Injuries:	Crew - None	Passengers - None
Nature of Damage:	Structural damage to left and right wings, broken HF antenna, dent to fin leading edge	
Commander's Licence:	FAA Private Pilot's Licence	
Commander's Age:	69 years	
Commander's Flying Experience:	3,900 hours (of which 600 were on type) Last 90 days - 16 hours Last 28 days - 5 hours	
Information Source:	AAIB Field Investigation

Synopsis

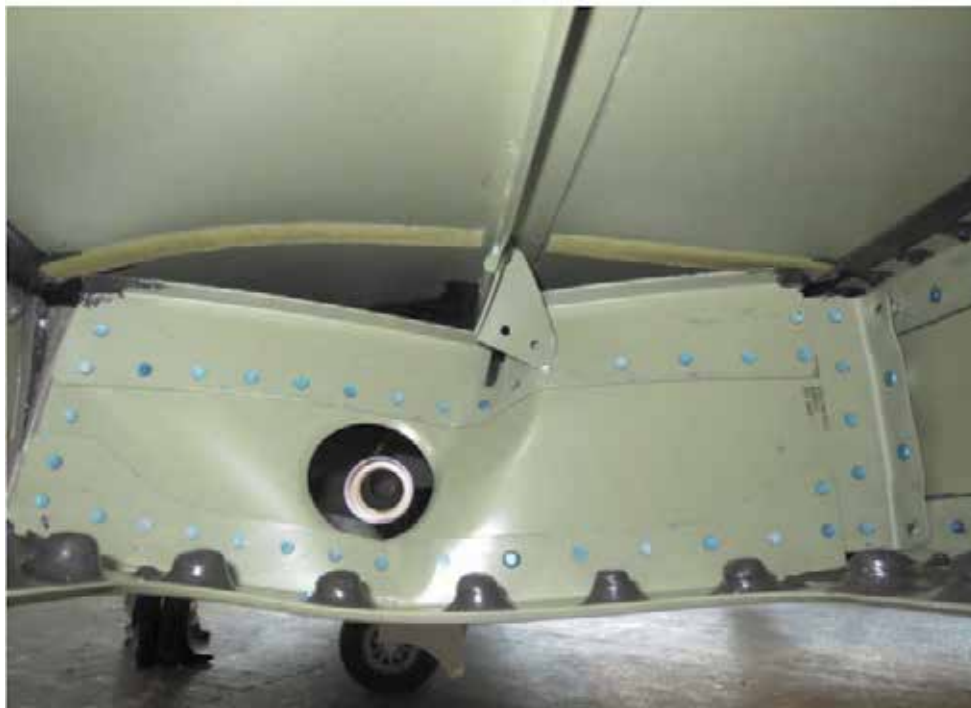
Figure 2

Inspection after the accident flight showed that the aircraft's wings were damaged in a manner consistent with overload in positive symmetrical bending. Five ribs in the outboard wingbox of the left and right wings were damaged by buckling in a manner similar to that shown in Figure 2, and the bonded joints between the ribs and the upper and lower wing skins had failed in overload. The upper and lower outboard wing skins of both wings were permanently deformed with a significant loss of aerofoil shape. Despite the disruption to the wing structure, which on this aircraft type forms an integral fuel tank, no fuel had leaked from the wings and the wing skins remained firmly attached to the front and rear spars. The upper wing skins above the main wheel wells, at the inboard end of the wing close to the fuselage, were also found buckled due to overload. The damage was consistent with symmetrical 'pullout' manoeuvre loads between +3.6g ('limit' load) and +5.4g ('ultimate' load).

Right wing internal damage at WS255.25, at approximately mid-span of the aileron

Both ailerons showed evidence of skin wrinkling along the trailing edge on their upper and lower surfaces.

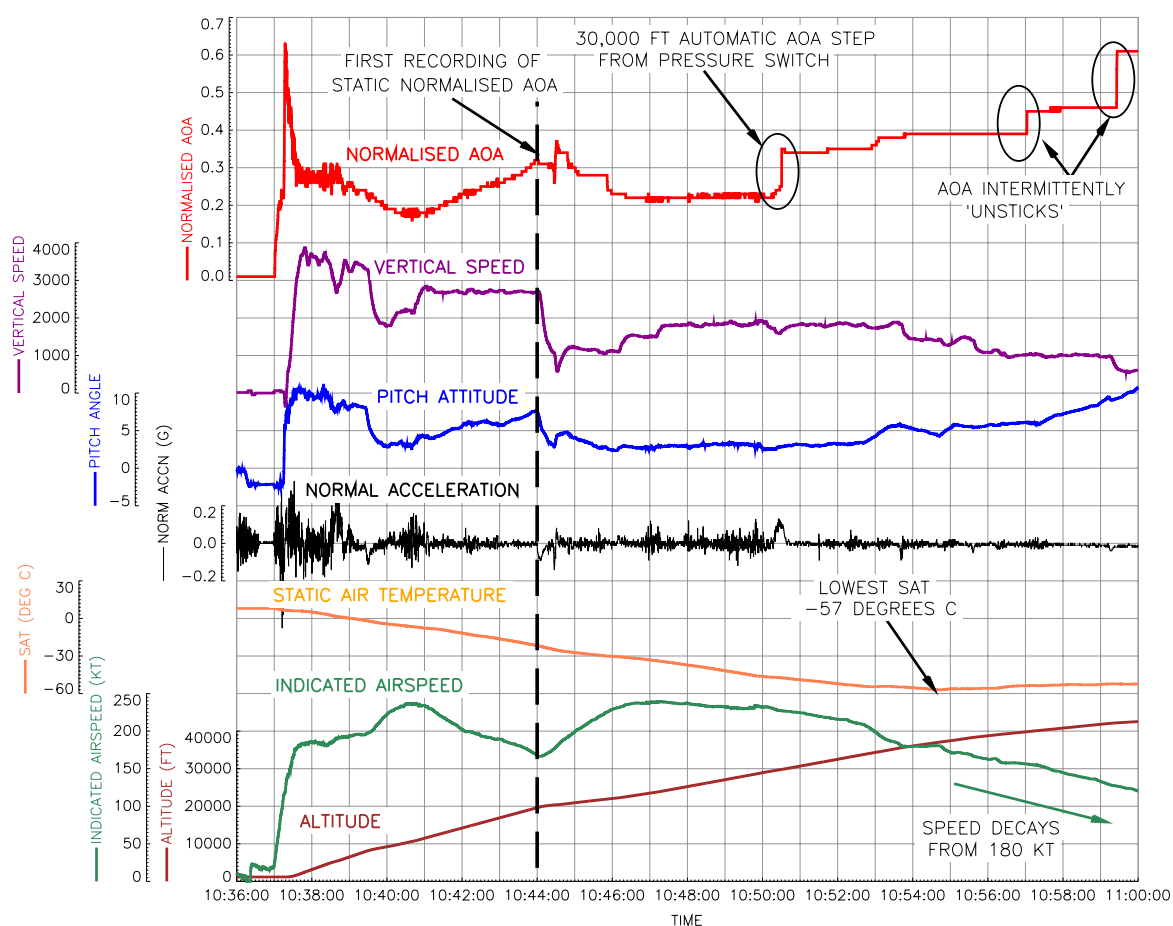
Figure 3
N380CR AReS data during climb

Figure 3 shows that at 1044:02 hrs, the recorded AReS data shows the normalised AOA remaining static as the aircraft climbed through FL197 at a SAT of -22°C. Despite recovering intermittently, as the aircraft climbed and the SAT reduced, periods of static normalised AOA were recorded.

At 1053:43 hrs while climbing through FL356, the indicated airspeed stabilised at 180 kt as the vertical speed reduced from approximately 1,750 ft/min to 1,400 ft/min. This airspeed was maintained for a minute after which it began to reduce. At 1056:41 hrs, the vertical speed reduced further to 1,000 ft/min as the aircraft climbed through FL395 at an indicated airspeed of 158 kt.

At 1059:17 hrs, at FL420 and 128 kt, a further reduction in the vertical speed to 500 ft/min was recorded but this did not stop the decay in airspeed. Nine seconds later, a 'step' change in the normalised AOA was recorded, from 0.46 to 0.61 units, where it remained for the next 45 seconds, despite a reducing airspeed and increasing pitch attitude. This step change (and others noted above FL300) were considered by the aircraft manufacturer to be characteristic of the AOA vane momentarily breaking loose from its static position. At 1100:01 hrs, the indicated airspeed reduced to below 120 kt with a recorded normalised AOA of 0.61 units and pitch attitude of 10.8° pitch-up.

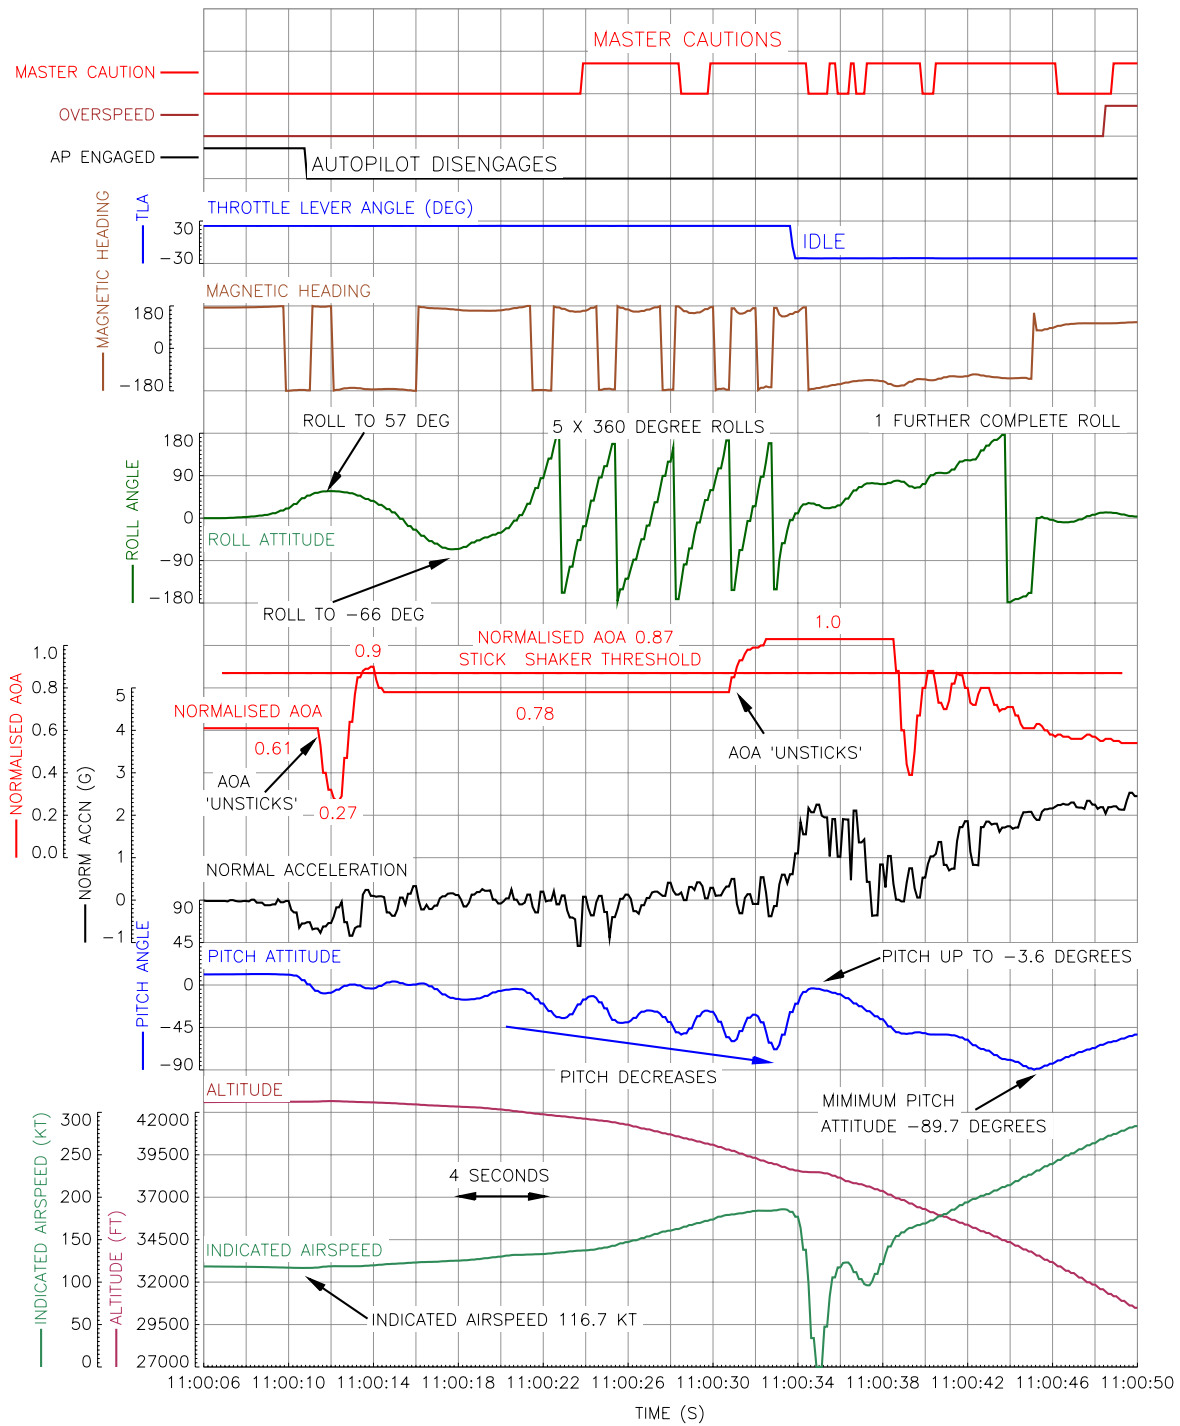
Figure 4
AReS parameters during loss of control

At 1100:08 hrs, while climbing through FL426 with a pitch attitude of 11.5°, the aircraft rolled right to 57° over a period of four seconds (Figure 4). No buffet vibration could be identified prior to this from the recorded accelerations. This roll attitude should have triggered the PFD 'declutter'⁴ mode and an EGPWS bank angle warning⁵. During this time, the aircraft pitched down to -9°, the autopilot disengaged⁶, the aircraft reached an indicated airspeed of 116.7 kt but the recorded normalised AOA remained at 0.61 units prior to reducing to 0.27 units.

The aircraft then rolled back to the left during which the normalised AOA increased to above the threshold required to activate the stick shaker (0.87) for approximately 0.5 seconds before again sticking at a value of 0.78. Control column and rudder pedal positions were not recorded, so it was not possible to establish the control inputs being made by the pilot.

After rolling to the left to -66°, the aircraft rolled back to the right and between 1100:12 hrs and 1100:35 hrs completed five 360° rolls to the right. The derived roll rates⁷ increased progressively from 111°/sec to 120, 152, 153 and finally to 181°/sec. During this, the EGPWS download confirmed a further 12 bank angle warnings and the aircraft oscillated in pitch and slowly pitched down to a minimum of -68°, before then pitching up to -3.6° with a normal acceleration of a 3.25g⁸. The outcome of this was not to arrest the descent but to reduce the airspeed significantly.

Engine power was reduced to IDLE at 1100:34 hrs and remained there for the next 72 seconds. During the fourth complete roll, the recorded normalised AOA became unstuck and increased to 1.0 for six seconds. No further static AOA behaviour was noted for the remainder of the recording.

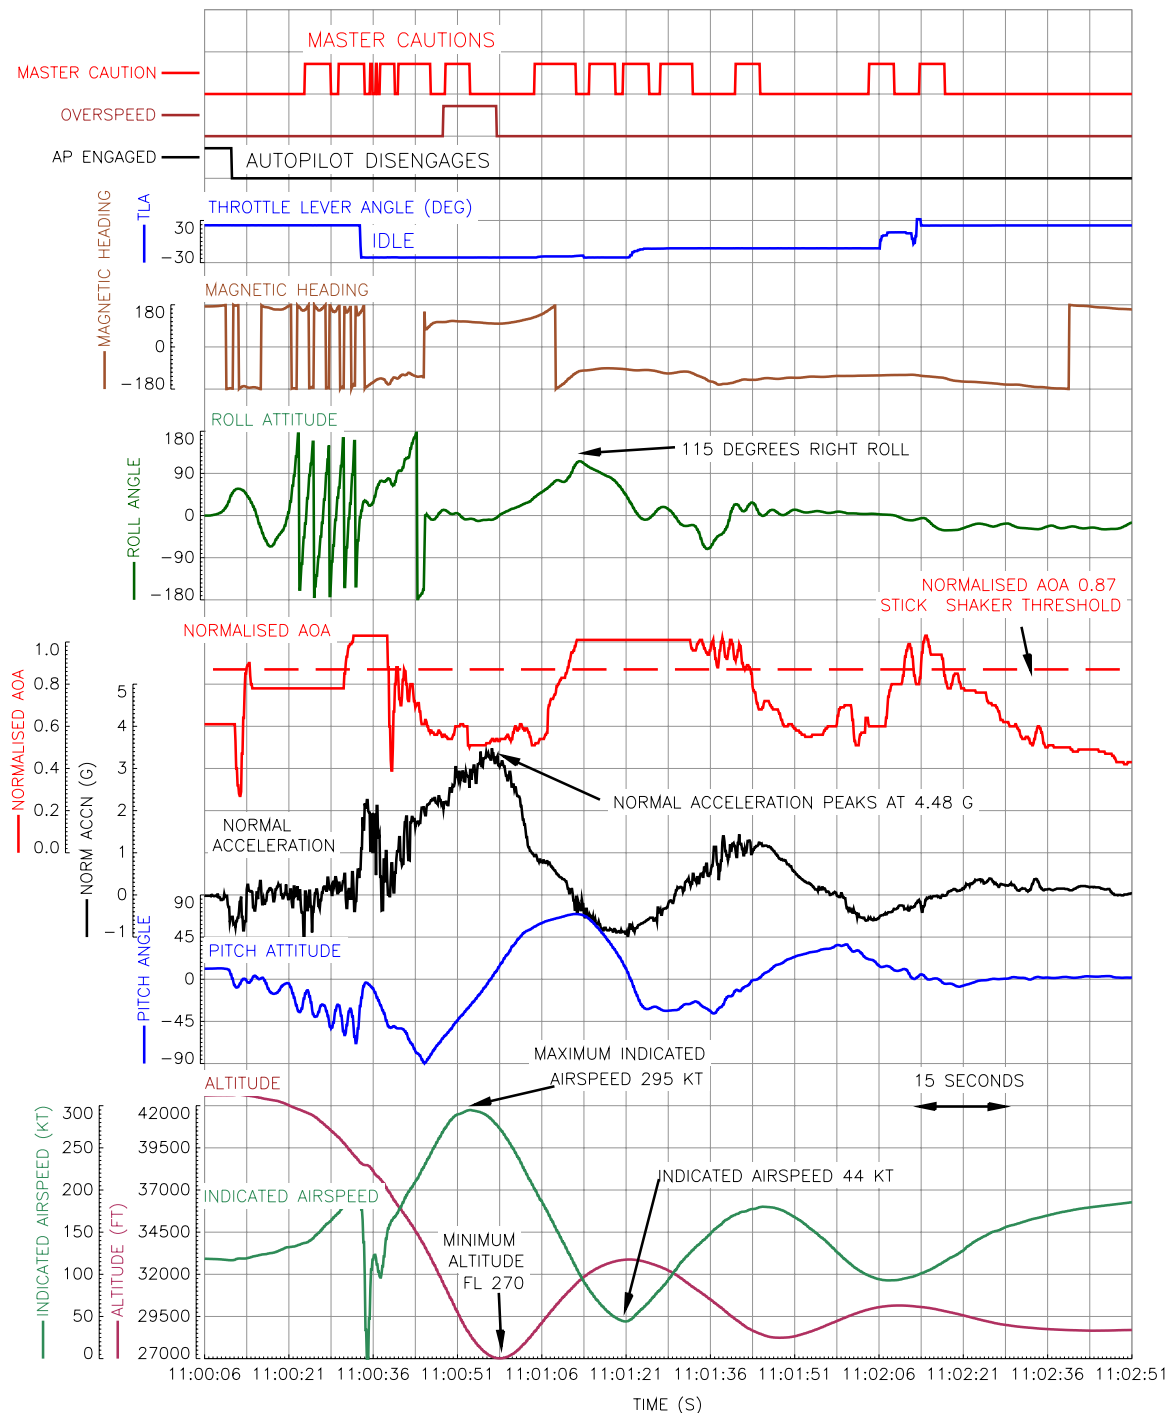
Figure 5
AReS data showing recovery

At 11:00:58 hrs, as the pitch attitude increased, the descent was arrested at FL270, which also corresponded with the peak normal acceleration of 4.48g. The descent of 15,662 ft over 46 seconds equated to a vertical speed of approximately 20,000 ft/min. Ten seconds prior to reaching the maximum pitch attitude of 70° during this pitching manoeuvre, the normalised

AOA increased to above 0.87 (peaking at 1.0) and remained there for the next 33 seconds. The minimum indicated airspeed as the aircraft began to pitch down again was 44 kt.

At the top of the second pitching manoeuvre, the normalised AOA again exceeded 0.87 for two separate periods of two seconds and four seconds, with a minimum recorded indicated airspeed of 93 kt.

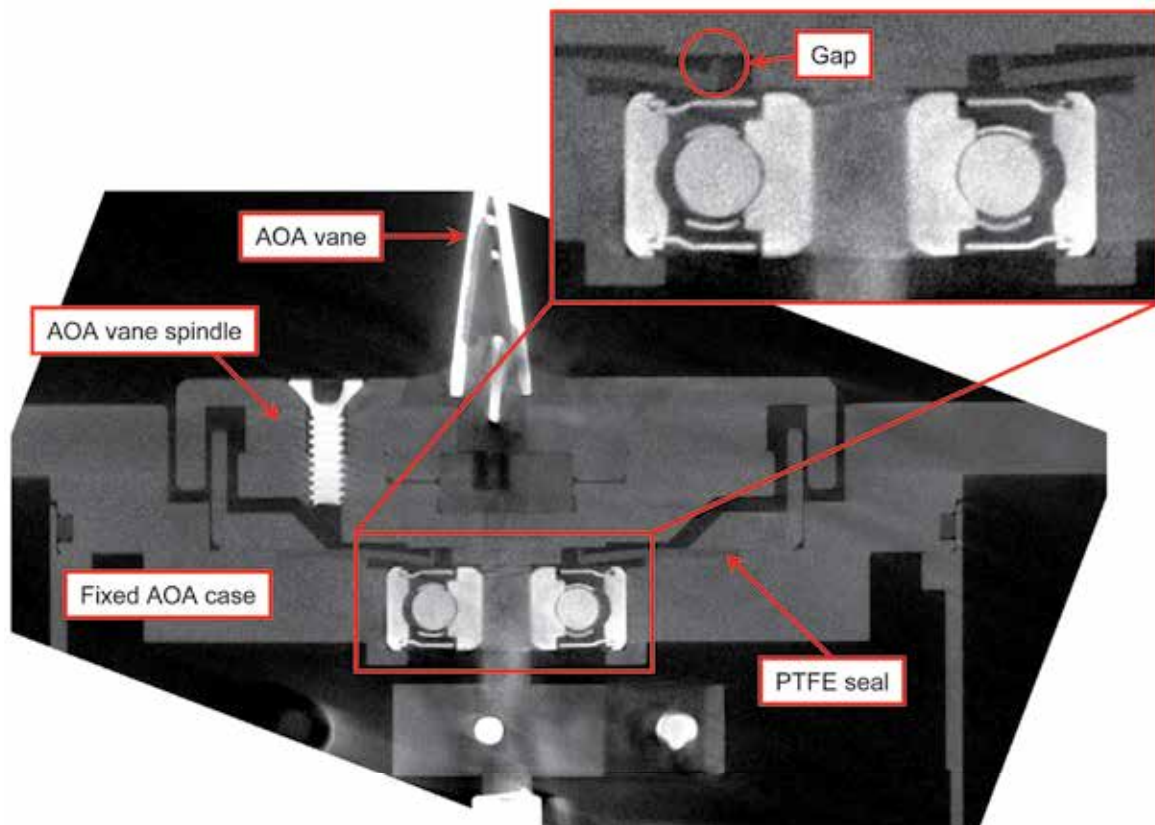
Figure 10

CT-scanned¹⁷ prior to disassembly to record its internal condition. The CT scans showed that an internal PTFE (polytetrafluoroethylene – a synthetic fluoropolymer) seal was laterally displaced and was not concentric with the vane spindle assembly or the AOA vane case, Figures 10 and 11. When viewed from the side, a gap was visible between the PTFE seal flange and the vane spindle assembly, which is not intended by the design, as the PTFE seal is required to prevent moisture and foreign objects from entering the AOA vane case from outside the unit.

Gap between AOA seal and vane spindle

CT-scanning images of the AOA vane showed that an internal PTFE seal was displaced and was not sealing correctly against the vane spindle, and leak testing of the unit confirmed the lack of sealing capability of the PTFE seal. Witness marks on the PTFE seal's flange showed that, at some point since the AOA vane unit was manufactured, the seal had been in full circumferential sliding contact with the vane spindle. It must, therefore, have moved position at some point during its service life in N380CR.

The presence of a gap between the PTFE seal and the internal volume of the AOA vane case provided a path for moisture to enter the vane case, when the aircraft is parked and unpressurised. There was, however, no visible evidence of water staining or corrosion on the internal components of the AOA case when those parts were examined but it is likely that only a small amount of moisture would be required to create an intermittent AOA 'sticking' mechanism. The sticking of the AOA position represented a subtle, dormant failure that was not readily apparent to the pilot as it did not generate a warning annunciation.

It is recommended that the Federal Aviation Administration requires the Cessna Aircraft Company, as the Type Certificate holder for the Citation CJ2+ aircraft, to conduct a survey of recorded flight data from Safe Flight Instrument Corporation model C-12717-1 angle-of-attack vane units, to determine the frequency of 'sticking' (static) angle-of-attack data.

It is recommended that the Federal Aviation Administration requires the Cessna Aircraft Company, as the Type Certificate holder for the Citation CJ2+ aircraft, to use the results of their survey (Safety Recommendation 2014-041) of recorded flight data from Safe Flight Instrument Corporation model C-12717-1 angle-of-attack vane units to amend the safety assessment of the aircraft's stall warning system.

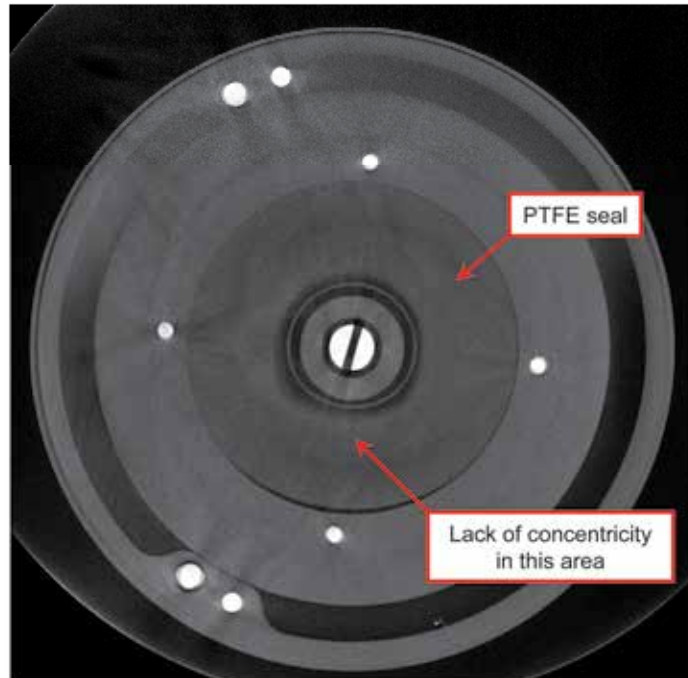
Figure 11

2.6 times the factory acceptance limit value of 500 cm³/min. Application of a soap bubble solution showed that the leaking air was escaping past the internal PTFE seal and through the annulus formed between the AOA vane spindle and the AOA case.

Lack of concentricity of AOA seal

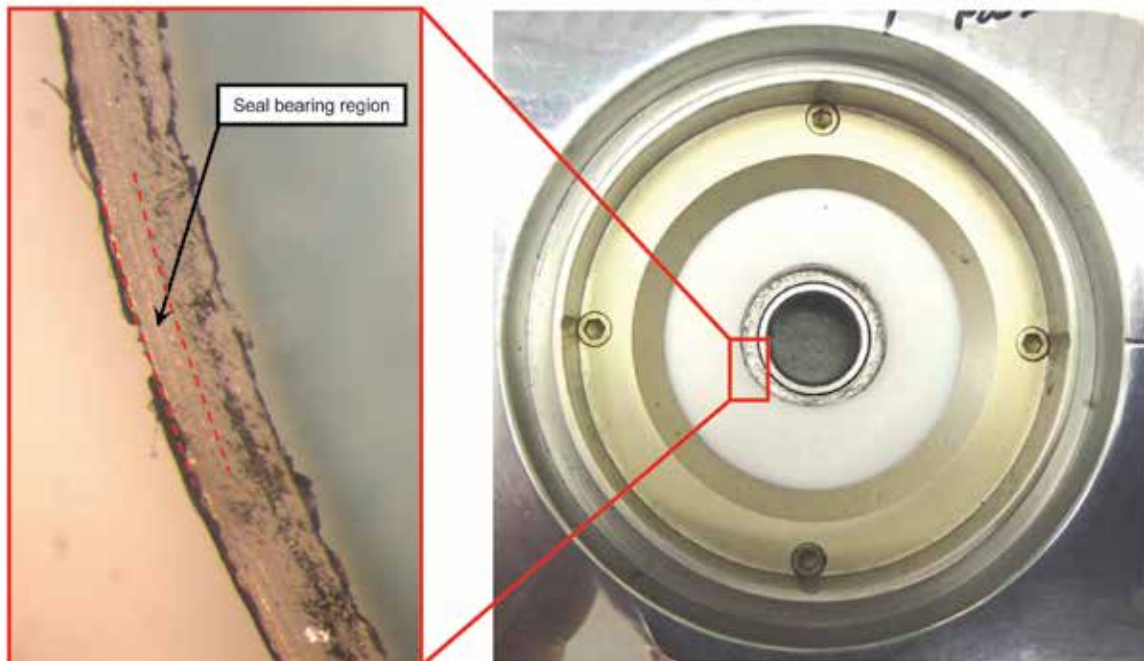
Figure 12

AOA seal condition showing circumferential wear marks on the bearing region

The sealing flange of the PTFE seal exhibited surface wear marks around the complete circumference of the flange, indicating that at some point following manufacture, the entirety of the seal's flange had been in sliding contact with the AOA vane spindle. It was therefore determined that the PTFE seal flange had moved to its deflected position at some point during the unit's service life on N380CR.
