Marine Accident Report 5/98

Report of the Inspector's Inquiry into the Grounding of the Bahamas Registered Passenger Ship

ALBATROS

on 16 May 1997
in Saint Mary's Sound, Isles of Scilly

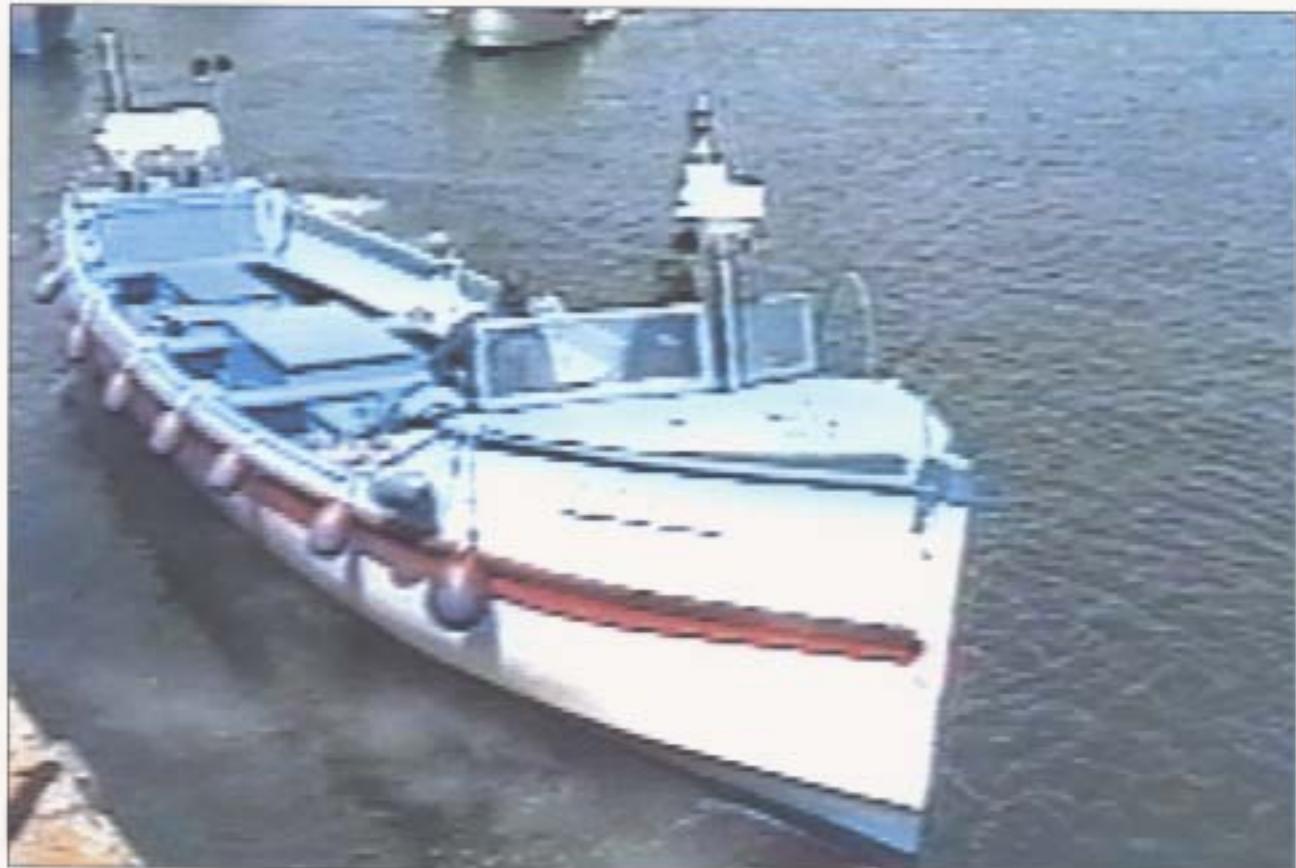
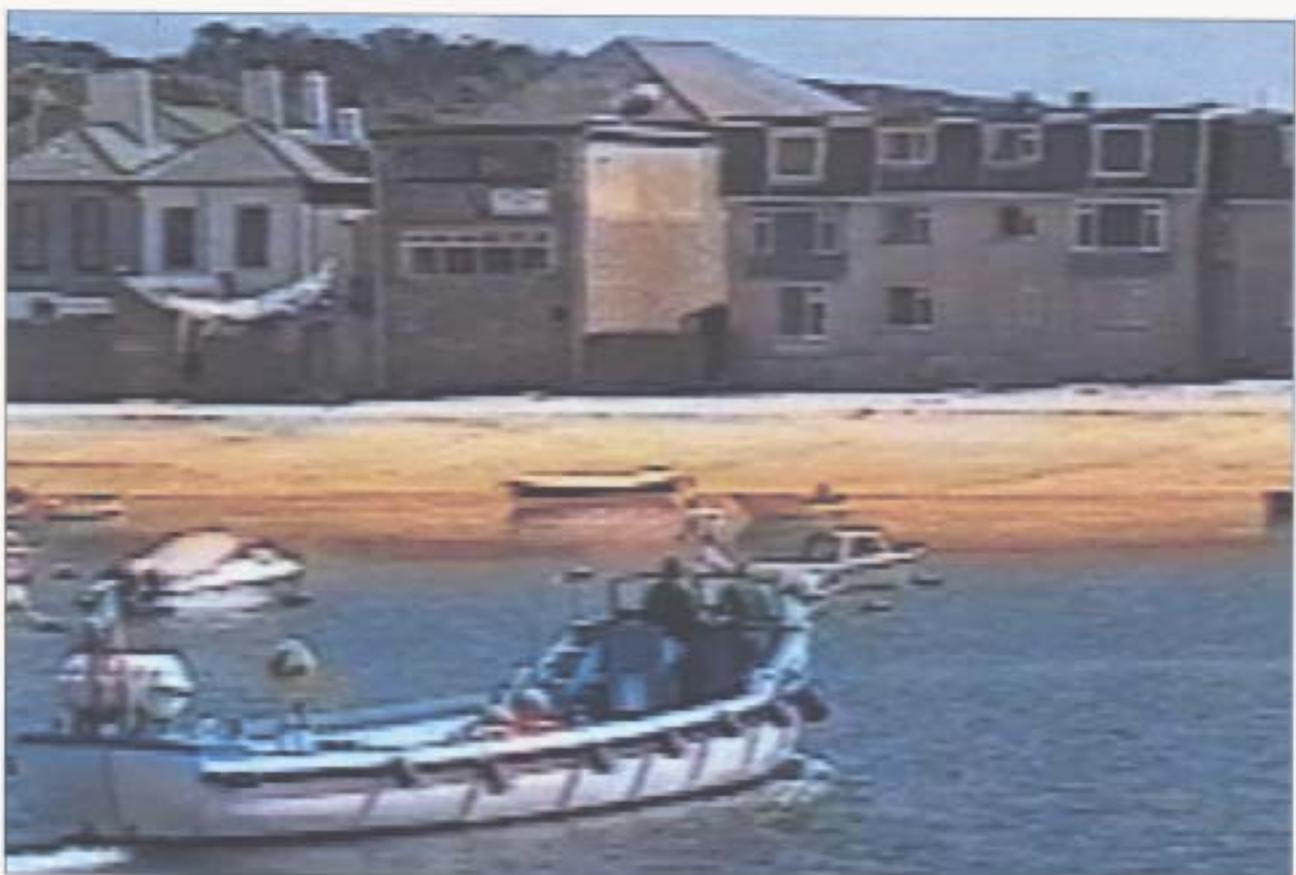
Figure 10.1: Kingsley II

Since the launches are made of wood and designed primarily for carrying passengers between the islands, their relatively light construction makes them susceptible to damage when manoeuvring alongside a large vessel in a seaway. Any damage so incurred could deprive the owners of a primary source of income.

- xv. The launch being used for pilotage duties on 16 May 1997 was inadequate for the purpose, due to the prevailing sea conditions.
- xvi. There were no malfunctions in any of the ship's systems that might have contributed to the accident.

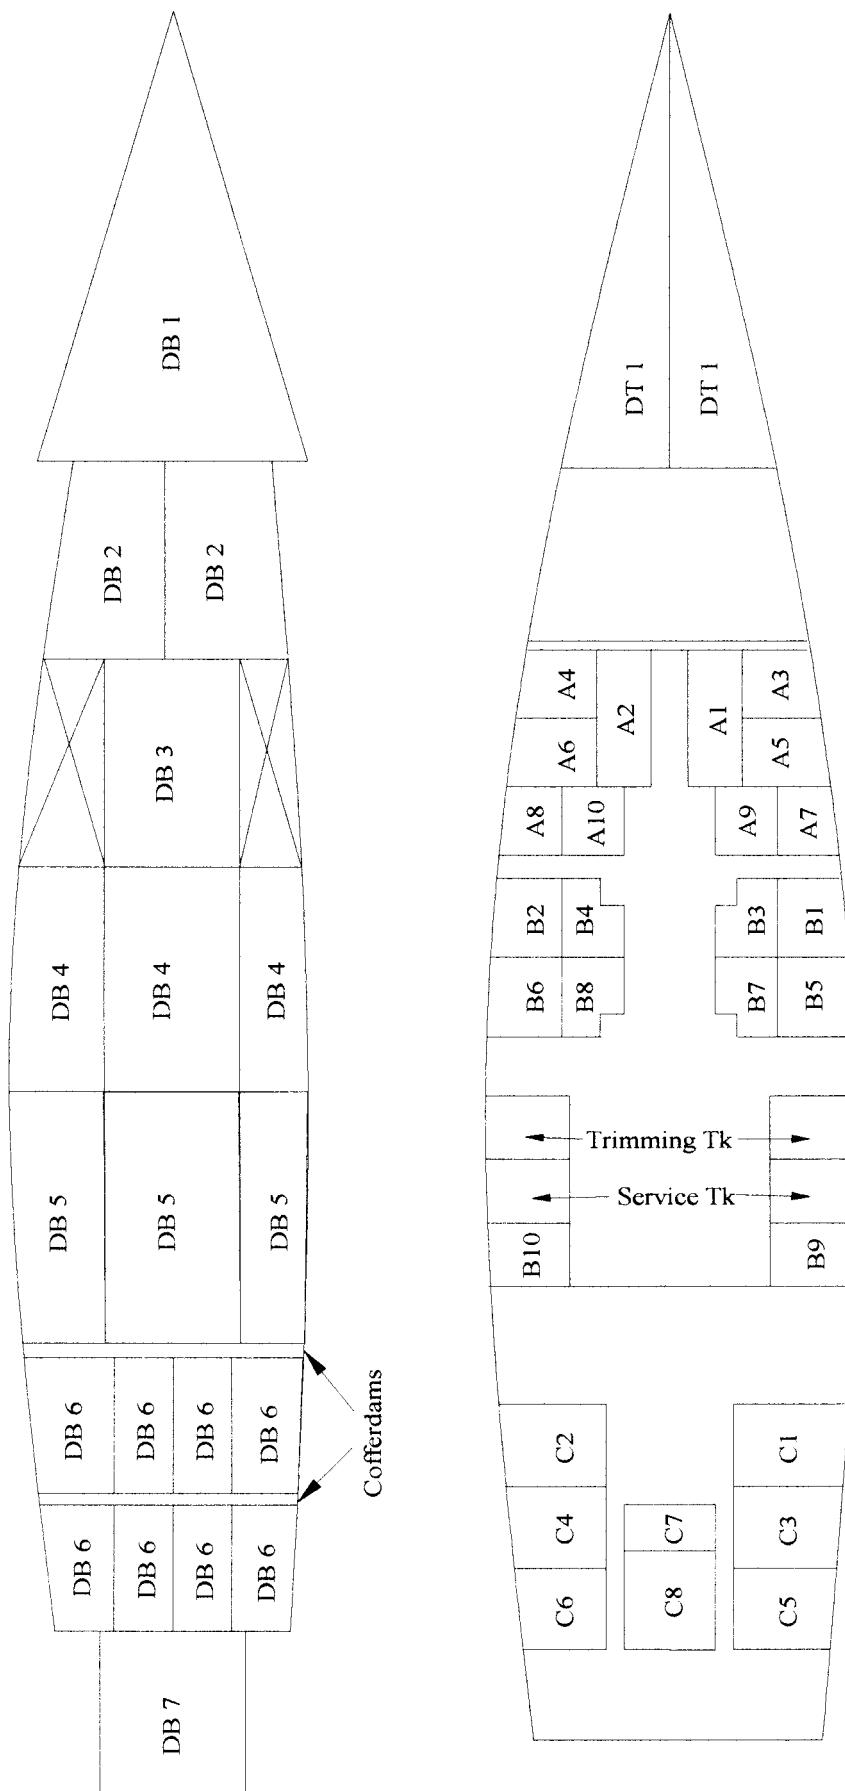
Figure 11: A schematic diagram showing the layout of the double bottoms and deep tanks

On Sunday 18 May a further underwater inspection was undertaken. The divers' video revealed damage to four double bottom tanks, a cofferdam and a number of other tanks (see Section 1.14 for details). Following concern that latent damage may have occurred to the ship's main propulsion system, the Lloyd's Surveyor specified that an escort tug would be needed for the passage to her next port in case engine failure occurred.

The initial surveys found that the majority of the damage was on the starboard side from frame 72 through to frame 205. In this area the bottom plating was heavily set up, locally holed, torn open or scored. Internal sections were affected and damage was in way of strakes A, B and C. The keel strake and the keel doubler plate were unaffected.

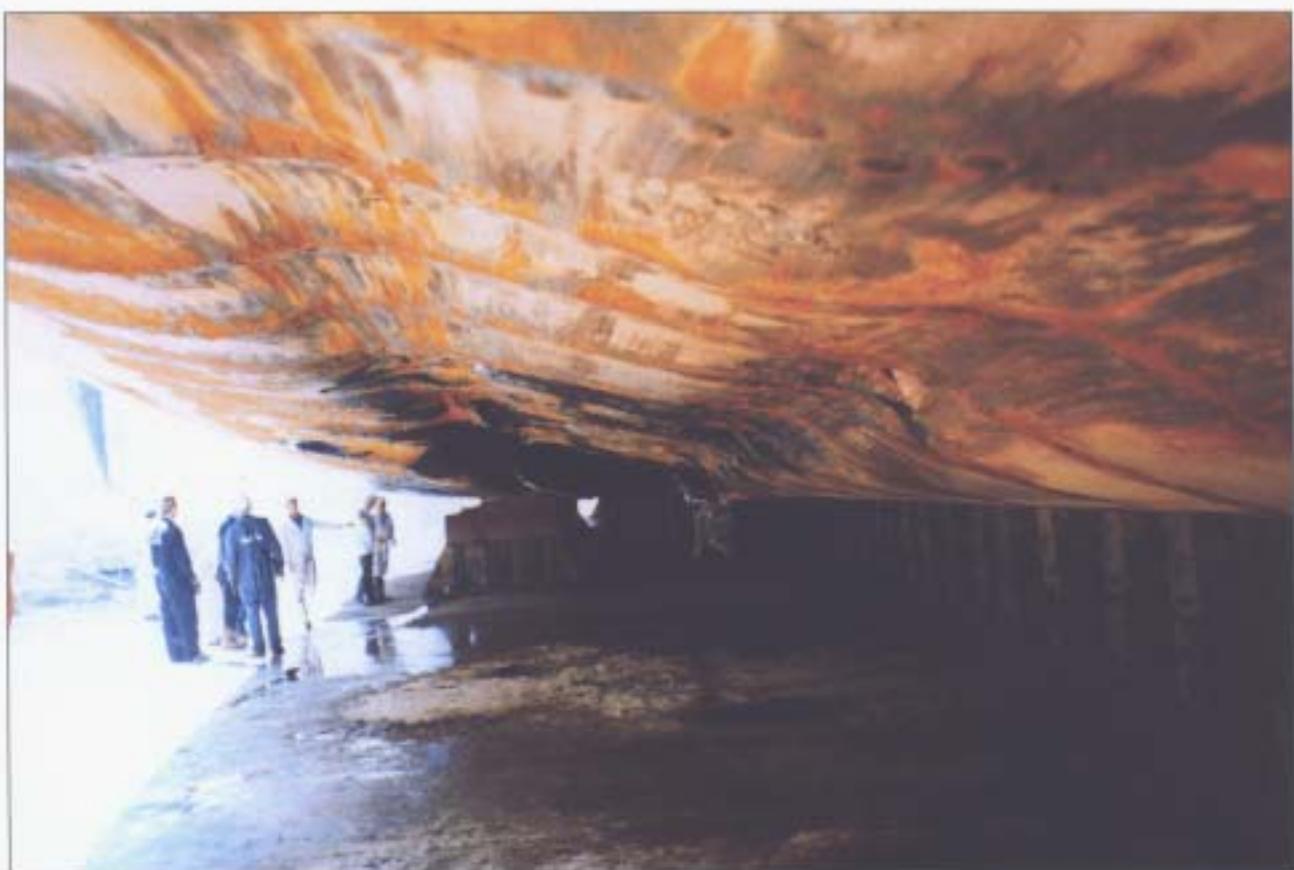
Figure 12.2: Looking aft from the same stand-point as 12.1 above. Note large hole in the aft end of No 3 double bottom.

The tears and holes in the double bottom fuel oil tanks were on the bottom or horizontal sections of the hull and water pressure contained the oil in these compartments. If damage had been sustained to the side or vertical sections of the fuel tanks, the leakage of oil would have been significant and pollution would have occurred.

Whilst the above was the basis for the repair specification, the actual repairs were more extensive than at first envisaged because of deformations to internal floors.

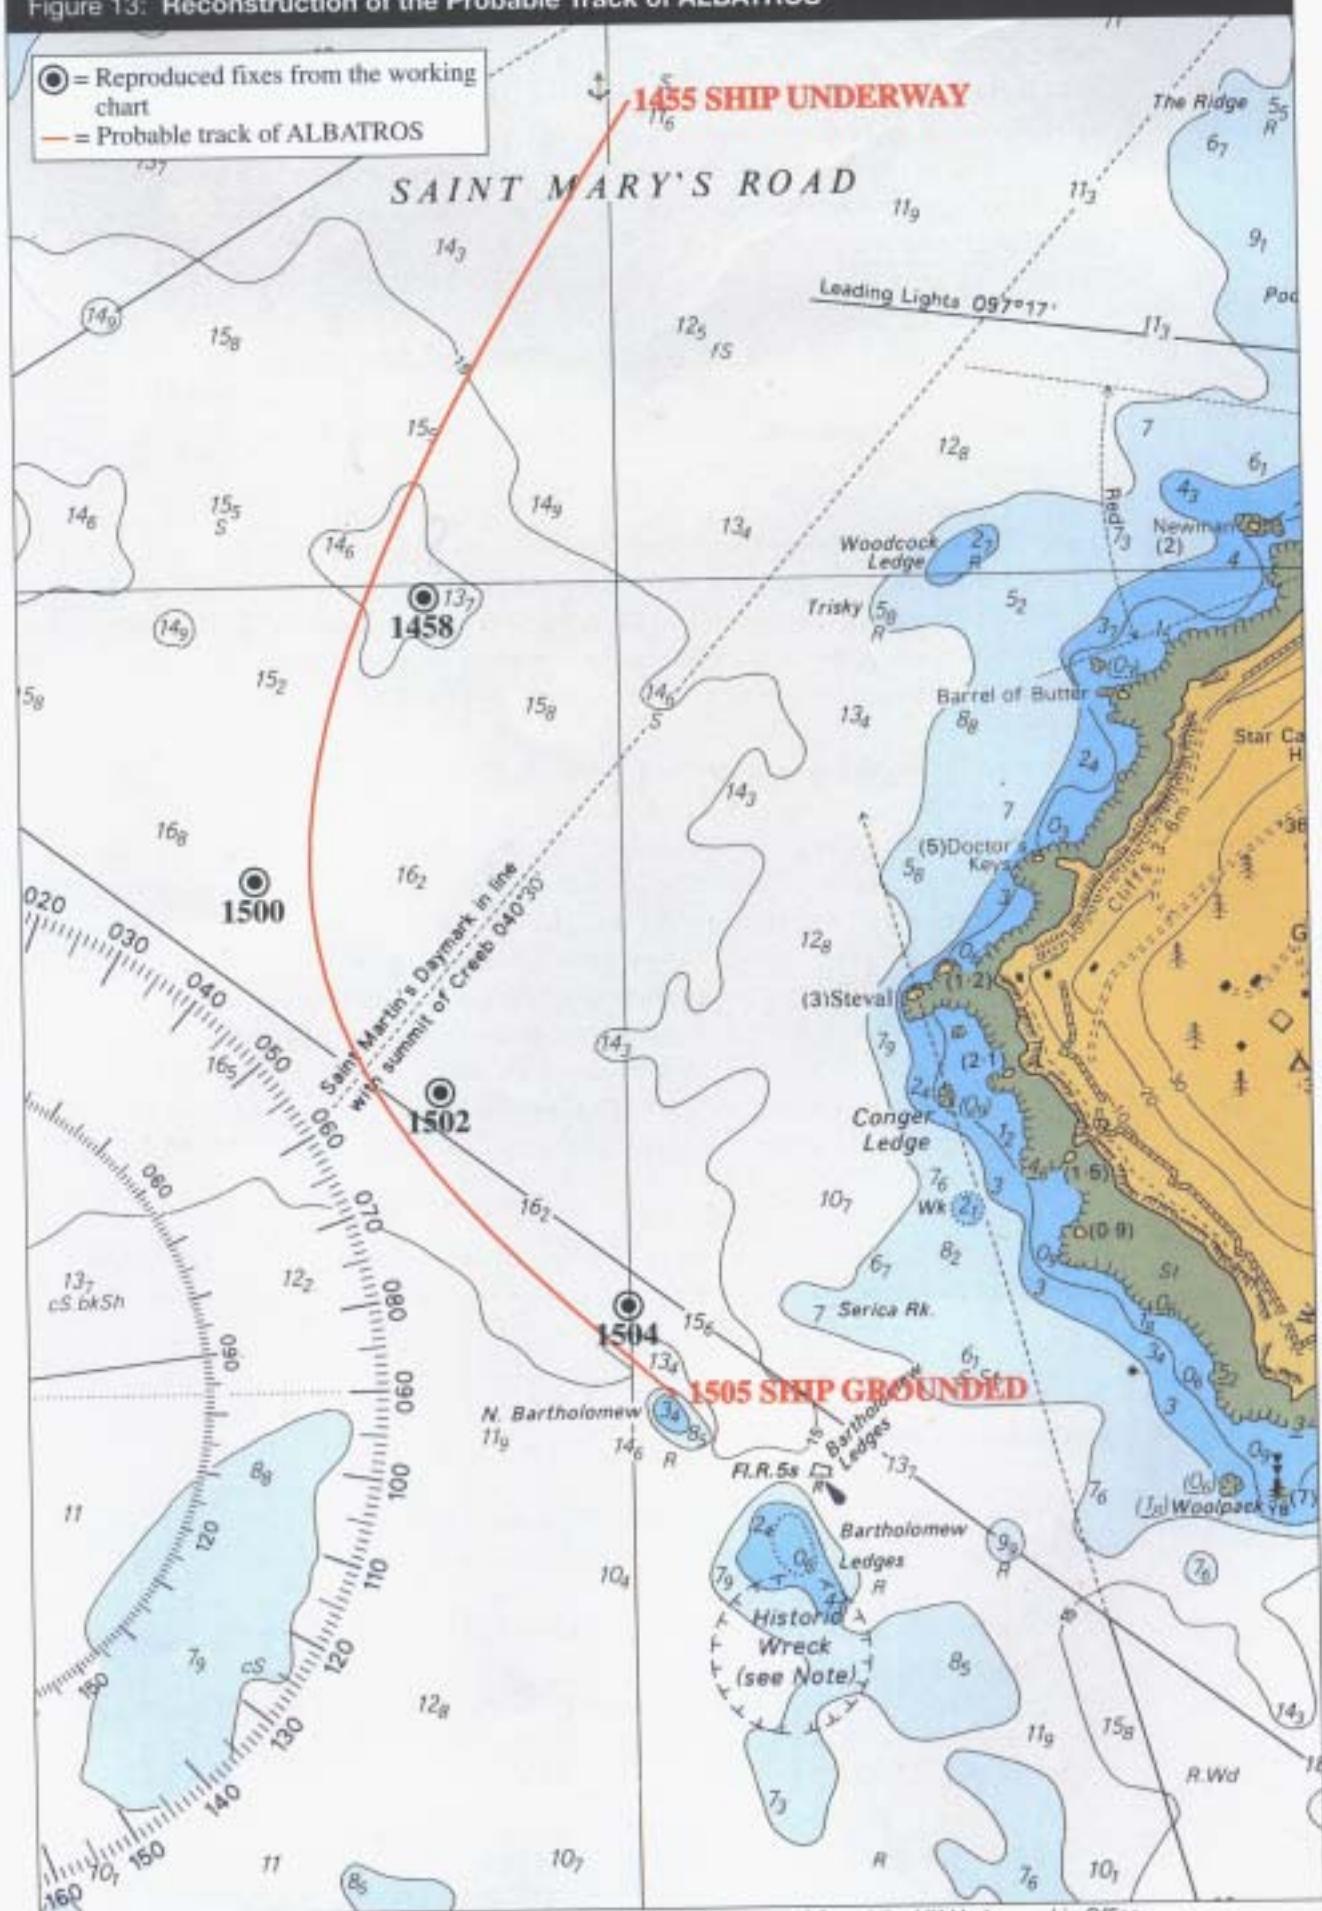
Figure 13: Reconstruction of the Probable Track of ALBATROS

The well established and normally reliable technique of navigating using parallel indexing on the radar was used but its failure to indicate that ALBATROS would overshoot her turn to port denied the Master a crucial warning that he was standing into danger. This failure can be attributed to a number of possible errors; an unknown variable range marker error, poor radar operation, an inability of the single parallel index line to indicate the ship was overshooting the turn, misplaced confidence in an ability to conduct visual pilotage and a disregard for the radar information being presented. Whatever the reason, interpretation of information provided by the radar failed to warn anyone in ALBATROS that the track being followed would result in her contacting the North Bartholomew Rock.

The Master relied very heavily on judging his position relative to the Bartholomew Ledges and Spanish Ledge Buoys, which he assumed were in their correct positions. At no stage was a bearing taken of the Bartholomew Buoy which might at least have alerted him to the possibility he was too far to the south of the planned track. Judging the ship's position by eye failed to give any indication of impending danger. The echo sounder digital display, above the forward bridge windows, gave no warning the ship was about to hit a rock. It is poor navigational practice to rely solely on buoys or other floating marks, without first verifying their positions.

The immediate cause of the accident was the Master's failure to execute and monitor the turn to port to ensure ALBATROS remained safe as she approached Saint Mary's Sound.

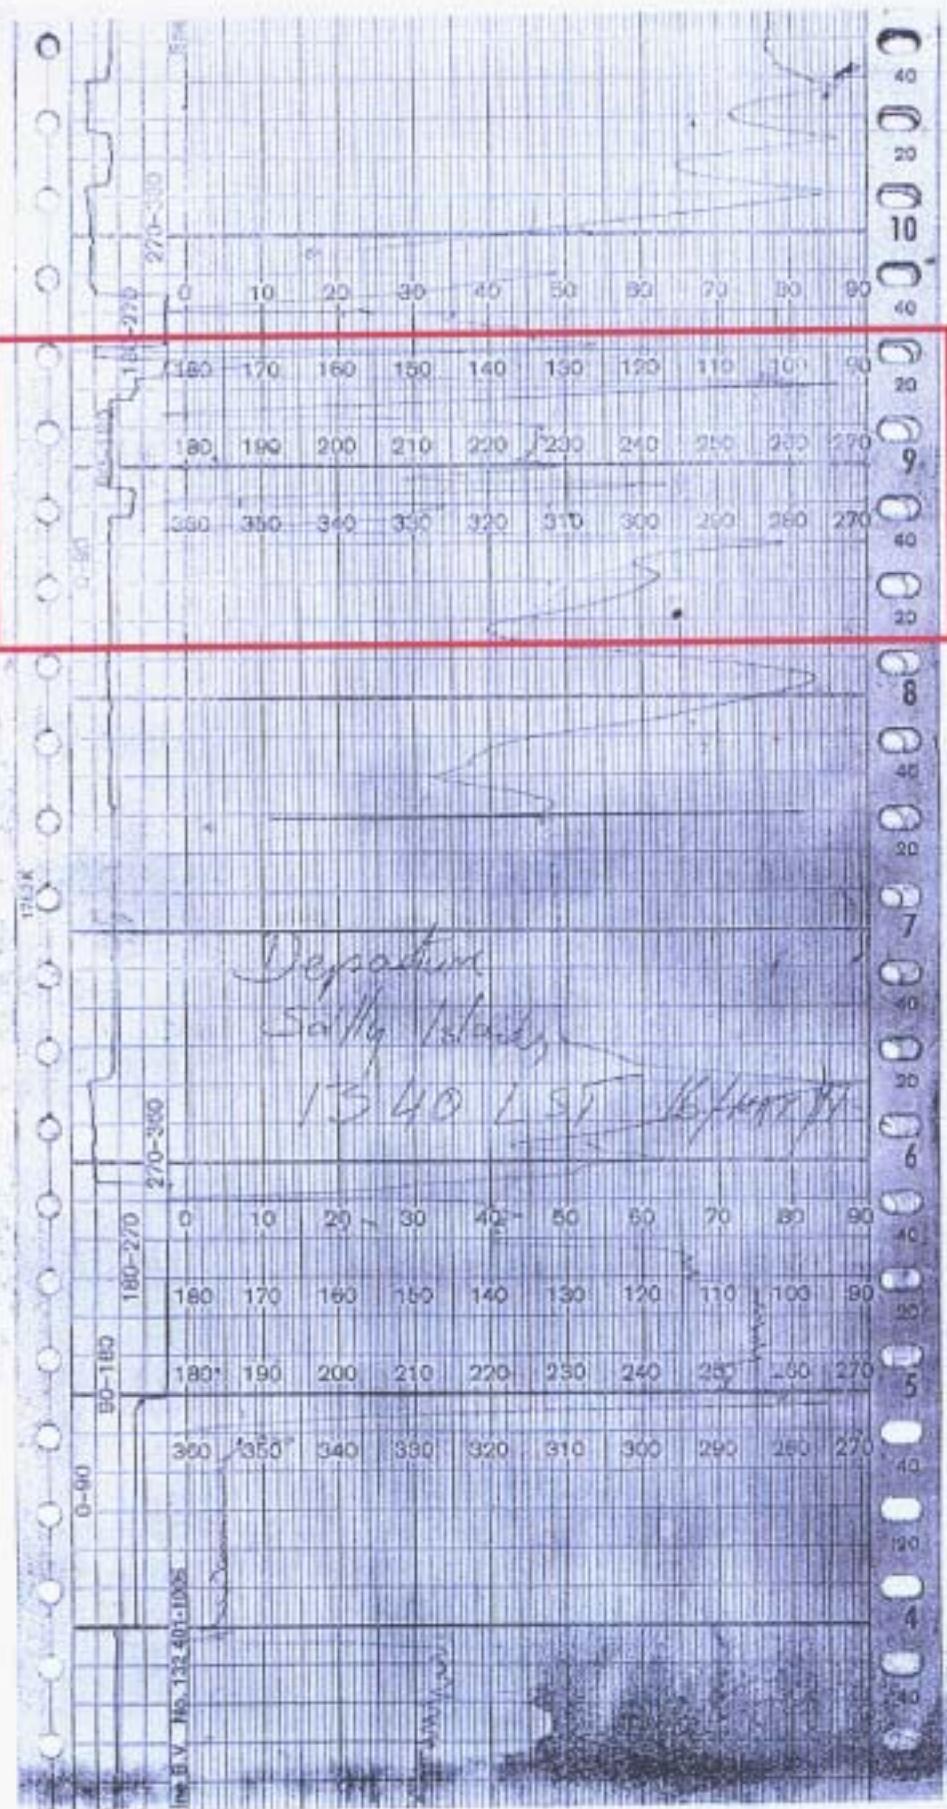
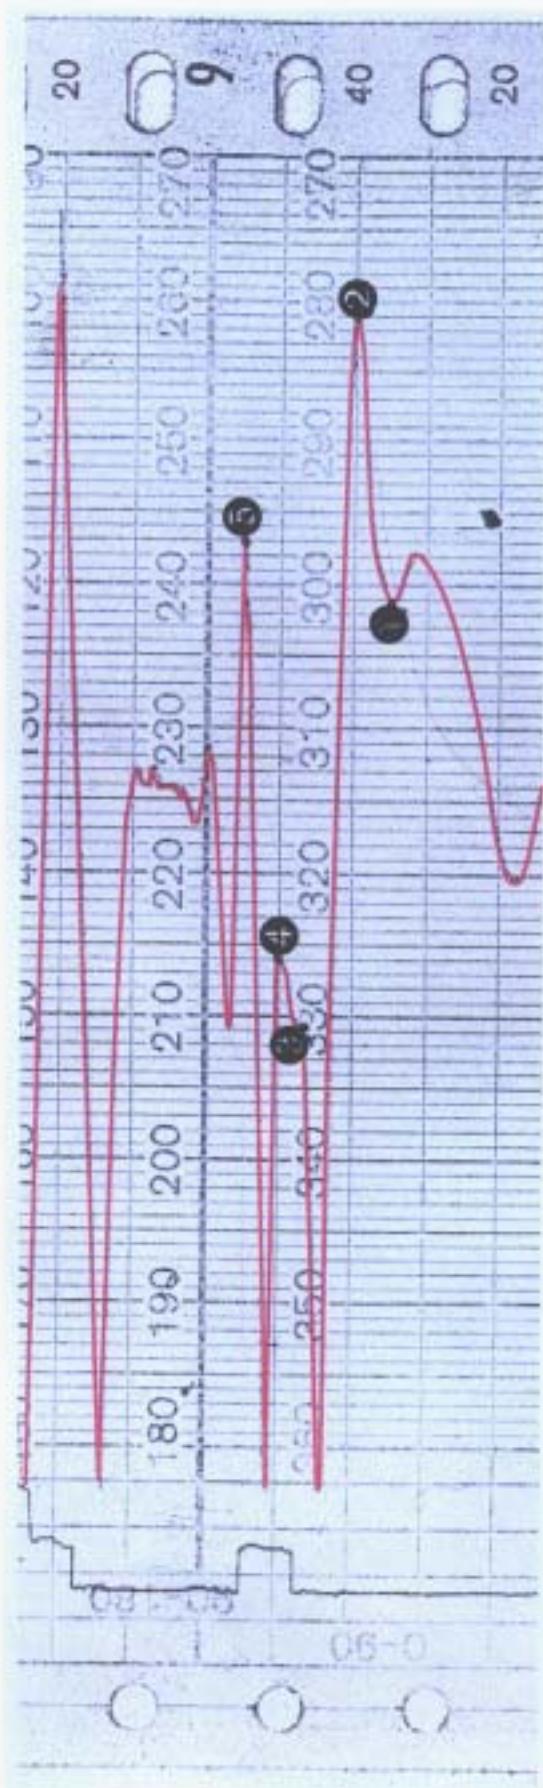
Annex 2 Part B: Detail of relevant portion of Course Recorder Tracing

1. = 1445 - Heading 121° - Commence weighing anchor
2. = 1450 - Heading 101°
3. = 1457 - Heading 210° - Reduced rate of turn
4. = 1500 - Heading 214°
5. = 1505 - Heading 117° - Grounded
