Report of the Chief Inspector of Marine Accidents
into the collision between the Fishing Vessel

ANTARES

HMS TRENCHANT

with the loss of four lives
on 22 November 1990

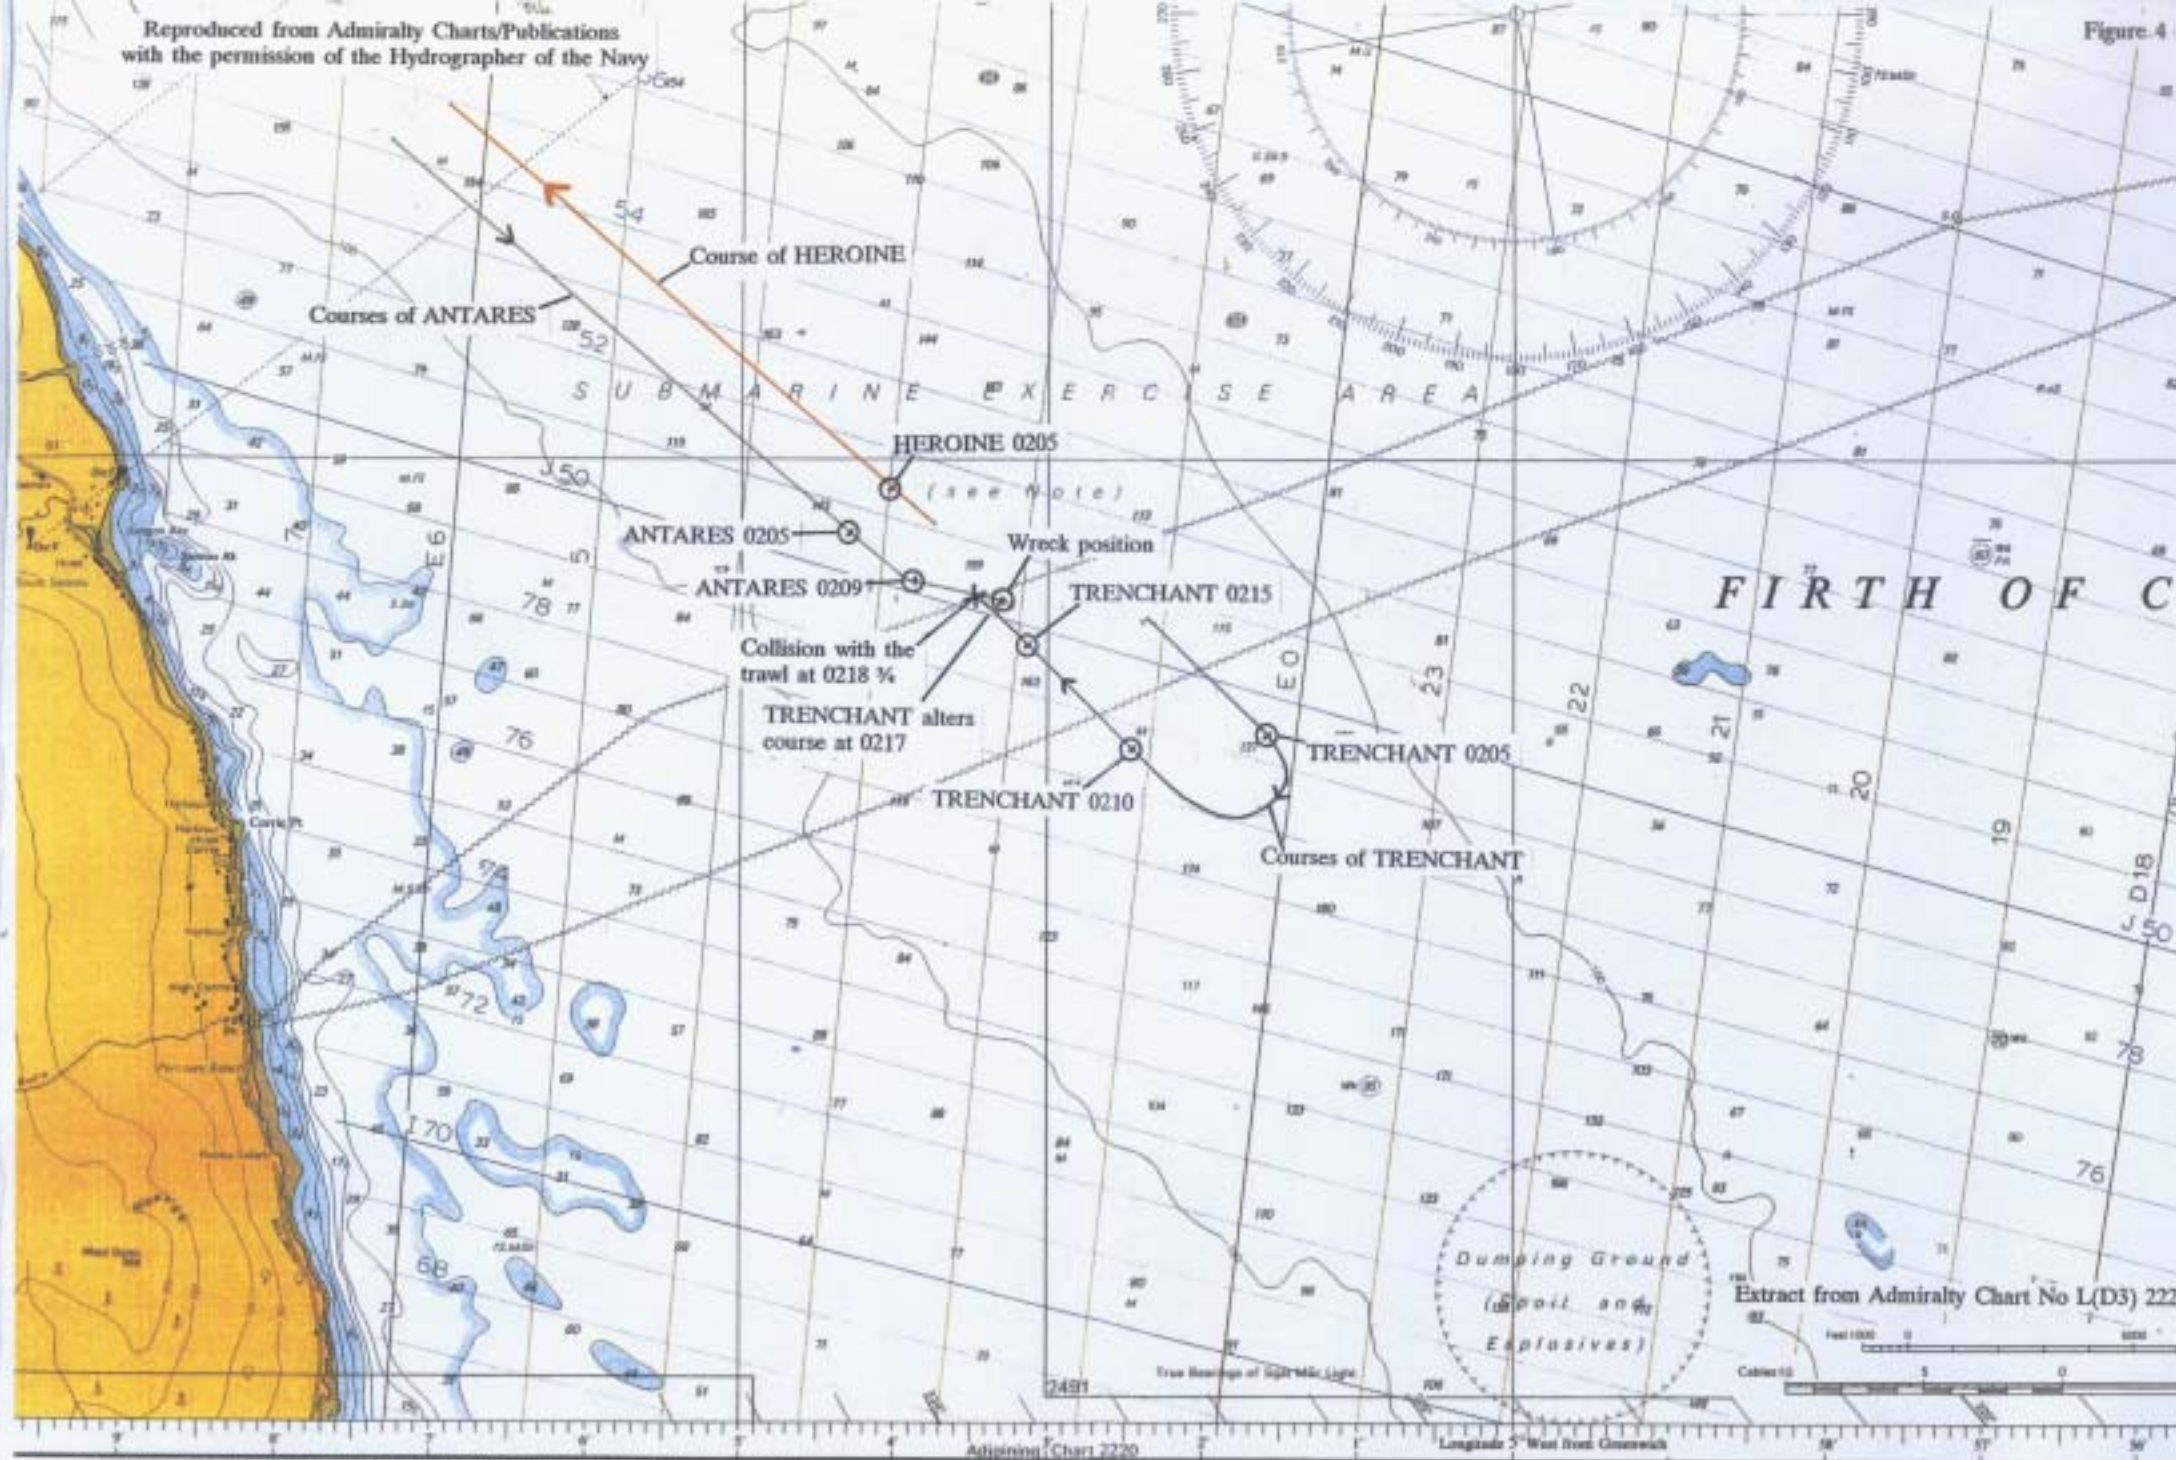
At 0219 hrs TRENCHANT collided with the warps of the ANTARES fishing gear which, at that stage, would be leading broad on the starboard quarter so that ANTARES was almost beam on to them, and the resulting transverse pull caused ANTARES to capsize to starboard and sink in position 55°39'.5N 5°03'.3W. (See Figure 4)
