Figure 1	Route of BRAER on approaching Shetland
Figure 2	Drift of BRAER
Figure 3	Photograph of BRAER aground
Figure 4	Plan showing position of air pipes and stowage of spare pipes
Figure 5	Photographs of the port double bottom diesel oil tank aft air pipe on sister ships
Figure 6	Photograph of BRAER showing broken rails
Figure 7	Photographs of the diesel oil settling and service tanks common air pipe on sister ships
Figure 8	General Arrangement Plan of BRAER
Figure 9	View looking forward on a sister ship
Annex 1	IMO Resolution A.535(13)
Annex 2	Draft Amendments to SOLAS Chapter V on Emergency Towing Arrangements on Tankers

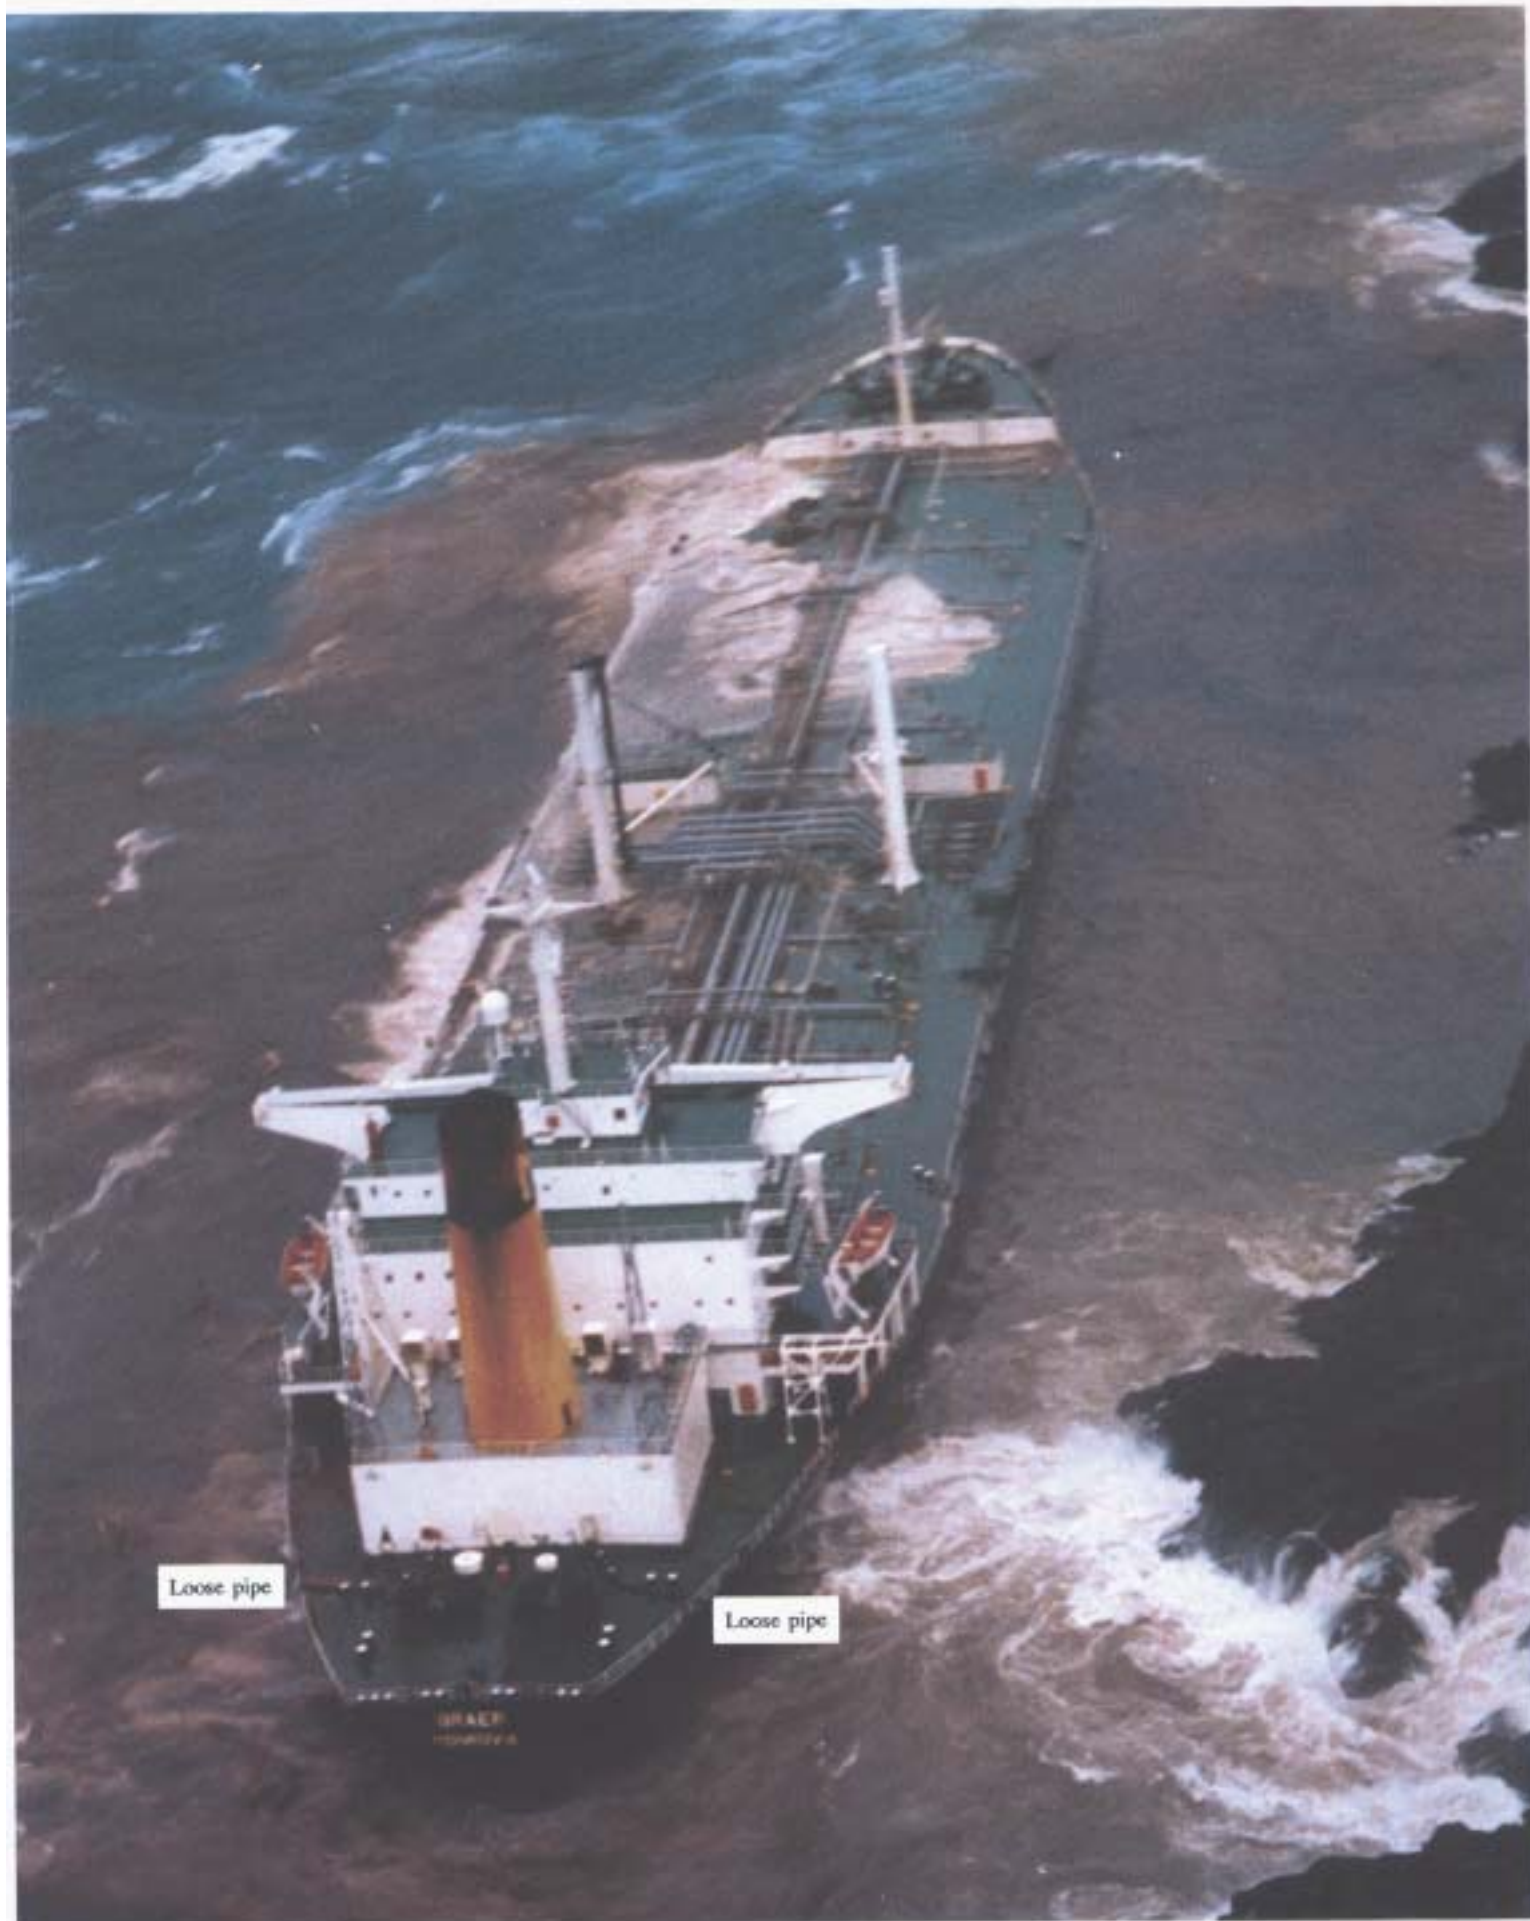
BRAER aground showing loose pipes,
port and starboard sides aft

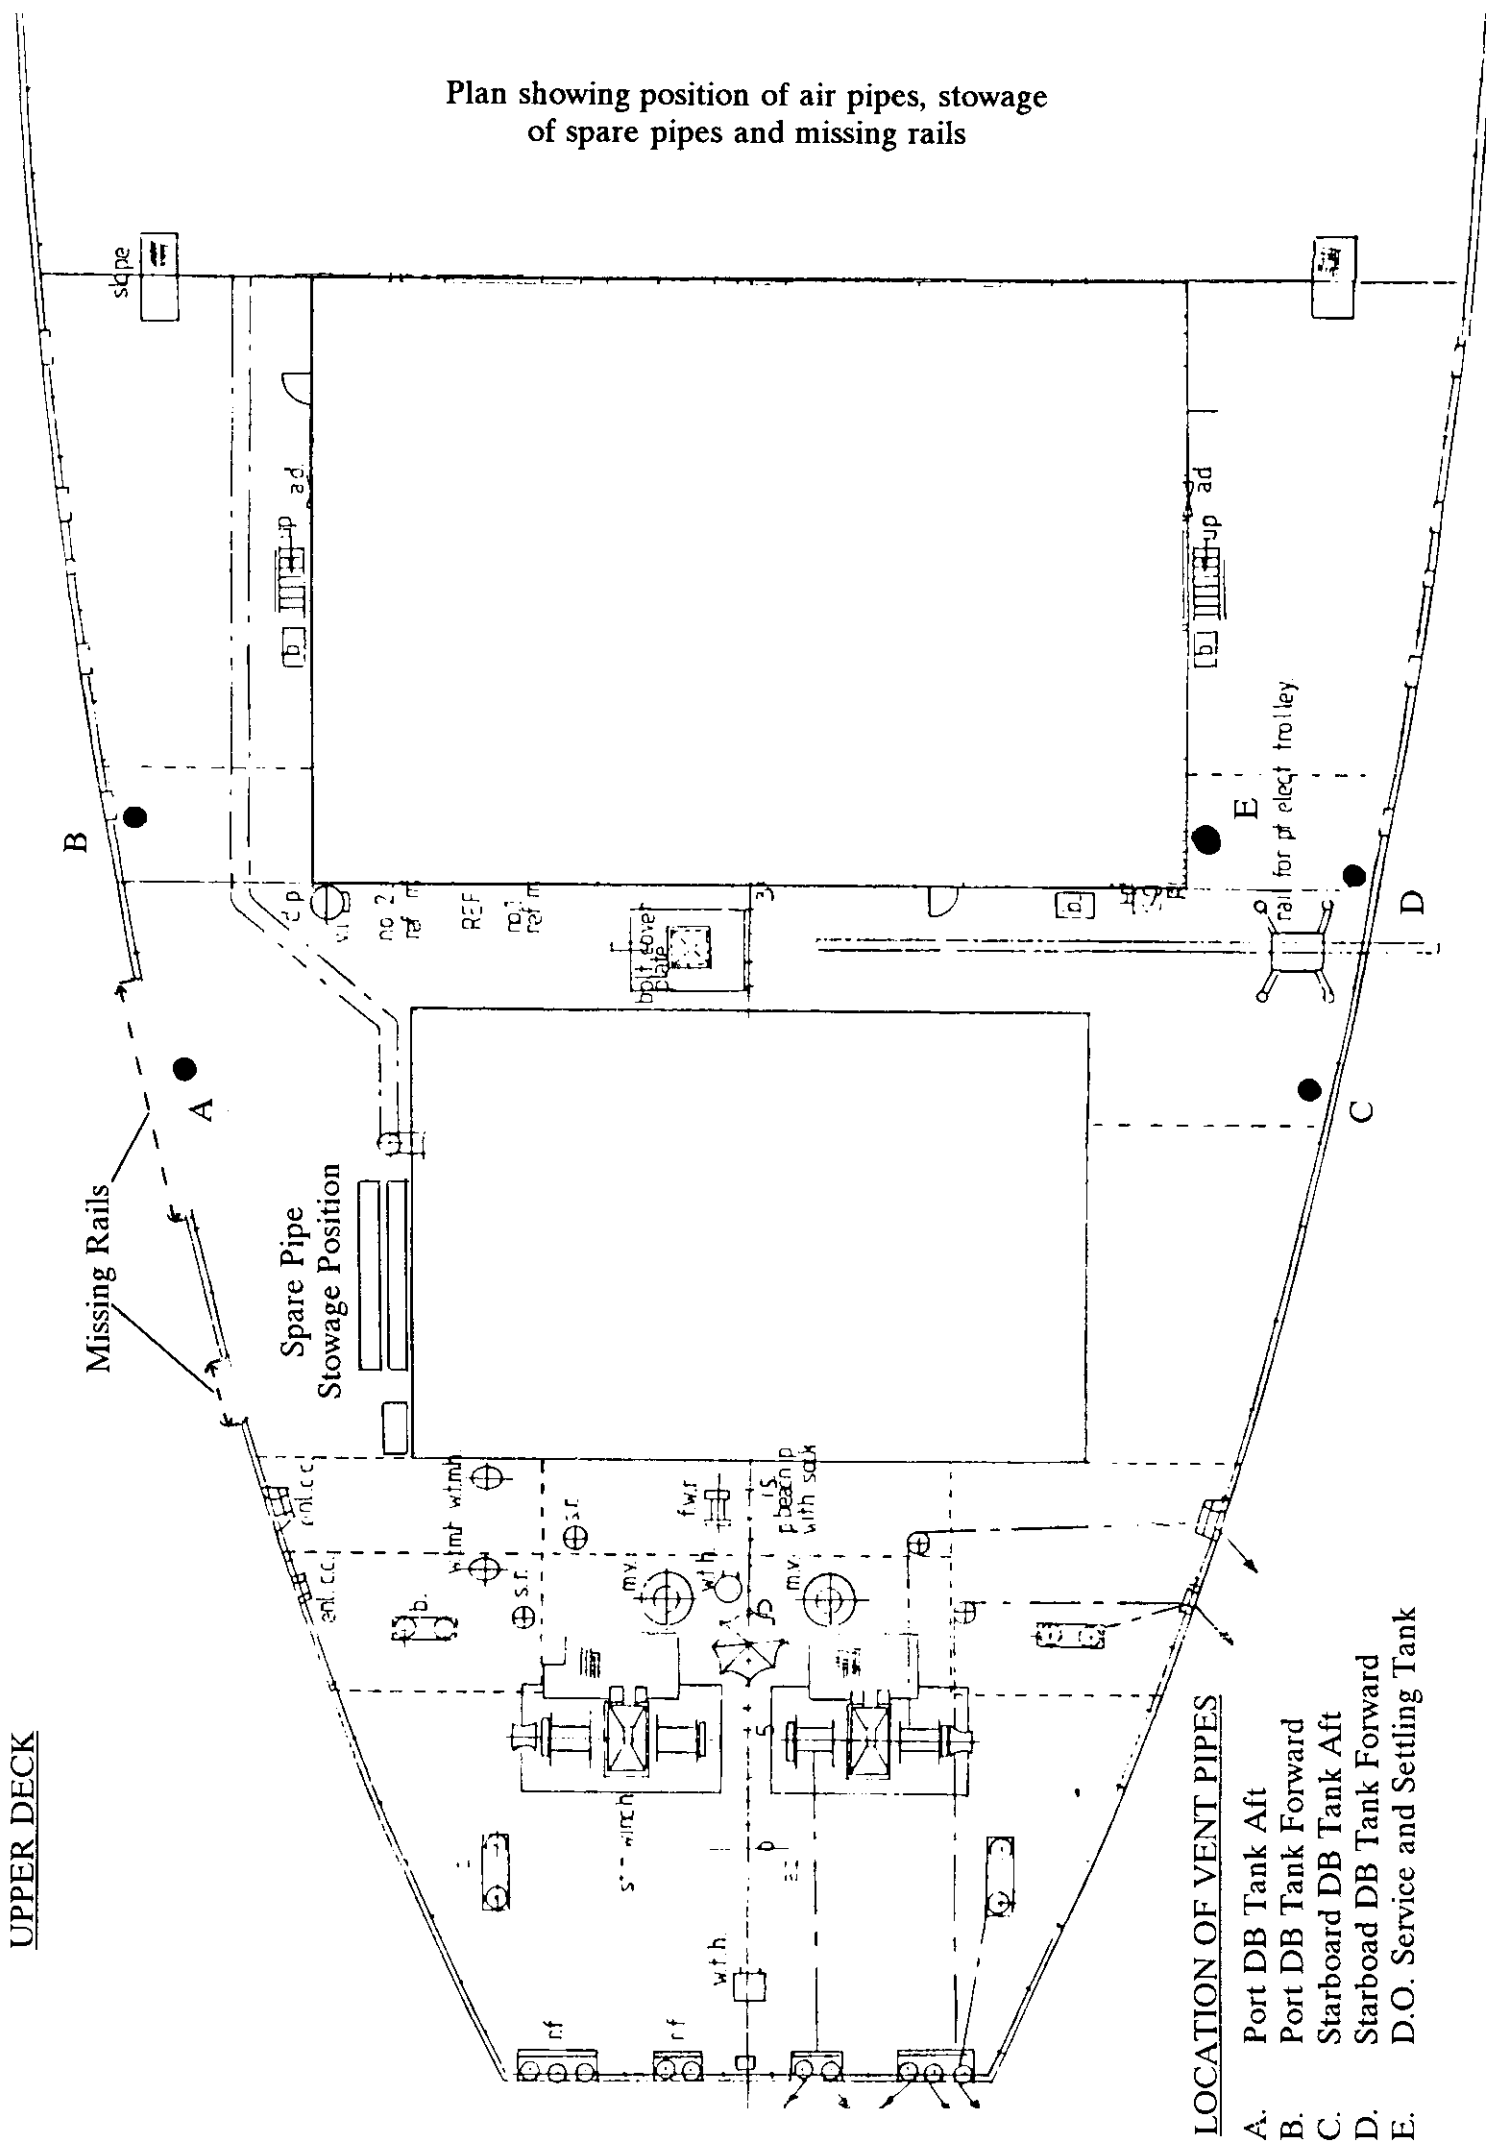
Plan showing position of air pipes, storage of spare pipes and missing rails

- A. Port DB Tank Aft
- B. Port DB Tank Forward
- C. Starboard DB Tank Aft
- D. Starboard DB Tank Forward
- E. D.O. Service and Settling Tank

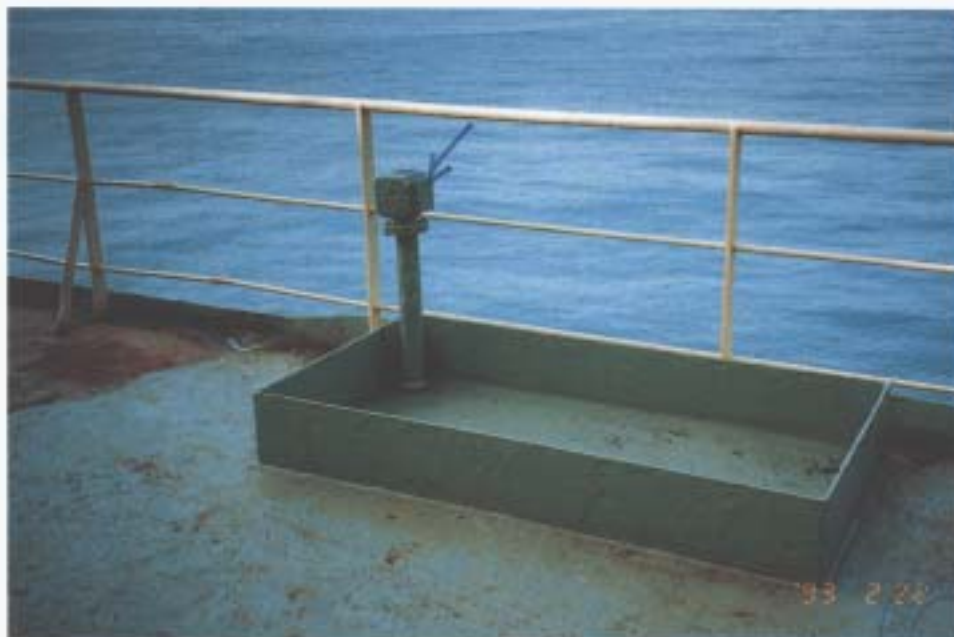
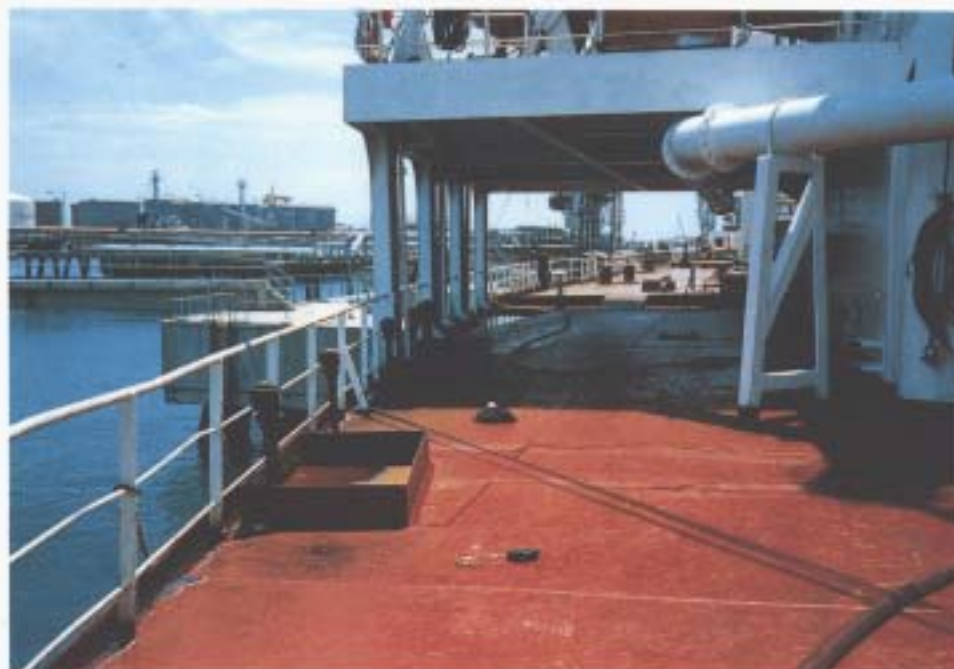
Port double bottom diesel oil tank, aft air pipe
(Photographs taken on sister ships)

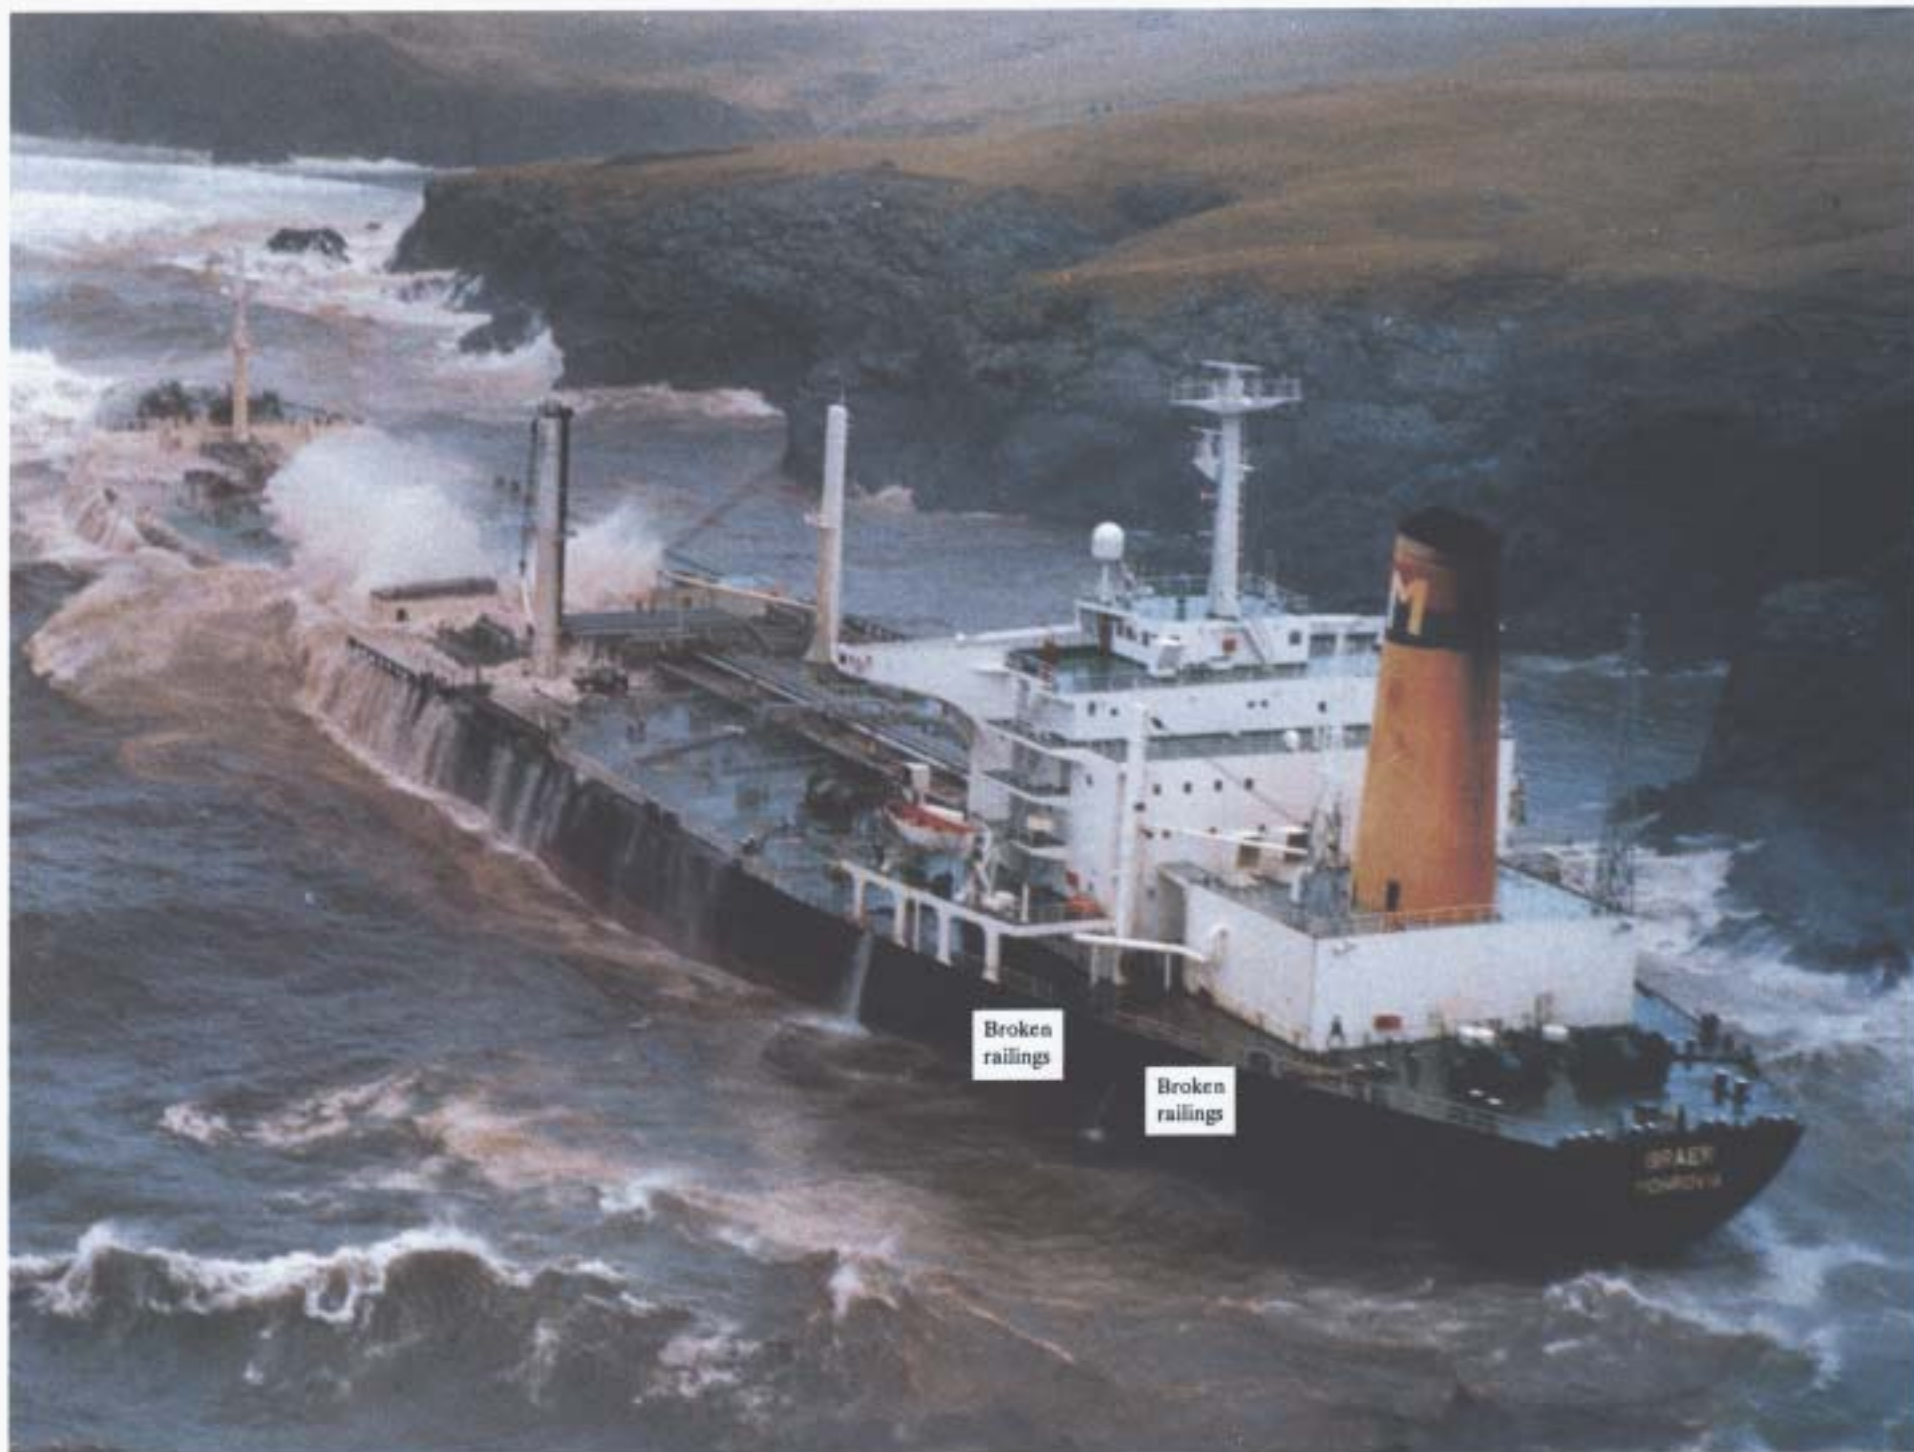
BRAER aground showing broken rails port side aft in way of air pipes

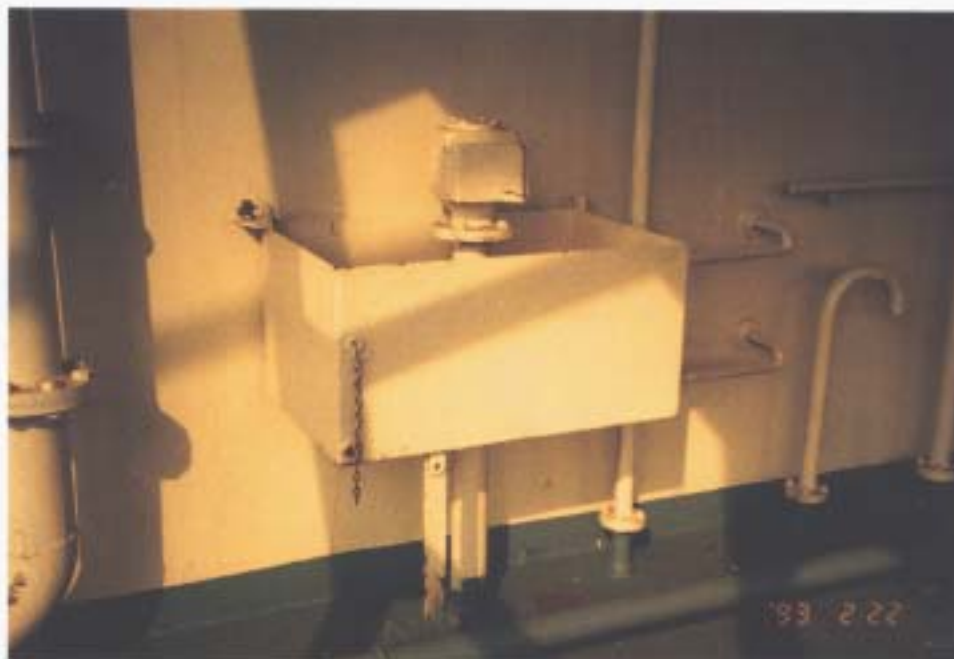
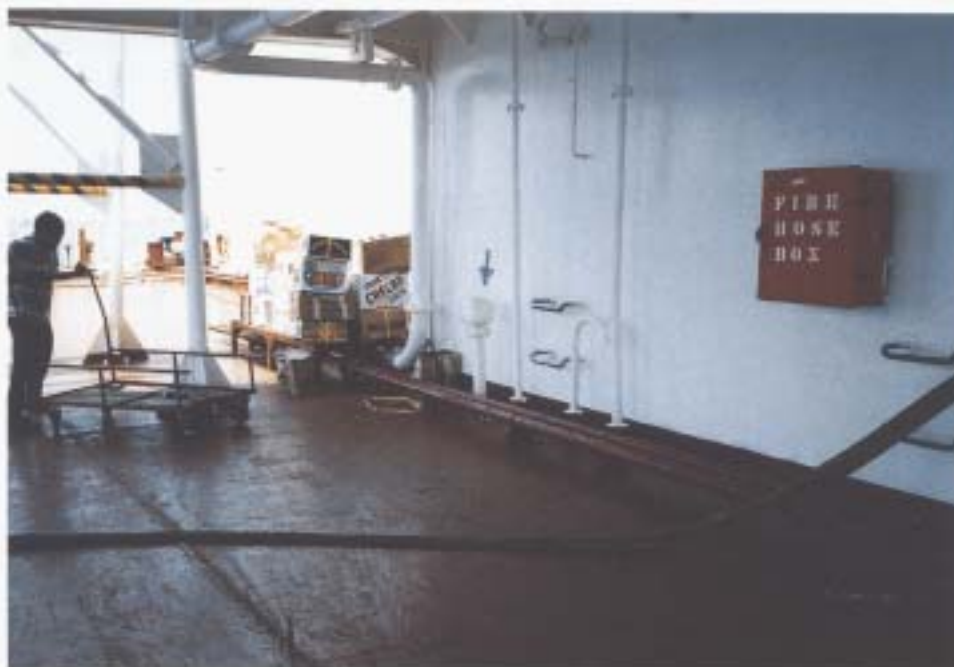
Common air pipe to diesel oil settling and service tanks, starboard side upper deck
(Photographs taken on two sister ships)
