Report of the Investigation  
into the Power Failure on

**CANBERRA**

off the Isle of Wight  
on 7 December 1994

Marine Accident Investigation Branch  
5/7 Brunswick Place  
SOUTHAMPTON  
SO15 2AN

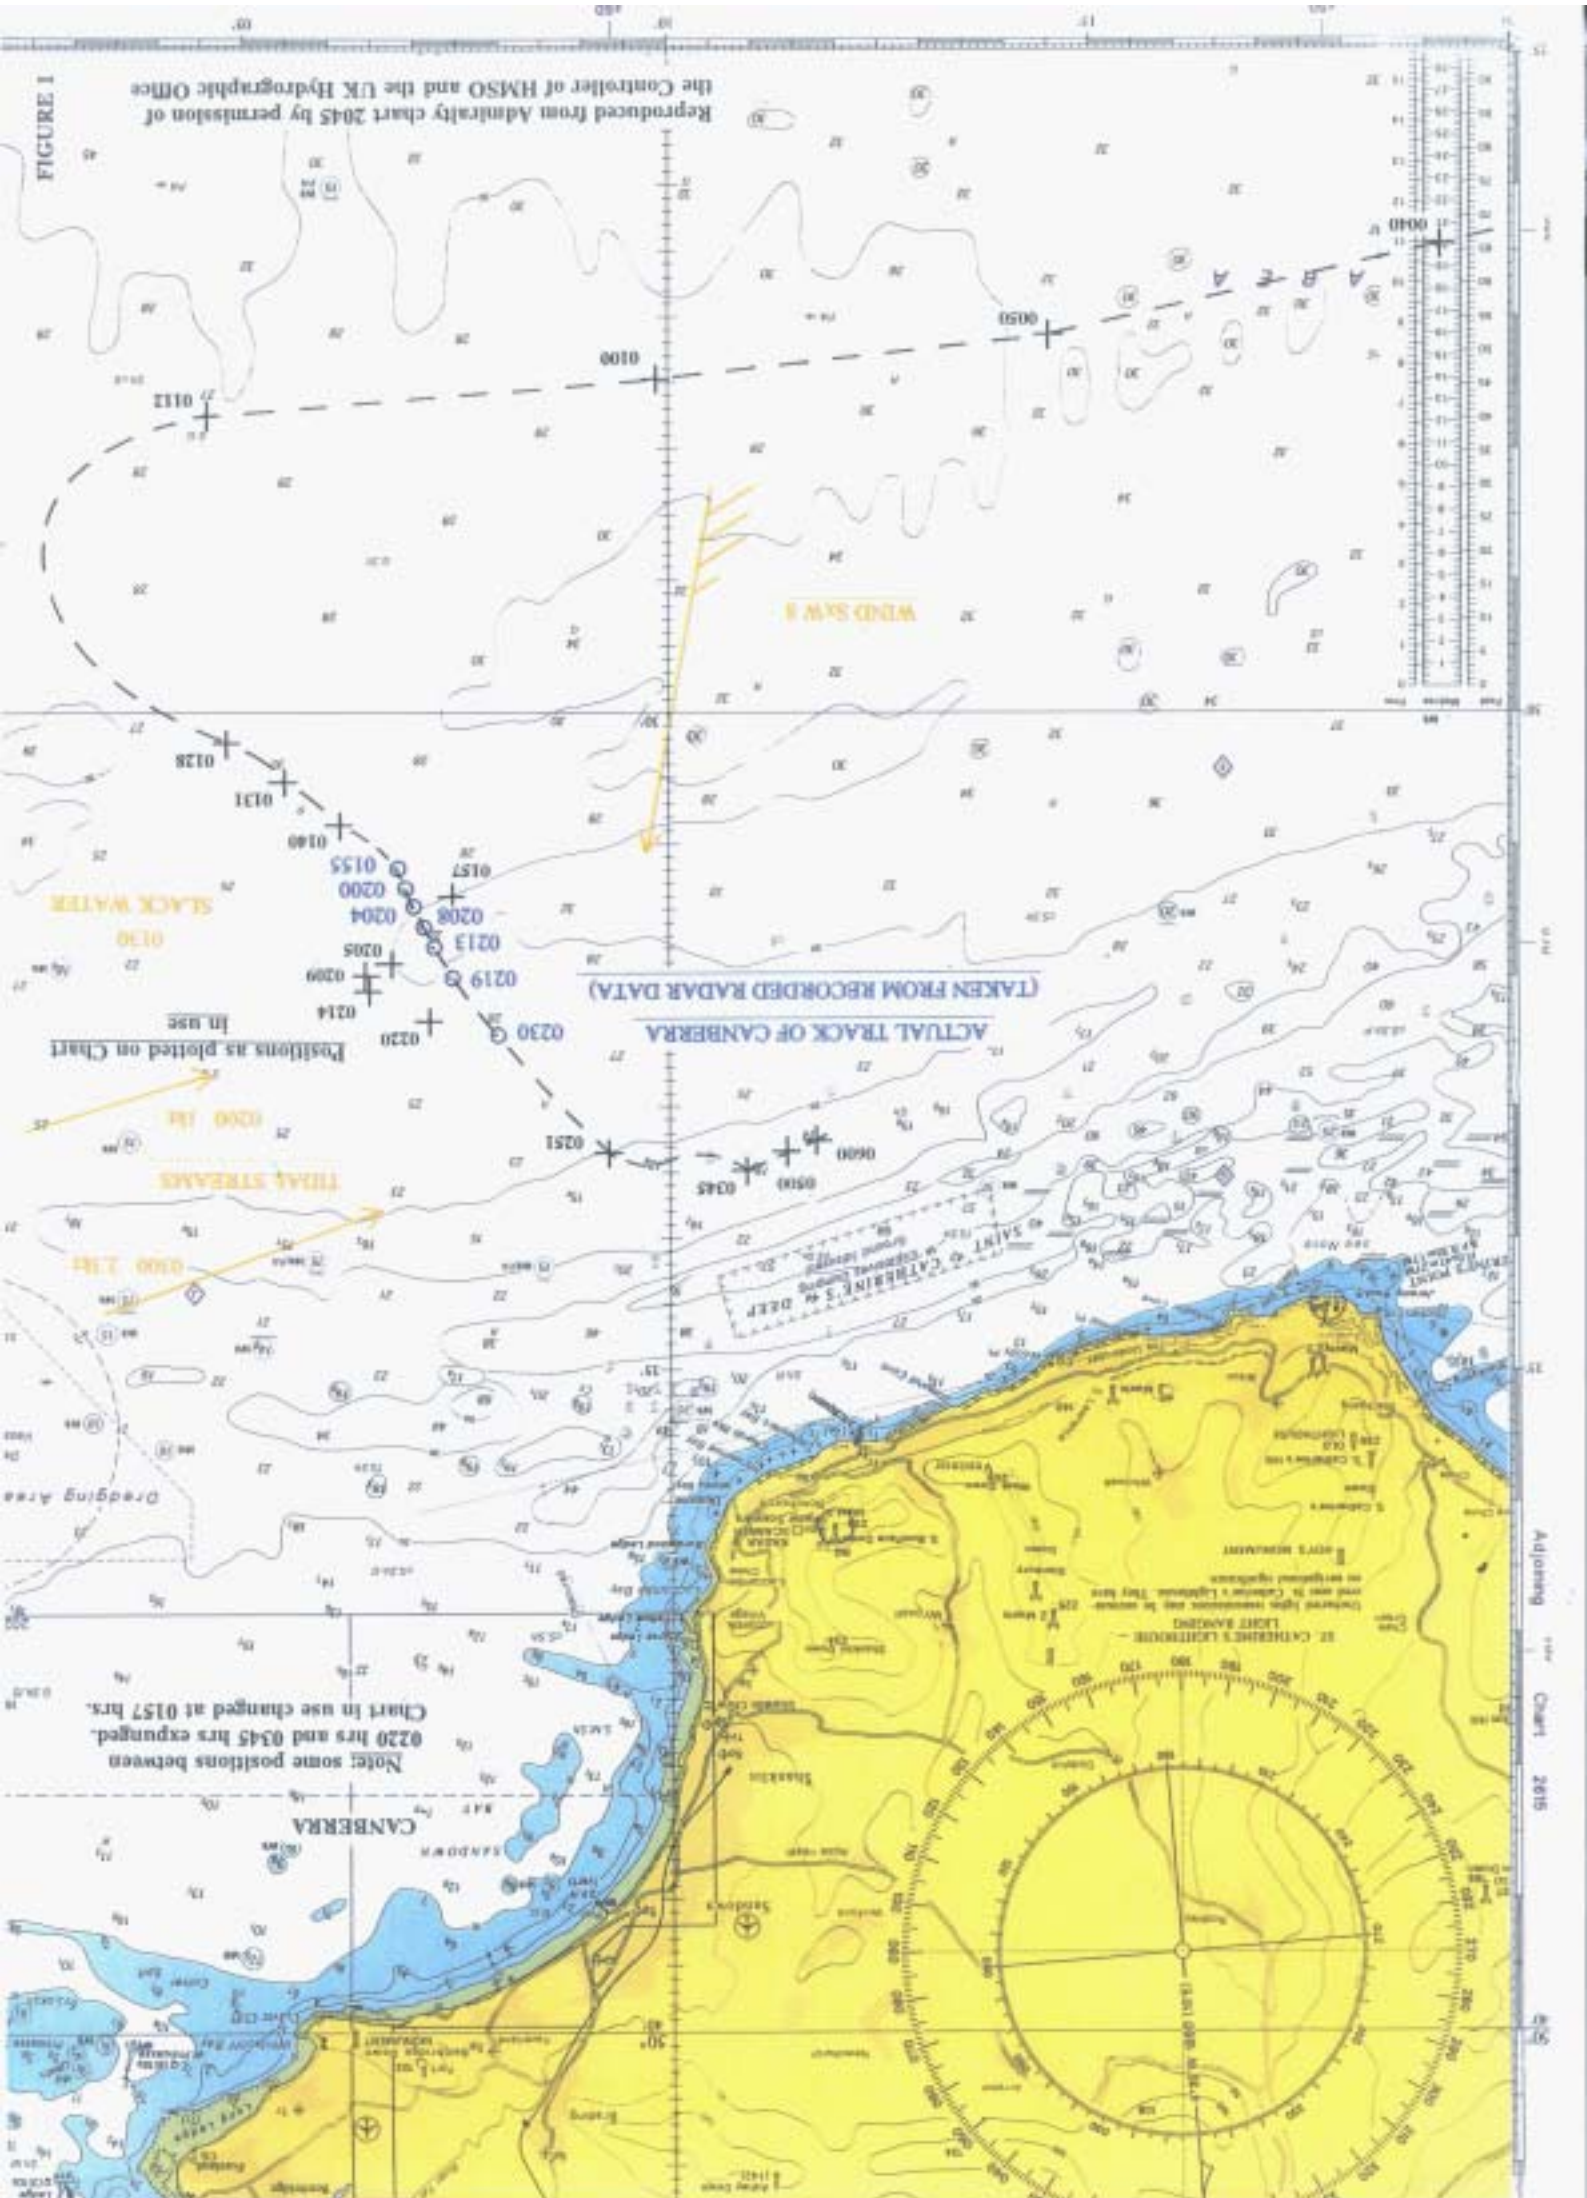
FIGURE 1

The chart was changed at 0157 hrs to the larger scale "Outer Approaches to the Solent" chart No BA 2045. There was an error in the first position, gained from two radar ranges, which was plotted on the new chart at 0157 hrs. Being the first position on the new chart it was used as the basis for subsequent charted drift direction and rate assessments during the next half an hour. These were consequently incorrect. The inaccuracy of the drift direction and rate assessment was further compounded by subsequent plotted positions at 0205 hrs, 0209 hrs and 0214 hrs also being in error (see Figure 1).
