Report on the Grounding of the British Ro-Ro Vessel

EARL GRANVILLE

off Cherbourg on 19 August 1989

May 1991

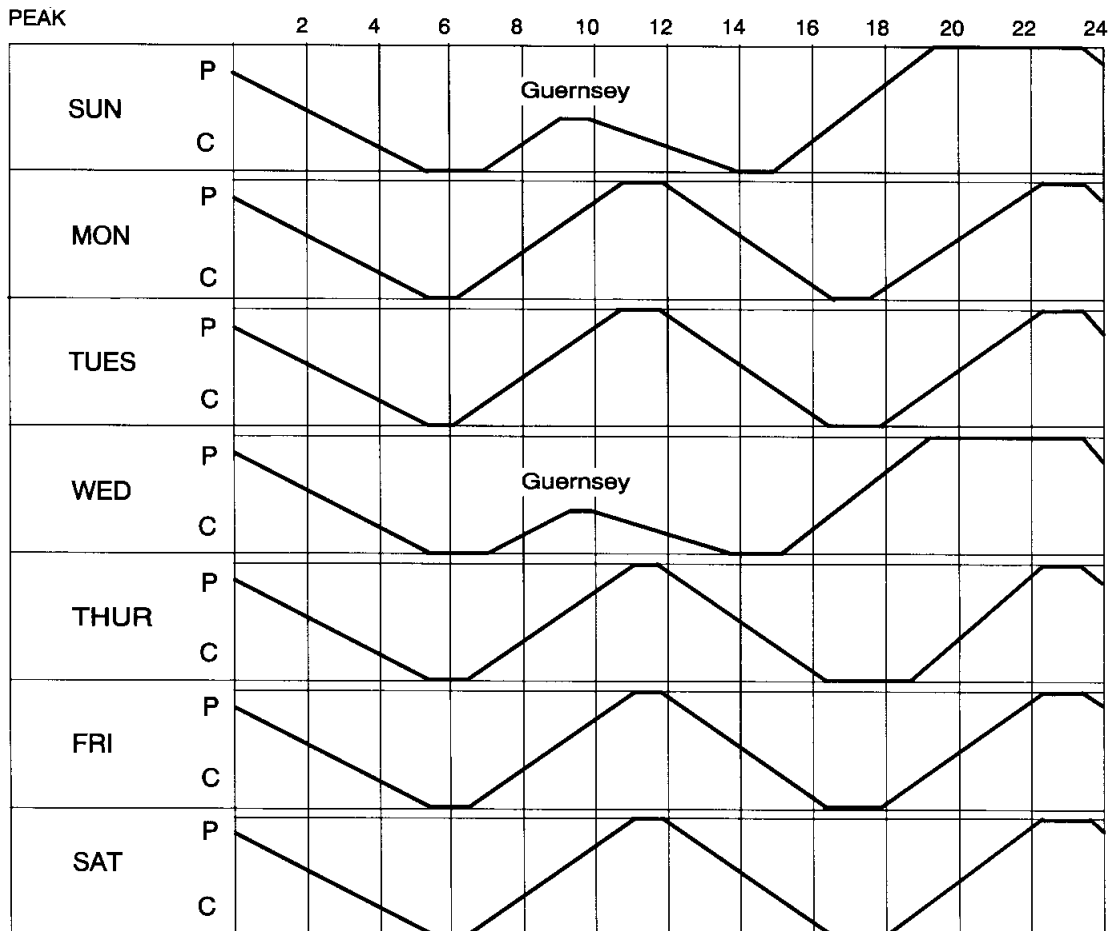
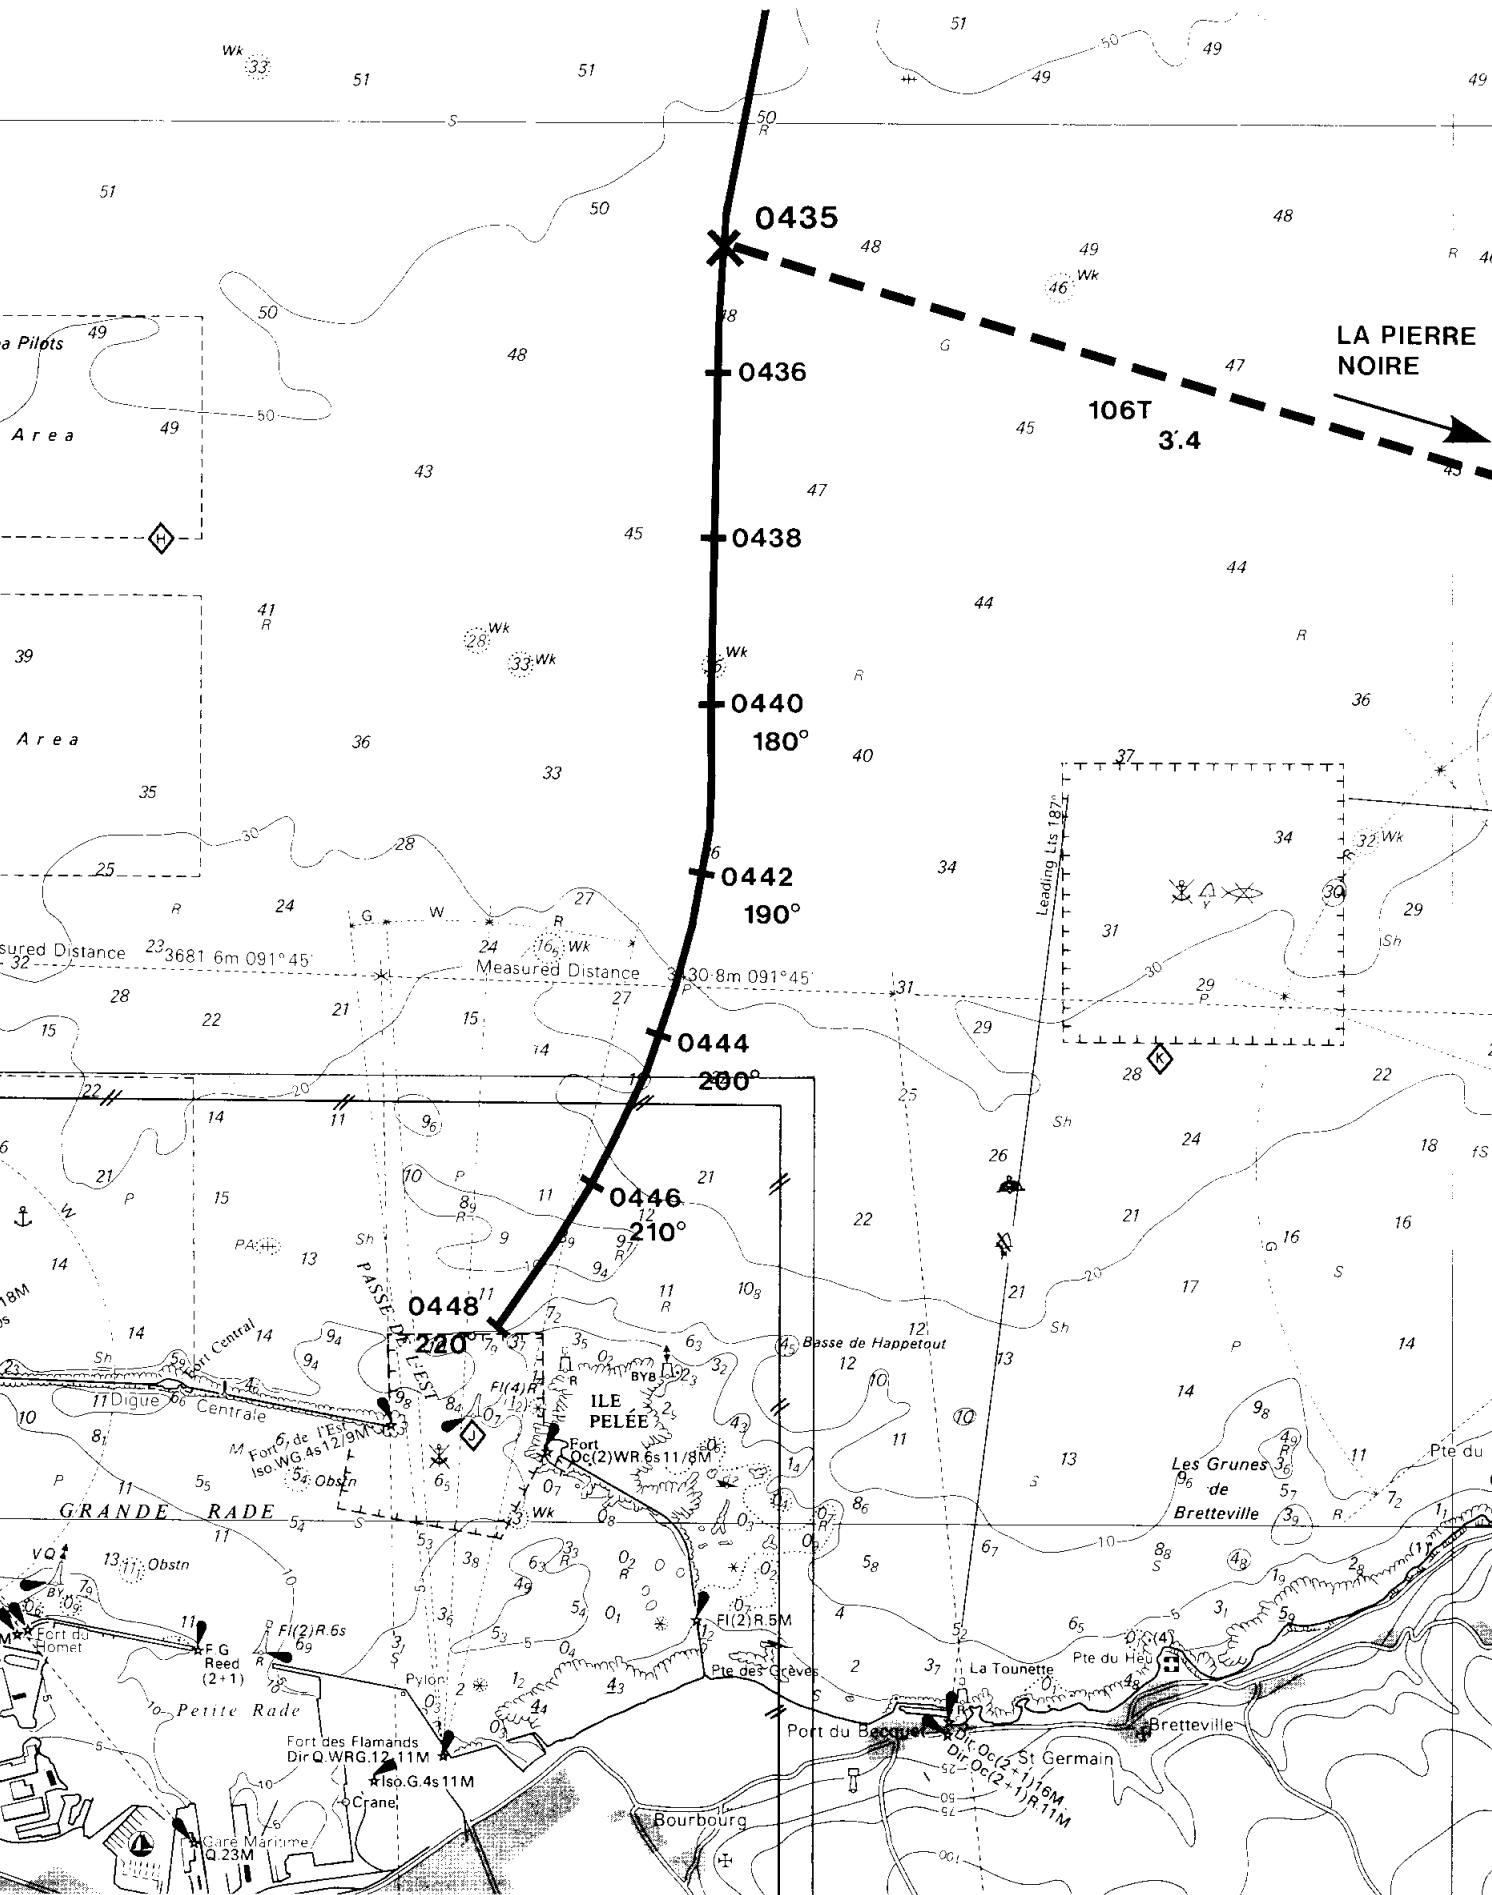
- 3.1.2 The chartlet at Figure 1 shows a re-construction of the track of the vessel prior to grounding. It is intended for illustration only and does not purport to show the exact track followed.

- 3.1.3 One point which is clearly demonstrated by the reconstruction, even allowing for some error in it, is that the approach was made outside the white sector of Fort des Flamands light, which leads clear of all dangers.

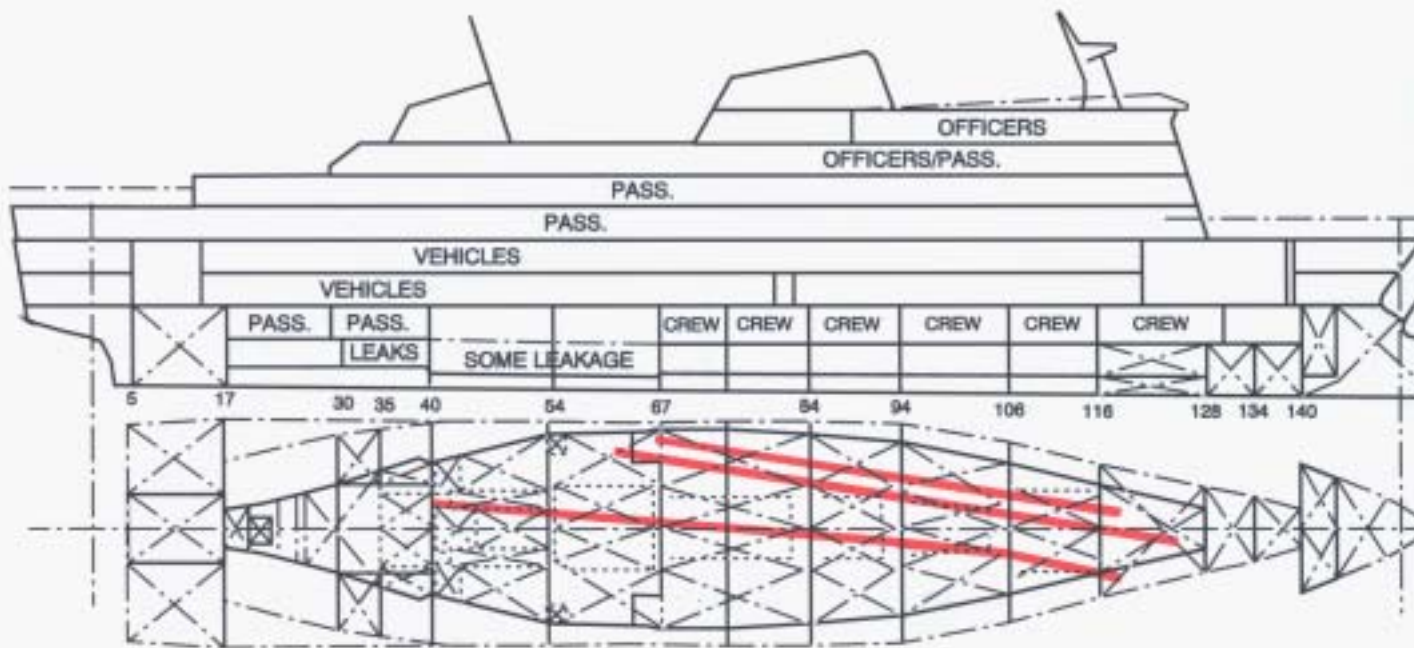
Figure 2A: APPROXIMATE LINES OF GROOVING IN BOTTOM

- 2.13 The vessel was damaged in such a way that it appeared as if 3 giant talons had been dragged across the bottom, as indicated in Figure 2a. It appears this was caused by 3 rocks projecting from the sea bed.

The rock that ran along the keel caused the keel to be set up 10cm or more over much of the length resulting in very extensive damage to frames and floors within the double bottoms. Flooding within the double bottom was extensive and water also entered some machinery spaces and the carpenter's store; see Section 3.4 and Figure 2b.

keel was not revealed until late on Monday 21 August. A thorough inspection showed extensive damage to the keel extending from Frame 138 to Frame 16. Longitudinal splits occurred over a length of 1.5m from Frame 113-111 and over a length of 14.3m between Frame 68 to 46 which is in way of the machinery spaces.

On average the keel area was set up at least 100mm.

On the port shell extensive damage occurred to A, B, C and D strakes within the area Frame 115 to Frame 30. Severe splits and heavy indentation (over 100mm) occurred mainly to B strake from Frame 107 to Frame 85.

On the starboard shell only indentation occurred, mainly in an area of A strake from Frame 138 to Frame 42.

- 3.4.5 The vessel was inspected in Cherbourg by Surveyors from the Department of Transport who identified the repairs which would be required before the vessel re-entered service. These have been carried out.

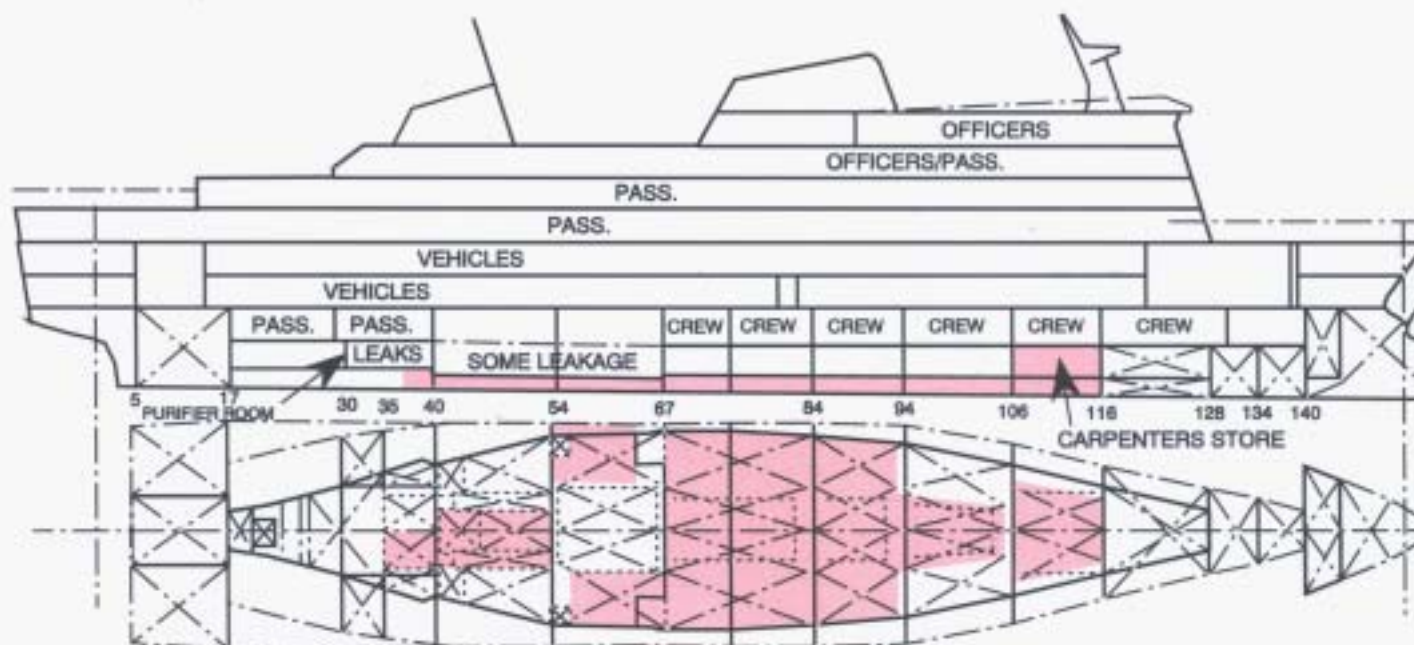
Figure 2B: DB₈ REPORTED LEAKING IN RED

- 3.4.1 Figure 2b indicates the extent of the flooding and leakage. It can be seen that many double bottom tanks were laid open, and water in substantial quantity also entered the stabilizer room, the tunnel space and the carpenter's store. There was no flooding of accommodation, but some water, and oil from ruptured tanks, came on to the car deck through vent pipes. The Chief Engineer Officer realised that it was unlikely that his pumps could cope with this leakage and advised the Master that assistance would be required from the Fire Service. At 0635 hrs as it was not clear that the vessel would remain afloat, the harbour authorities, not wishing the linkspan to be blocked, decided to move the vessel by tugs to the Quai du France where access was easier for salvage pumps and divers and also to place a boom round the vessel to contain the extensive oil spillage that was taking place.
