MAIB
MARINE ACCIDENT INVESTIGATION BRANCH

'HAVKONG' INCIDENT

**A joint report of the 'Havkong'
incident at Braefoot Bay Terminal
by Aberdour, Fife on
23 January 1993**

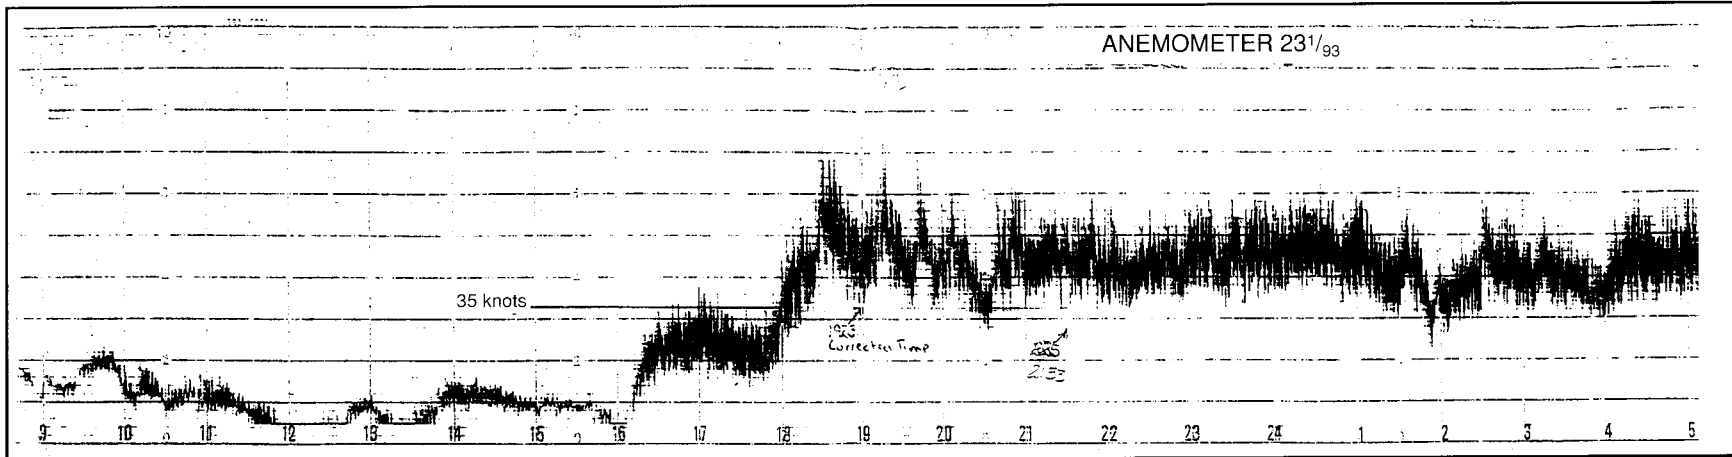
Extract from pen chart recording of wind speed

176 The records from the remote station on Inchcolm Island which represent the conditions that evening show that the wind varied between a minimum of 25 knots and a maximum of 37 knots in the hour between 1720 h and 1820 h. In that hour Inchcolm recorded a peak gust of 47 knots. This was broadly in line with the forecast.

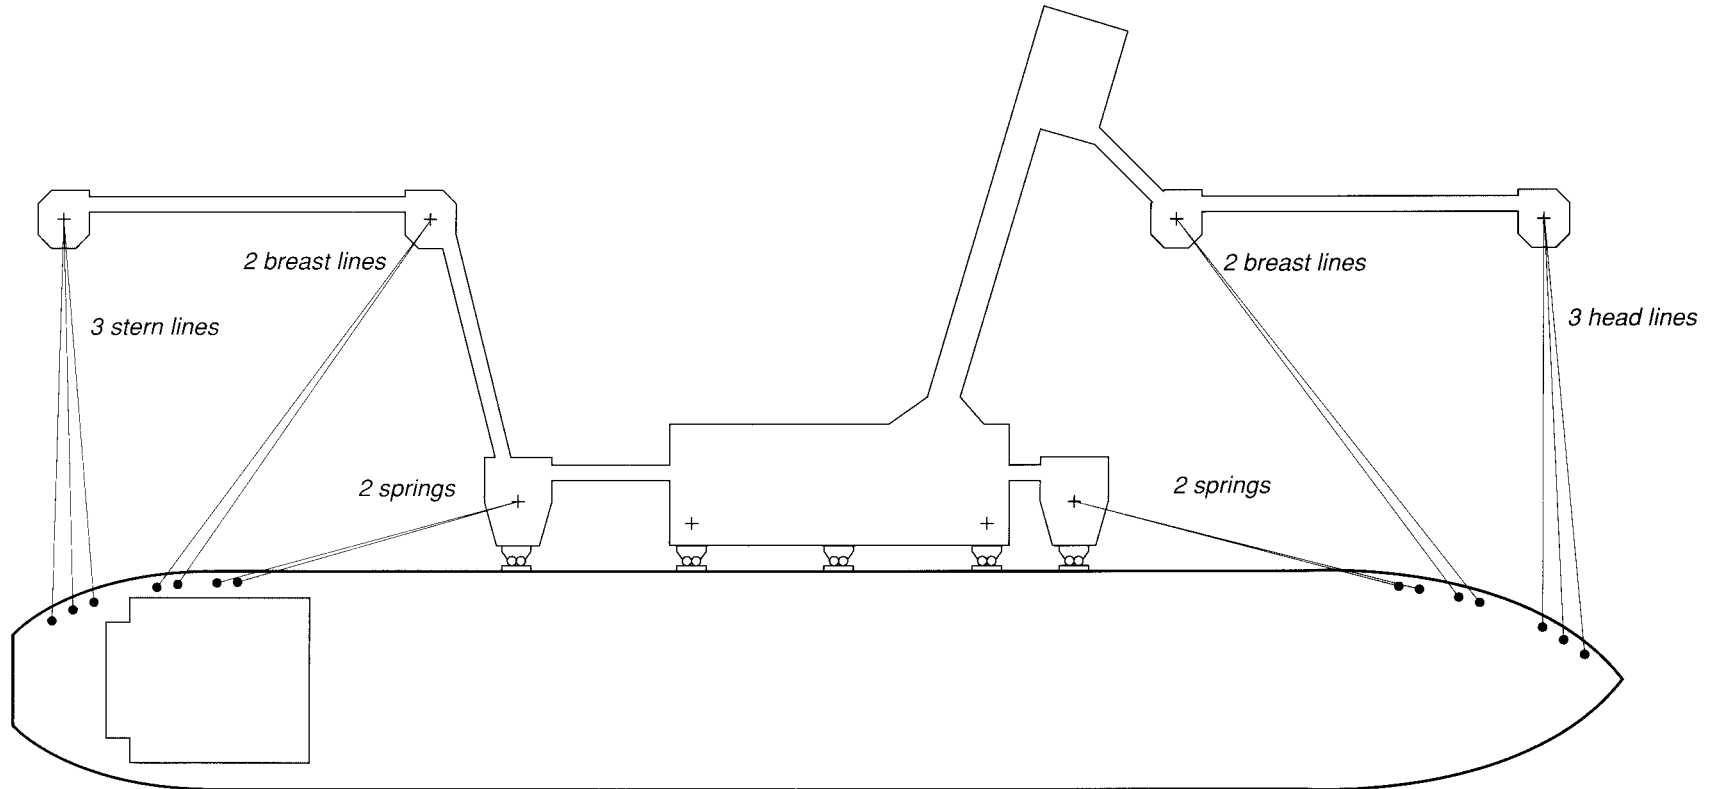
APPENDIX 4
Typical mooring arrangement at Shell jetty for ships of Havkong's size

- 139 The recommended pattern shown diagrammatically in the 'Jetty Regulations' booklet (see Appendix 4) for the Braefoot Bay west jetty for a 60 000 cubic metre ship indicates a variation on the OCIMF idealised pattern but one that still follows the basic guidelines.

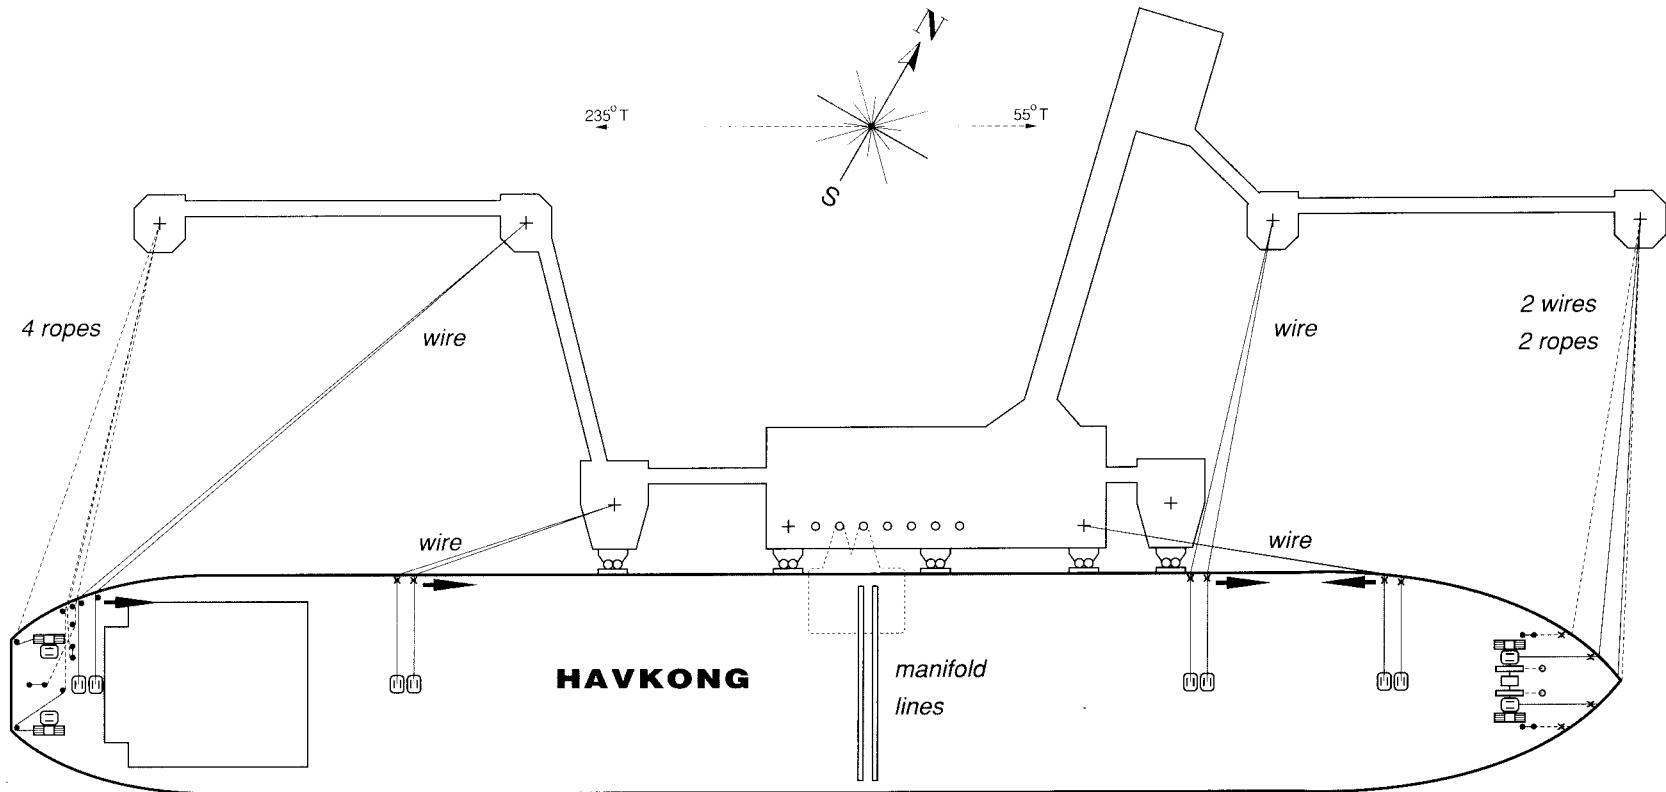
Final moored arrangement for Havkong

141 An examination of the actual pattern achieved by Havkong, however, shows that it differs from the recommended pattern in several fundamental ways although still complying with the actual wire numbers required:

Ideal/recommended	Havkong
Stern lines lead perpendicular or slightly aft.	Stern lines led forward.
Forward breast lines lead partly aft.	Forward breast lines led slightly forward.
Aft breast lines lead slightly forward.	Aft breast lines led significantly forward.

142 These differences may be explained by the configuration of Havkong. They could have been overcome, but only by introducing further problems. For example, the forward breast lines and springs could have been reversed, giving a better angle for the breast lines. This arrangement would, however, have resulted in very short springs with only the rope tails external to the ship which would, in turn, have brought problems with changes in tide and loading conditions on the ship. It is recommended practice (OCIMF) that all lines are approximately the same length. A reversal of the forward springs and breast lines would have defeated this recommendation.

- 146 It is considered that the personnel both ashore and on Havkong responsible for assessing the mooring arrangements at the jetty failed to appreciate the effect of minor variations in the mooring pattern geometry and concentrated on line numbers instead, thereby allowing Havkong to berth using a pattern which was deficient in the amount of restraint it provided in the forwards direction.
