Report of the Chief Inspector of Marine Accidents
into the failure of the Lifeboat
Launching Equipment on mv NORSEA
on 5 February 1992
With the loss of 2 lives

Marine Accident Investigation Branch
5/7 Brunswick Place
SOUTHAMPTON
Hants SO1 2AN

1. SUMMARY

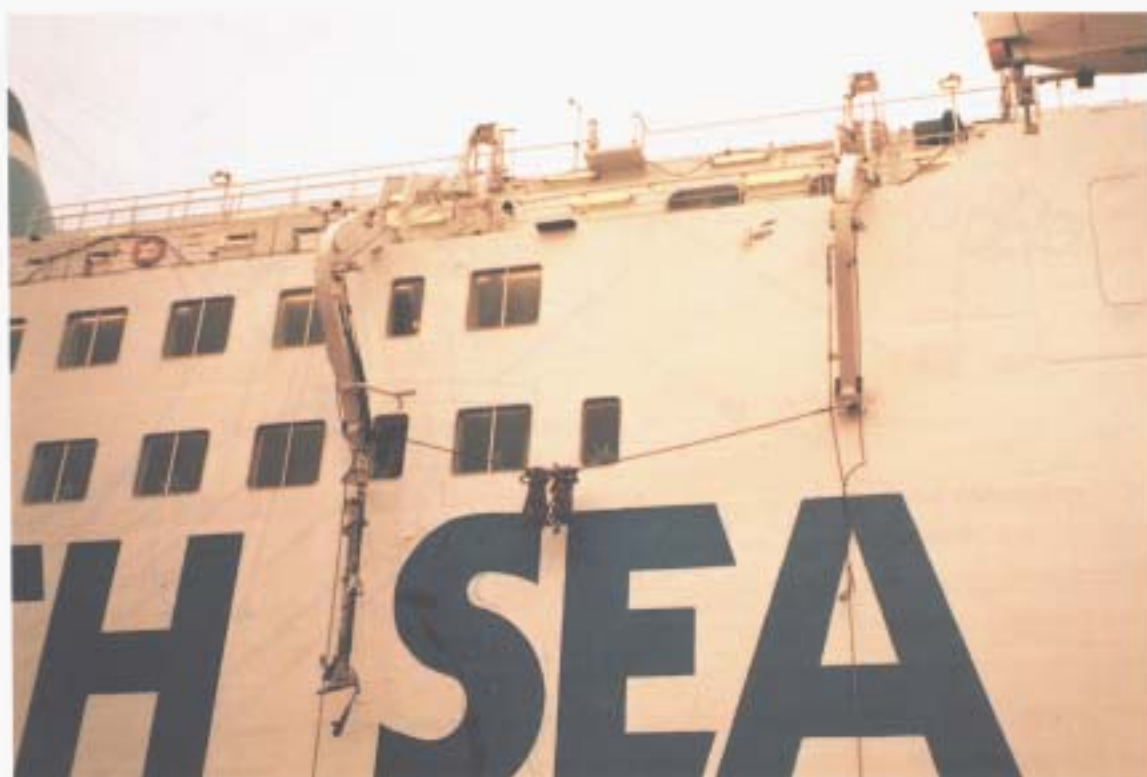
Failed Davit Arms suspended from their respective Lower Rollers. The Aft Arm is on the left of the picture

The upper rollers of both forward and aft arms of the davits were free of their trackways. The lower rollers were still in place on their arms and within their tracks. The head of each arm was resting against the shell plating of the vessel, the horns having damaged the plating, (see figure 4).

Damage to the aft trackway comprised splay in both channels and distortion of the track flanges was symmetrical indicating that the trackway failed in this area due to the top roller of the aft davit arm pushing out in a normal direction to the plane of the trackway flanges.

The local damage to the forward trackway flanges showing significant splay in the aft direction in way of the position where the upper rollers would be with the davit arm swung out matched the effect of the forward davit arm twisting out in the aft direction.

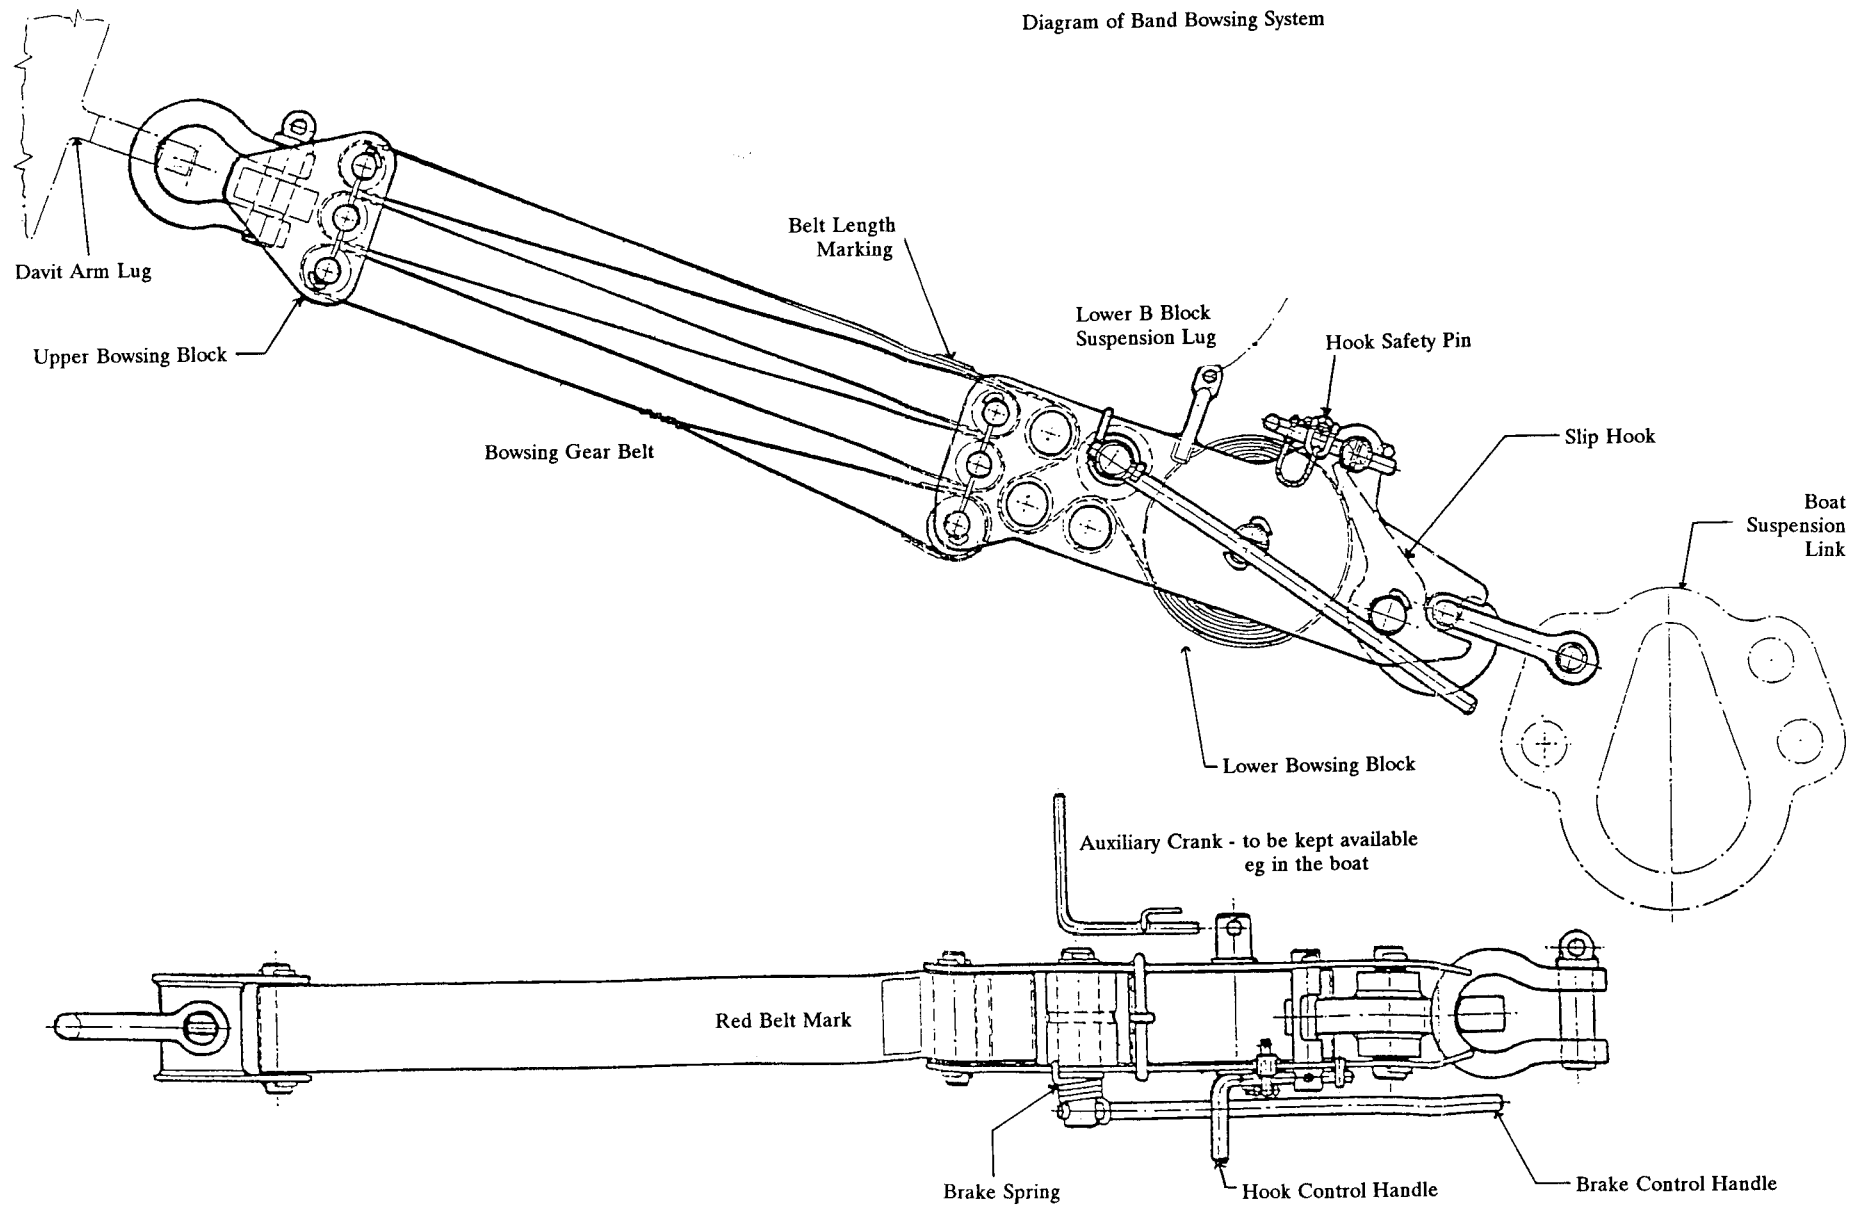
Diagram of Band Bowsing System

The BBS avoids the cumbersome change over to the bowsing tackle. Unlike its tricing pendant counterpart, it is designed to support the working load of the lifeboat (weight of the lifeboat and equipment plus the weight of the total number of persons). By operating the BBS brake lever from the lifeboat hatch position the band is allowed to pay out. The lifeboat is moved outwards from the ship's side to be supported fully by the fall wire in readiness to be lowered. Before lowering, the BBS is disconnected from the lower block, (see figure 6).

The BBS is designed to apply bowing loads to the lower block plates of the lifeboat, with a line of action at a substantial angle to the horizontal plane. Thus, whenever the BBS is in operation it must, by design, support a proportion of the lifeboat's weight. Should the BBS load be released at one end when the lifeboat is in the bowed-in condition, then again from static considerations only, the load in the falls at the end released becomes greater than at the end which remains bowed-in. Any potential movement of the fall wire induced by this difference of load will be towards the davit arm at which the BBS has been released.

The design of the BBS like that used on NORSEA needs to be reviewed. The locking of the BBS and control of paying out of the band must be assured at all times. Specification of the slipping load is incomplete and could lead to potentially unsafe operating conditions.

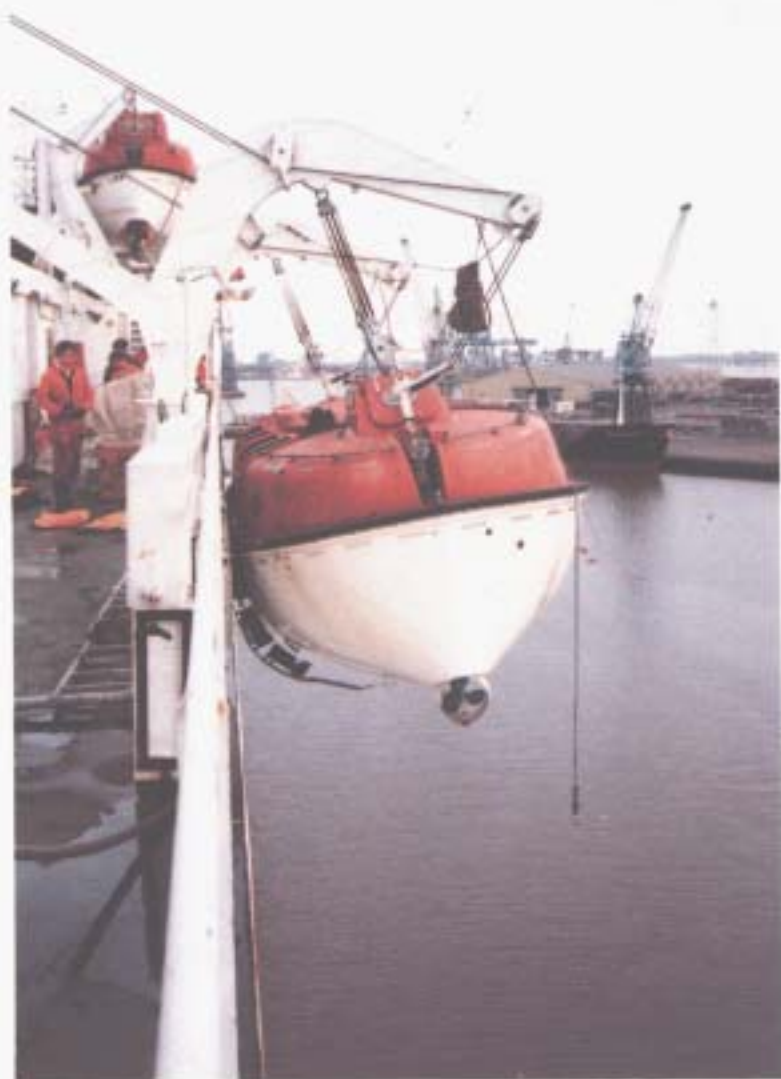
Loaded Lifeboat suspended BBS
