MARINE SALVAGE

SEA EMPRESS
General Arrangement and Tank Layout

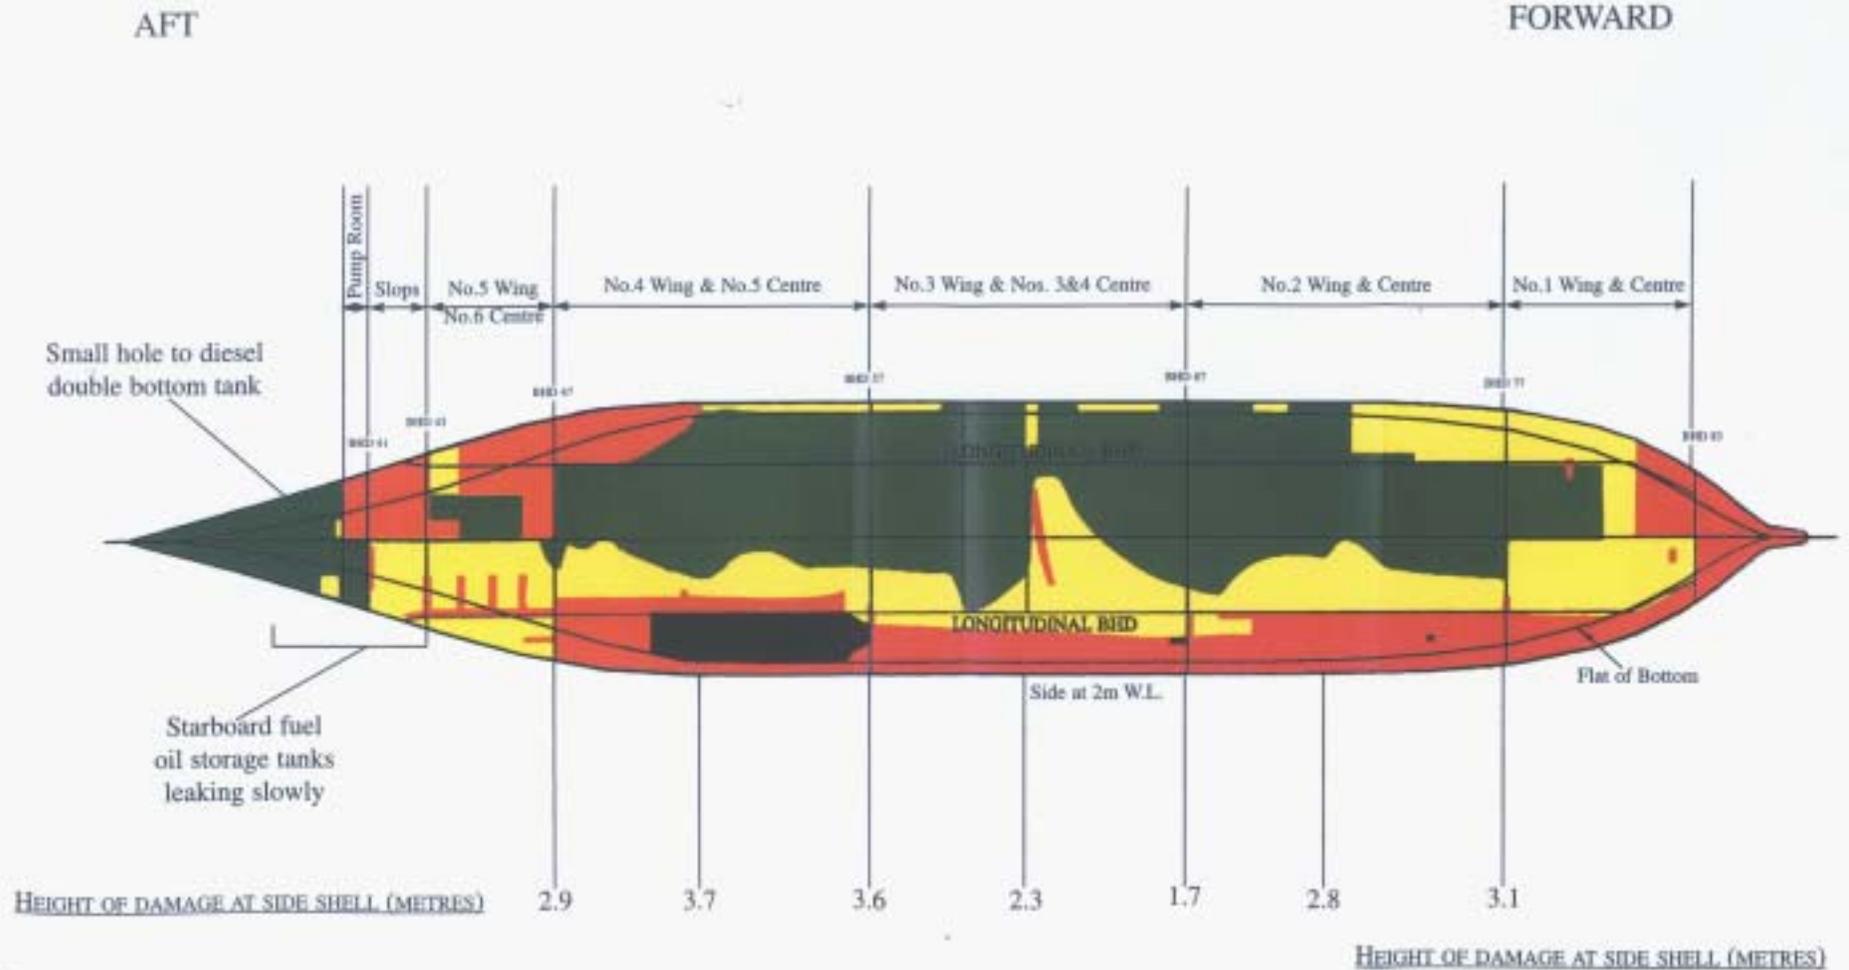
- D.1.7 The Master kept Acomarit fully advised of the situation at regular intervals. By 2315 hrs he was able to fax them an initial condition report indicating that Nos 1, 2, 3, and 4 Starboard tanks, together with No 6 Centre tank, were damaged. Also that the status of Nos 1, 2, 3, 4, and 5 Centre tanks could not be determined. They were also advised that the list was 10° to starboard and the bottom of the pump room was damaged on the starboard side and flooding. Although the

AN ESTIMATION OF THE EXTENT OF THE INITIAL DAMAGE TO SEA EMPRESS

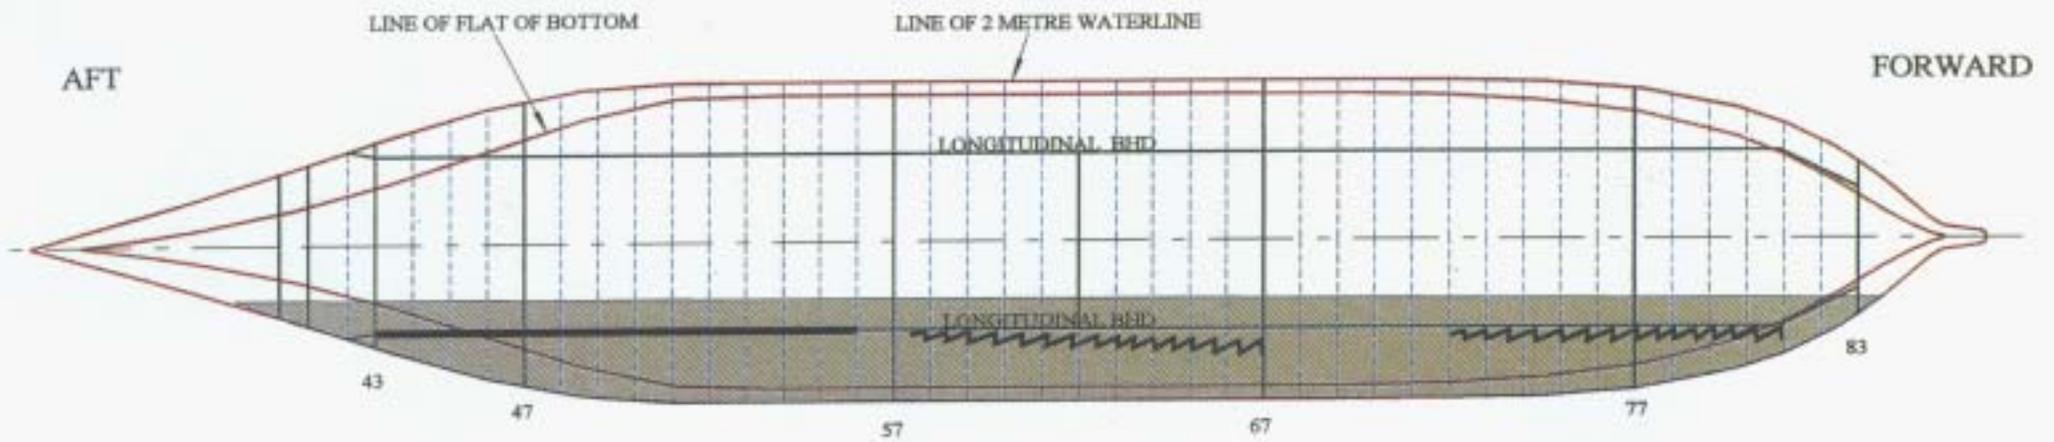
Area Over Which Longitudinal Scratching And Damage Is Discernable

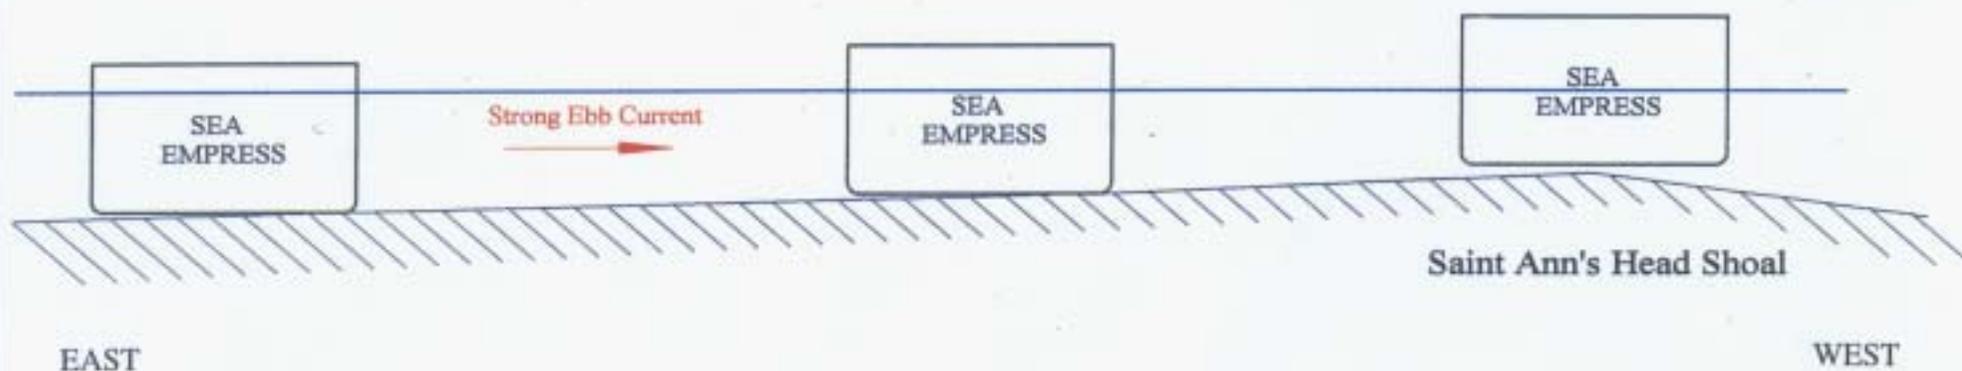
AN ILLUSTRATION OF THE FACTORS INVOLVED IN THE FAILED
REFLOATING ATTEMPT OF TUESDAY 20 FEBRUARY AND THE SUCCESSFUL
REFLOATING ATTEMPT ON WEDNESDAY 21 FEBRUARY

Tuesday 20/02 - During the failed re-floating the vessel is held against the shoal by the strong ebb current and carried into shallower water, finally grounding with a mean draught of about 16.6 metres. There was insufficient tug power available to pull her away from the shoal against the ebb current.

Wednesday 21/02 - The vessel's mean draught, at about 12 metres, has been reduced to such an extent that she now floats clear over the shoal and can be turned by the tugs so that she is end on to the ebb current, greatly reducing the current force and allowing the tugs to pull her away.

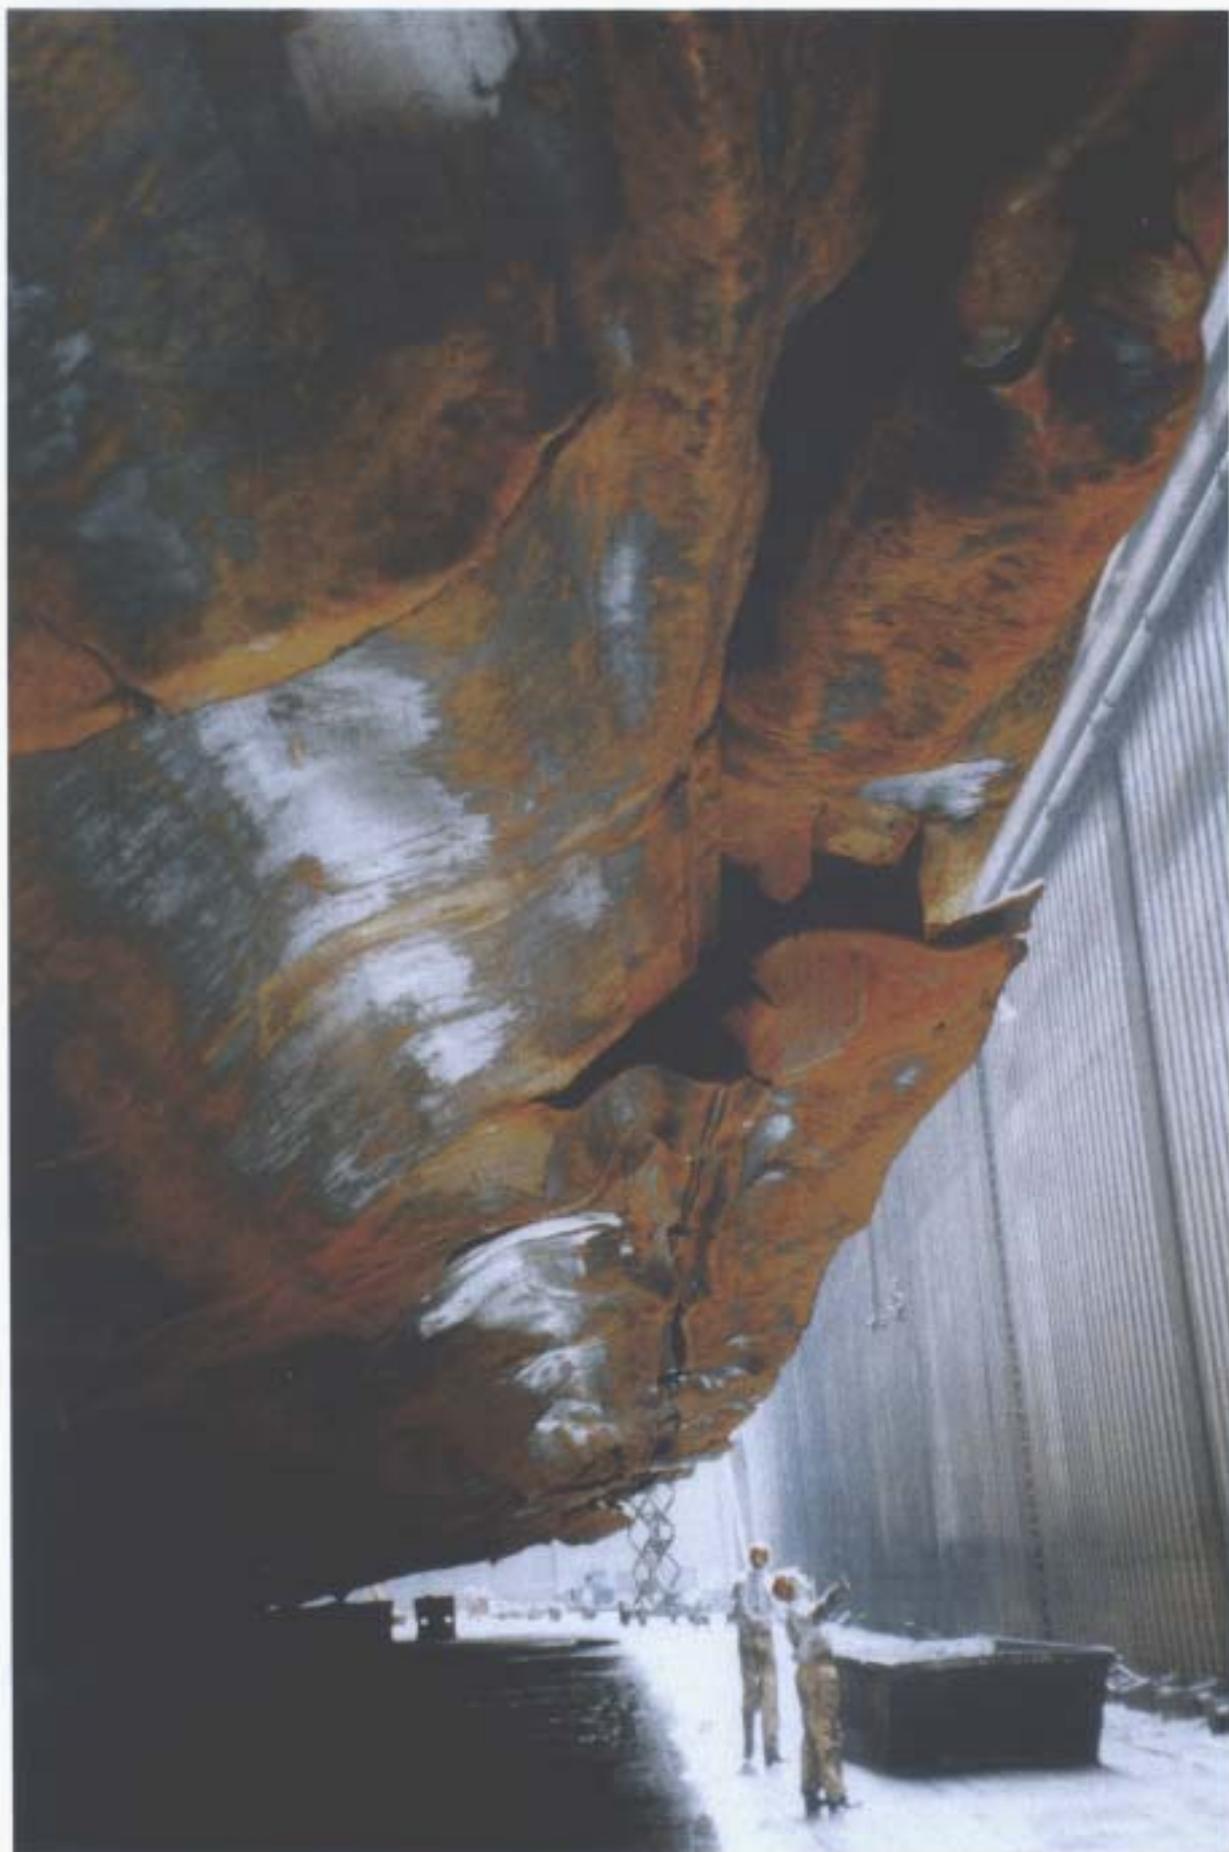
General View of Bottom Damage to SEA EMPRESS

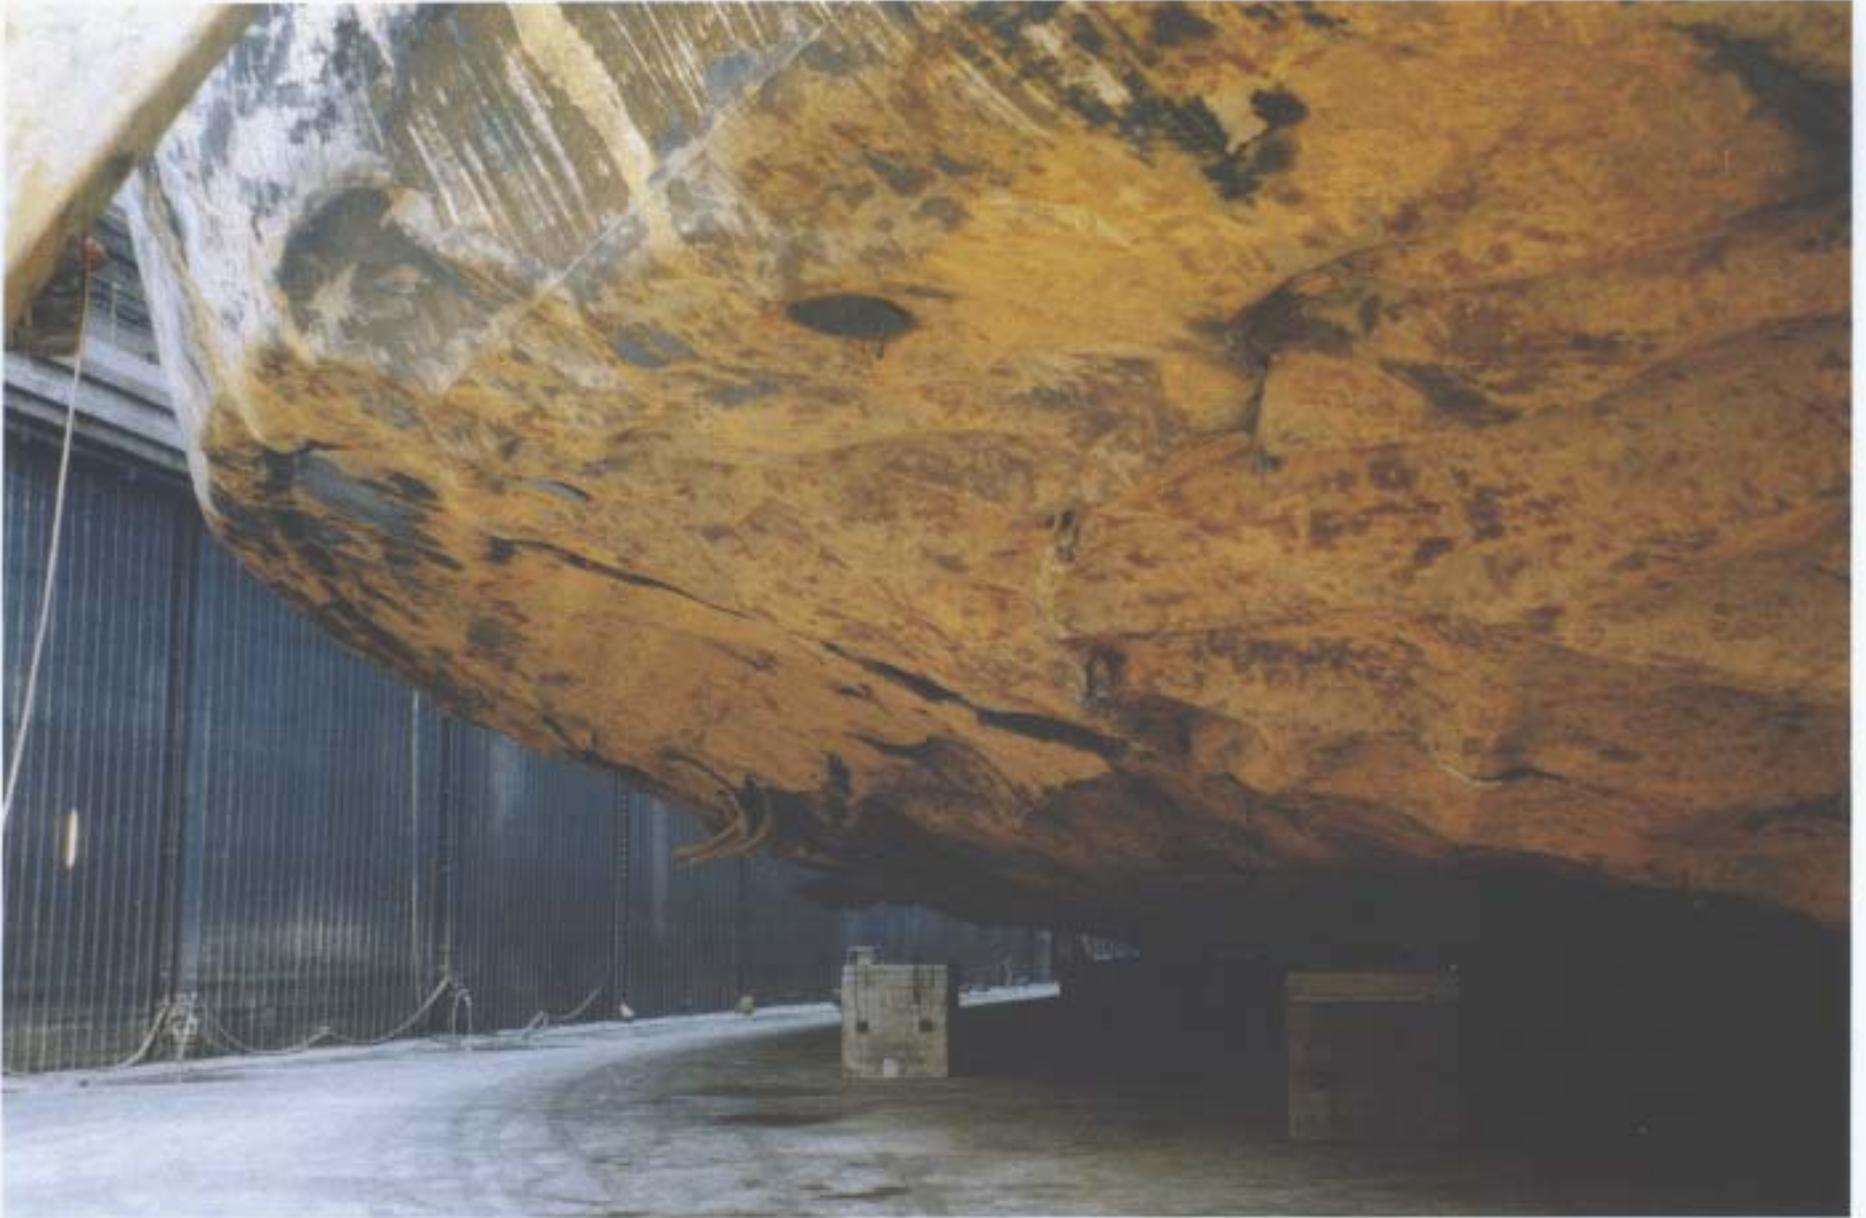
General View of Bottom Damage to SEA EMPRESS

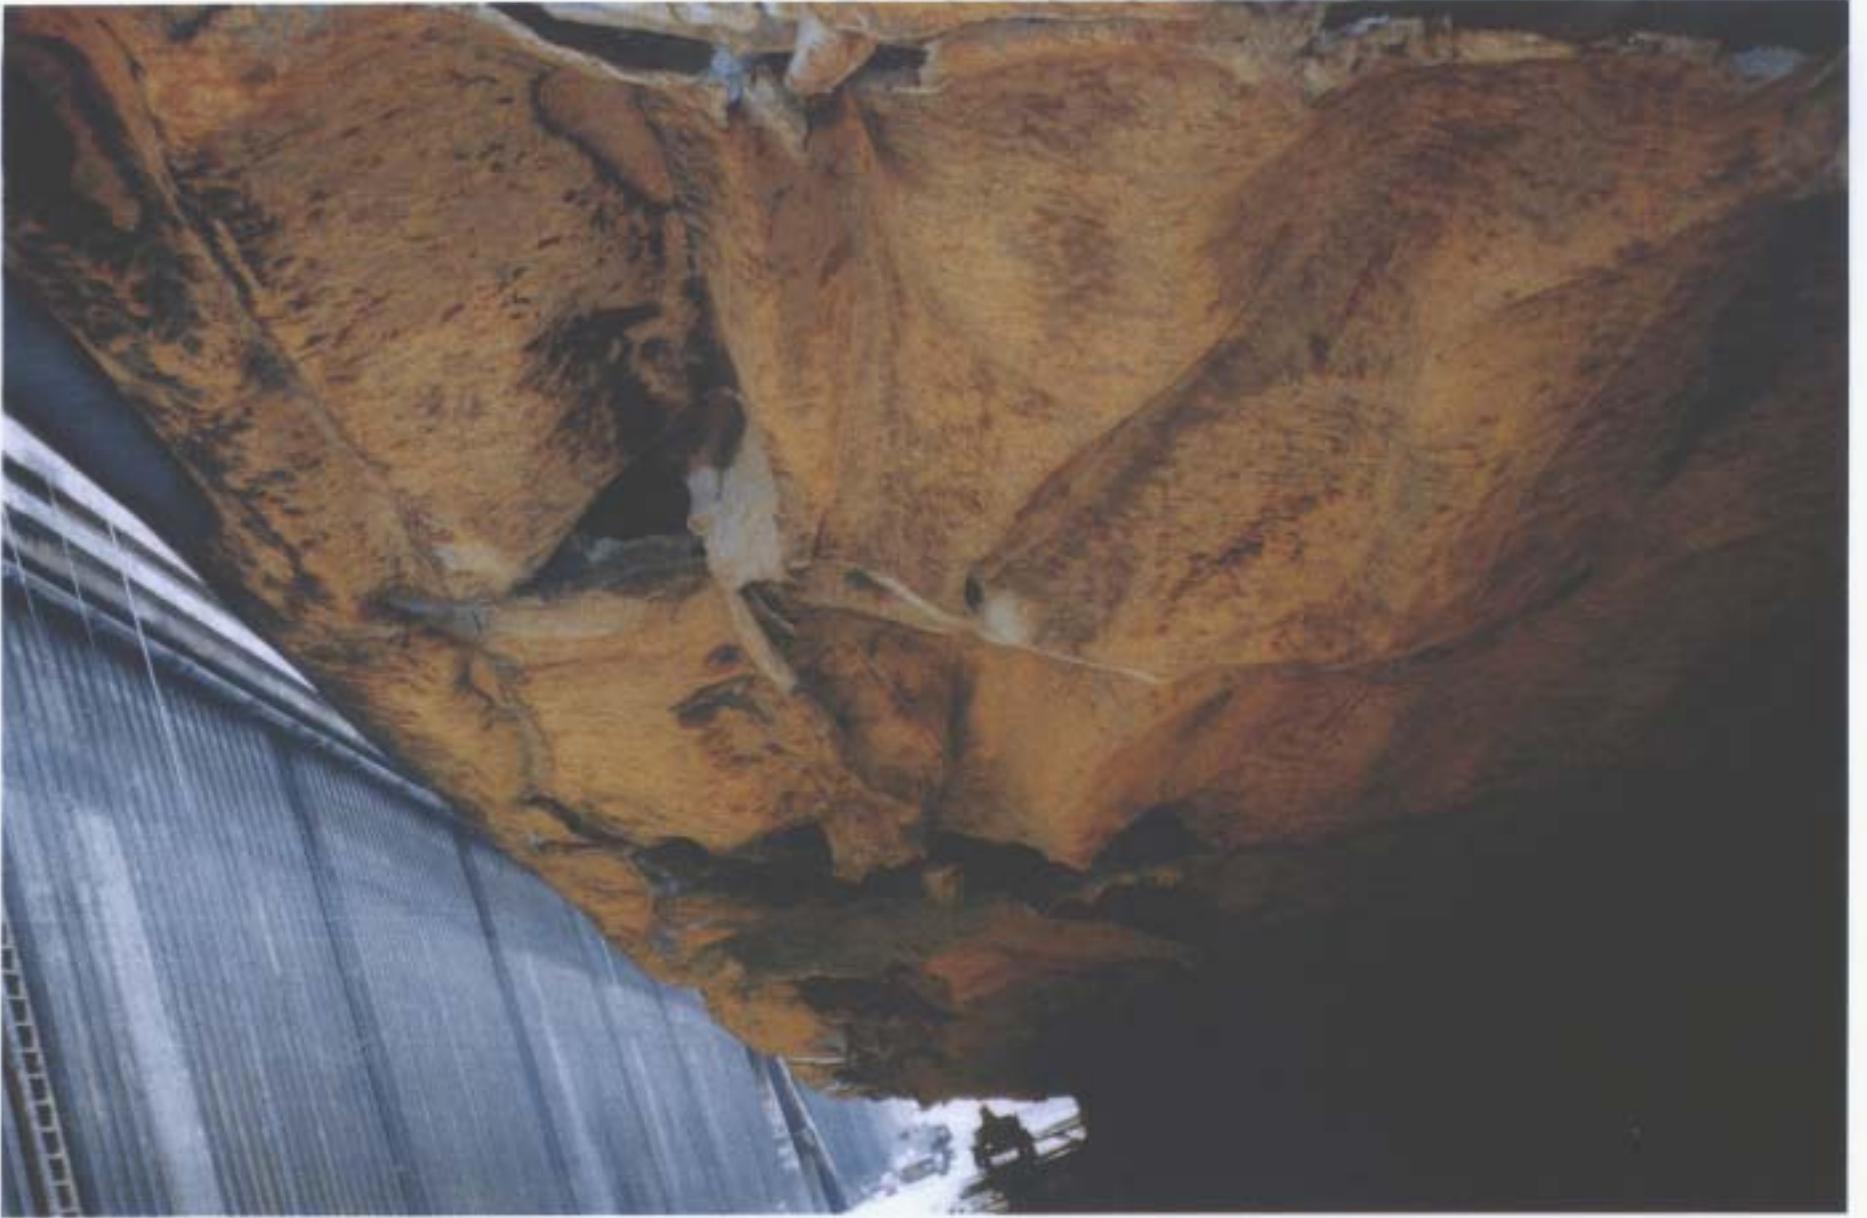
General View of Bottom Damage to SEA EMPRESS

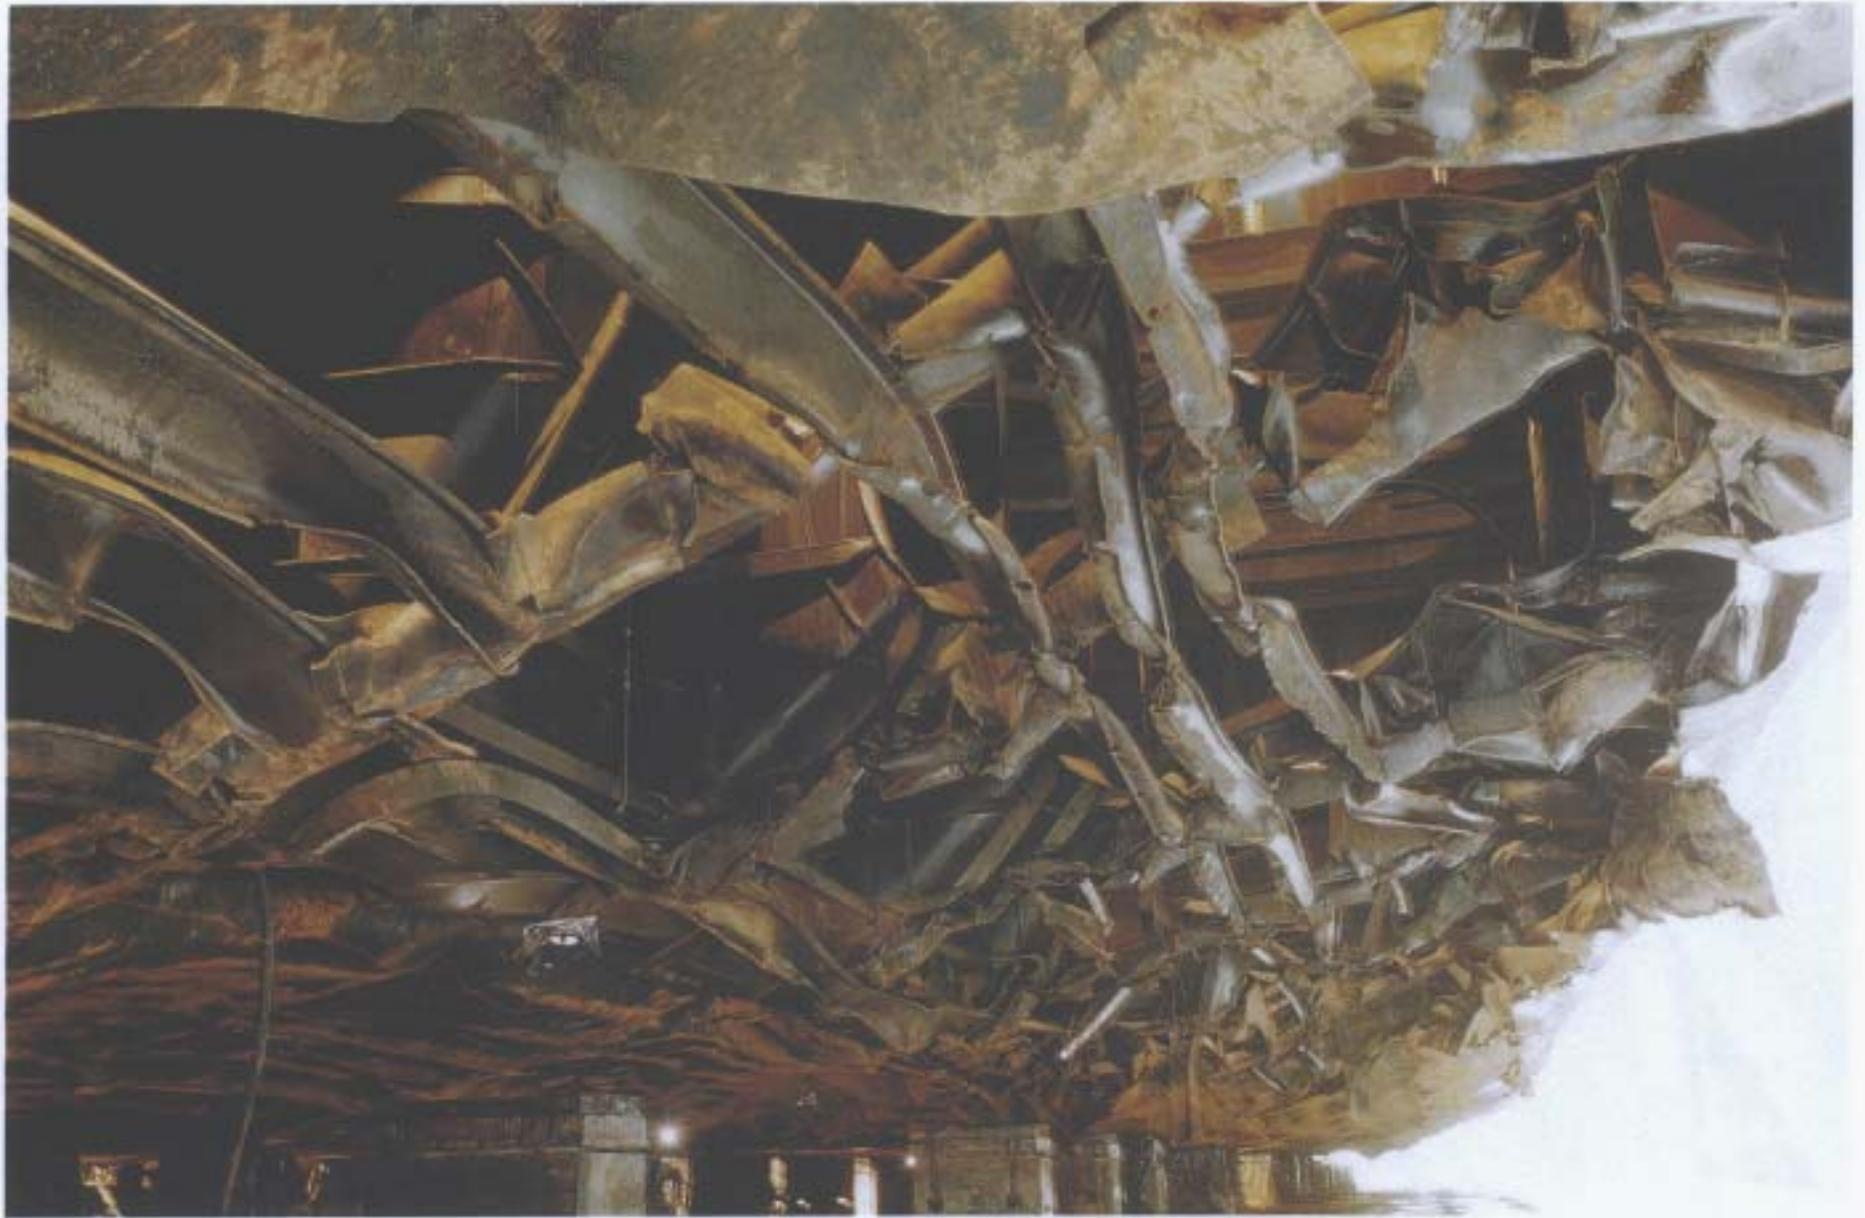
General View of Bottom Damage to SEA EMPRESS
