Report of the Chief Inspector of Marine Accidents
into the collision between the Fishing Vessel
WILHELMINA J
and MV **ZULFIKAR**
with the loss of six lives
on 10 April 1991

Marine Accident Investigation Branch
5/7 Brunswick Place
Southampton
Hants SO1 2AN

17 July 1992

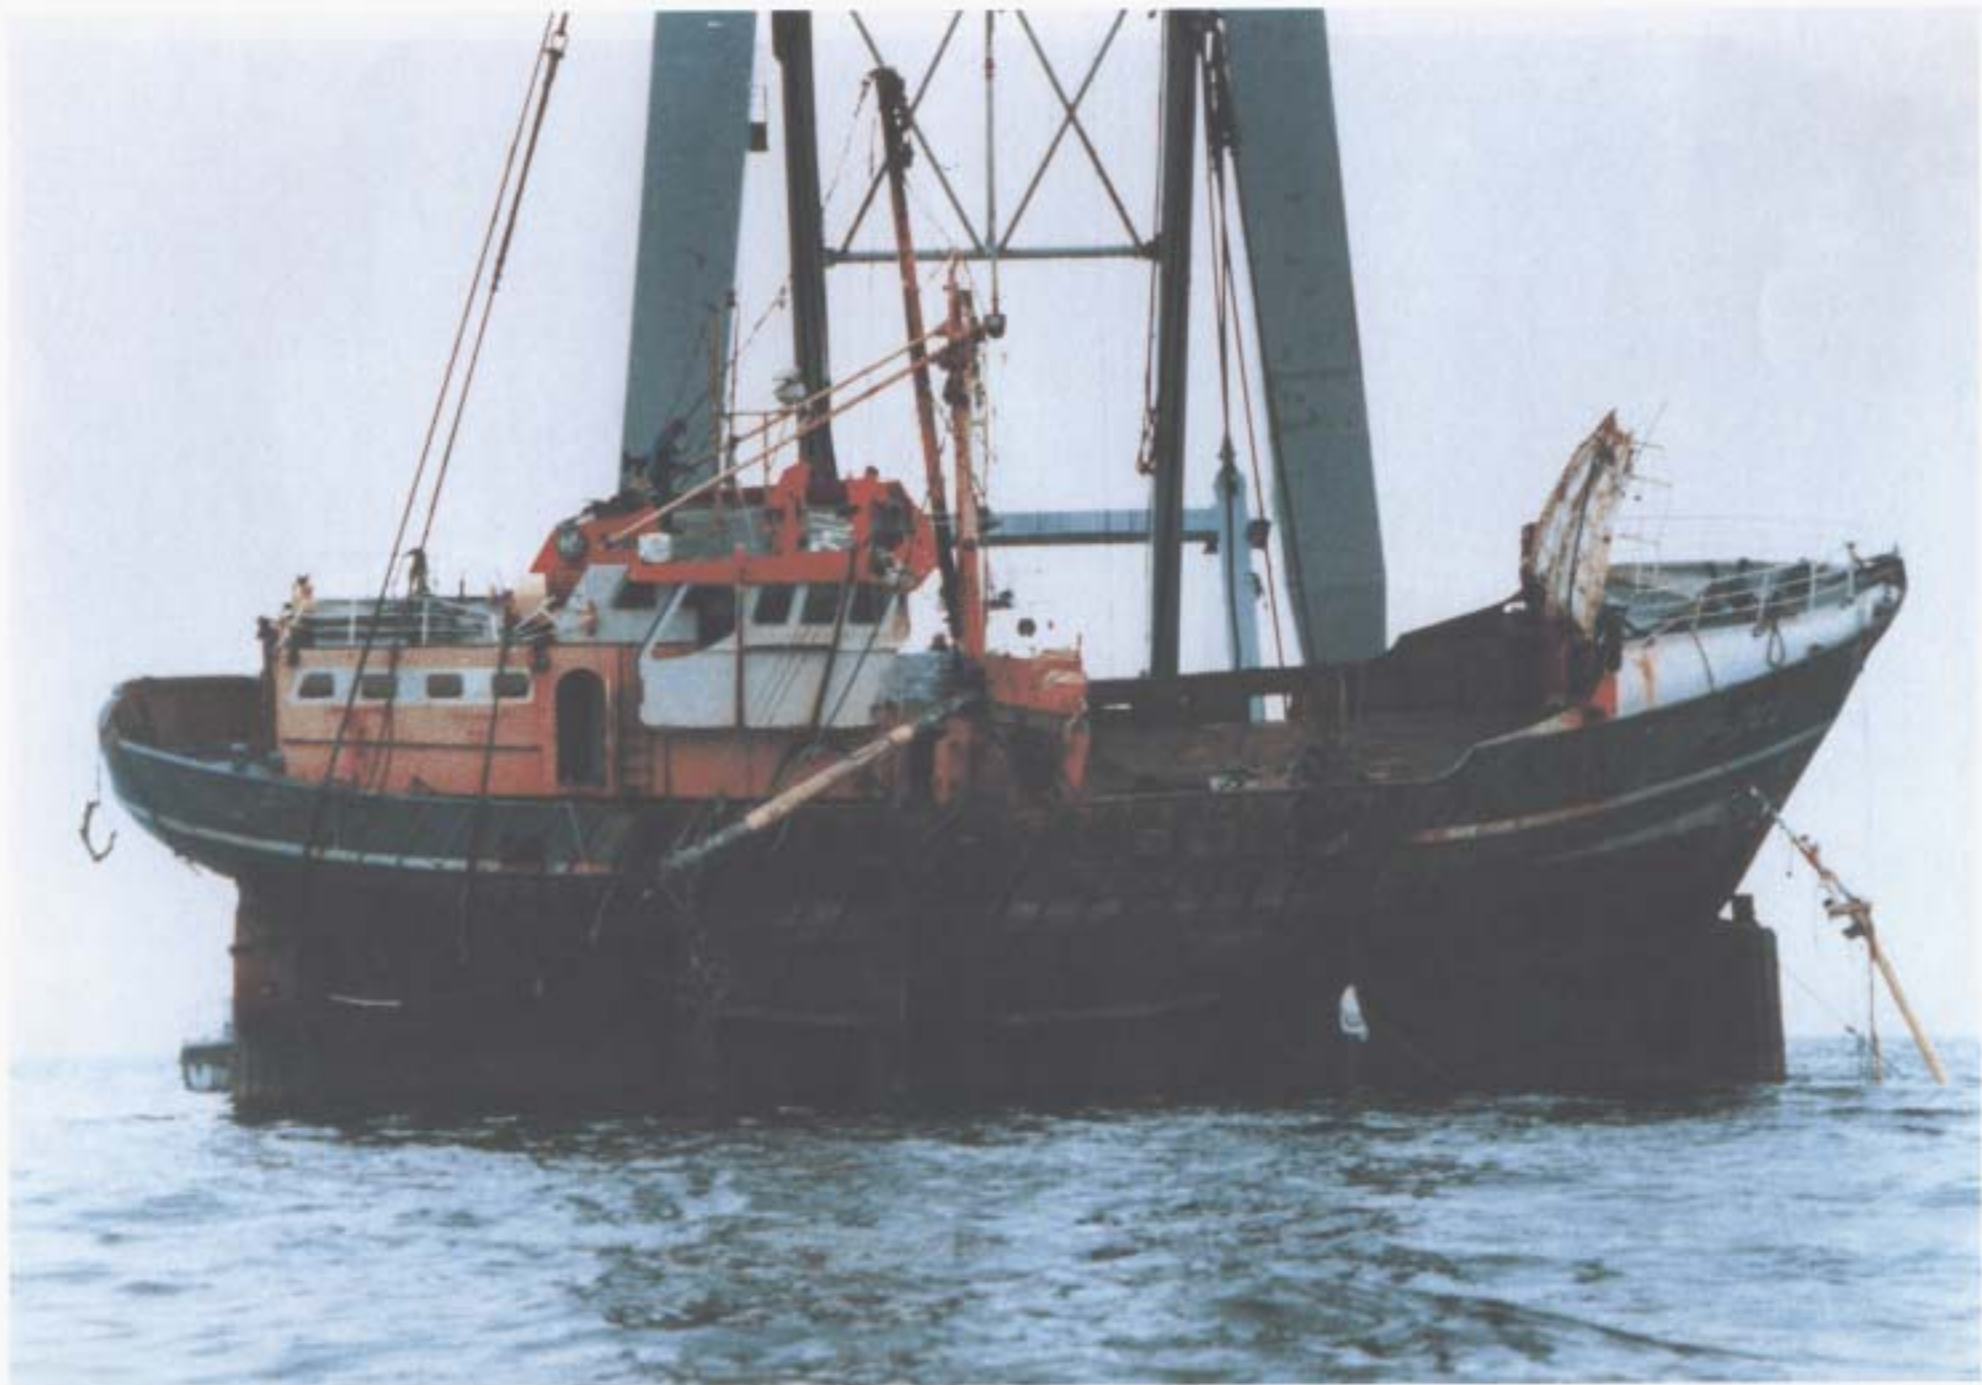
- 7.1 Inspection of the wreck of WILHELMINA J showed that the deep impact in the starboard side of the hull was collision damage (see Figures 4.1 and 4.2). The breaching of the machinery space in way of the impact, well below the water-line, would have led to very rapid flooding of that space. The machinery space was one of the two major compartments in the vessel, entirely aft of amidships and separated from the fish room by a cross bunker fuel oil tank extending above the water-line. Flooding would therefore have been confined initially to the after half of the hull. The fish room, the net store and the whaleback space, all in the fore part of the hull, formed individual weathertight compartments. The consequent residual buoyancy at the forward end and rapid flooding at the after end would have led to a considerable trim by the stern as the vessel sank.

WILHELMINA J - WRECK DURING SALVAGE OPERATION

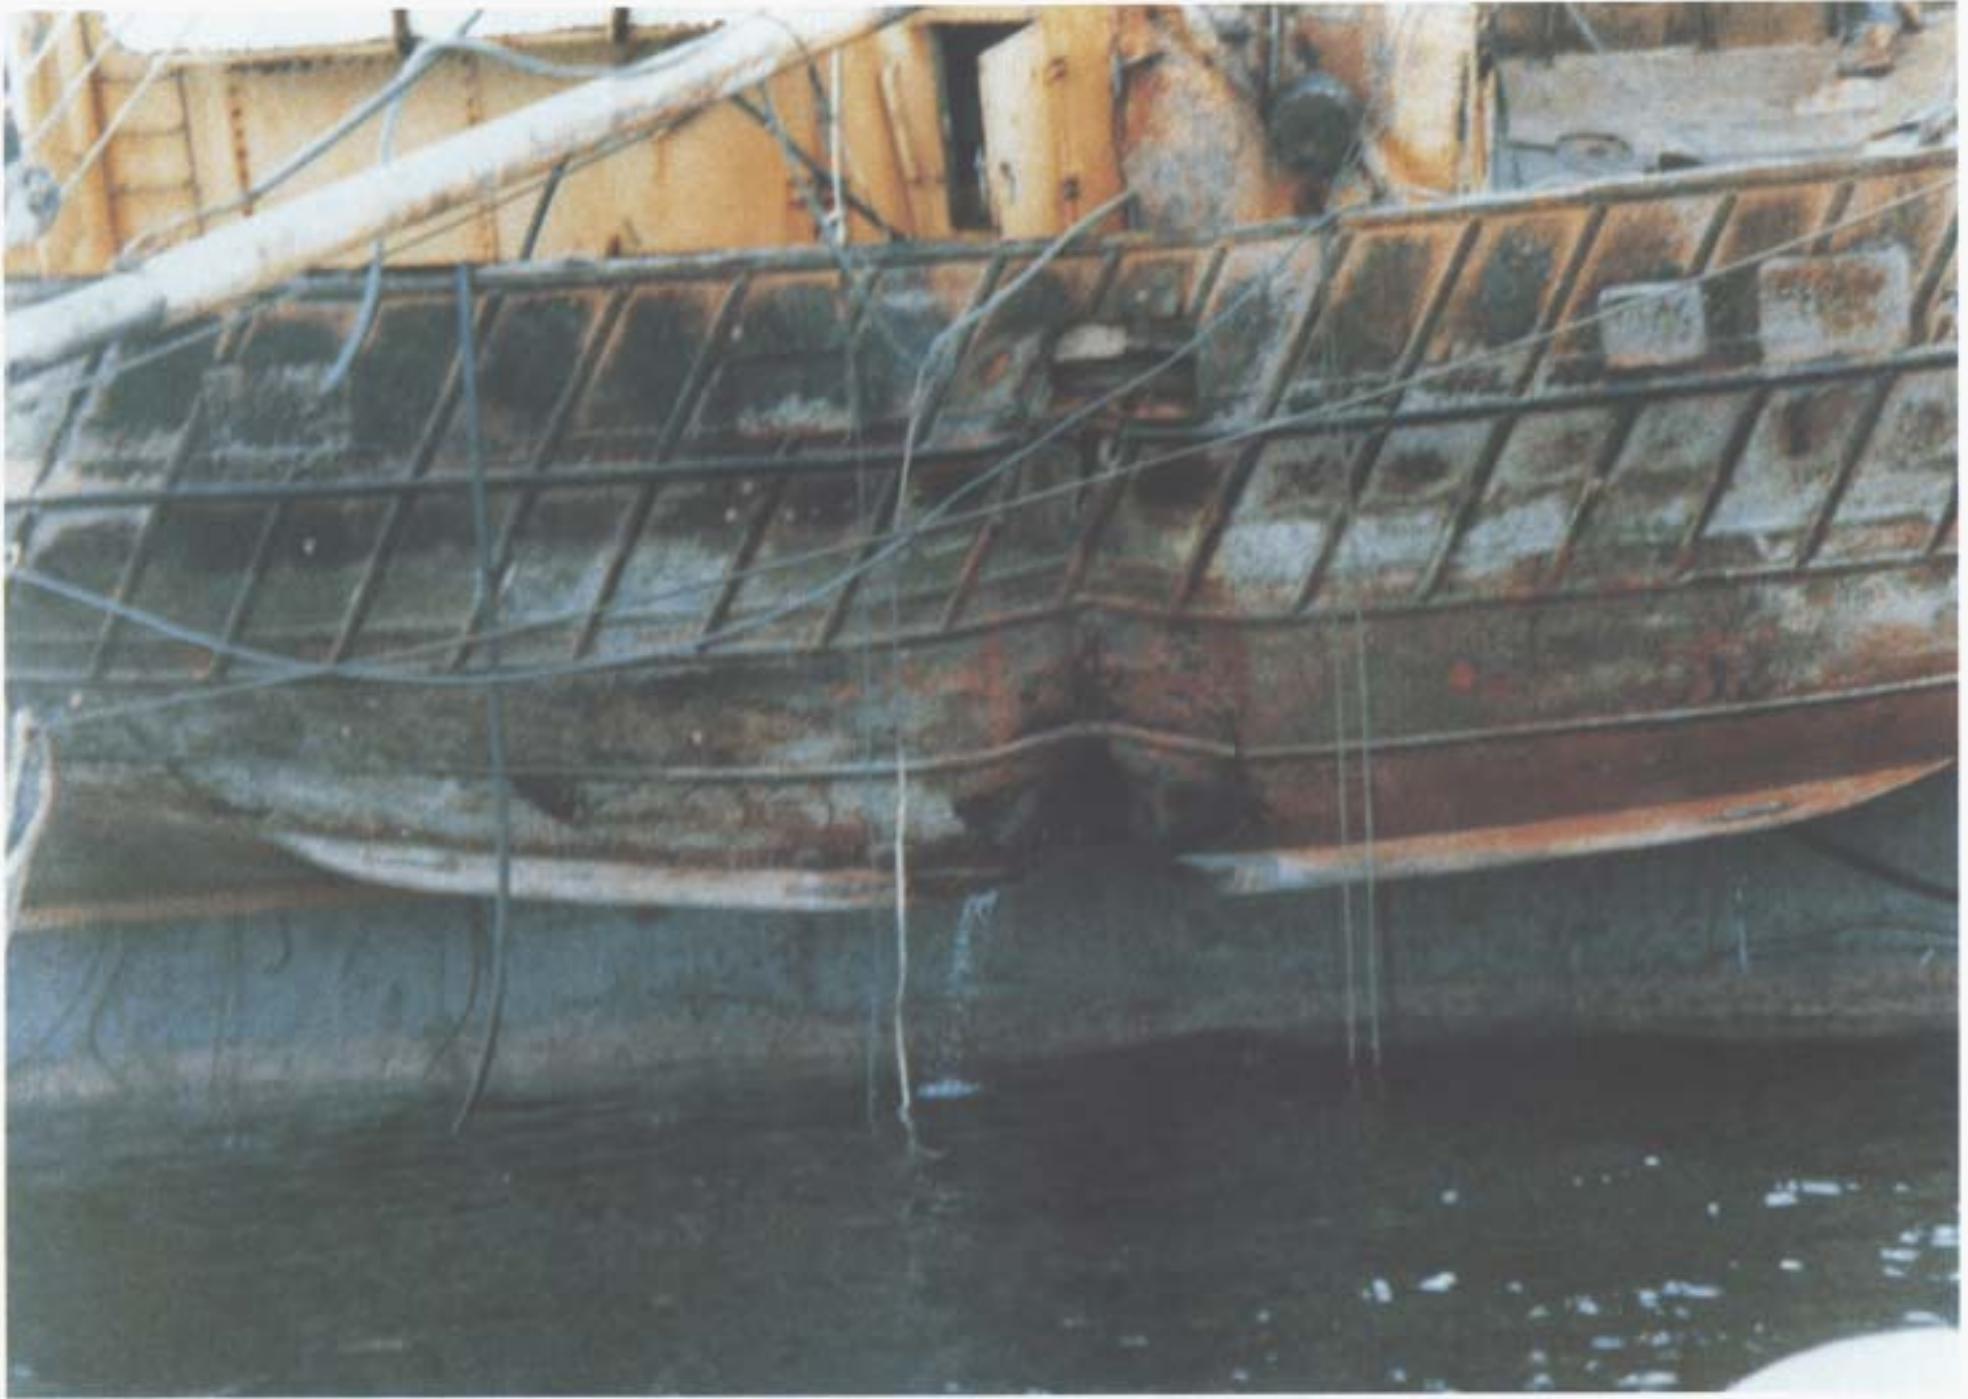
- 6.2 The collision damage was a deep impact on the starboard side of the hull extending from the bulwark downwards, past the bilge keel, to a point 85cms from the bar keel. There was a deep hole into the engine room in way of the bilge keel and a vertical split in the sheer strake just below deck level. There was further impact damage on the forward corner of the wheelhouse top in way of the starboard navigation light. The starboard hull damage was located nearly amidships, just aft of the 'A' section mast and just forward of the wheelhouse front. At the after end of the hull, the stern plating was found to be flattened in way of the bulwark, which was split at the top, and the sheerstrake. The rudder stock had been bent to port and the rudder was broken off (the rudder had been located on the sea bed beside the stern). There was further damage at the forward end of the hull where the foremast had been pulled out of the deck. The after part of the forecastle deck, through which the foremast passed, had been bent upwards. It is known that this forward damage was caused during an earlier lifting attempt.

WILHELMINA J - DAMAGE TO STARBOARD SIDE OF HULL

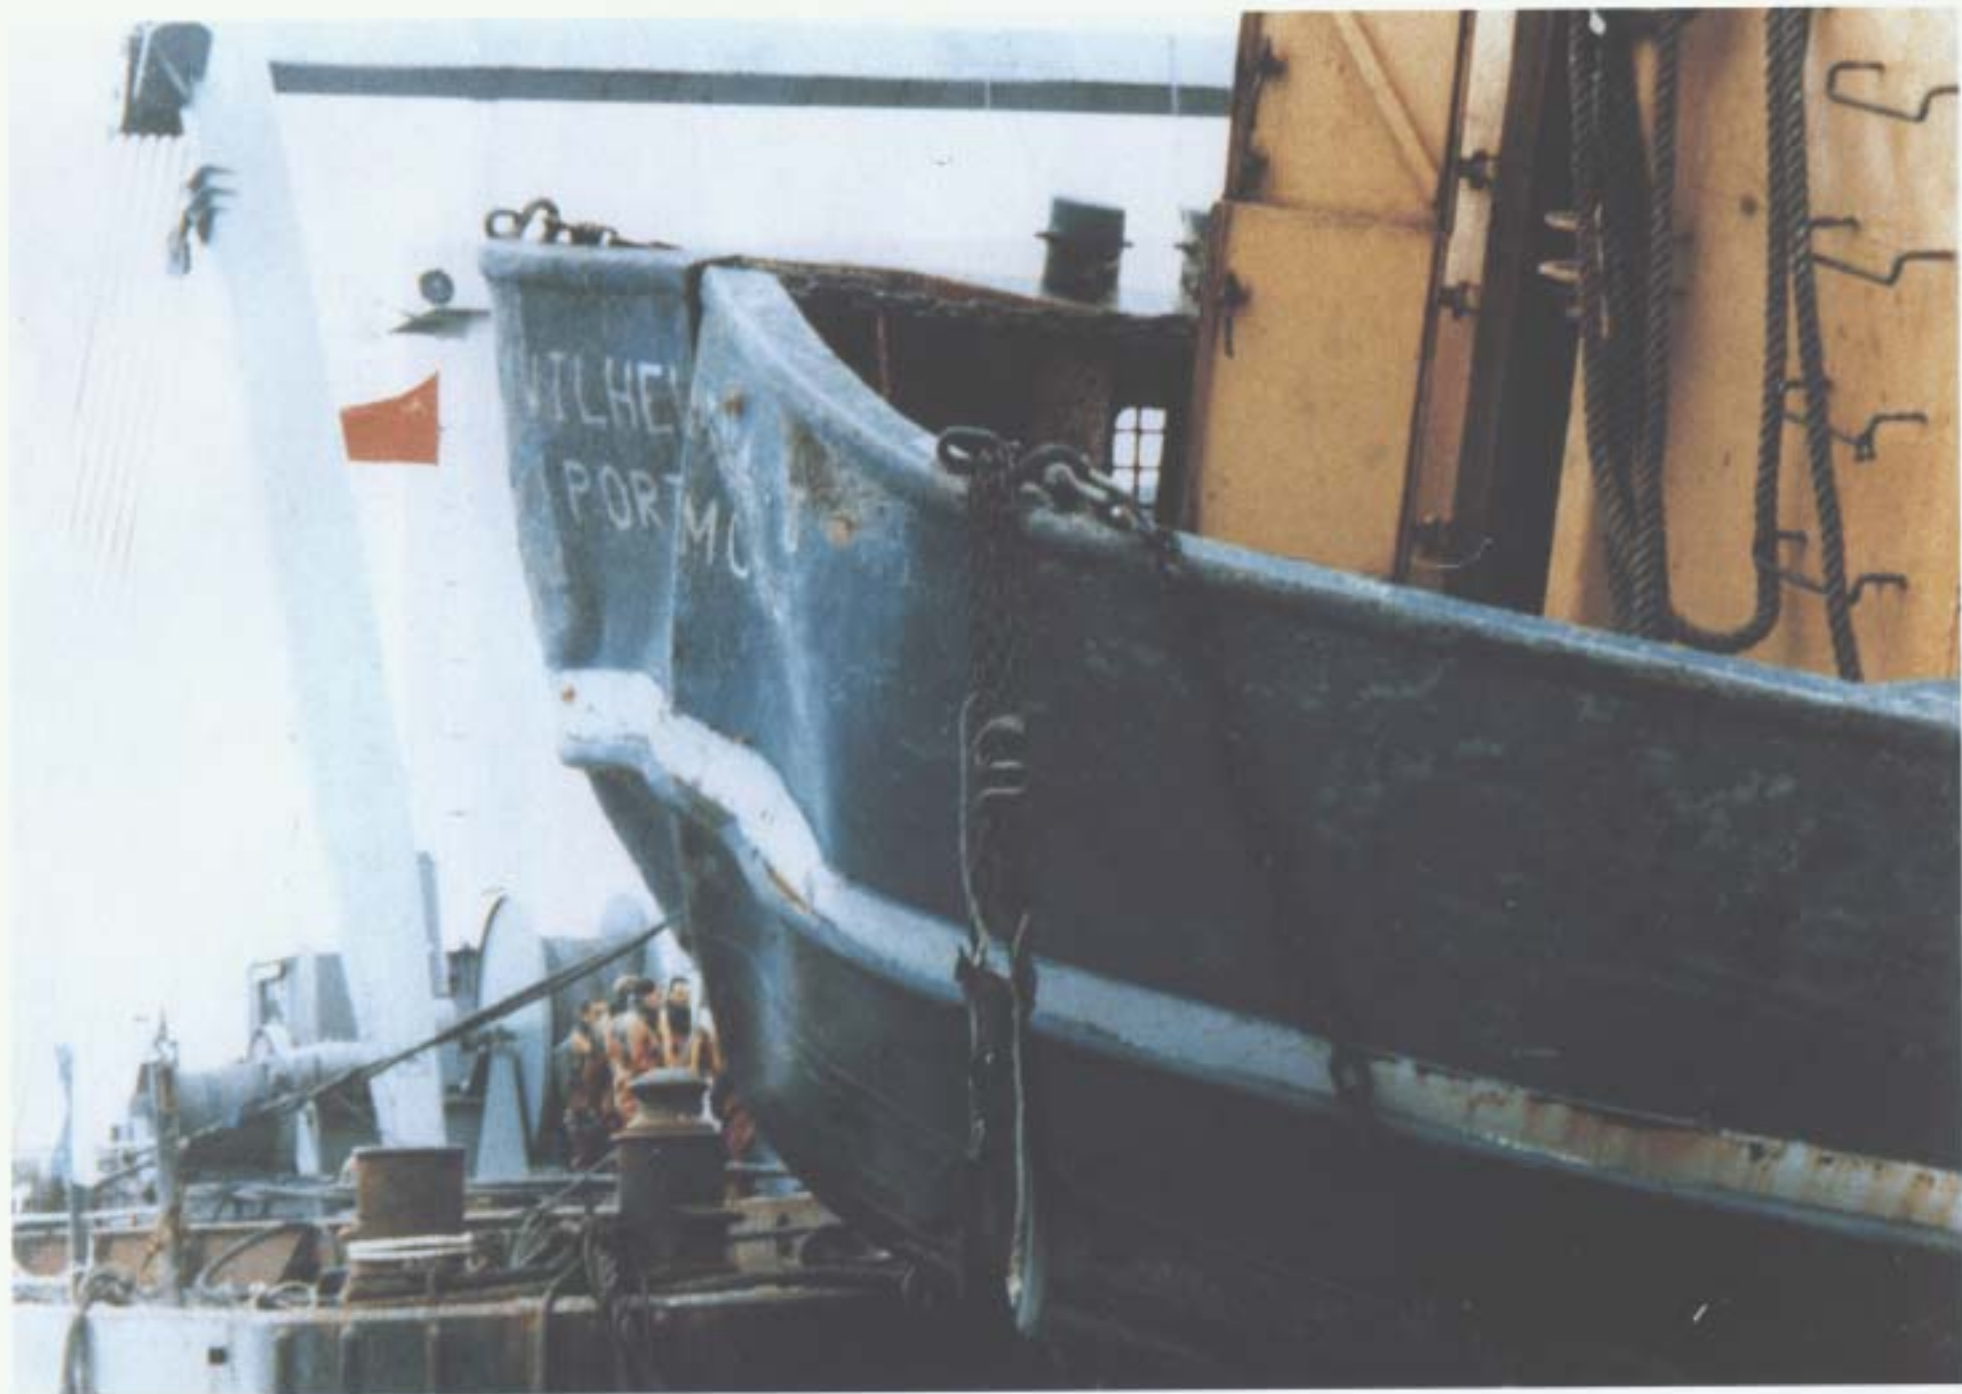
This would appear to be the most likely explanation for the damage found at the after end of the hull. The whaleback space and the fish room withstood considerable pressure before their final flooding, as evidenced by the water pressure damage to the fish room hatch coaming and lid and the bursting inwards of the weathertight door to the whaleback space. It is therefore most probable that these forward spaces, by their residual buoyancy had held the vessel in an almost vertical attitude until the after end struck the seabed, initially in way of the soft rounded cruiser form stern and the rudder. The flattening of the stern was very unlikely to have been caused by a steel-on-steel collision contact since the paintwork was virtually intact (see Figure 4.3).

WILHELMINA J - DAMAGE AT STERN

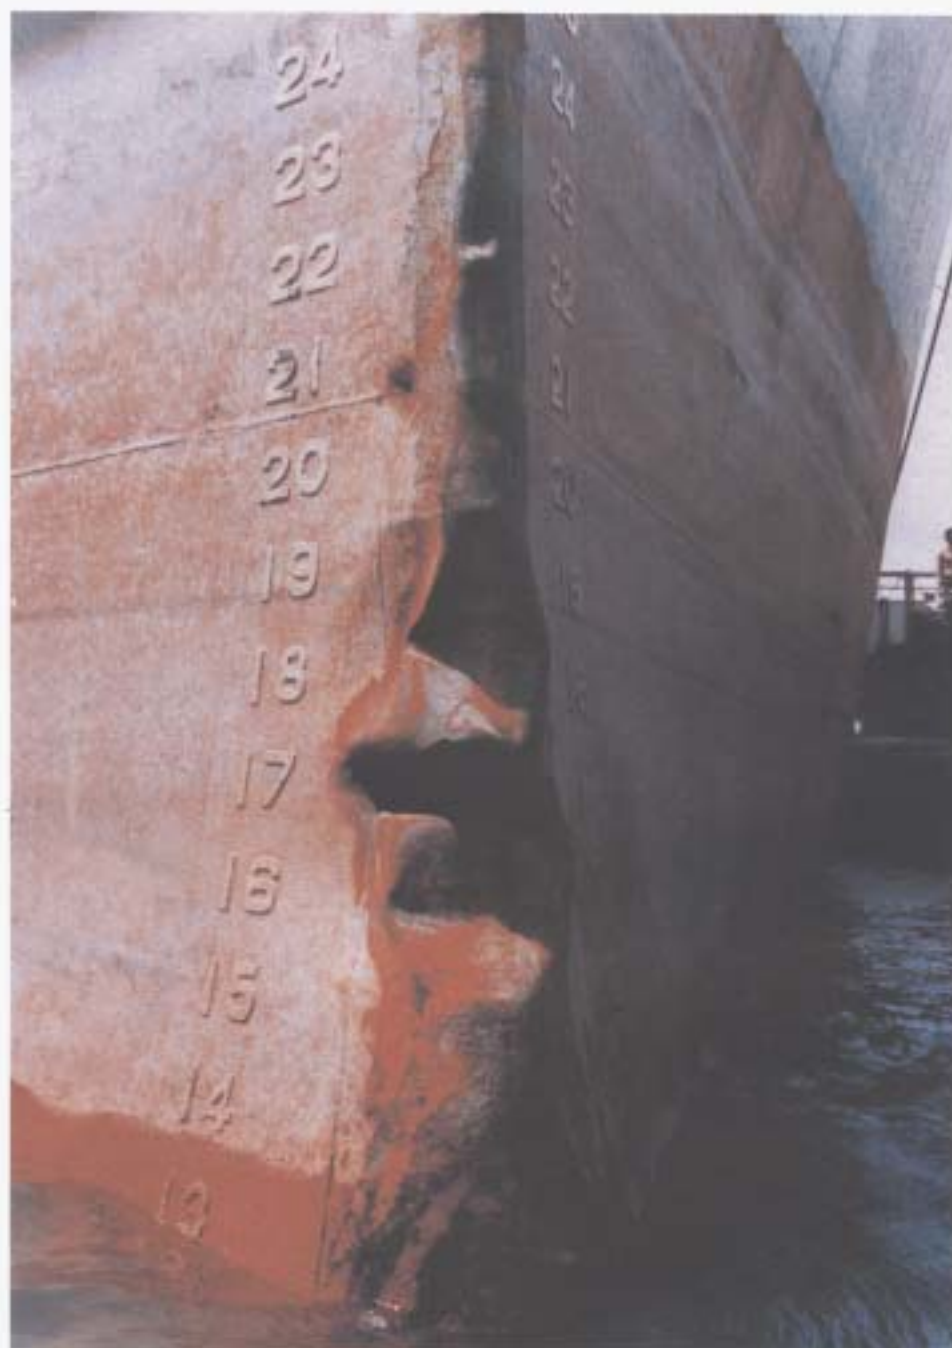
FIGURE 5.1

There was lesser collision damage to the stem extending upwards from the hole for a distance of about 20 feet (6 metres) to a point about 10 feet (3 metres) above the collision water-line. Additionally there was a deep indent below the hole in way of the 16 feet (4.87 metres) draught mark and an isolated saucer-shaped indent in the bow plating on the port side some 7 feet (2 metres) above the load water-line and about the same distance aft of the stem. Blue paint marks were discovered on various parts of the stem damage.

ZULFIKAR - FORWARD VIEW OF DAMAGE TO BOW

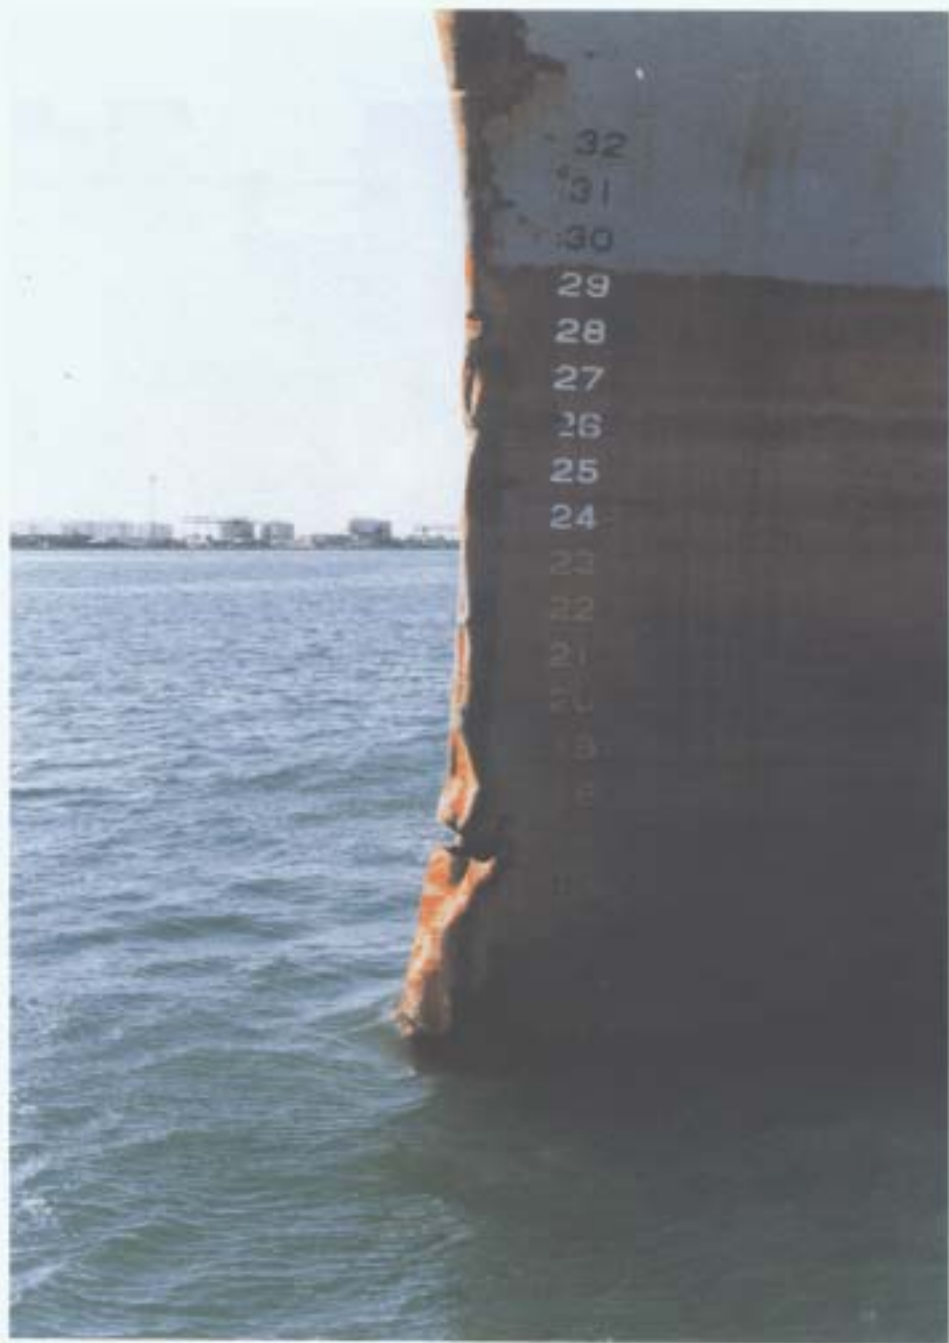
ZULFIKAR - SIDE VIEW OF DAMAGE TO BOW

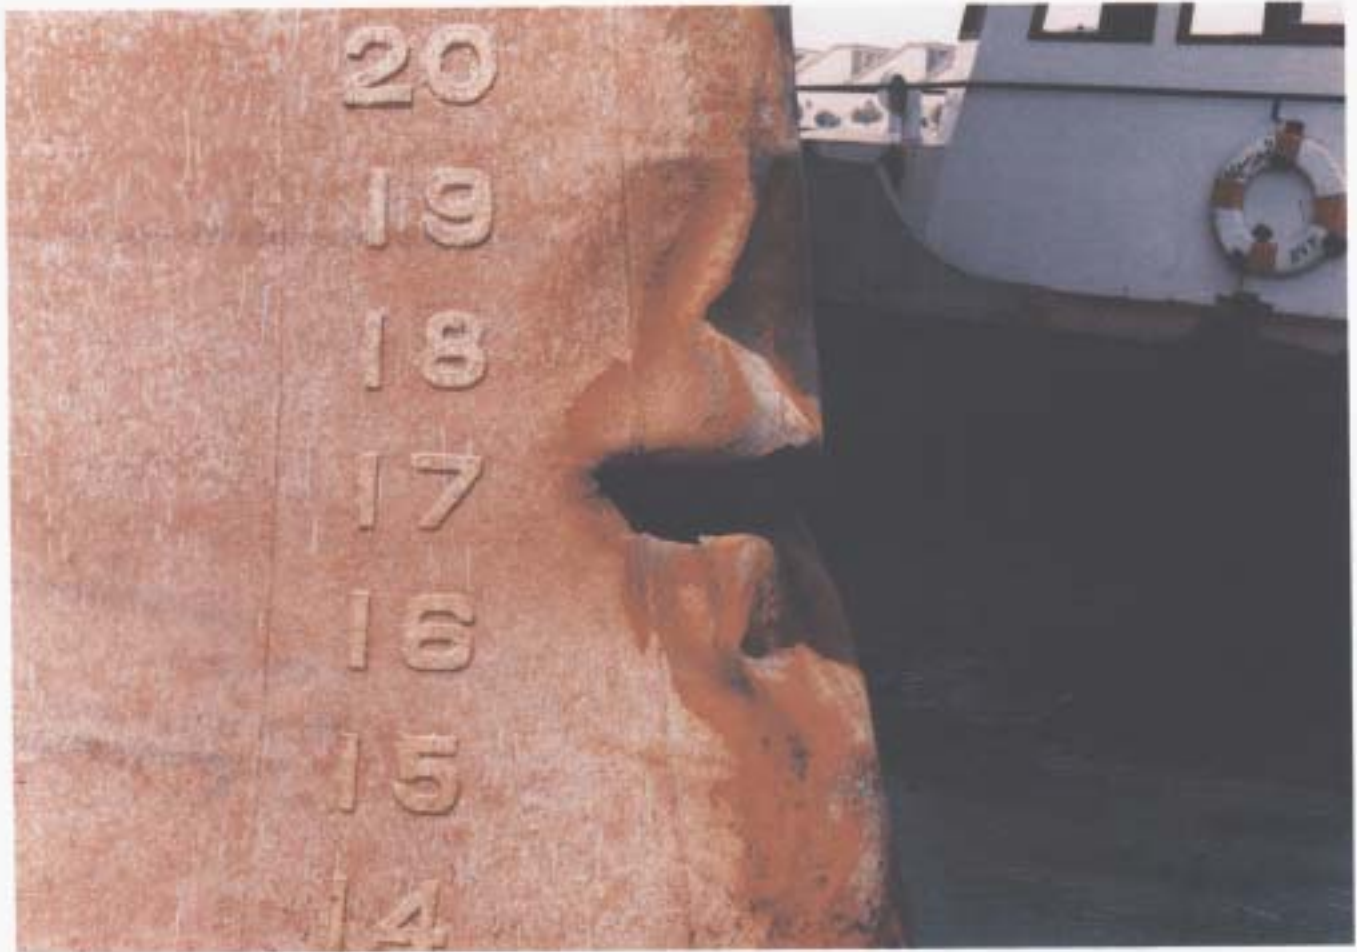
FIGURE 5.3

- 7.2 At the time of the collision ZULFIKAR was drawing about 28 feet (8.53 metres) forward. The Master's assessment of the extent of the collision damage was founded on what he could see at and above that water-line. He had assumed that the indents visible in way of the 27 feet (8.23 metres) draught mark and just below it had caused the hole and consequent flooding of the forepeak ballast space. This was later proved not to be the case after the discharge of most of the cargo from the forward holds of the vessel at Port Said, Egypt.

ZULFIKAR - CLOSE-UP OF MAJOR DAMAGE TO BOW
