Report of the Investigation into the Sinking
of the Fishing Vessel

GREY FLAMINGO

with the Loss of Life
of Two Crew Members

Marine Accident Investigation Branch
5/7 Brunswick Place
SOUTHAMPTON
Hants SO1 2AN

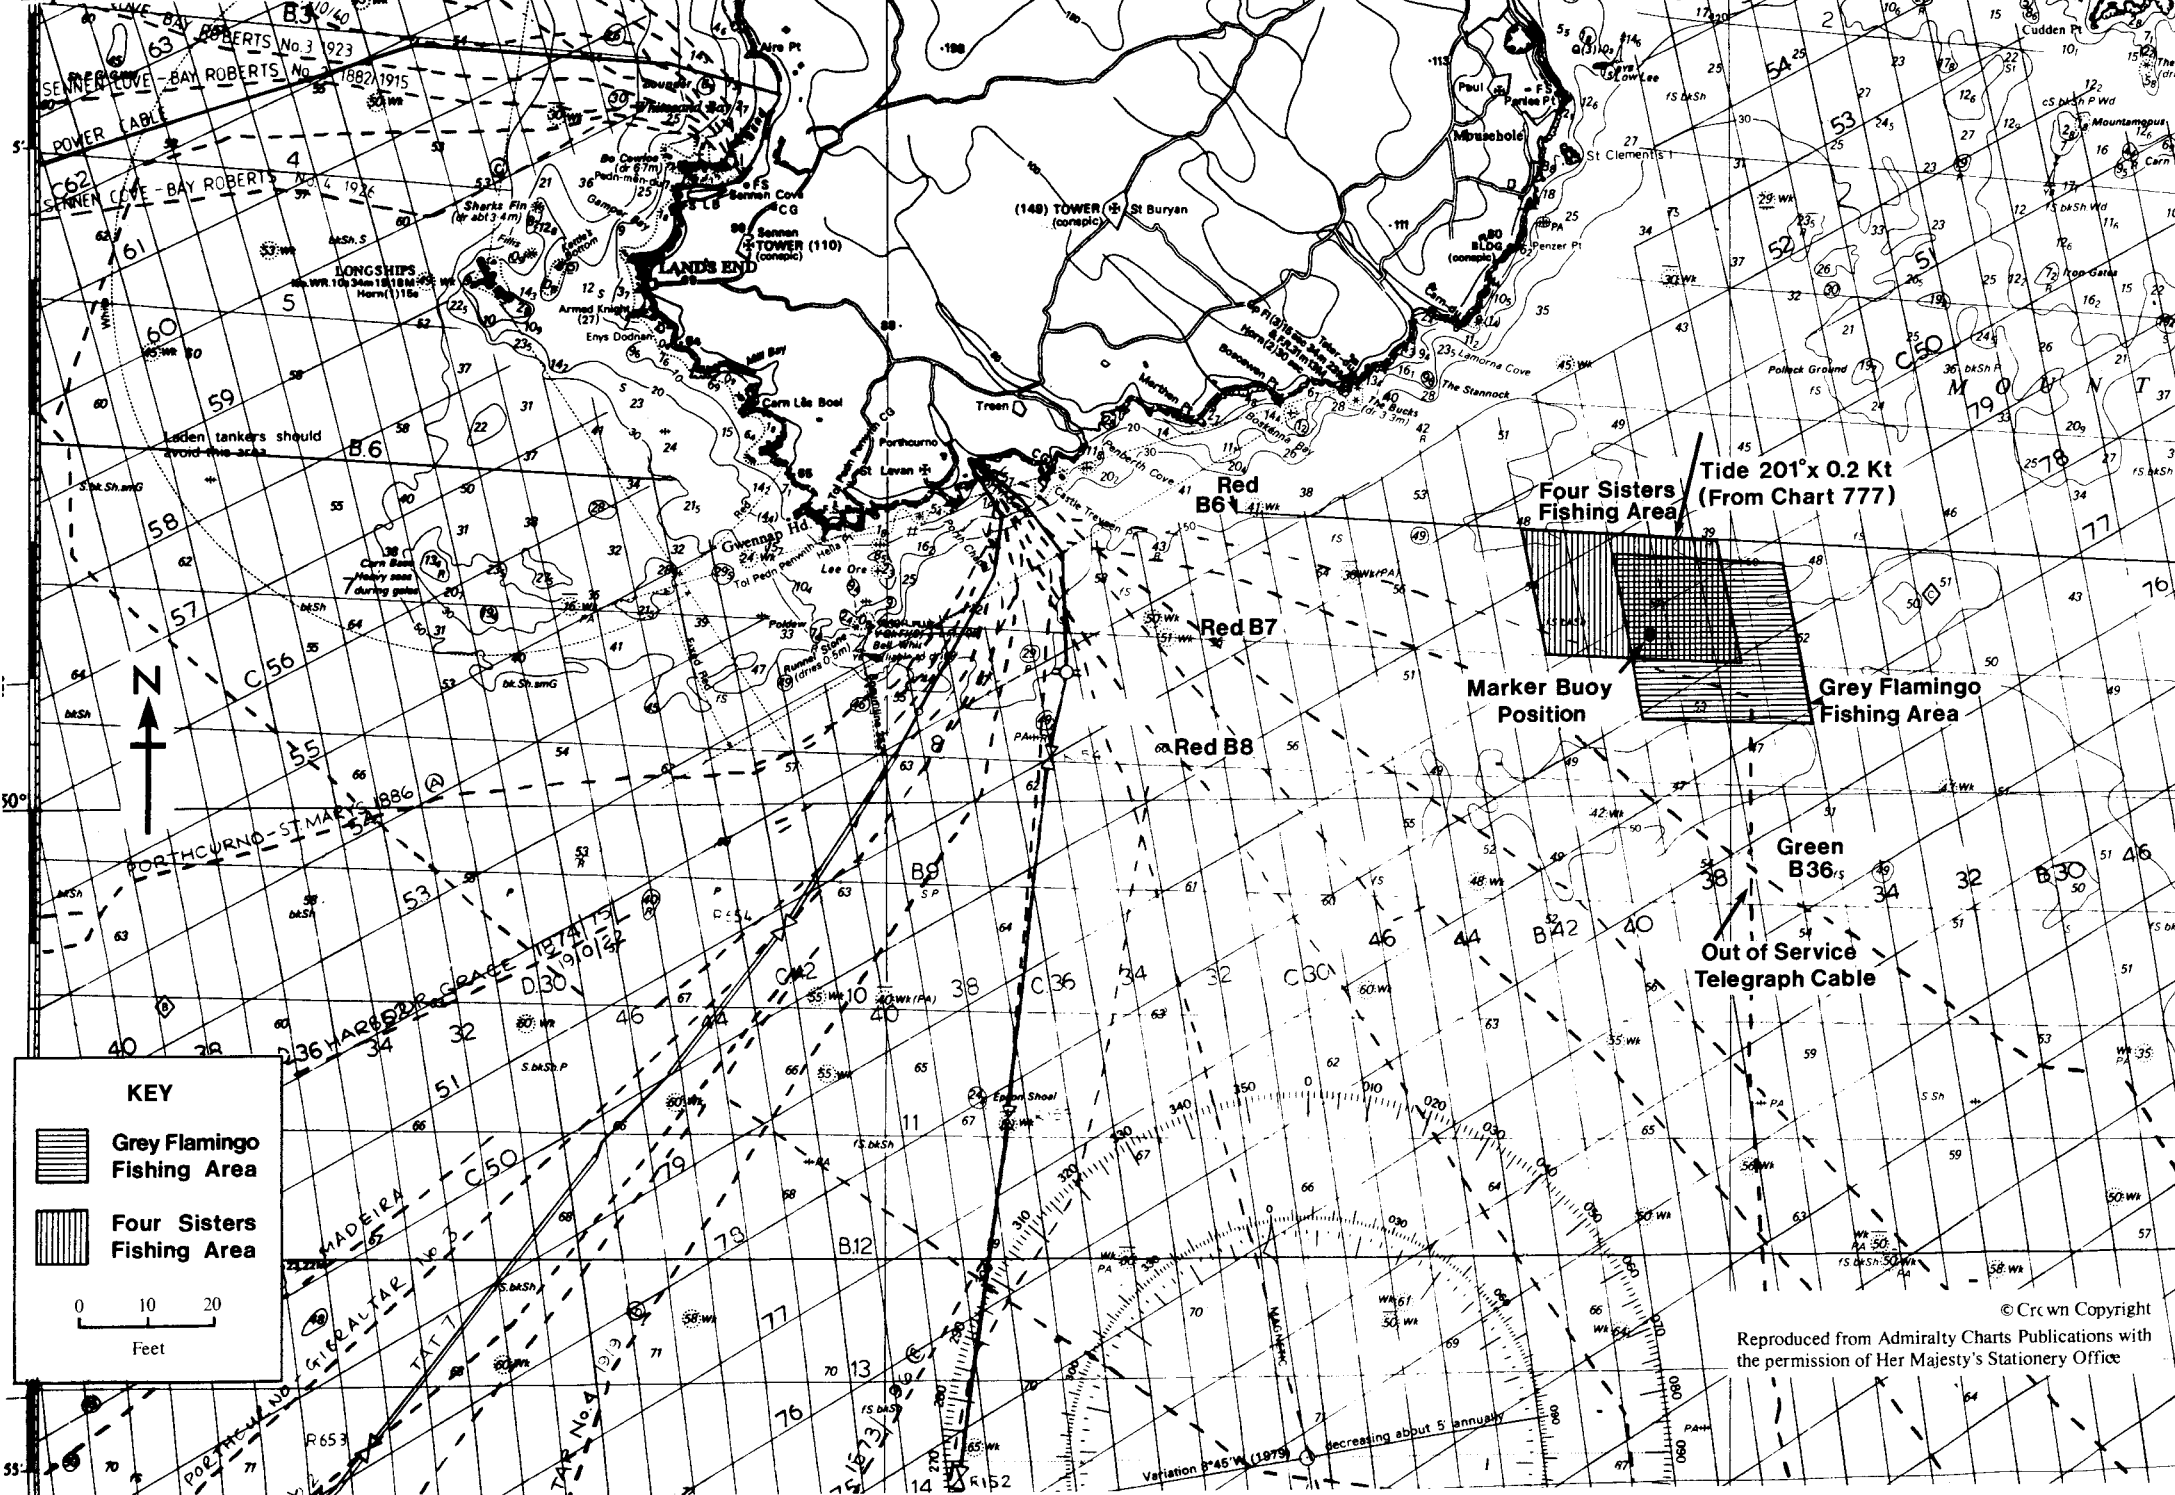
4.1 The wreck has not been located. However, the most probable position is that of the marker buoy, shown on Fig 2, which was dropped by the rescue helicopter and confirmed by Penlee life-boat as marking the spot where oil and debris were found on the surface.

4.2 It is not uncommon for trawlers to experience snagged gear: the cause may be any obstruction on the sea bed such as wreckage or a rock. In this instance, it will be seen from Fig 2 that there are a number of submarine cables - shown in dashed line - in the area, one of which (now out of service) passes close to the believed position of sinking. It seems probable that both sets of GREY FLAMINGO'S gear, and probably the port side gear of FOUR SISTERS also, were fouled by this cable. In support of this theory:

- 5.1 GREY FLAMINGO snagged both sets of her fishing gear while she was beam trawling in an approximate position 3 miles SSE of Lamorna, Cornwall. The obstruction which snagged the gear has not been positively identified, but it seems most probable that it was an out of service submarine cable.

- 4.1 **The positions of submarine cables which cross the grounds which they fish.**

Fishermen are reminded that information on both cables in use and out of service can be obtained from Ministry of Agriculture Food and Fisheries Offices and local offices of the Sea Fish Industry Authority.

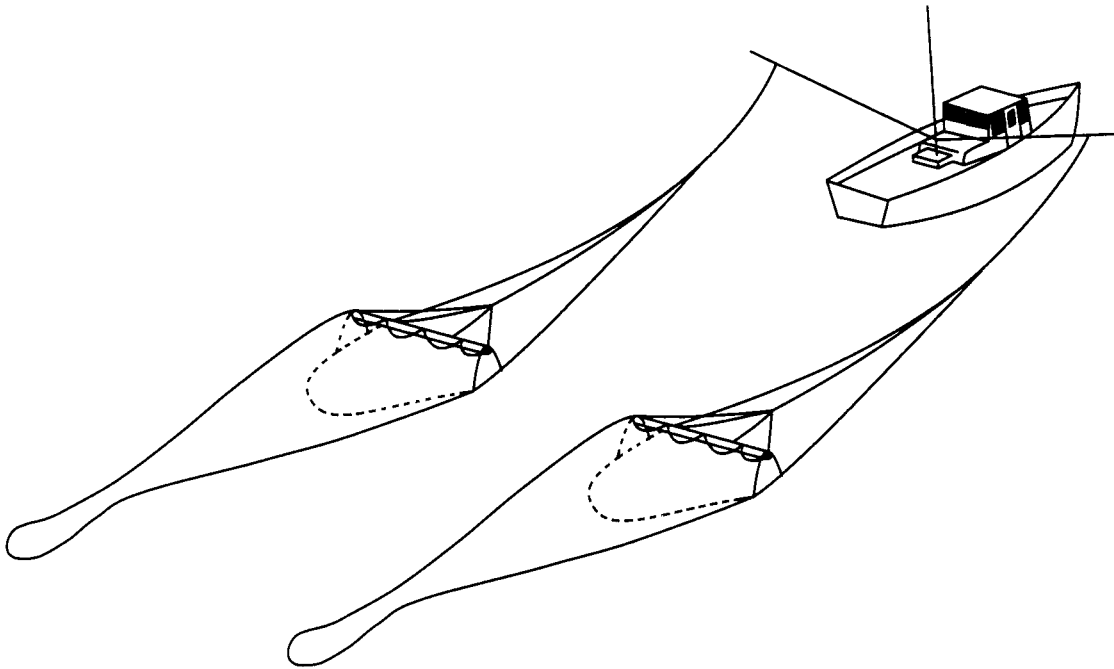
Figure 3

Typical Double Rig Trawling with Beam Nets

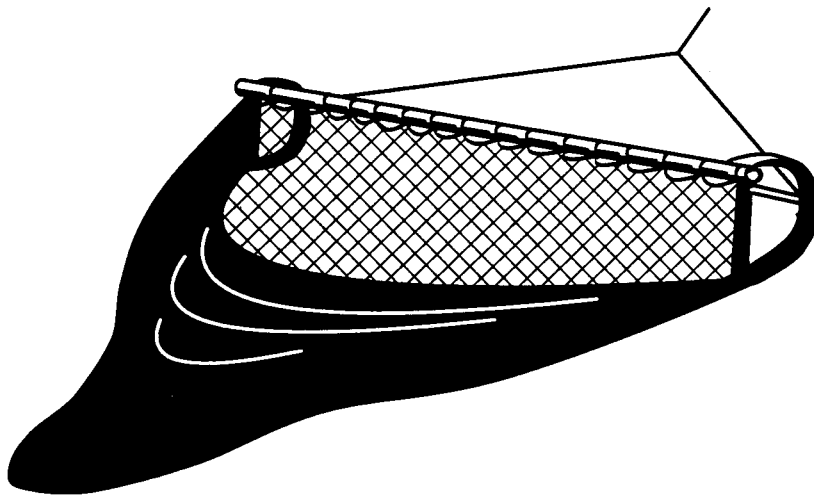
Figure 4

Typical Beam Trawl
