Report of the Chief Inspector of Marine Accidents

into the capsize and sinking of

MAJESTIC

on 13 June 1989

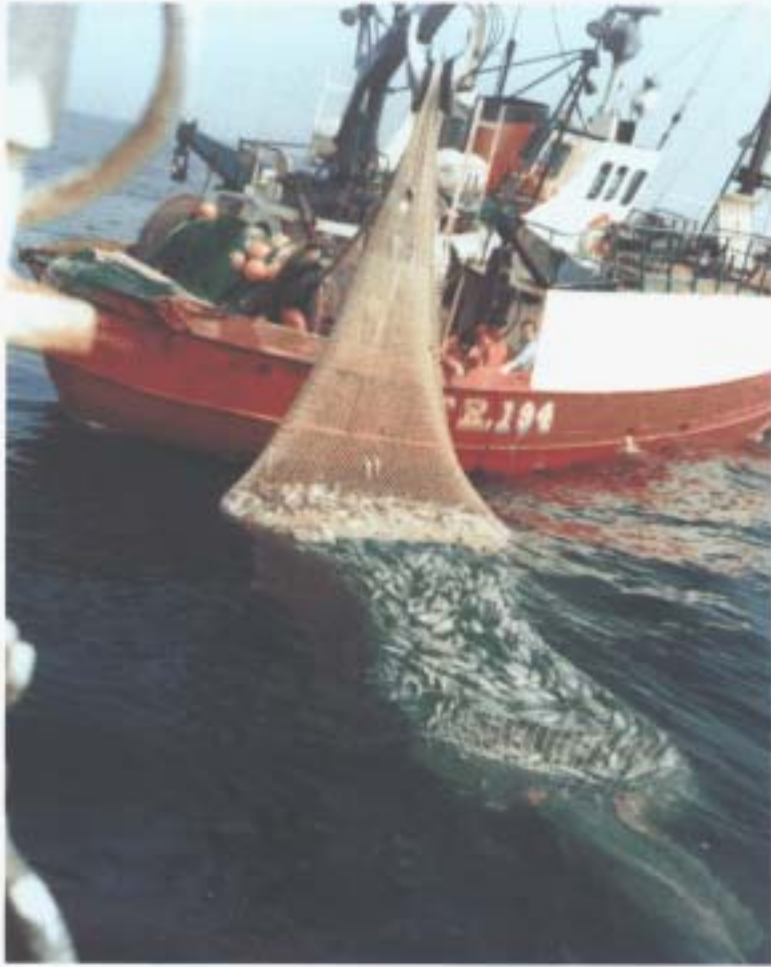
2.2 A general layout of the vessel is shown in Figure 1. The photographs of the vessel in Figure 2 were taken in about 1985 since when the hatch on the shelter had been altered so that it opened on top of the shelter.

MAJESTIC (these photographs taken about 1985)

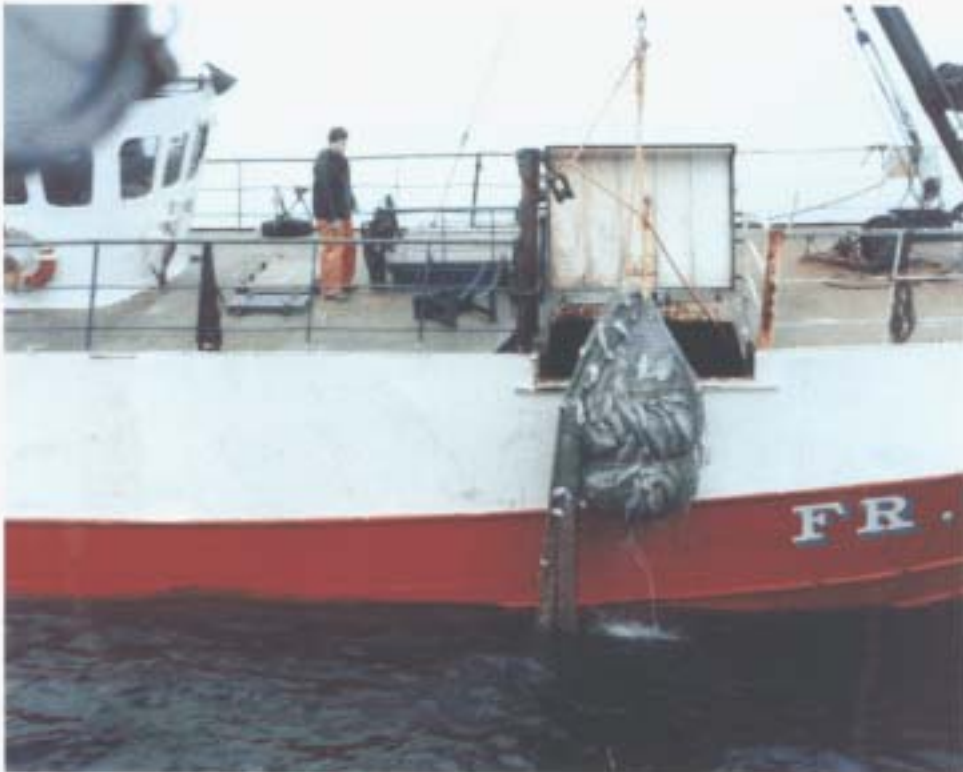
RELATIVE POSITIONS OF "MAJESTIC" AND "MYSTIC" (Not to Scale)

The Skipper of MAJESTIC then put his engine control to dead slow ahead and gave the order to heave in the wire. MAJESTIC took up a position abaft MYSTIC, (as shown in Figure 3), with its trawl wire running out through the starboard gallow block at almost 90° to the vessels centre line.

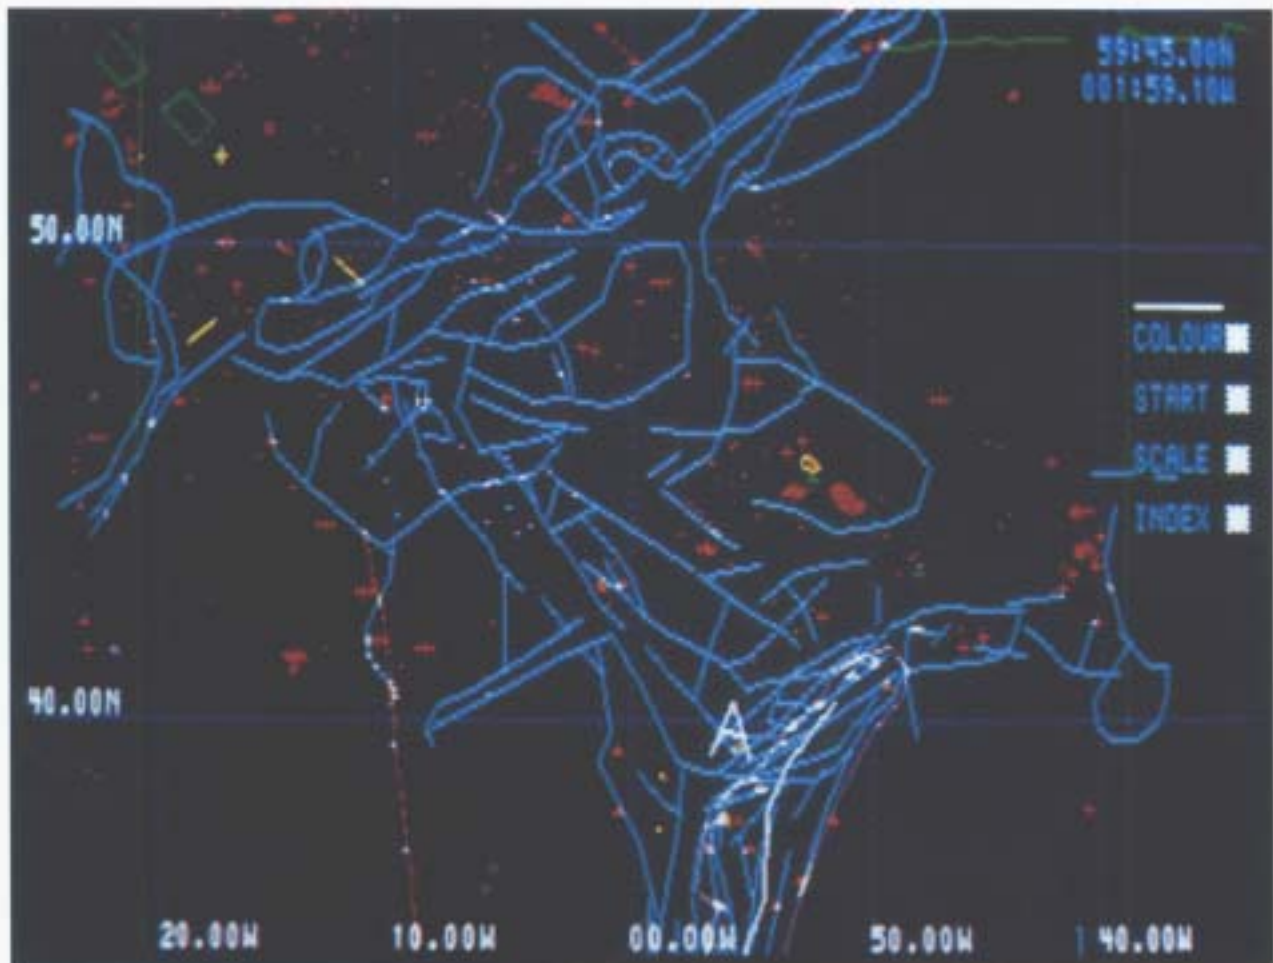
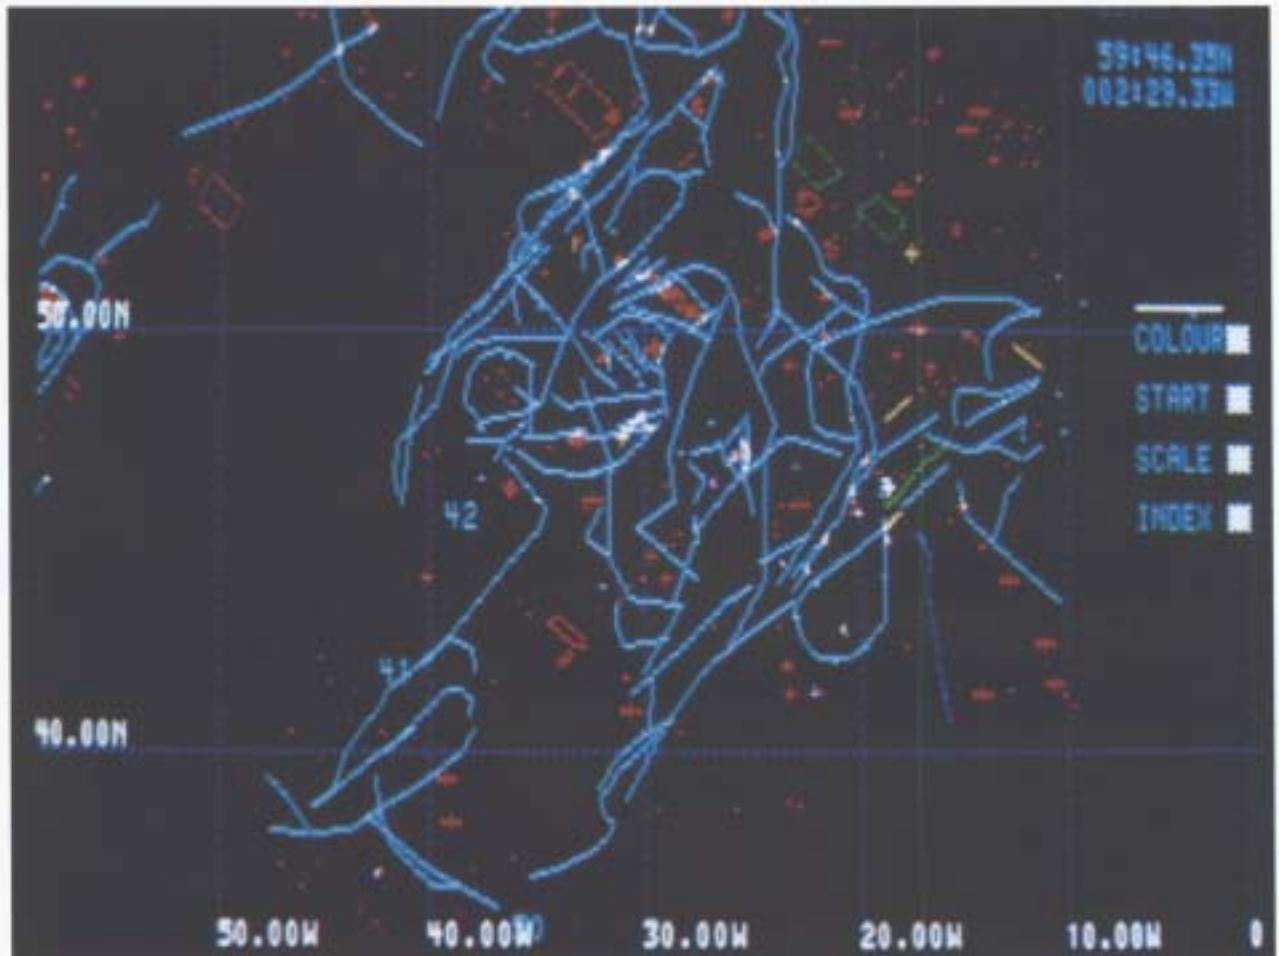
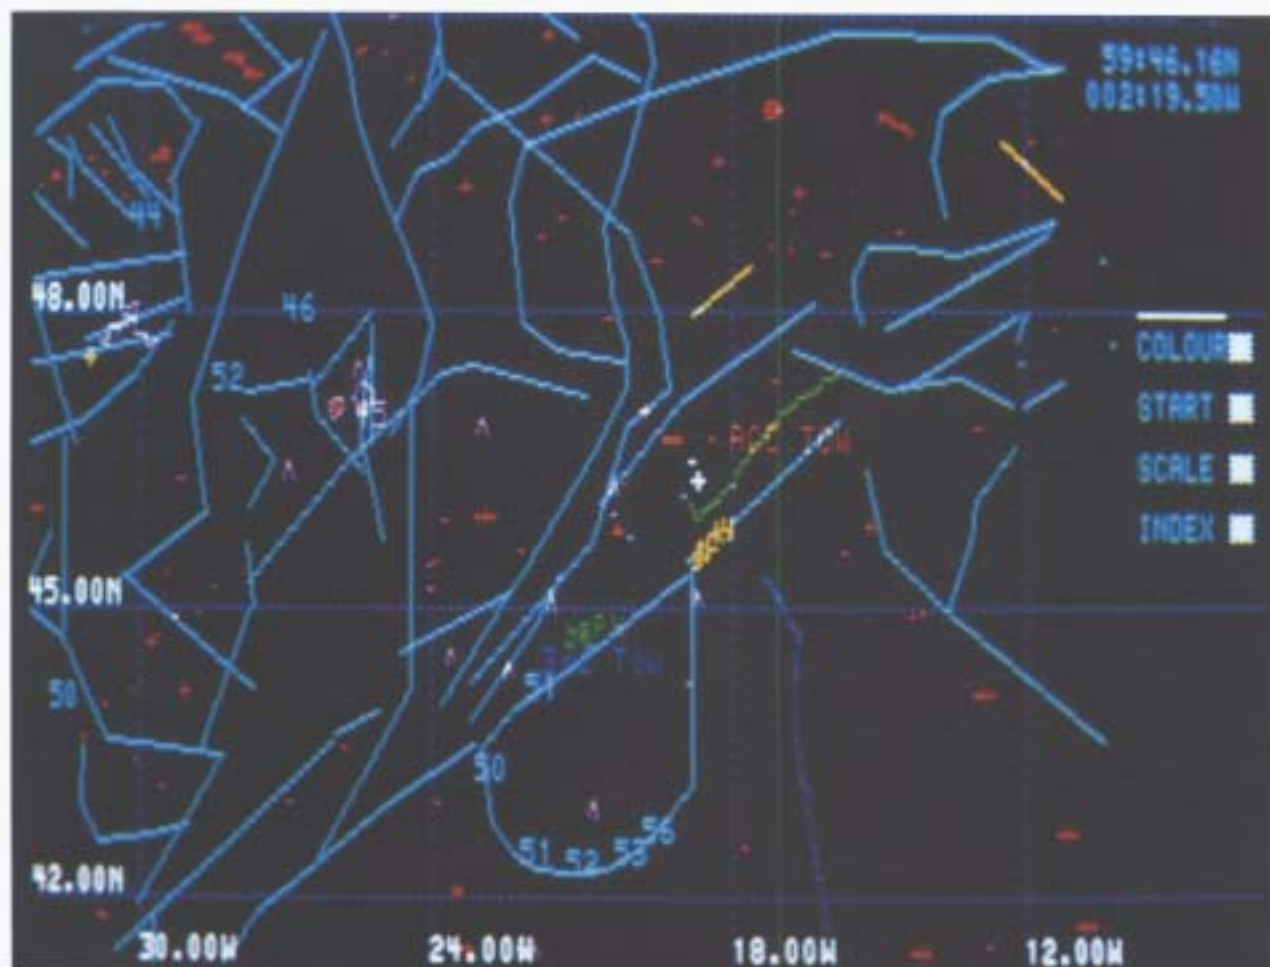
MYSTIC's trawl tracks

5.2 Information from MYSTIC's plotter has been copied which illustrates the large number of "fasteners" recorded in the area. Examples are given at Figure 4.

From the information available it is considered that the trawl wire came fast on the sea bed or on an object which was in close proximity to where MAJESTIC was when heaving in. It could have been that the net was caught first and that the wire came fast on something else after MAJESTIC started to heave. When the Skipper of MAJESTIC had about 400m of wire still to heave in, knowing that he was in 100m of water, his thoughts were that the fastener was probably at or nearer to the net.
