Report of the Investigation into the  
Loss of the Fishing Vessel

**OCEAN HOUND**

with the loss of five lives  
on 10/11 August 1991

Marine Accident Investigation Branch  
5/7 Brunswick Place  
SOUTHAMPTON  
S01 2AN

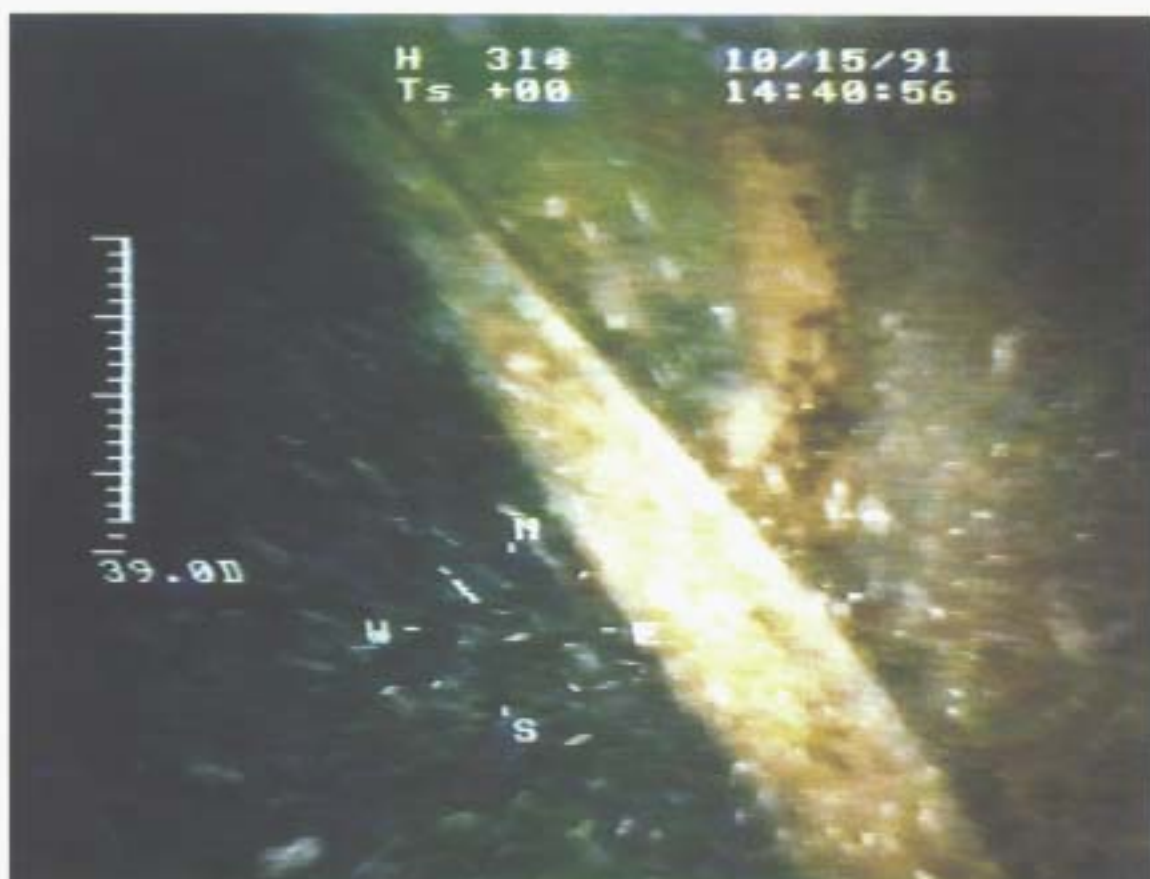
FIGURE 4.1

- Stem forefoot bent round from starboard to port, damage extending downwards from just below the waterline for approximately 2 metres. (See Figure 4.1)
- Buckling of the hull plating amidships mainly on the starboard side and extending from deck level down to the bilge keel.
- Extensive deck damage in front of the winch housing.
- Guardrail buckled, forward starboard side of whaleback.
- Minor scrape marks, mainly on the port side.
- Fish separator detached from its mountings.
- Miscellaneous minor damage: bridge floodlights broken, compass out of gimbals, etc.

- .1 The nature of the damage forward is consistent with the vessel being capsized at the time of impact rather than upright. While the damage to the forefoot could have been caused when upright by a bulbous bow, it is difficult to see how the upper part of a colliding vessel's bow could have damaged the rails without also causing other damage forward above the waterline.

FOREFOOT DAMAGE

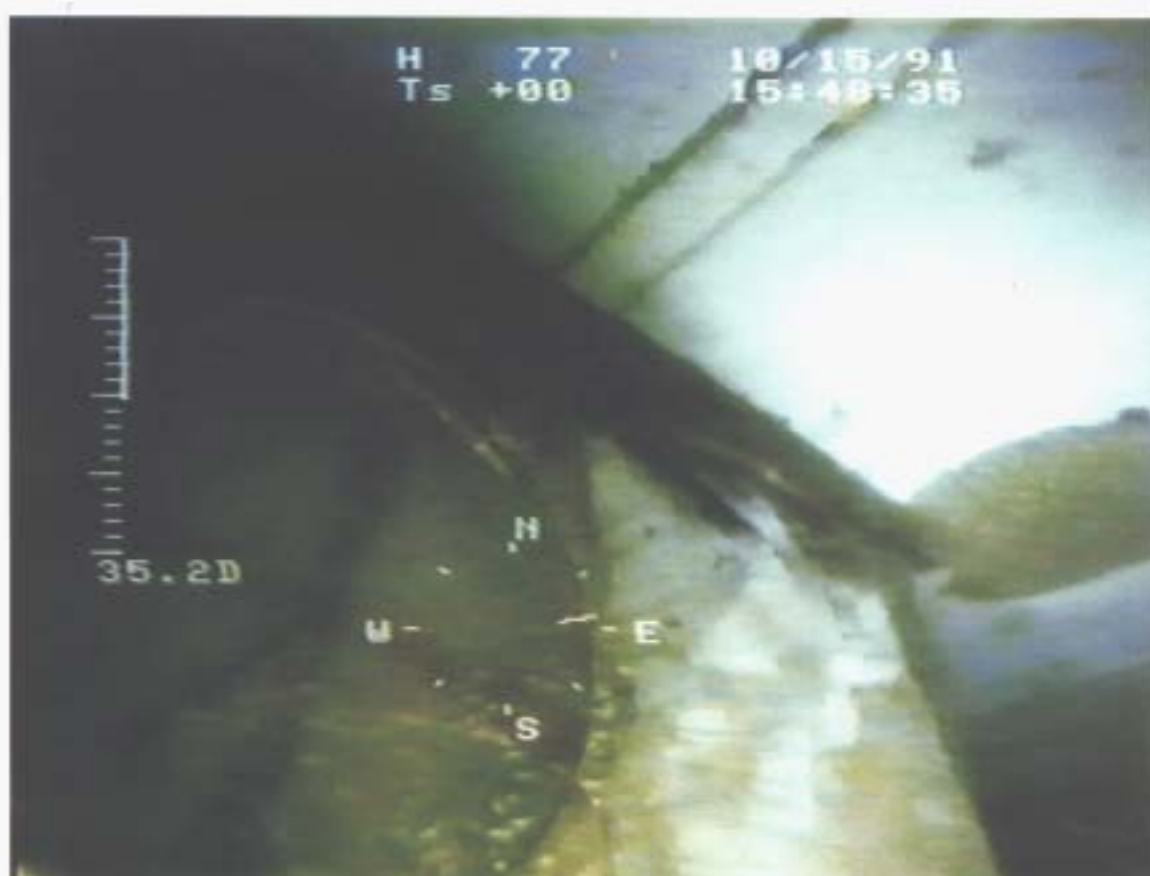
FIGURE 4.2

Investigation has shown that the vessel's bridge and galley clocks had stopped at about 1237 (ship's time), that is 2337 hrs GMT. This fact, coupled with the radar record and other evidence, indicates that at 2337 hrs on 10 August OCEAN HOUND was probably involved in a collision or very close quarter situation with an unidentified vessel, causing her immediate capsize.

- Rudder hard to starboard.
- Engine control at Full Ahead.
- Wheelhouse clock stopped at 1237, galley clock at 1235. (See Figure 4.2)
- Port derrick and fishing gear stowed, starboard derrick out.
- Hatch to engine room from wheelhouse jammed partly open.
- Galley drawers thrown out to starboard.
- Bulwark freeing port hinged cover plates on both sides of the vessel jammed open.
- Of those parts that were visible, there appeared to be no penetration of the shell plating.
- There appeared to be no damage to the vessel's superstructure, masts or derricks.

WHEELHOUSE CLOCK SHOWING 1237
