Combined report on the investigations of the  
sinking and abandonment of the DUKW amphibious passenger  
vehicle

## ***Wacker Quacker 1***

fire and abandonment of the DUKW amphibious passenger  
vehicle

## ***Cleopatra***

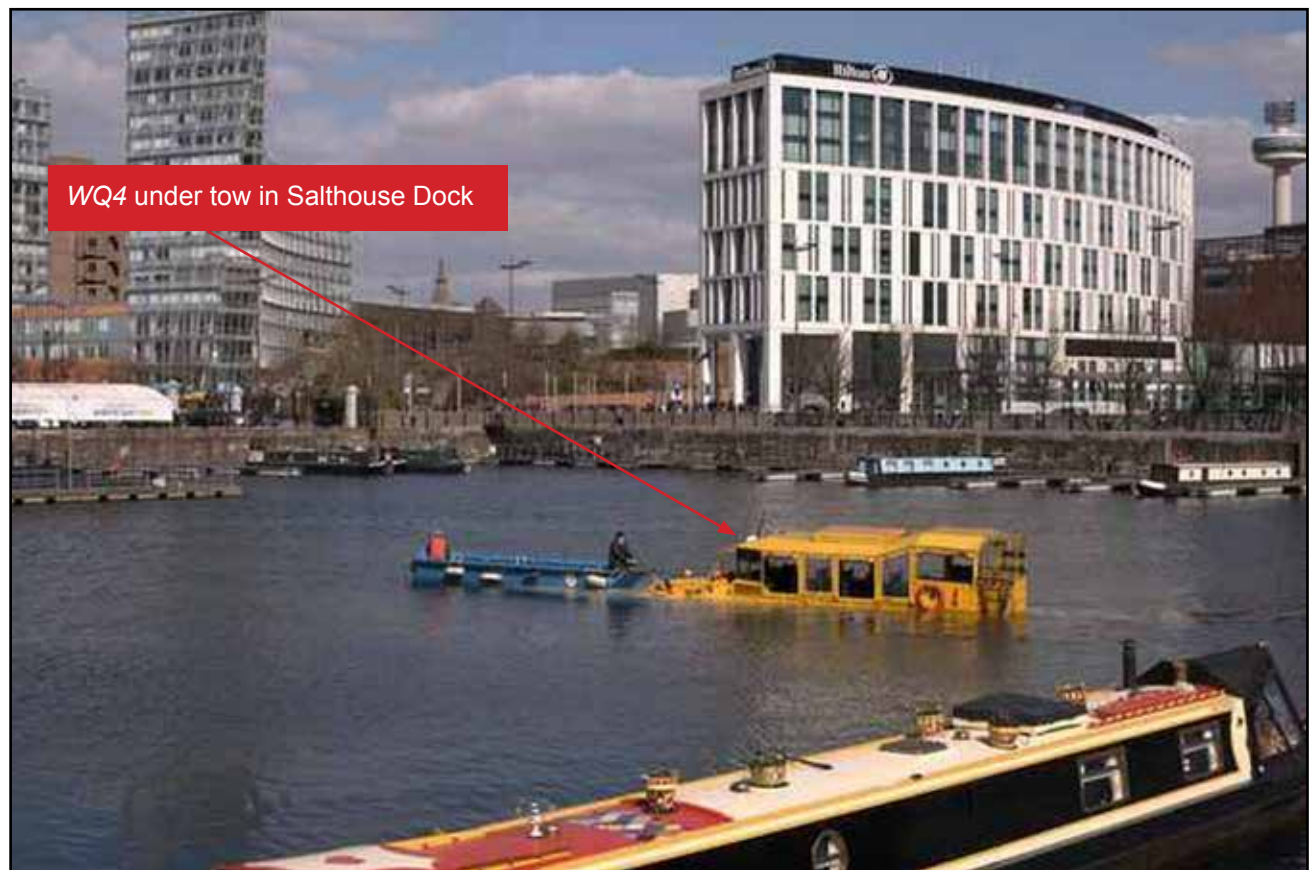
On 30 March 2013, *WQ4* sank (**Figure 2**) while under tow in Salthouse Dock, Liverpool. There was no one on board at the time, and the sinking was investigated by the Maritime and Coastguard Agency (MCA). During its investigation, the MCA discovered that the hulls of TYD's vehicles did not contain the appropriate quantities of buoyancy foam required to keep them afloat when flooded. The MCA immediately suspended TYD's waterborne operations and instructed the company to insert an agreed volume of additional foam. TYD engaged the services of an independent firm of naval architects, Burness Corlett Three Quays Ltd (BCTQ), to calculate how much foam was needed to meet the MCA's requirements. Six weeks later, having satisfied the MCA that it had met its buoyancy standards, TYD resumed its operations on the water.

**Figure 2:** *Wacker Quacker 4* sinking in Salthouse Dock, Liverpool, on 30 March 2013

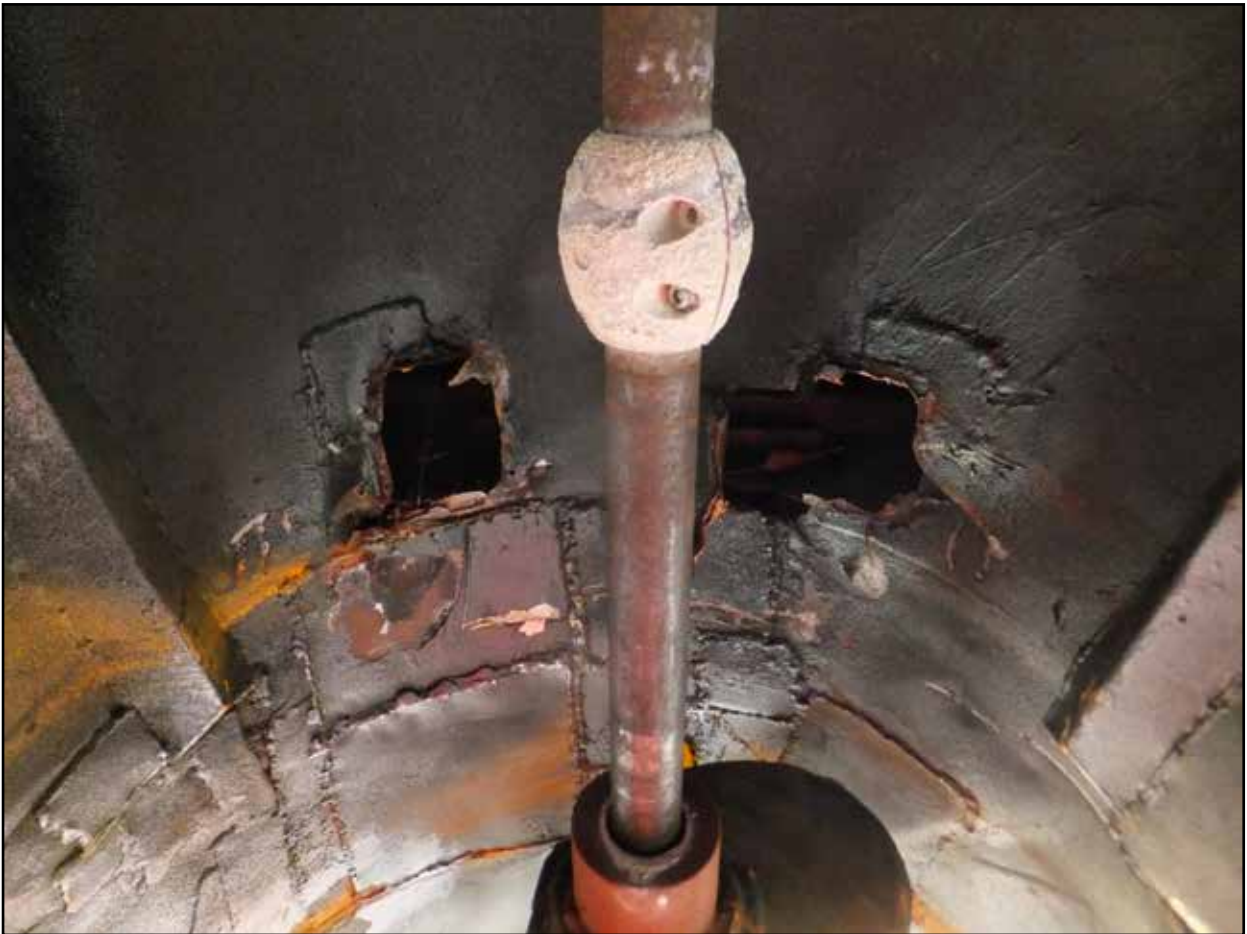
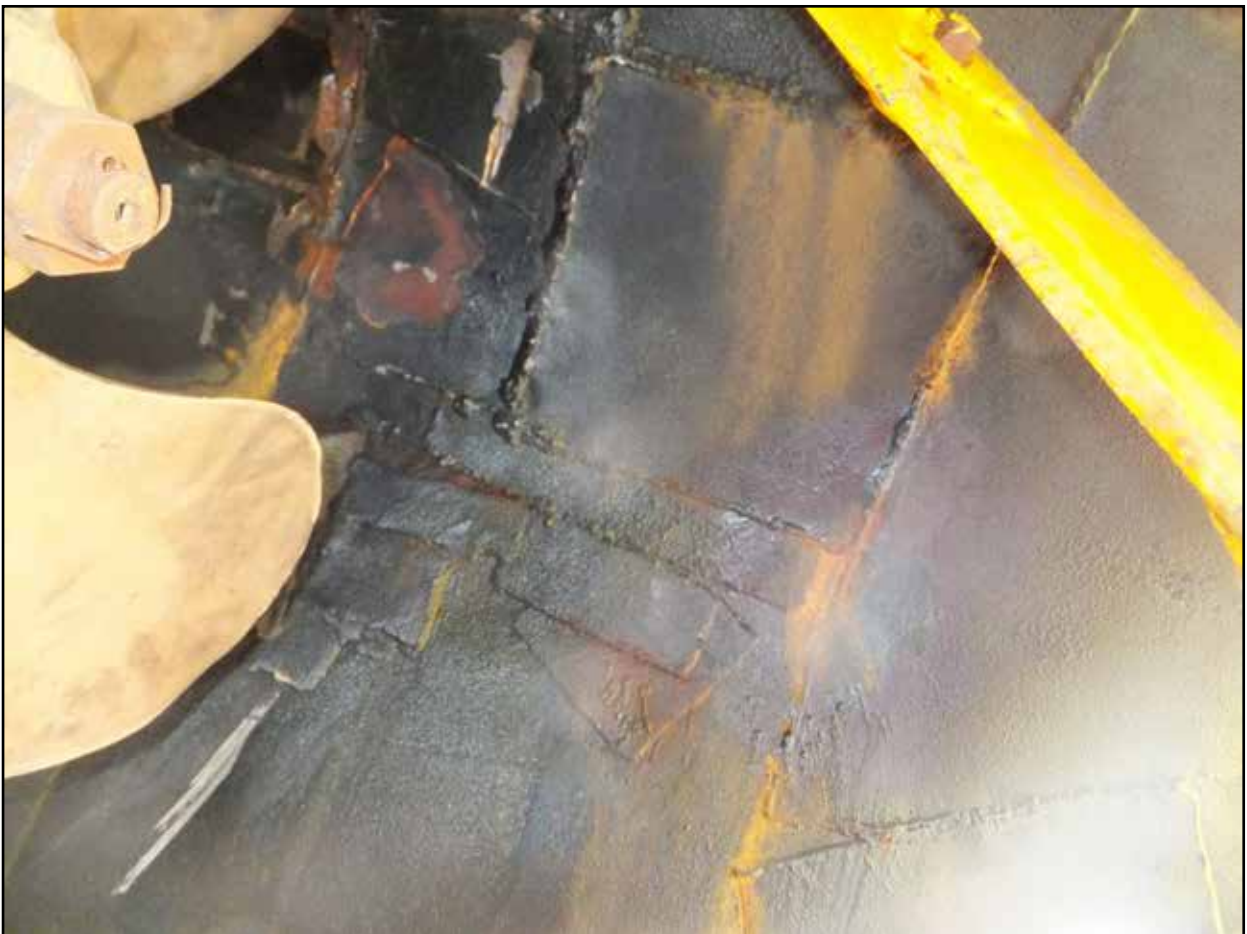
**Figure 21:** External patch repairs to the hull of *Wacker Quacker 1*

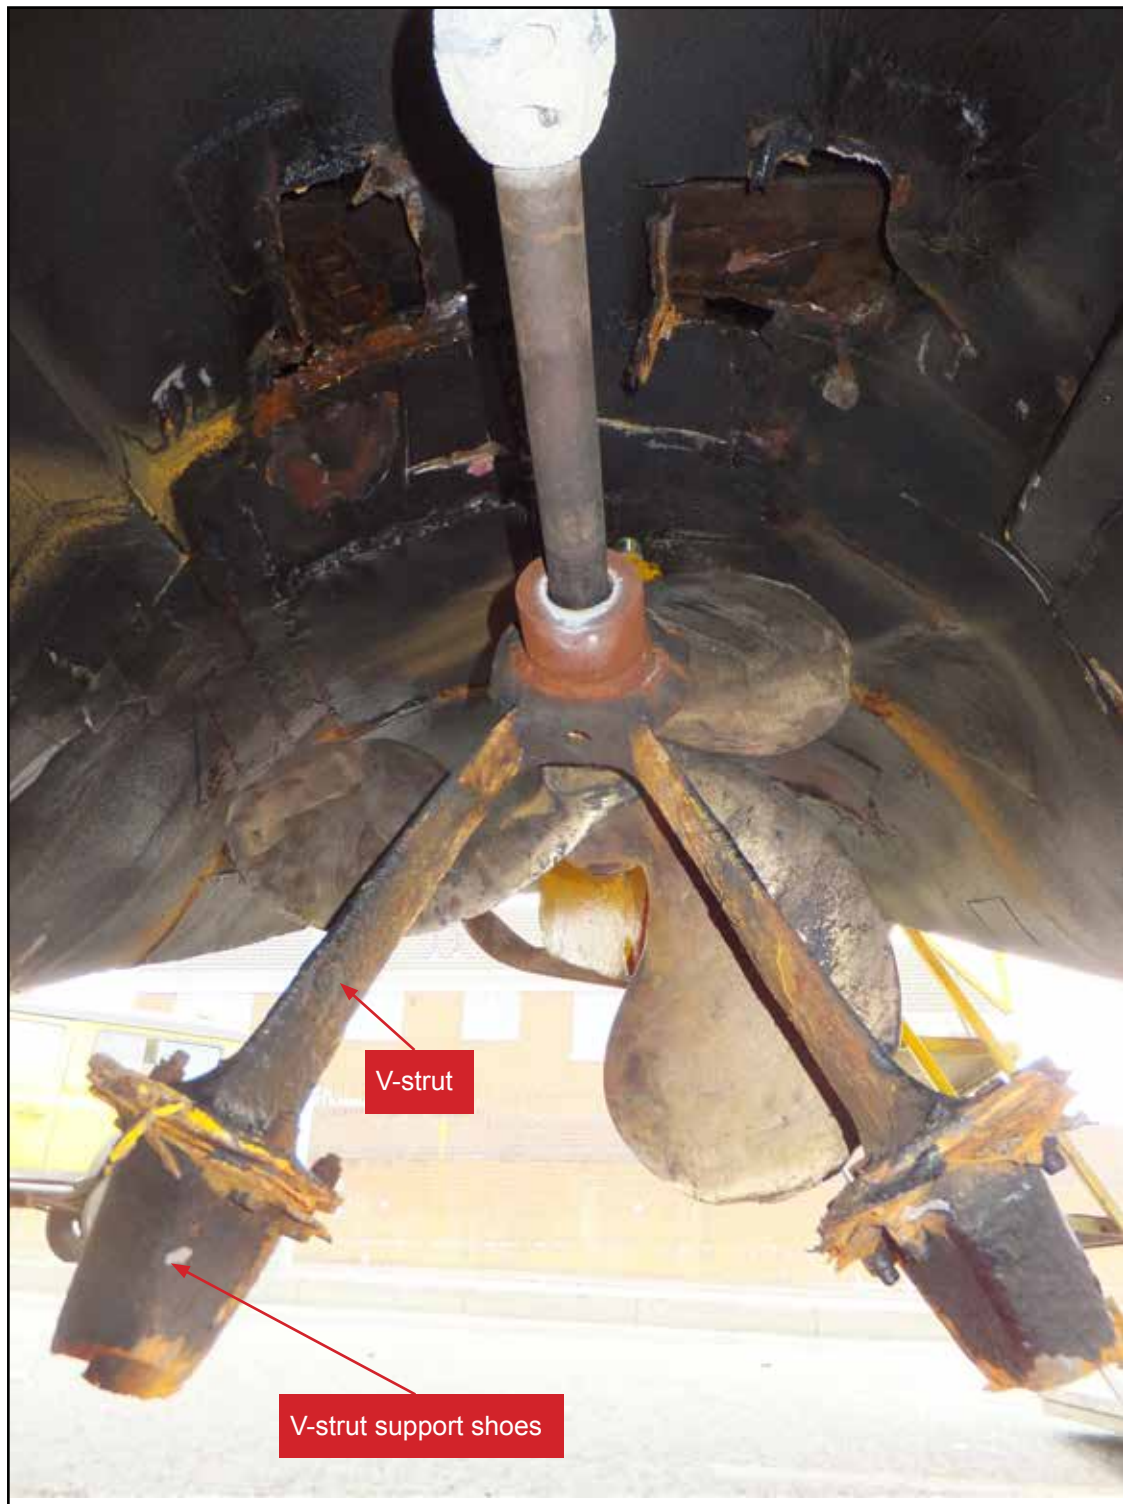
**Figure 22:** V-strut suspended from *Wacker Quacker 1*'s propeller shaft

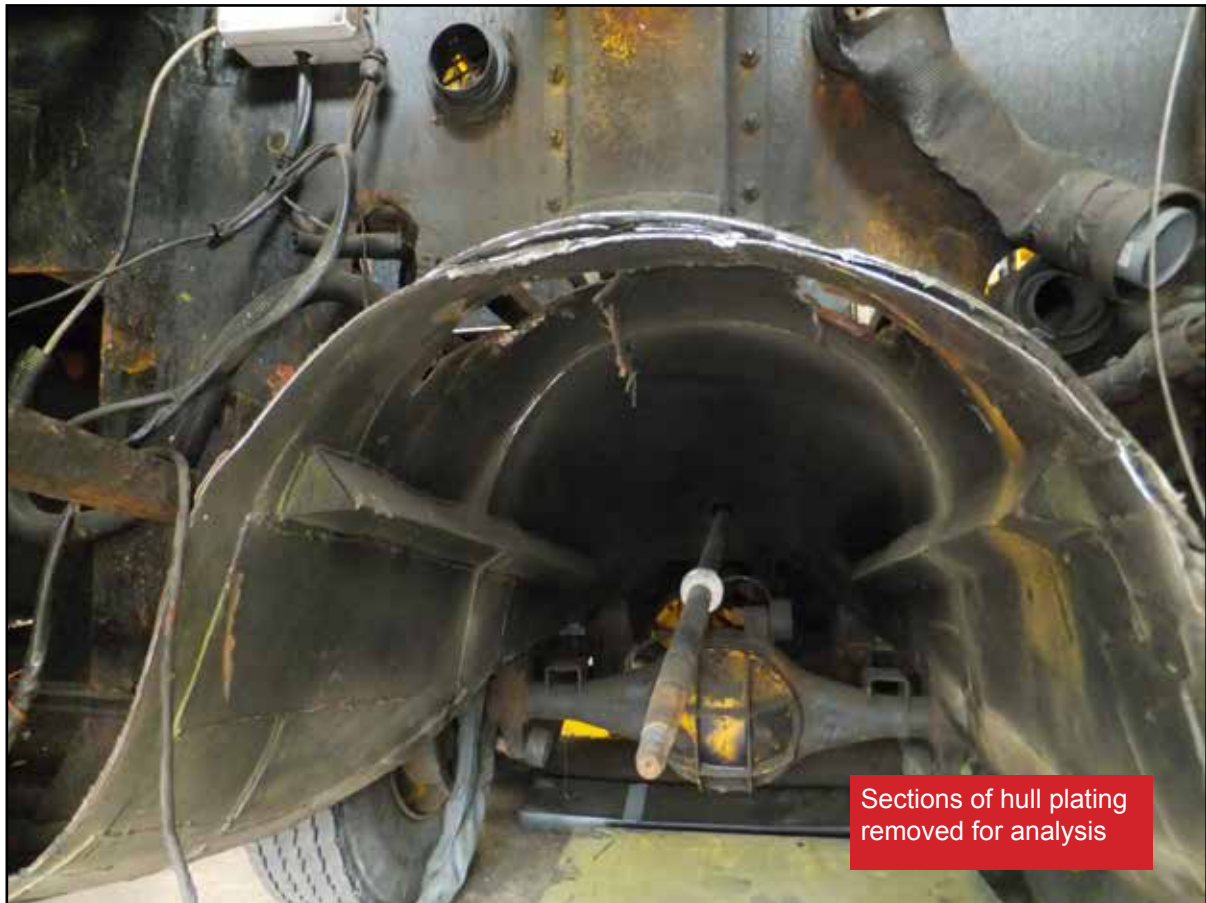
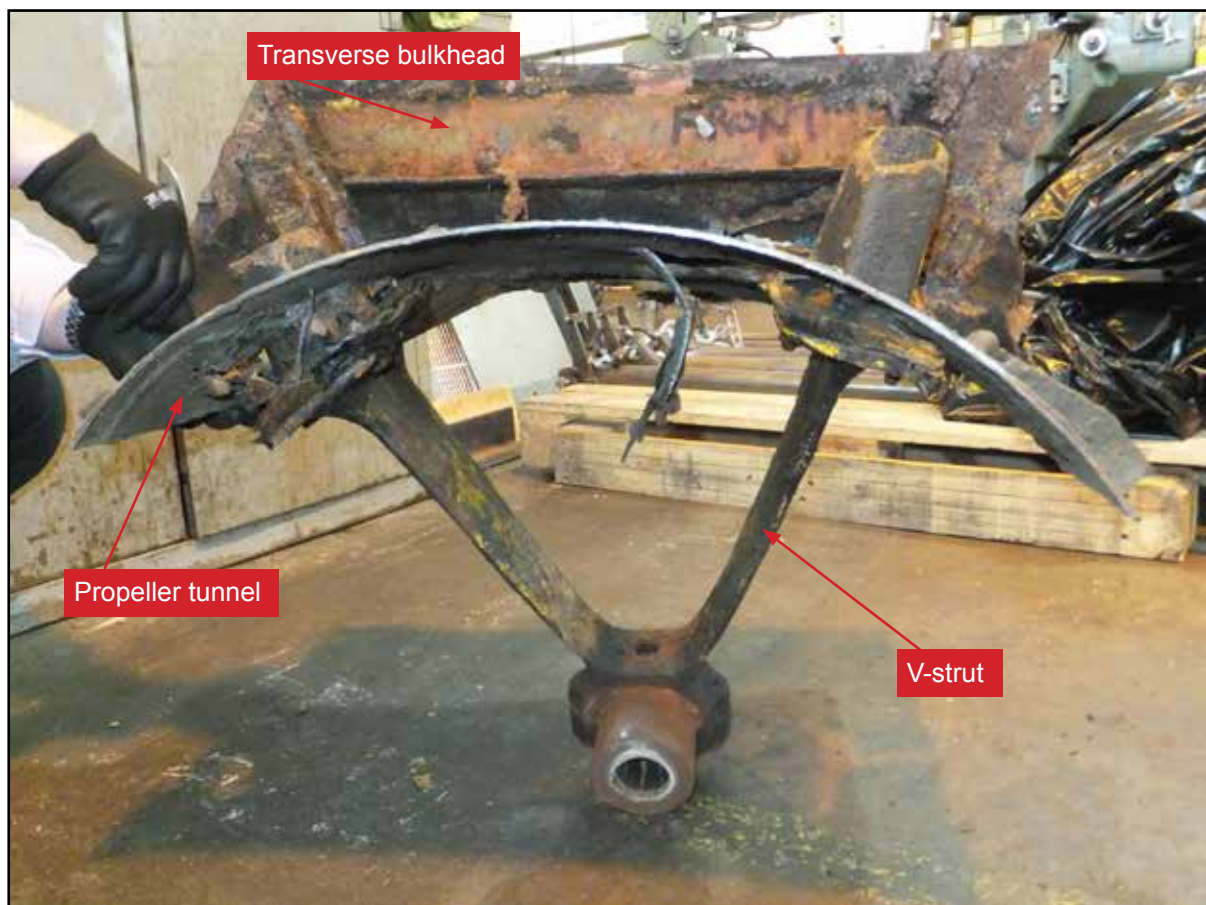
Two sections of the propeller tunnel plating and a section of the aft transverse bulkhead were cut from the hull of *WQ1* and were sent, along with the propeller shaft v-strut (**Figure 23**), to The Test House (Cambridge) Ltd for metallurgical analysis. One of the tunnel sections included the two holes where the v-strut feet had been attached. The other section included large areas where it was evident that previous hull repairs had been carried out. The section of transverse bulkhead included the area where the v-strut support shoes had been attached.

**Figure 23:** Sections of propeller shaft tunnel and aft transverse bulkhead cut away and despatched for metallurgical analysis

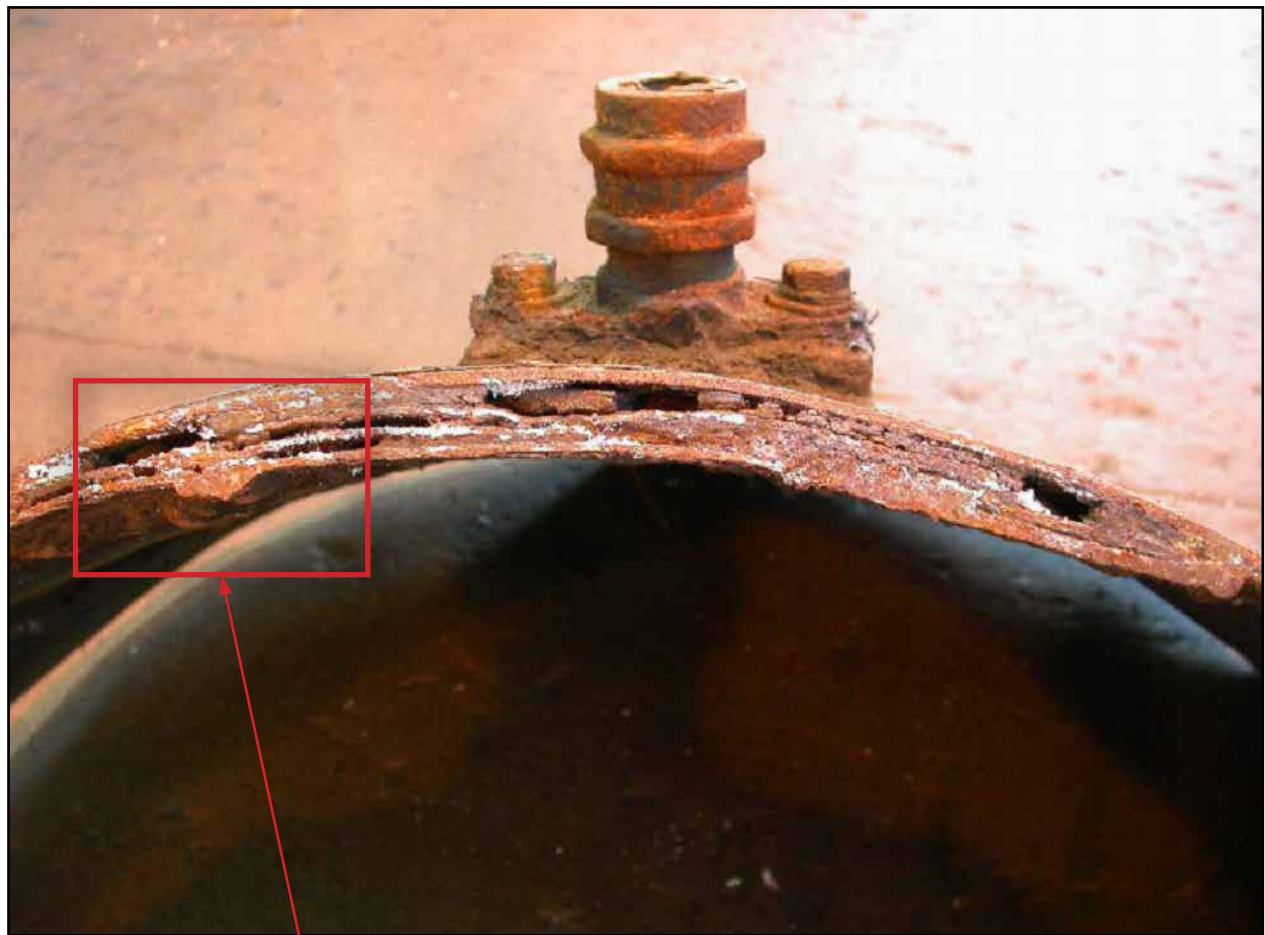
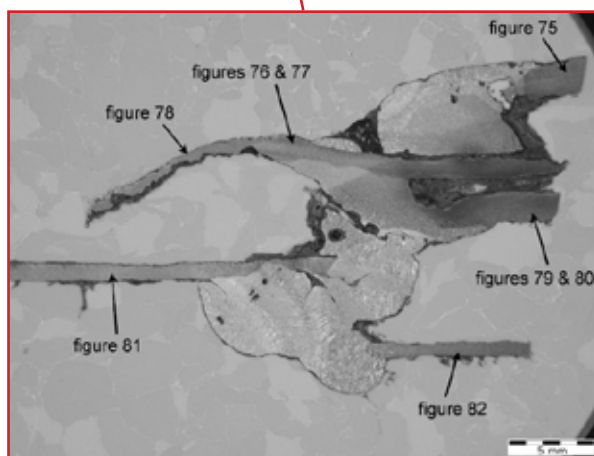
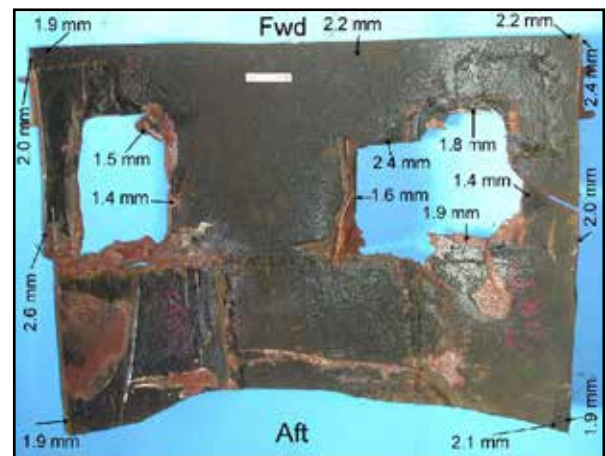
Layers of welded patch repairs

Plate thicknesses around the holes where v-strut feet had been attached

**Figure 24:** Analysis of propeller tunnel plating and welded repairs

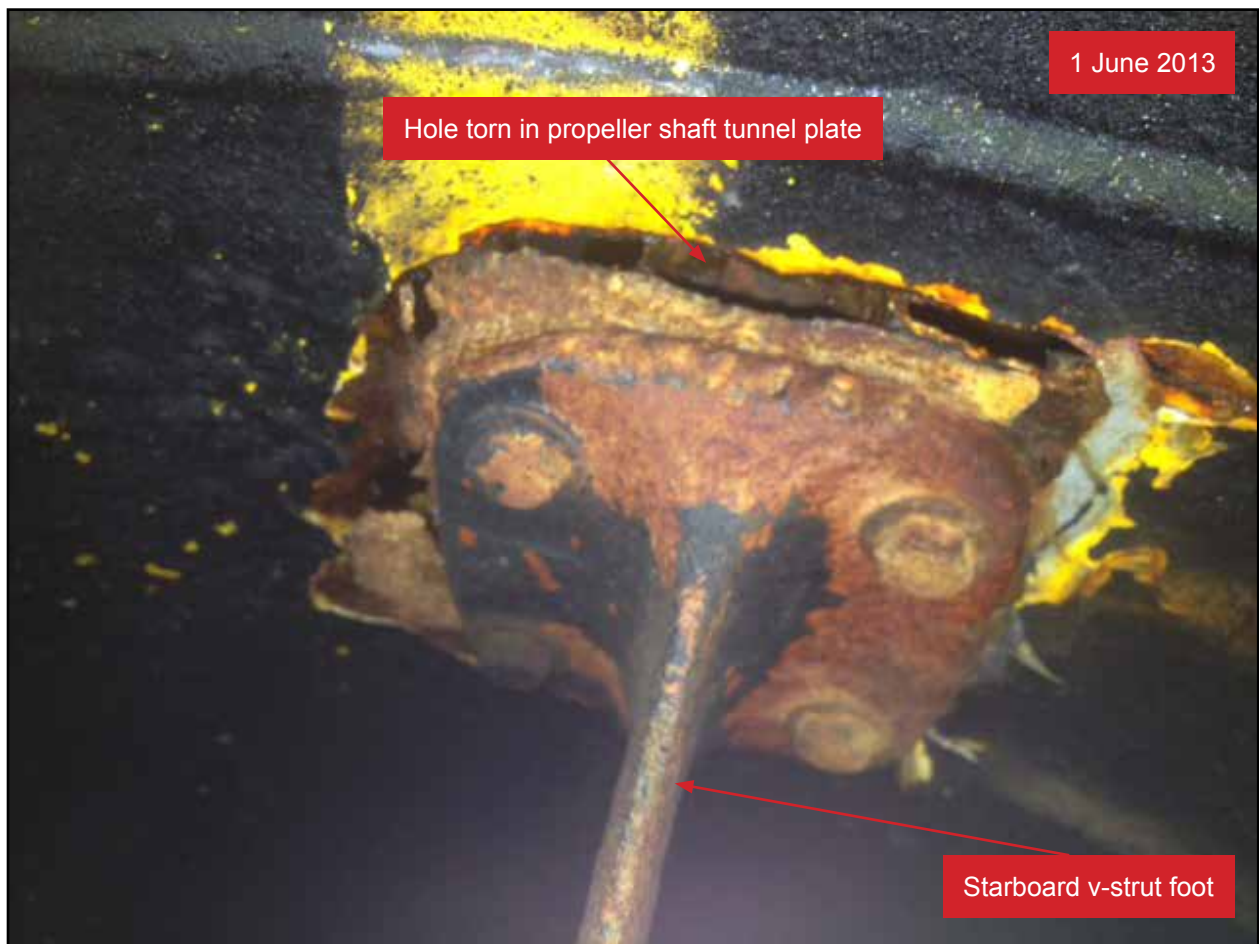
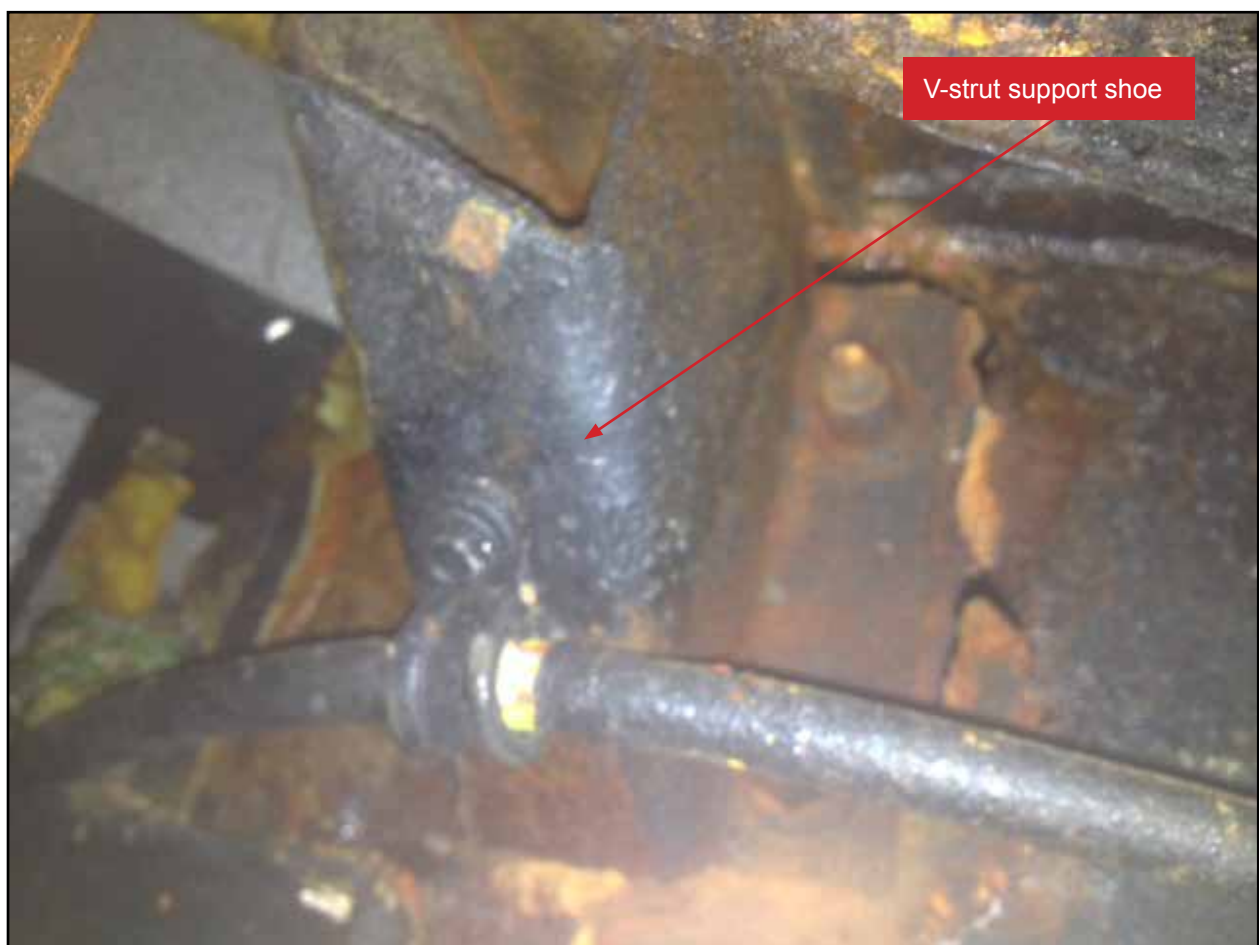
**Figure 29:** Similar hull failure discovered on board *Wacker Quacker 2* two weeks earlier

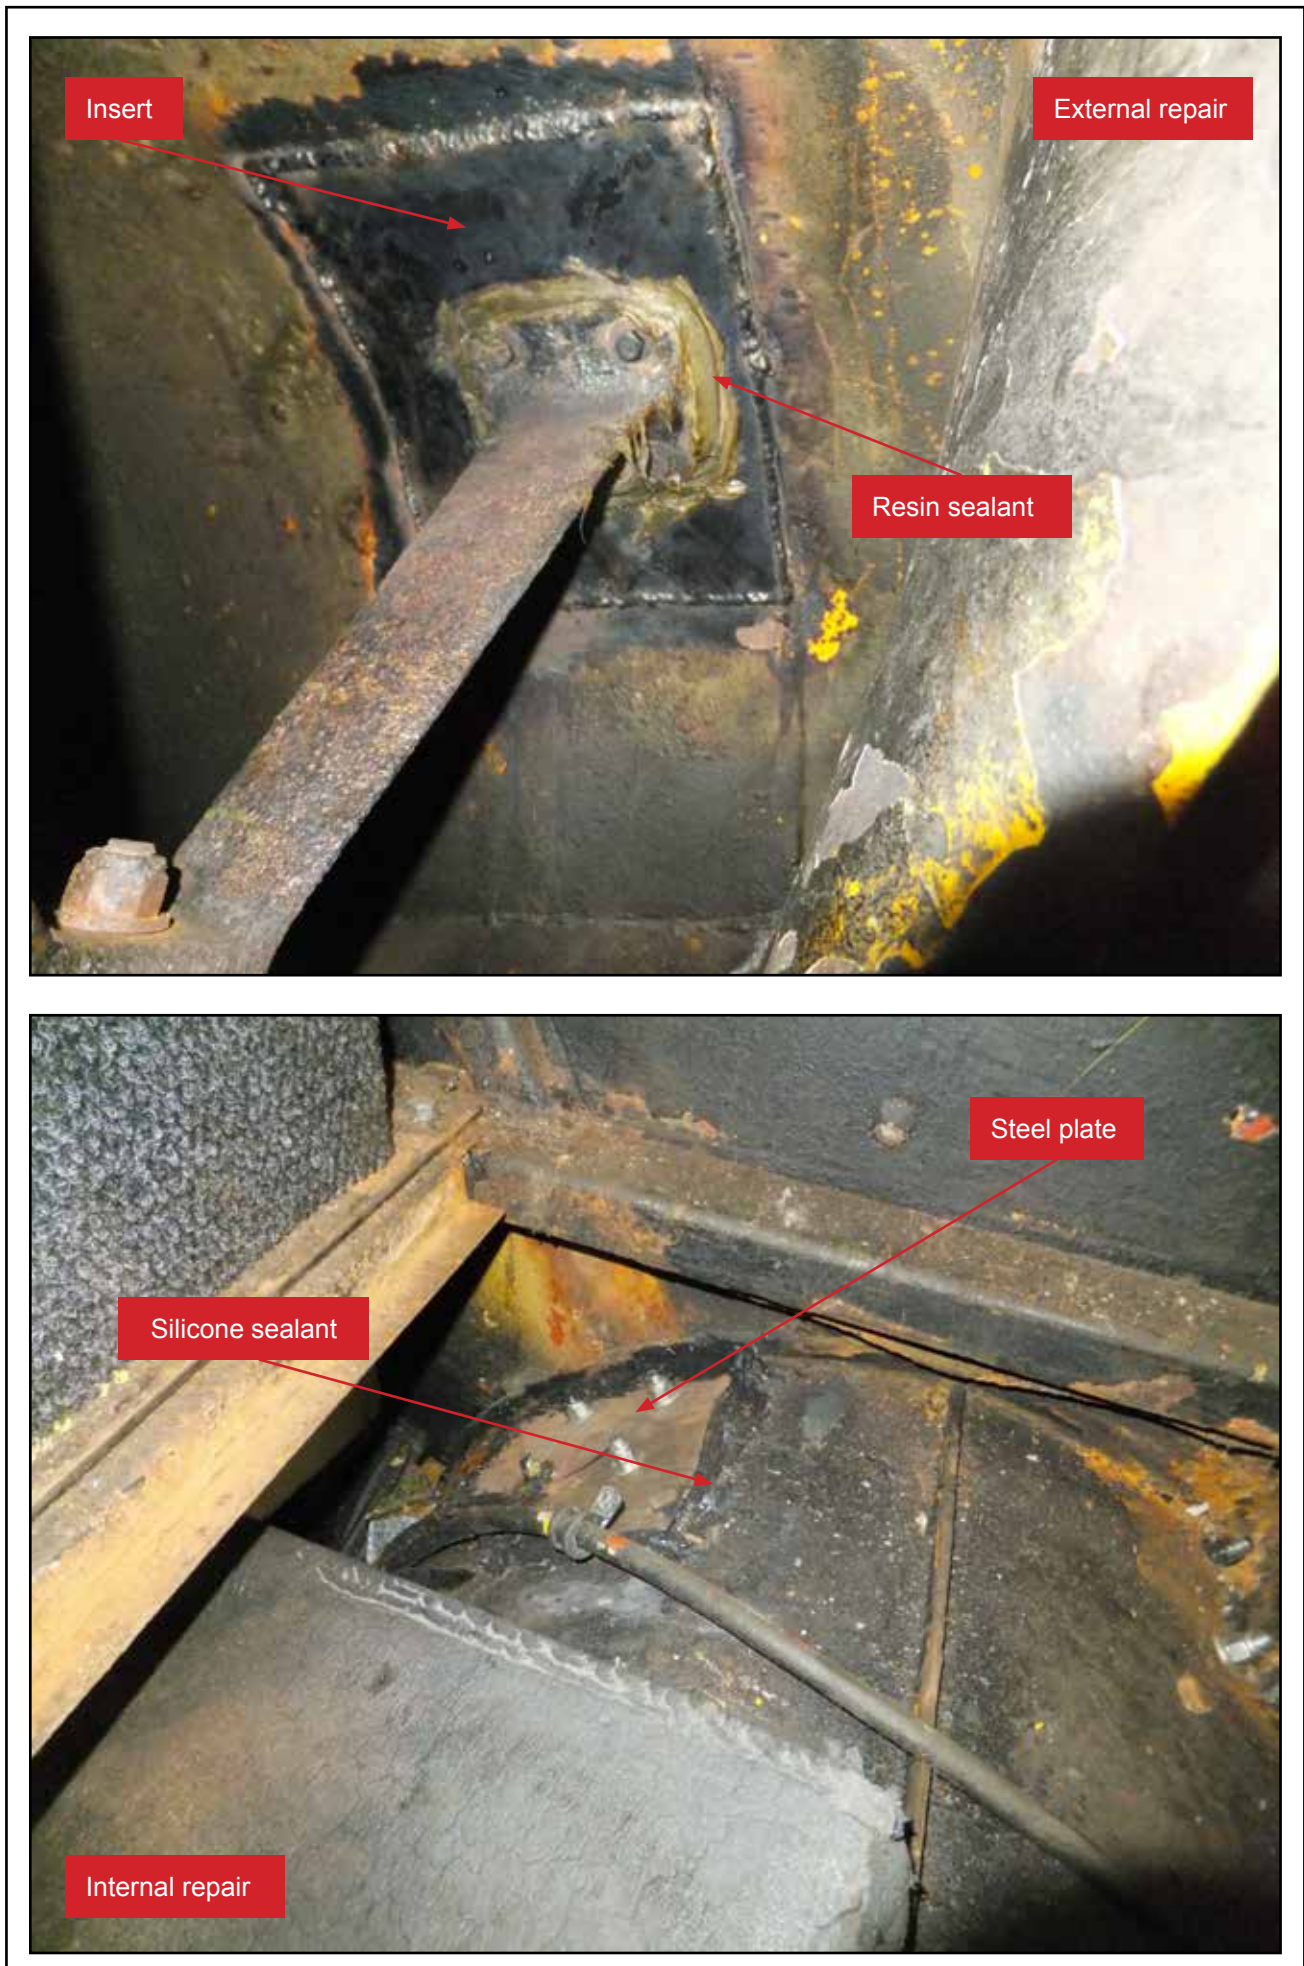
**Figure 30:** Hull repairs carried out by garage staff

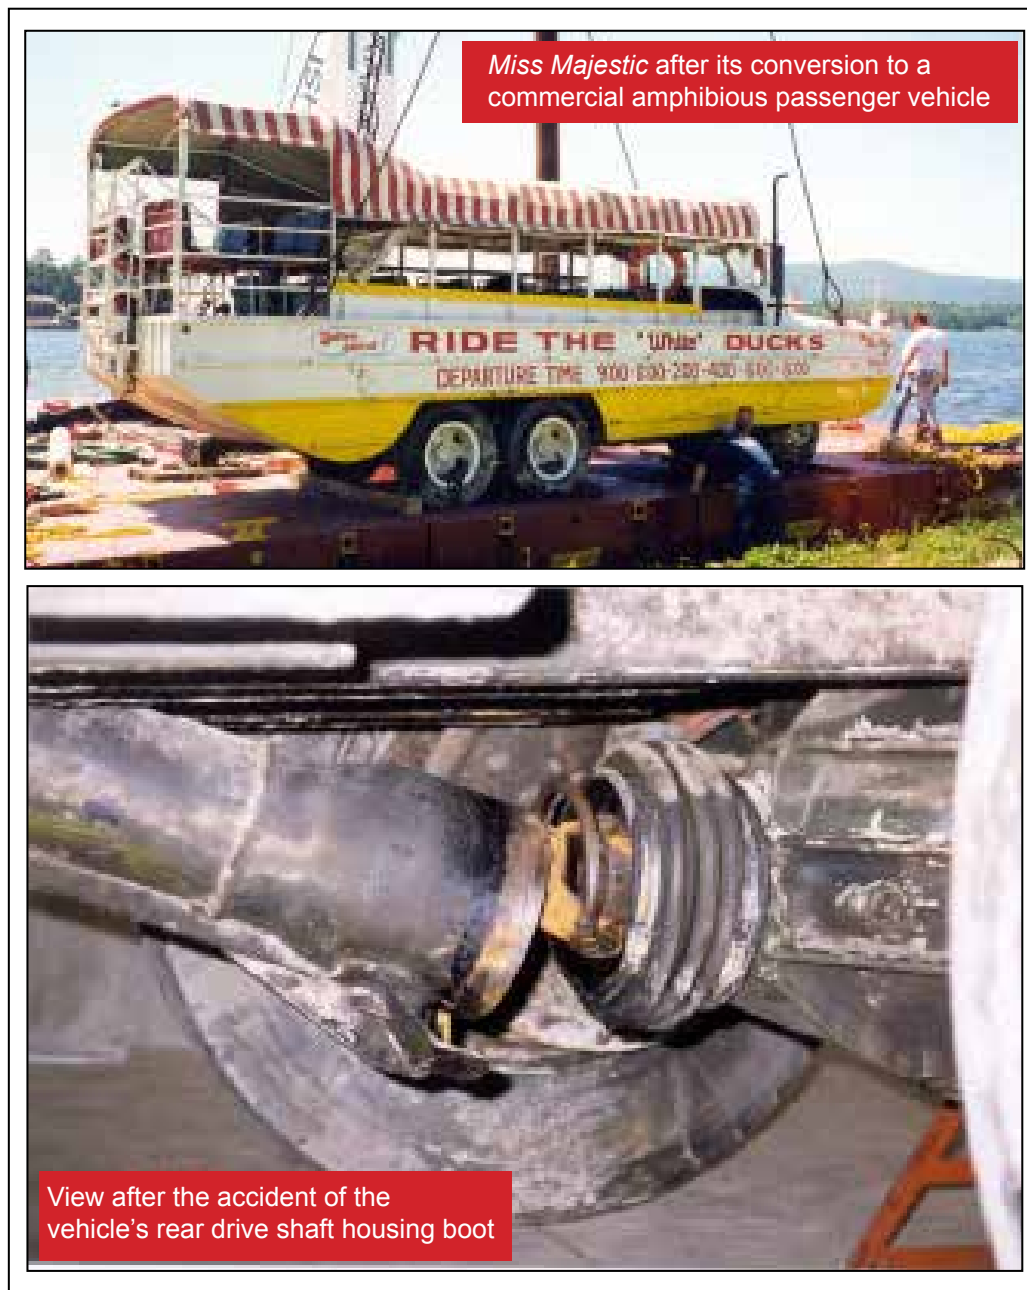
When *Miss Majestic* was inspected after she had been recovered from the lake bed, the investigators discovered that the rear drive shaft housing's aft rubber boot had worked loose because it had not been fitted correctly (**Figure 31**).

**Figure 31:** Sinking of DUKW *Miss Majestic* on 1 May 1999

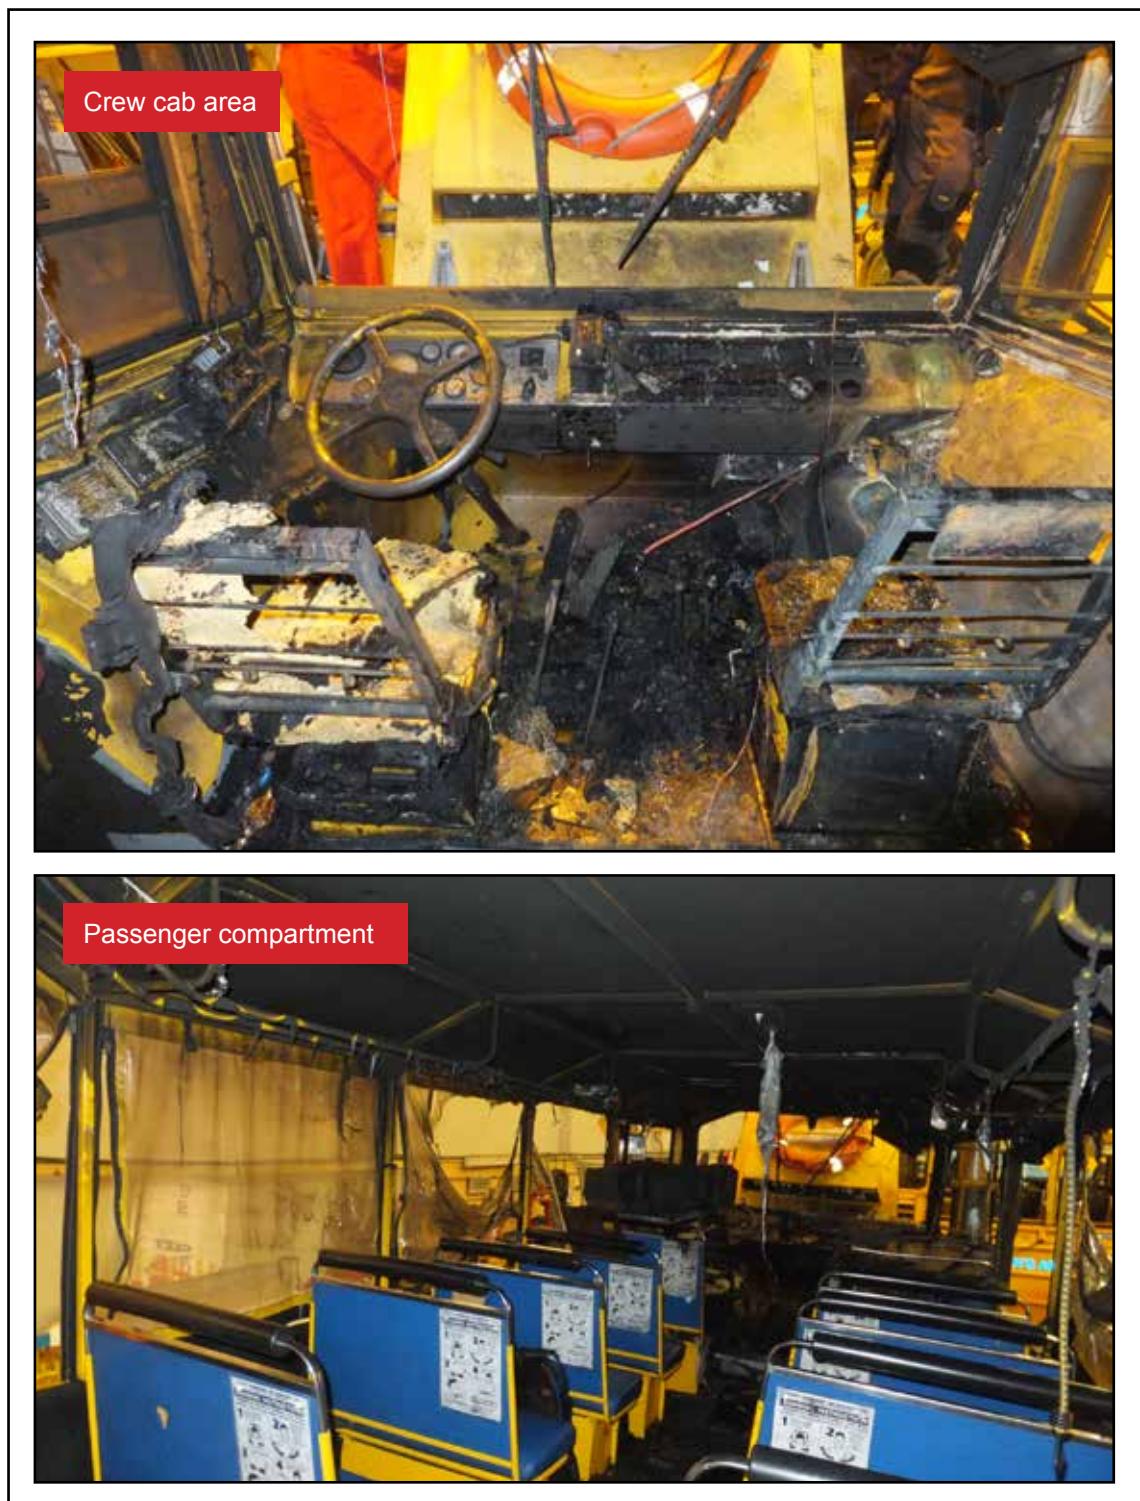
The underside of the engine compartment access hatch had been fire damaged and was coated with soot, as was the compartment's aft transverse bulkhead. The engine's fuel filter/water-separator bowl had partially melted. The engine and automatic gearbox oil levels were checked and found to be at the correct running levels.

**Figure 52:** Fire damaged passenger compartment and crew cab

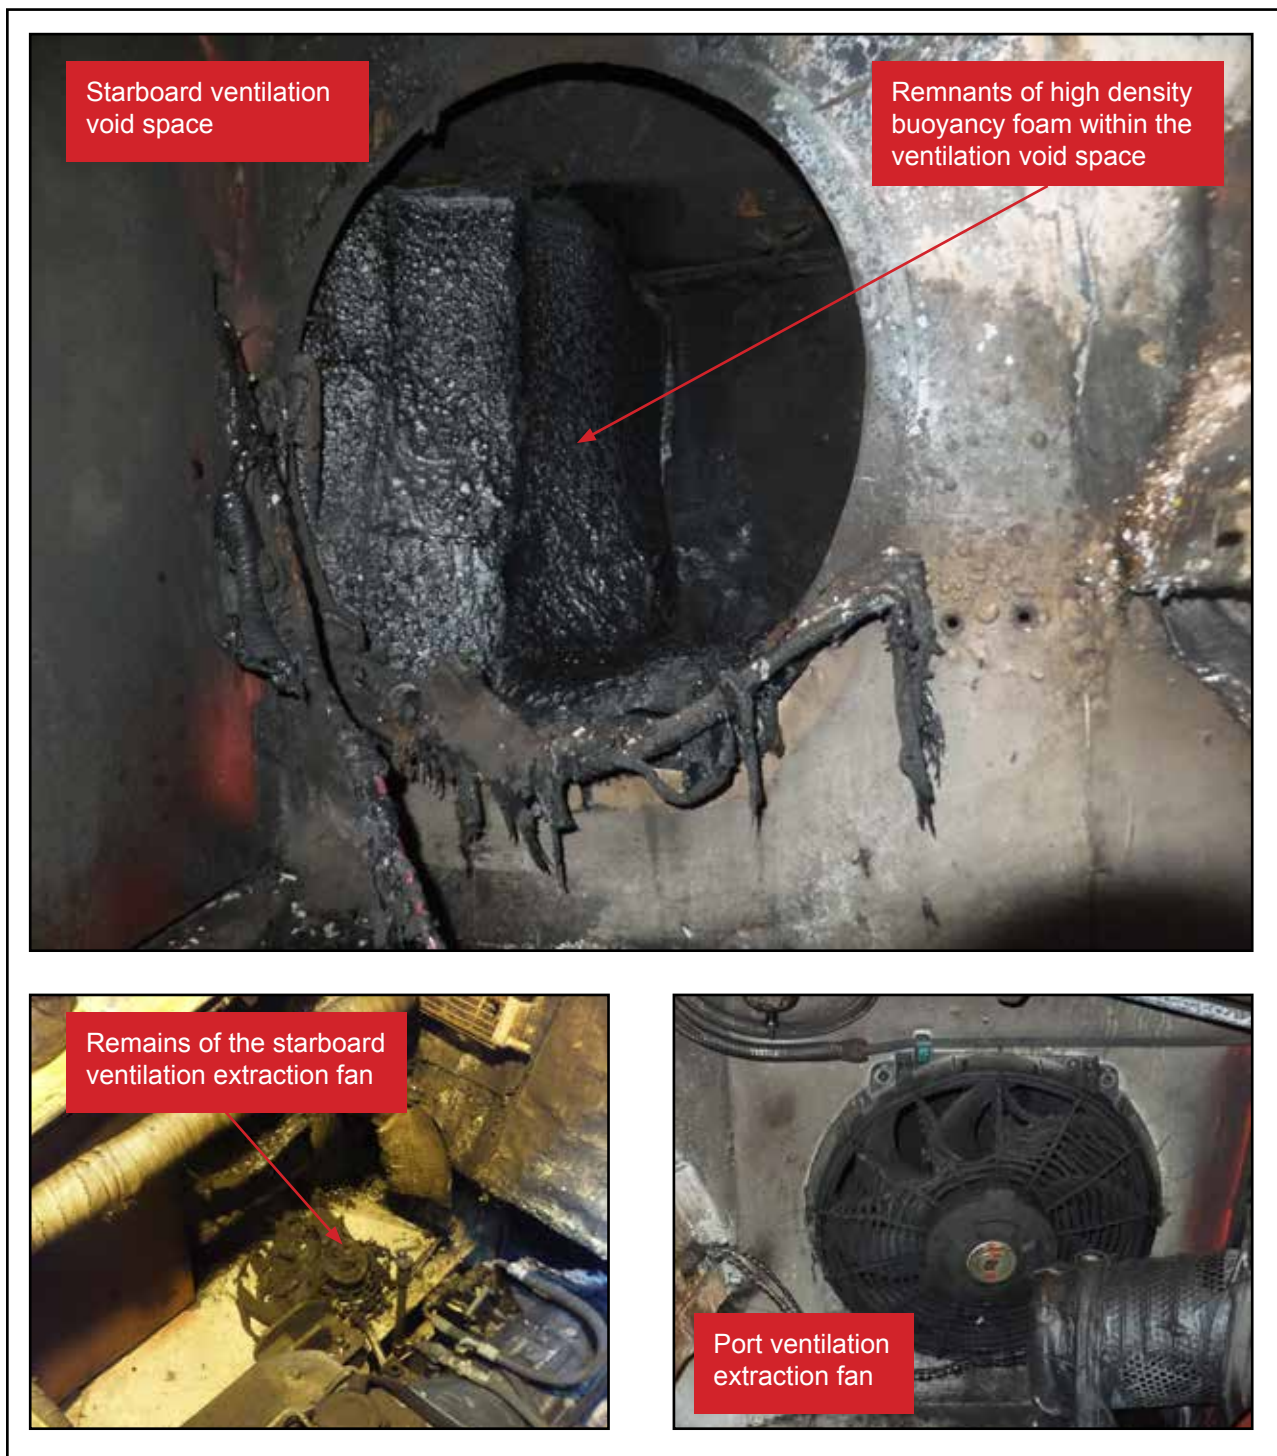
The starboard extraction fan had suffered extensive heat damage with most of its plastic grille consumed. The fan had fallen from its fastenings and was found on the wheel arch (**Figure 53**). The port extraction fan remained intact but its plastic protective grille had suffered minor heat damage and was covered in soot deposits.

**Figure 53:** Fire damage within the engine compartment and starboard ventilation void space

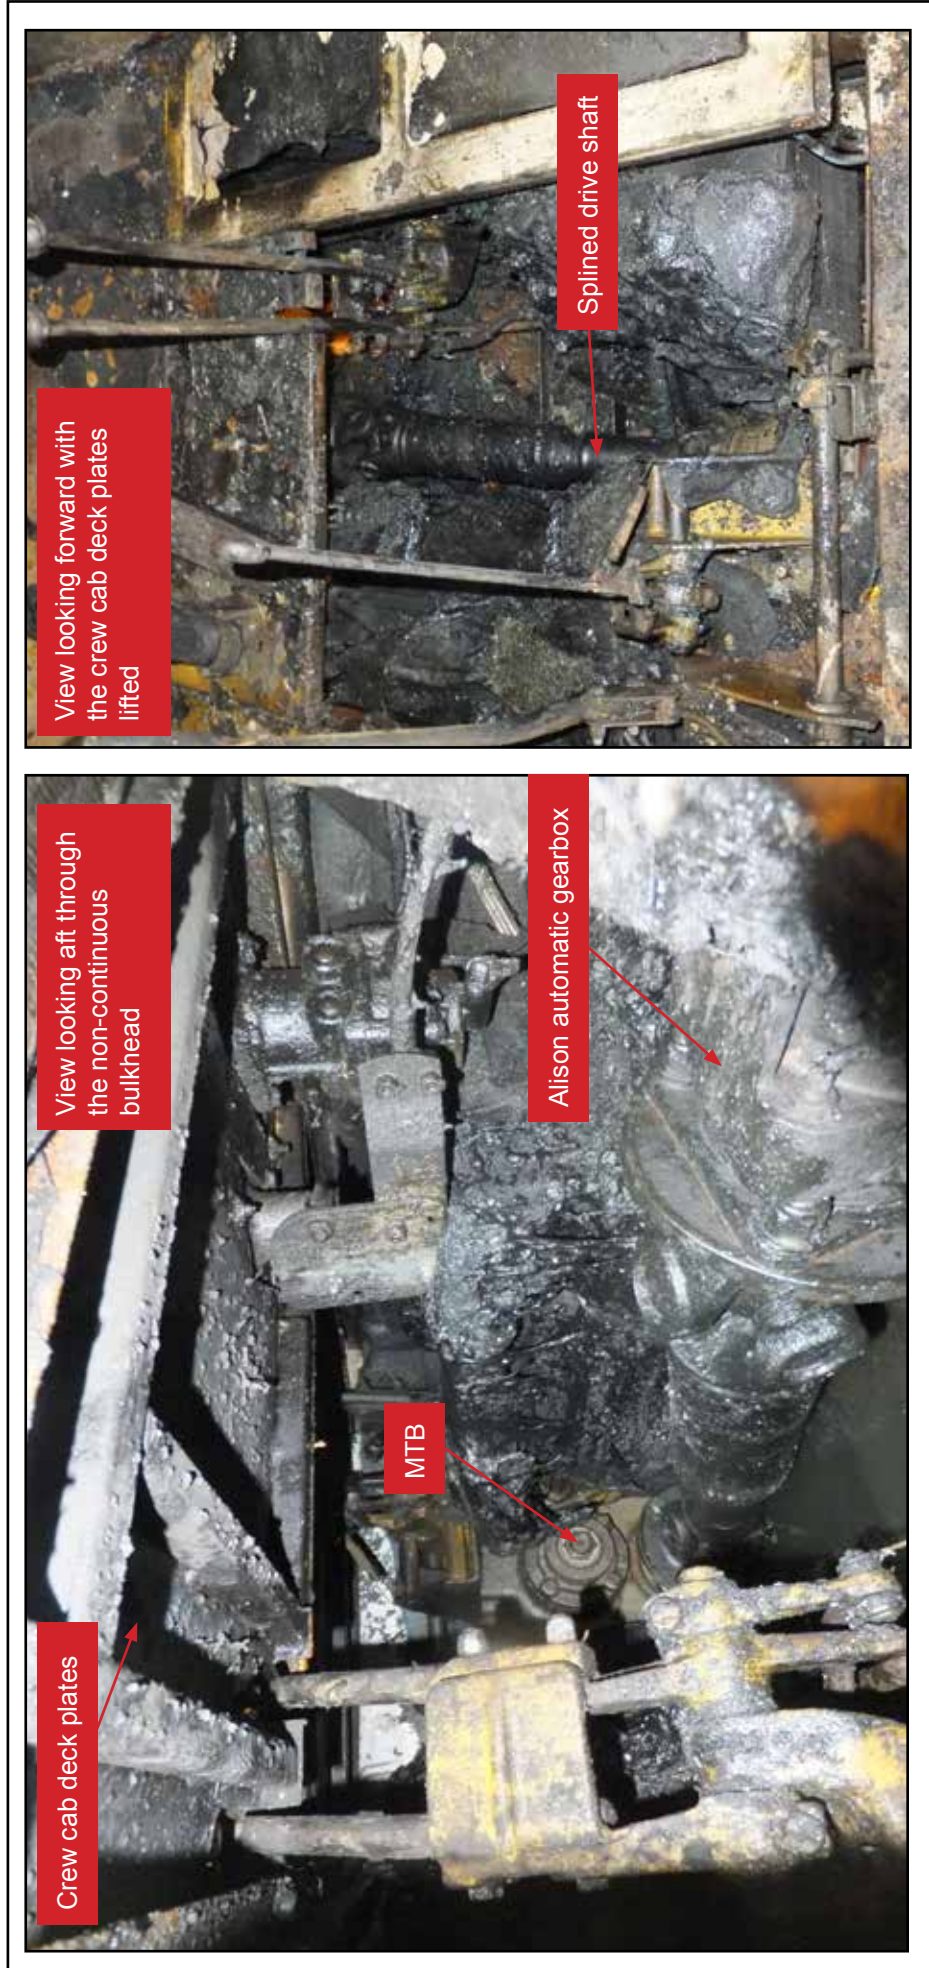
**Figure 54:** Fire damage under the crew cab

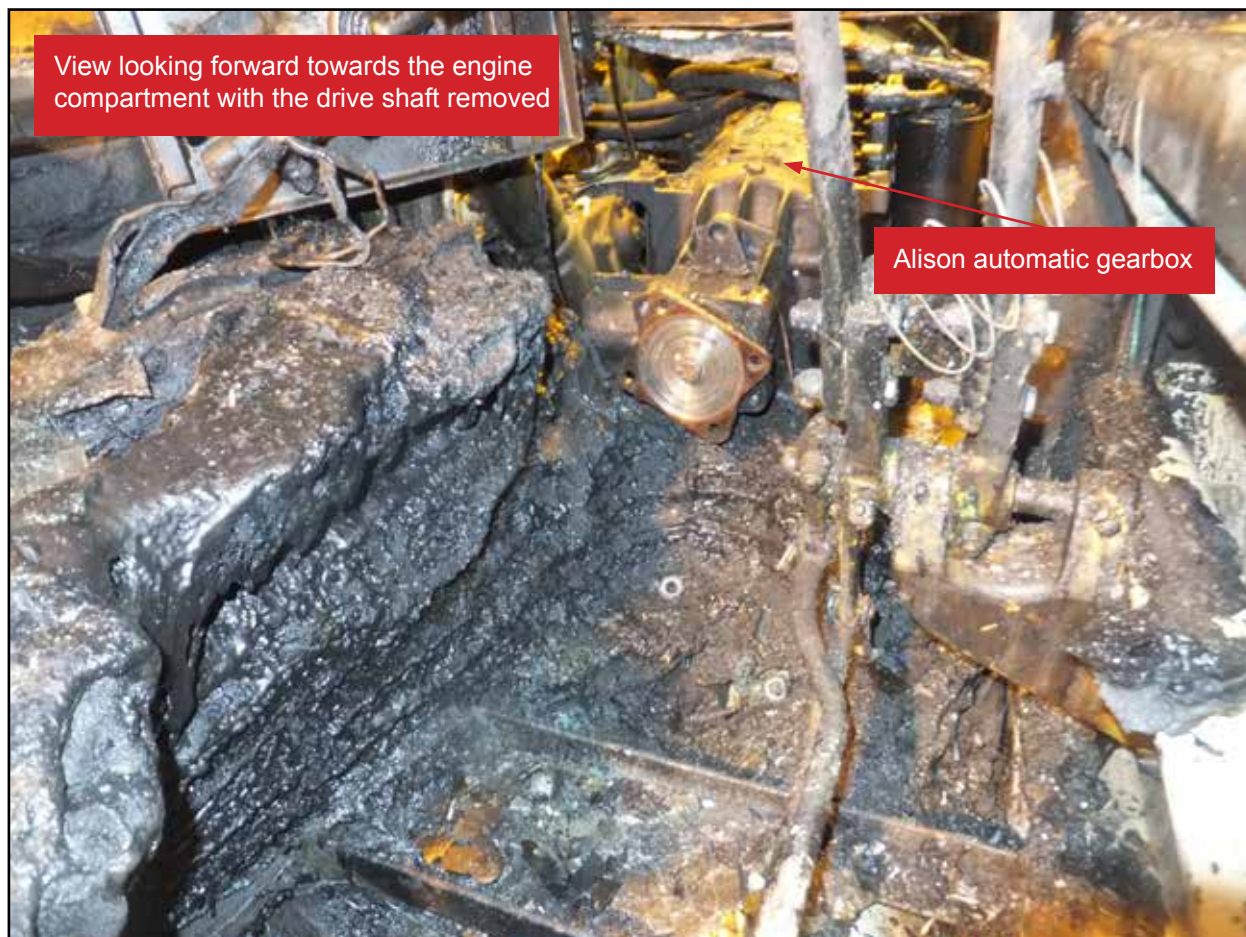
**Figure 55:** Area of deepest burn within central void space aft of the automatic gearbox
