Combined report on the investigations of the  
sinking and abandonment of the DUKW amphibious passenger  
vehicle

## ***Wacker Quacker 1***

fire and abandonment of the DUKW amphibious passenger  
vehicle

## ***Cleopatra***

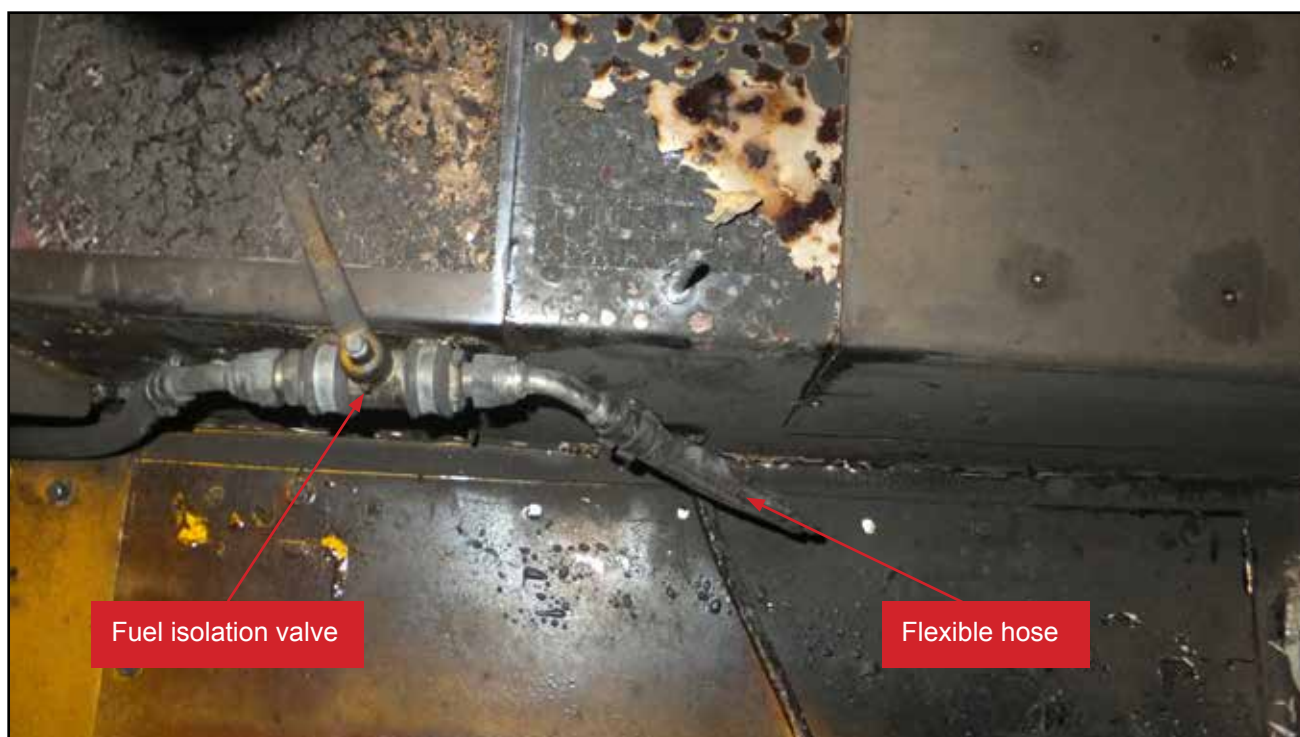
**Figure 56:** Burnt through section of flexible hose

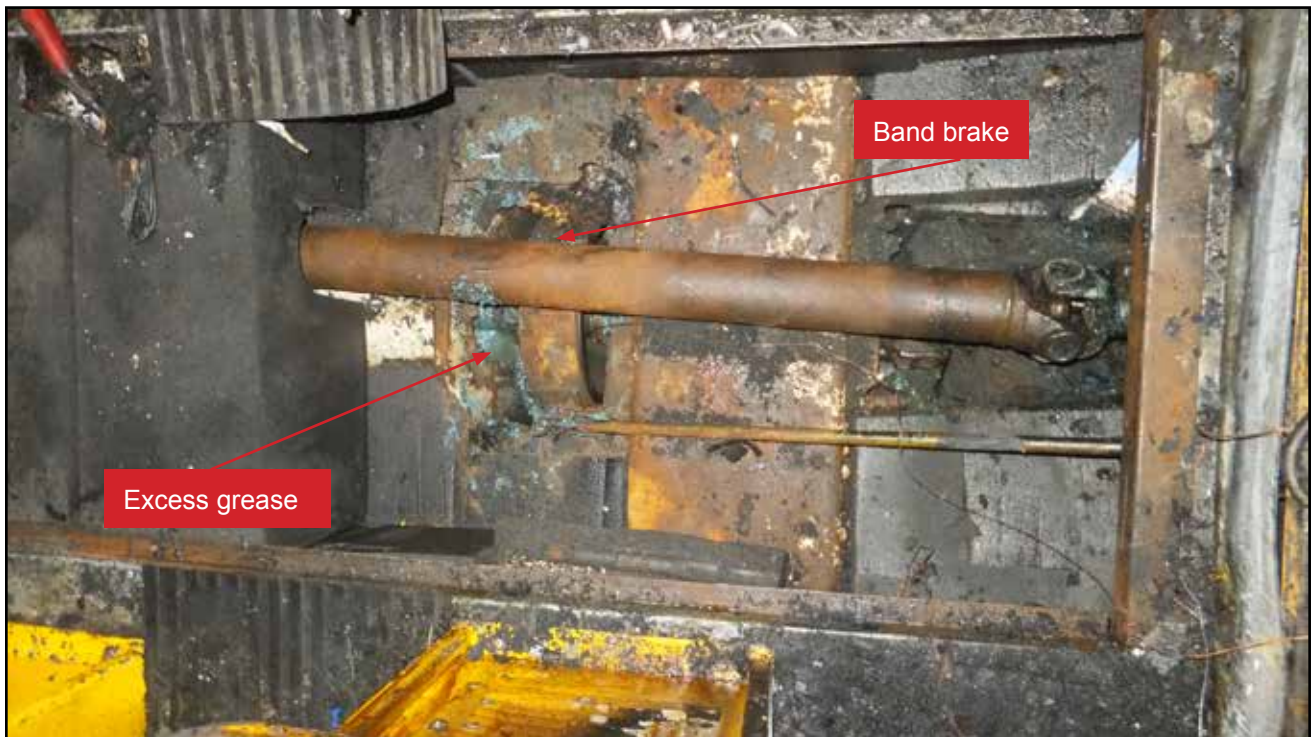
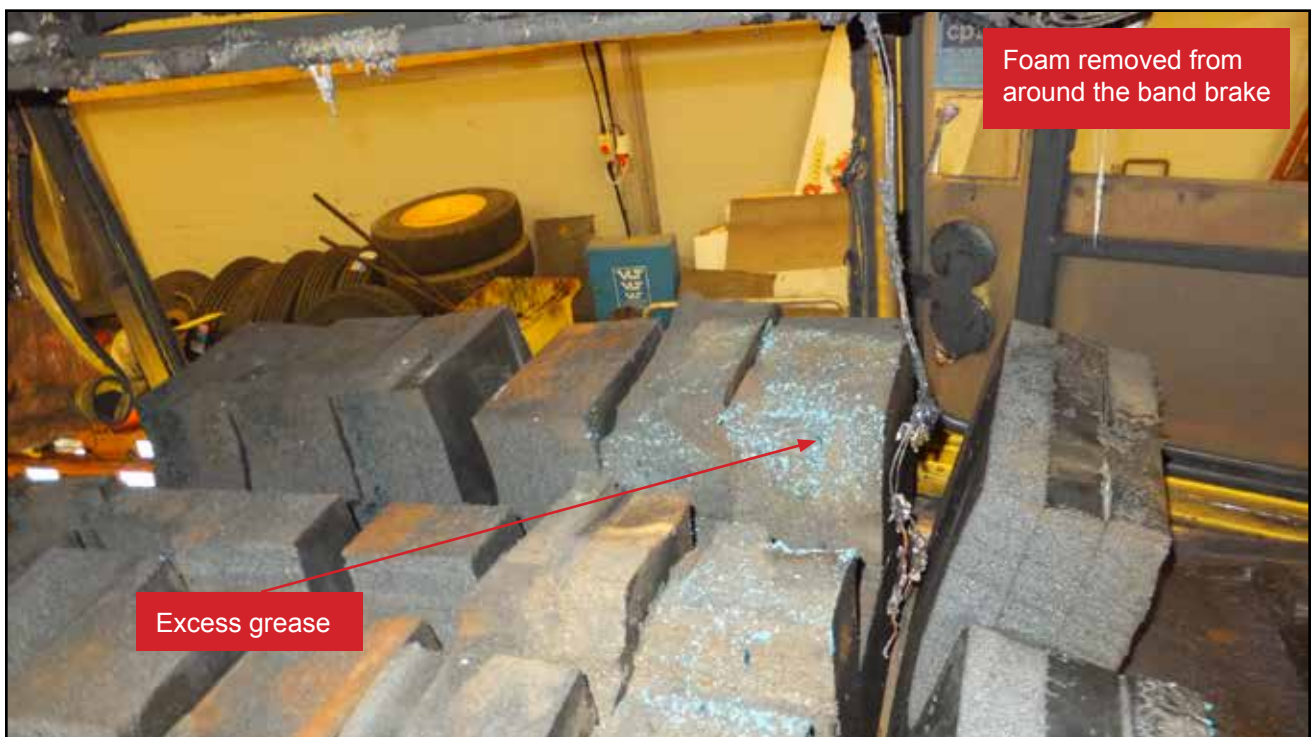
**Figure 57:** Grease contaminated foam removed from around the band brake

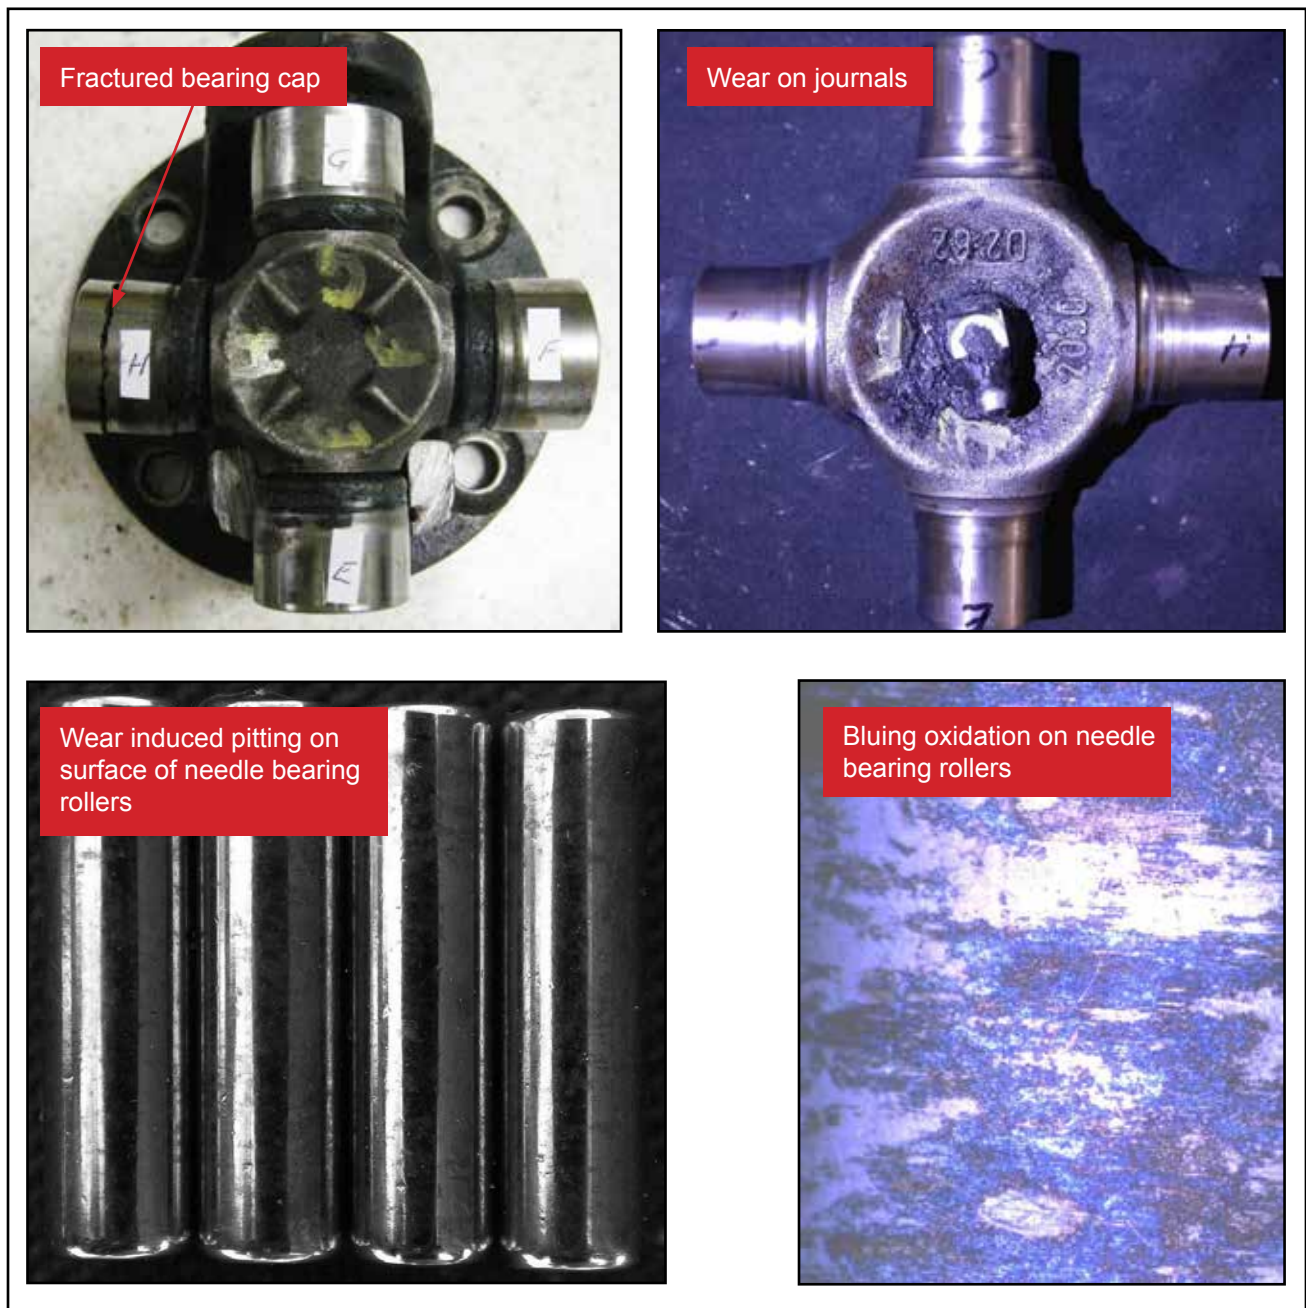
**Figure 58:** Laboratory analysis of the forward drive shaft universal joint

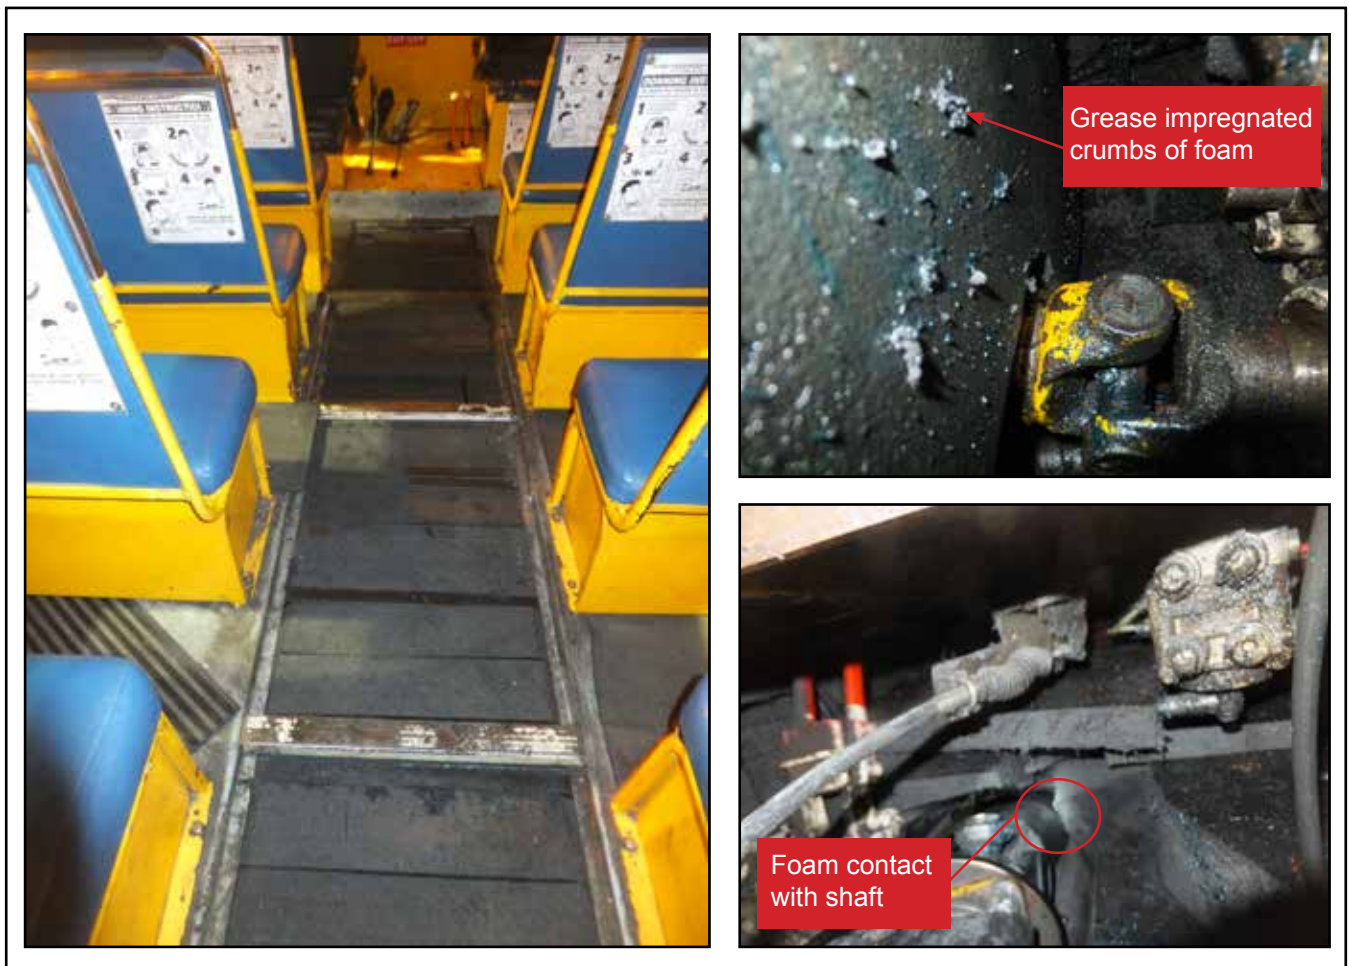
To allow the garage mechanics to carry out their weekly maintenance tasks, they had to remove the tightly packed foam from each DUKW's central void space (**Figure 59**). The need to remove and then reinstall the foam to grease the drive shaft bearings and UJs meant that the time taken to complete the vehicles' weekly maintenance routines increased significantly and required the vehicles to be taken out of service for a full day.

**Figure 59:** Tightly packed foam in central void space

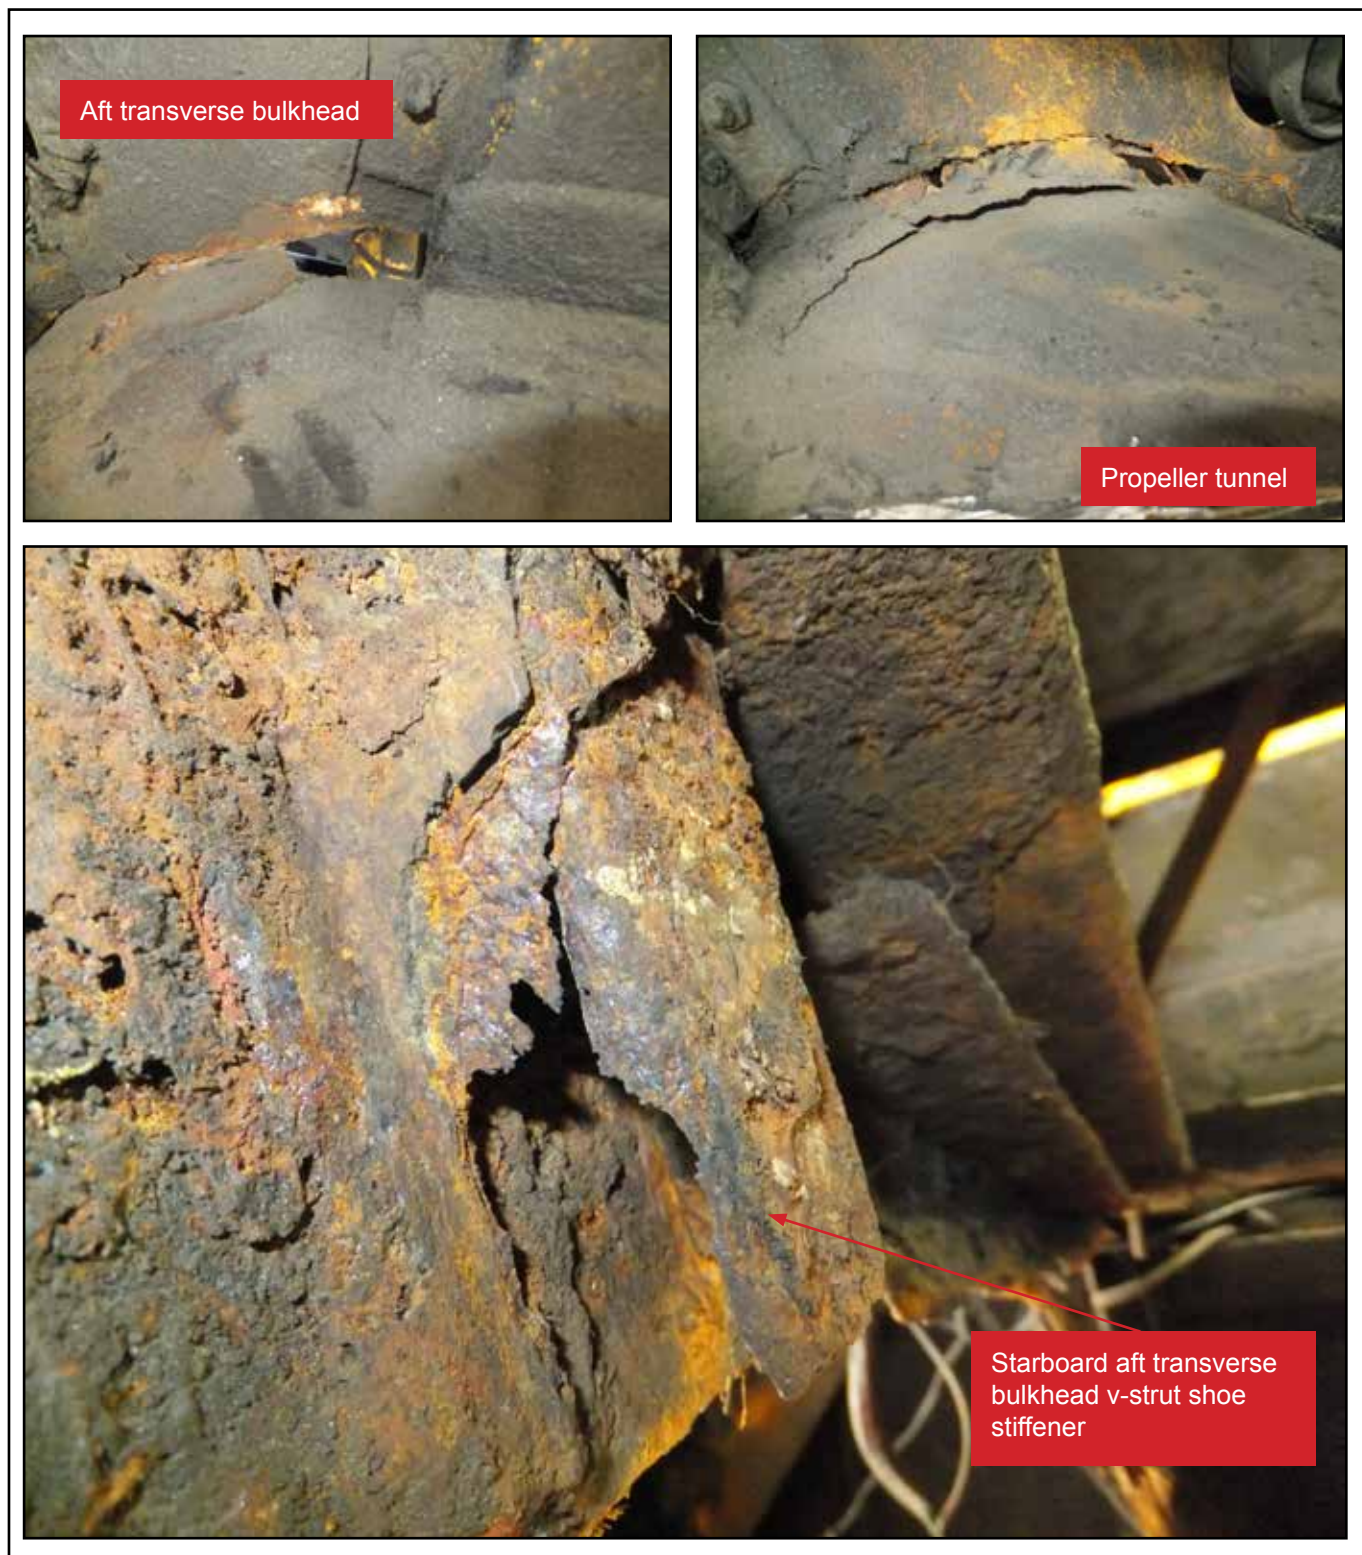
**Figure 60:** Hull corrosion within *Wacker Quacker 1*'s aft void space
