**Foundering of the fishing vessel**

***Diamond***

**resulting in the death of a crew member**

**25 March 2014**

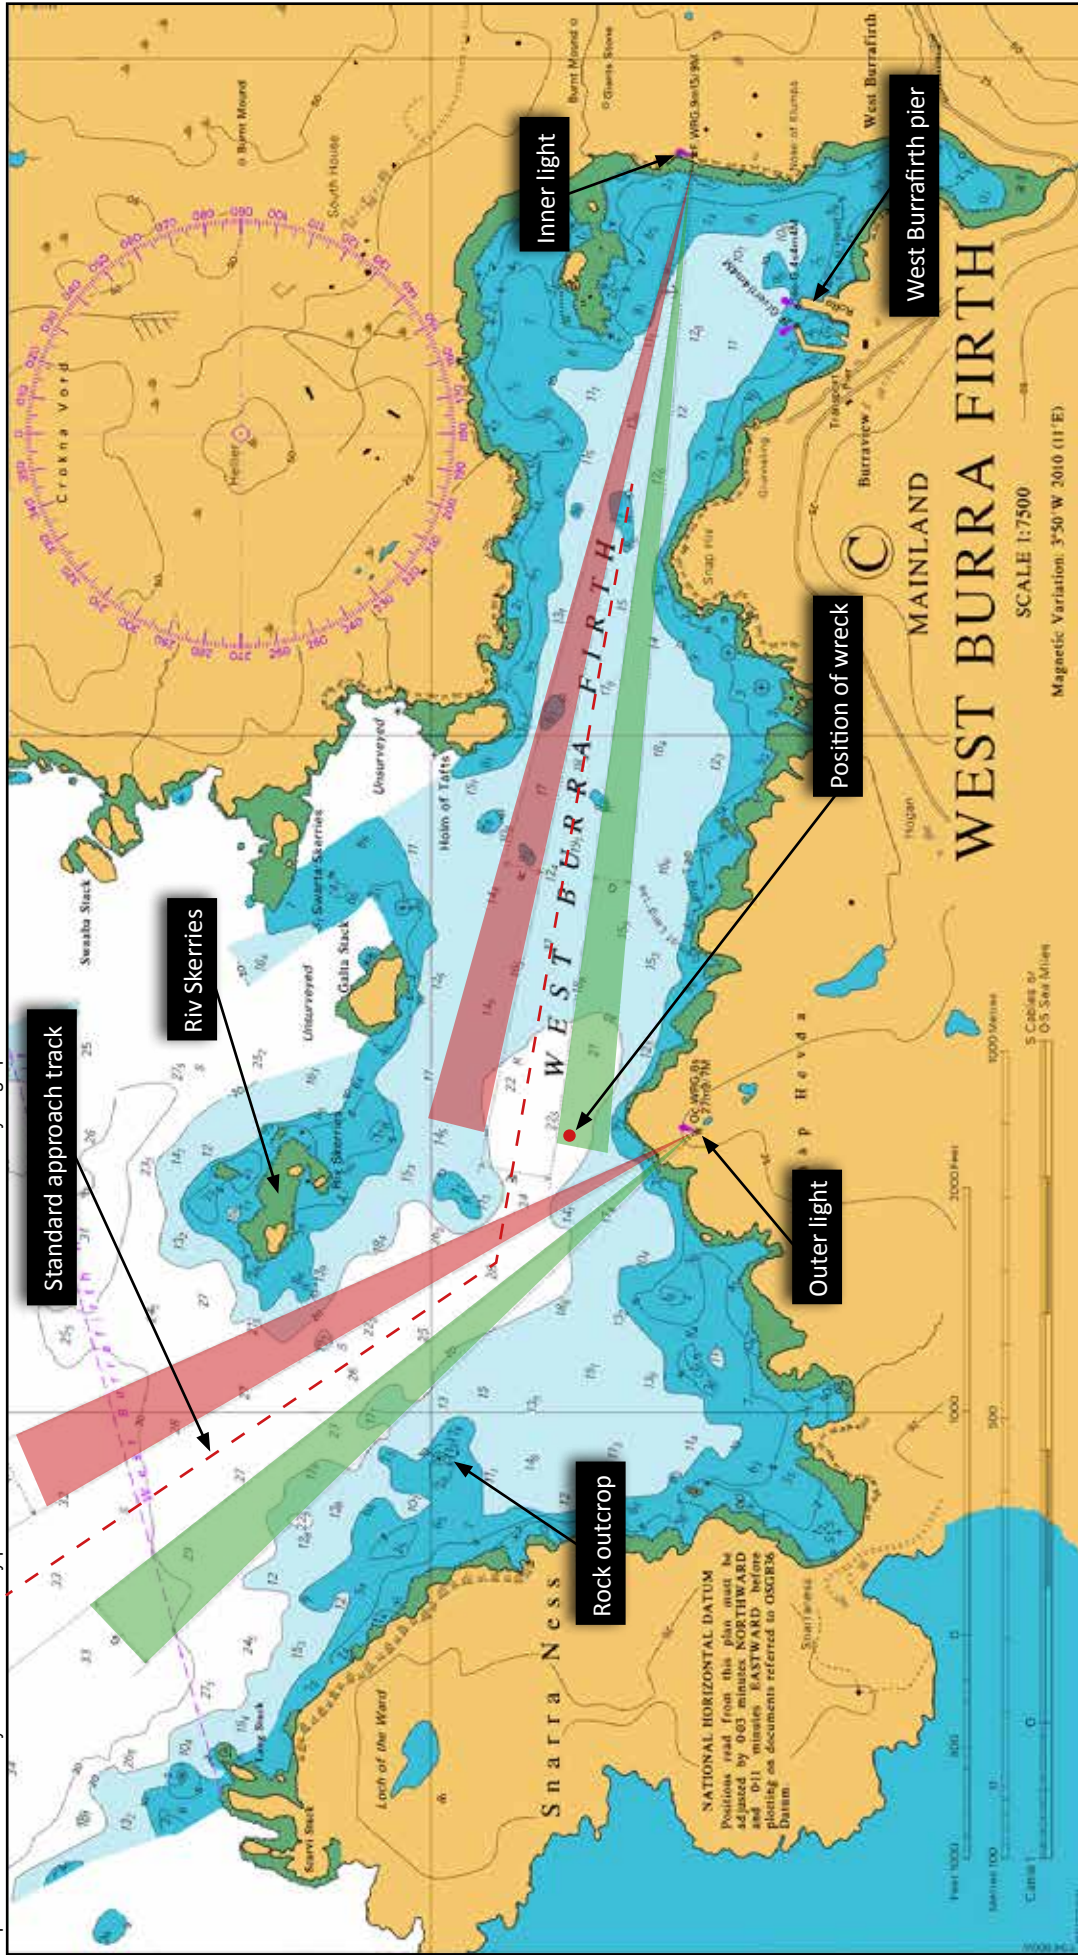
**Figure 3:** Chartlet of West Burra Firth with added sector light colours and standard approach track. The red dot shows the position of Diamond on the seabed

The evidence indicates it is most likely that *Diamond* hit the rocky outcrop east of Snarra Ness. The skipper navigated into the firth from the north-west and *Diamond* was observed, by another fishing vessel, to be closer to the coast of Snarra Ness than would be expected, and probably to the west of the outer light safe sector.

*Diamond* struck a rock outside of the main navigation channel, most likely to the east of Snarra Ness.

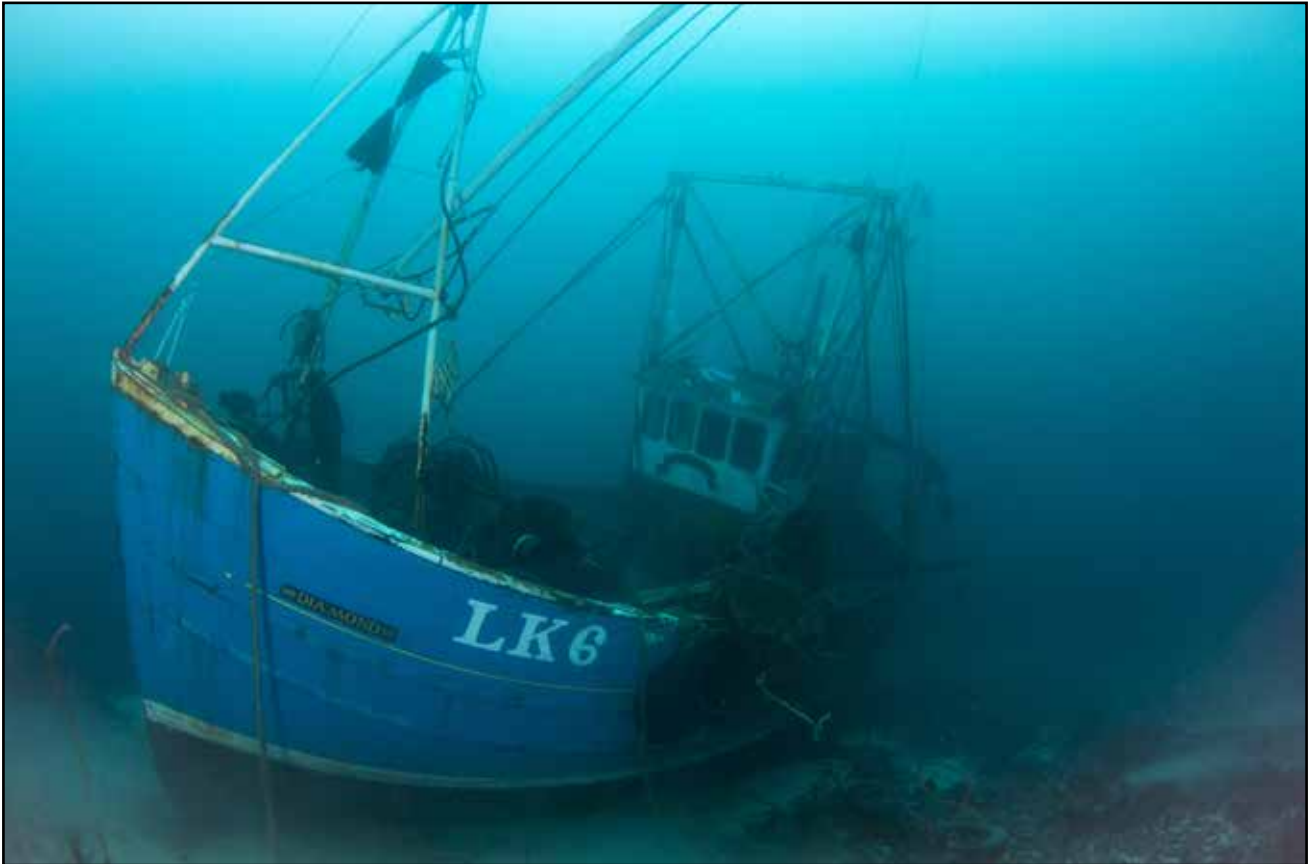
On 29 April 2014, a commercial diving team contracted by the MAIB conducted a visual survey of the vessel's exterior. The wreck was located in position 60°17'.9N 001°33'.62W (**Figure 4**). The inspection showed damage to the bow, specifically stem damage with substantial scraping on the port side. The hull planks were displaced and a section of plank was missing on the starboard side (**Figure 5**).

The rudder was found to be at about 15° to port and the engine controls in the ahead position at about 75% of full travel. Other details noted were: the scallop dredge gear was displaced forward; the main hold hatch cover was off; and the lifebuoys were wedged tight in their holding brackets.

**Figure 4:** *Diamond* resting on the seabed

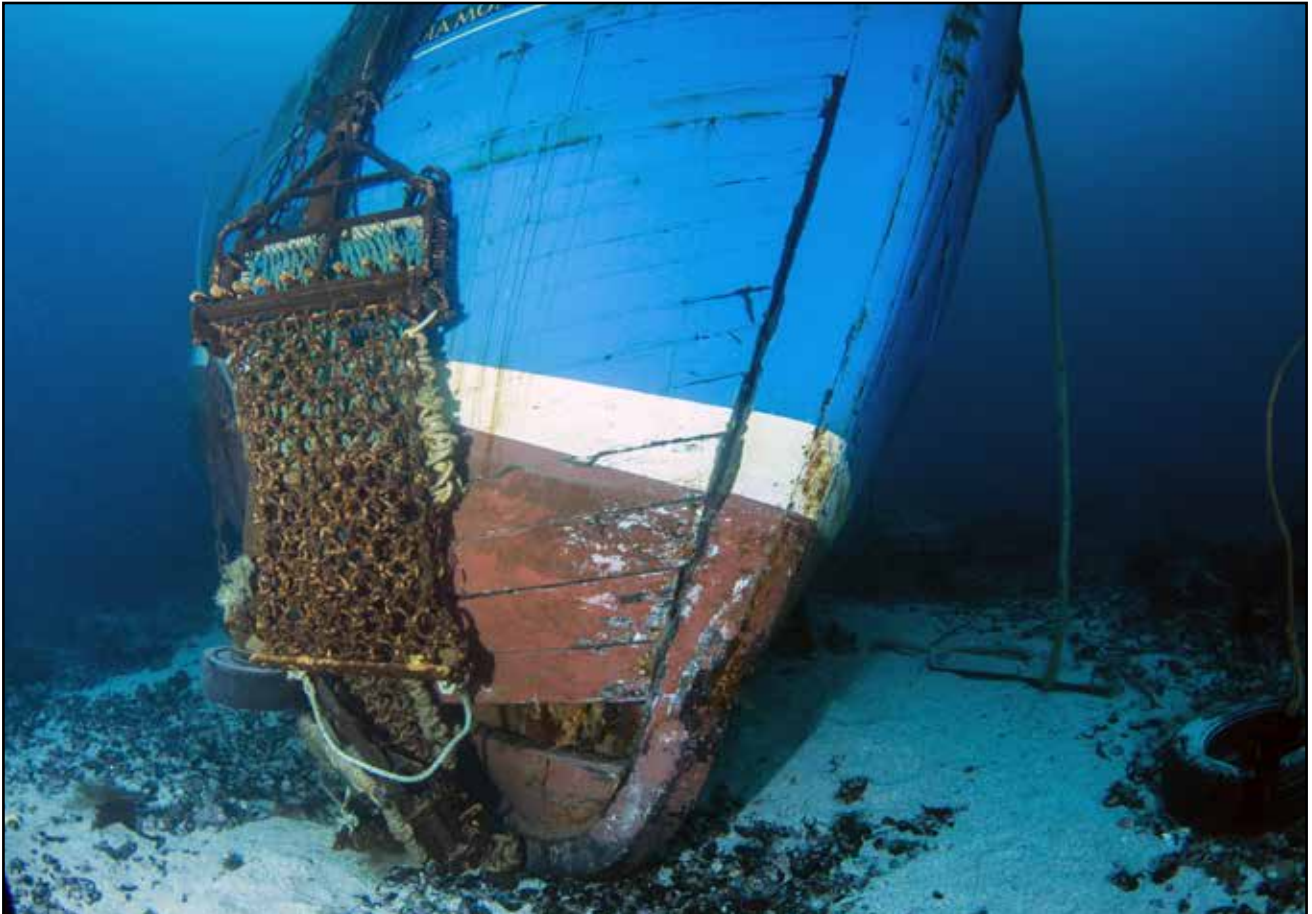
**Figure 5:** Photograph of stem and starboard side of *Diamond* showing missing and displaced planks

*Diamond* was travelling at between 5 and 6 knots. The force of the grounding taken on the stem displaced several planks on both sides, particularly the starboard side. The damage to the hull allowed water to flood the hull which had no watertight integrity between spaces.

The vessel sank rapidly due to the damage to the wooden hull and resultant flooding through the non-watertight bulkheads.
