Rail Accident Report

**Fatal accident involving a track worker near
Newark North Gate station
22 January 2014**

Report 01/2015
February 2015

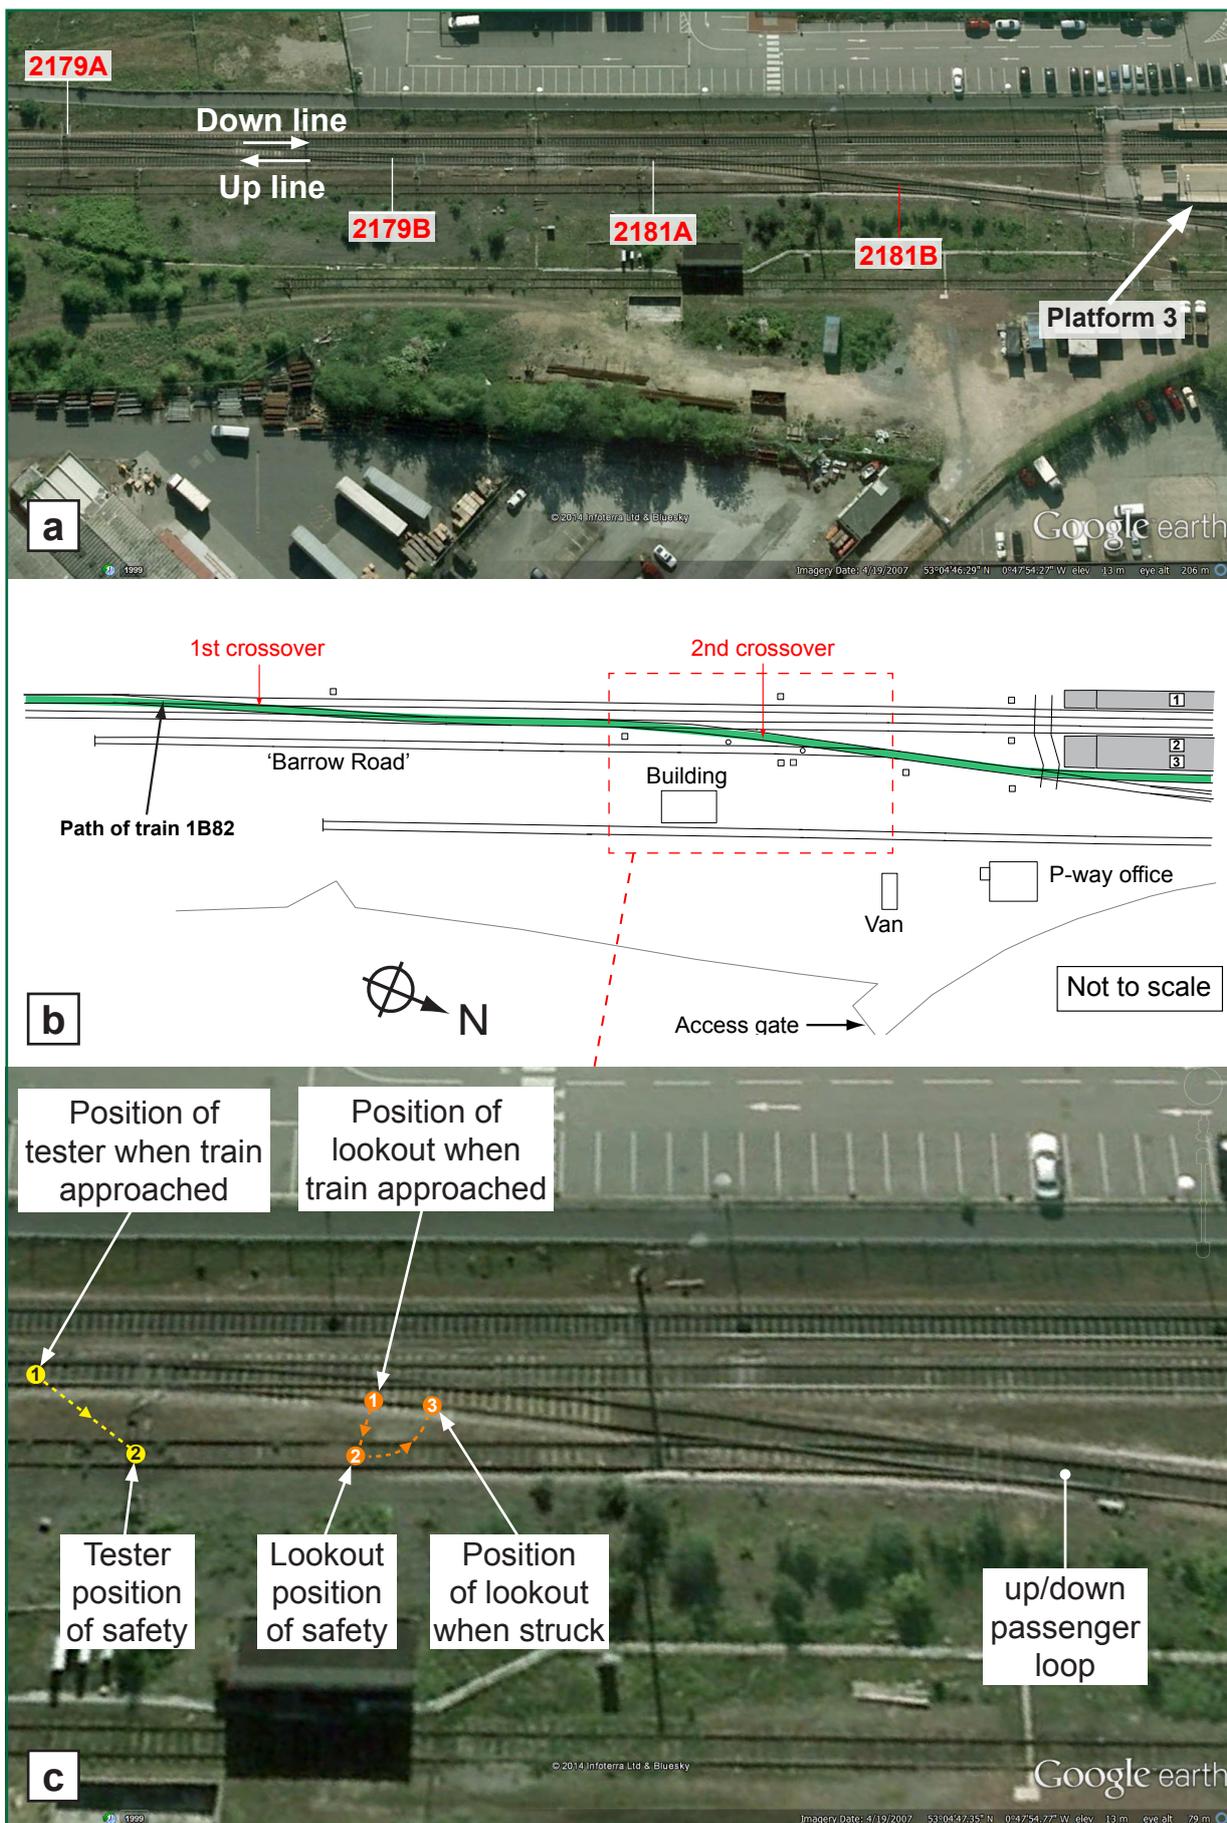
Figure 3: Layout of the tracks at Newark South Junction (located at 119 miles 73 chains)

- 12 The train involved in this accident had been routed over two crossovers. The first is between 2179A points and 2179B points (figure 3a) and takes northbound trains (approaching from the left in figure 3) from the down main line onto the up main line. The second crossover is between 2181A points and 2181B points and takes northbound trains from the up main line onto the up/down Passenger Loop. The maximum permitted speeds through both crossovers is 30 mph (48 km/h). The lookout was standing on the right hand rail of the second crossover (viewed in the direction of travel of the train) at the position shown in figure 3c when he was struck by train 1B82.

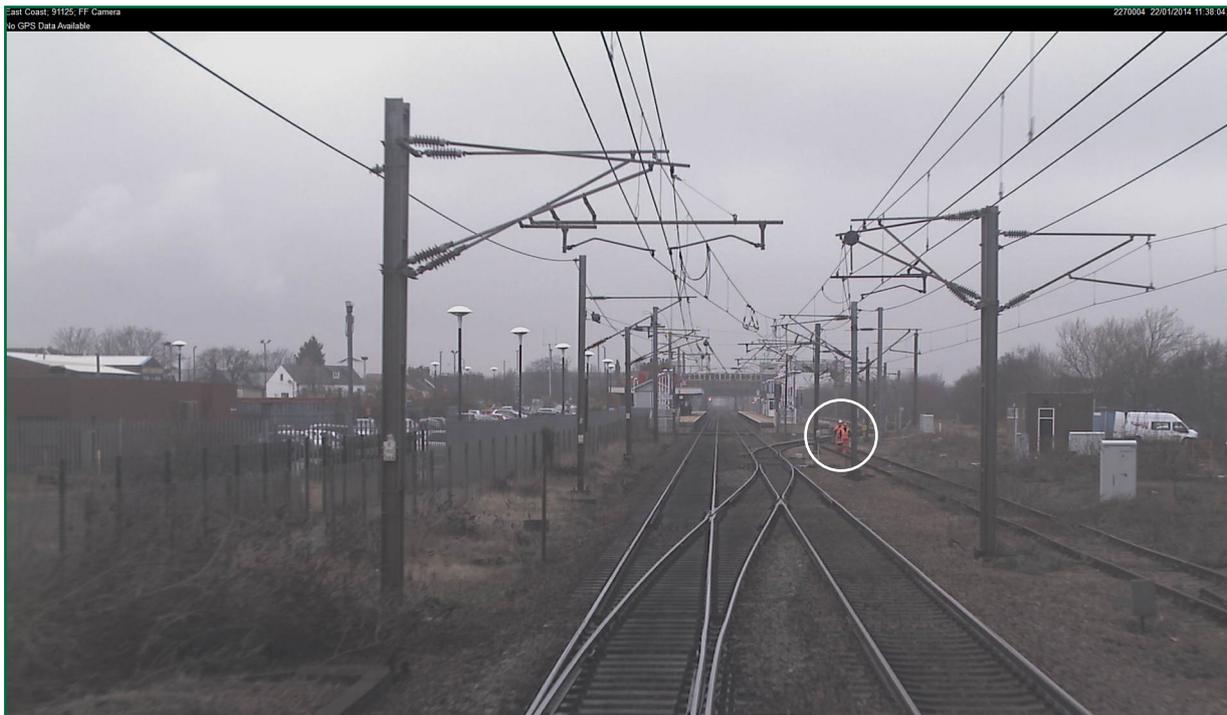
Figure 5: The lookout and tester in the position of safety (image courtesy of East Coast Railways Mainline Company Ltd)

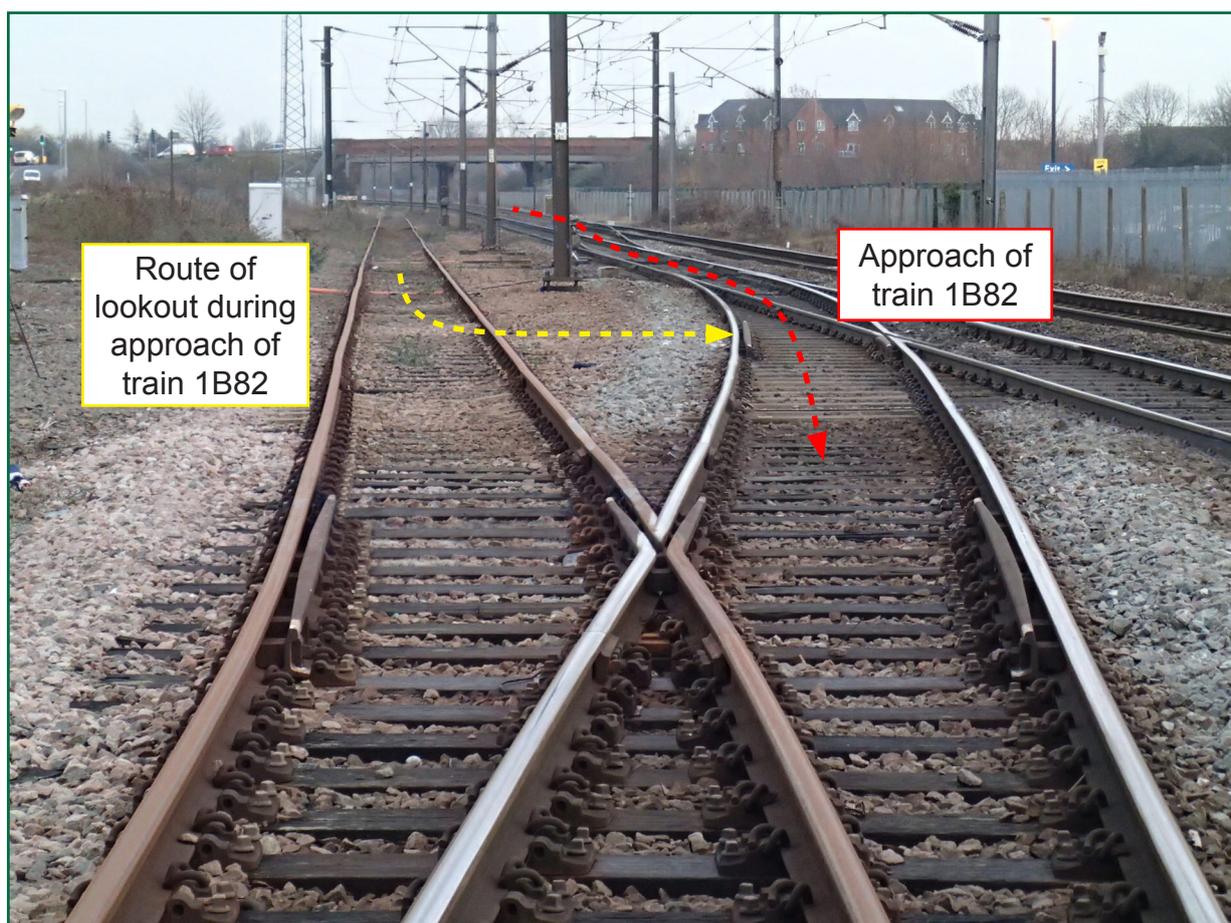
Figure 6: The path taken by the lookout toward the up/down Passenger Loop and the position he was struck.

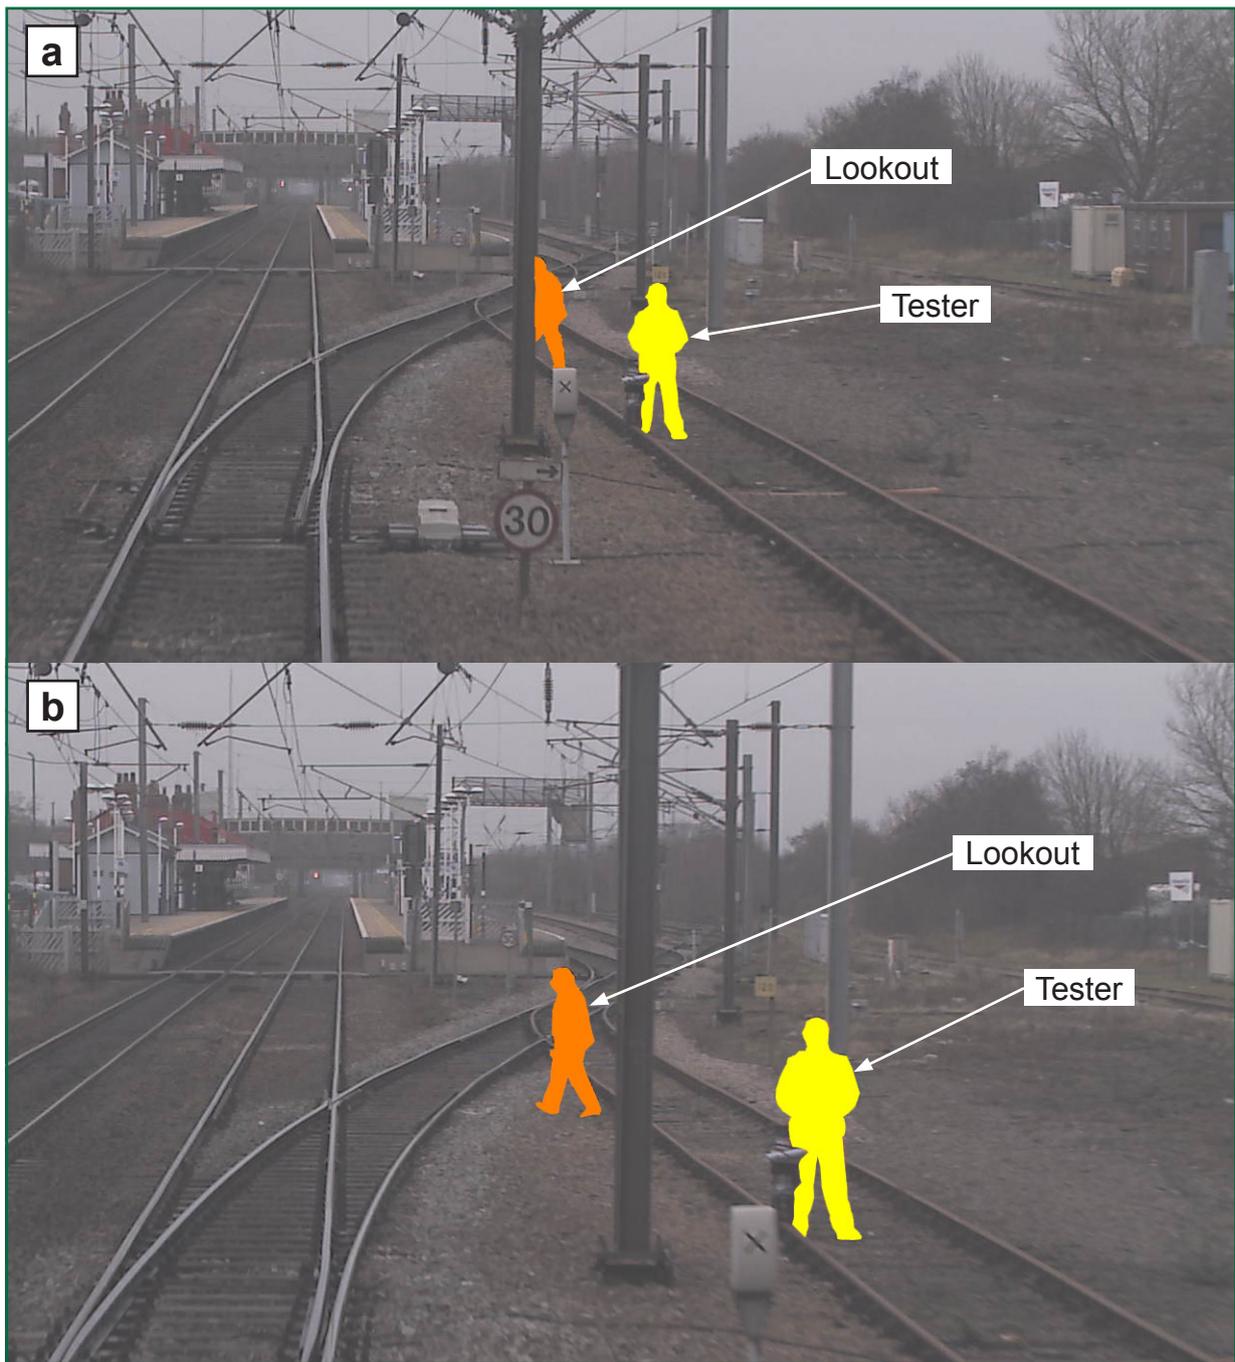
Figure 7: Forward facing CCTV images showing position of lookout approximately 2 seconds (a) and 1 second (b) before the train's second horn and emergency brake (images courtesy of East Coast Railways Mainline Company Ltd)

- 63 The expected reaction time for a driver responding to a familiar but unexpected hazard is likely to be around 1.5 seconds³. The positions of the lookout at one and two seconds before the emergency brake and horn were applied (based on CCTV images), are shown in figures 7a and 7b respectively. These indicate that the driver reacted as soon as it was clear the lookout had left the position of safety and was moving towards the up/down Passenger Loop.

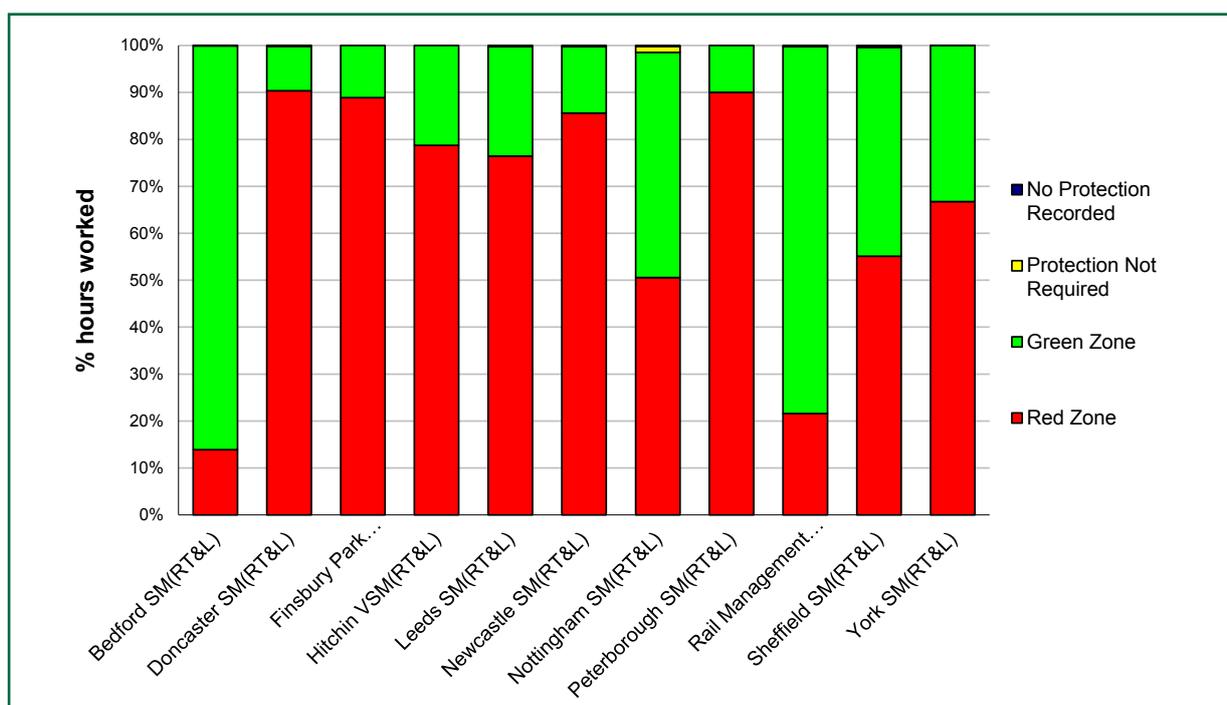
- 84 Figure 8 shows data provided by Network Rail on the proportion of red and green zone working for the rail testing and lubrication teams of each *delivery unit* of the LNE&EM route between August 2013 and January 2014. For some units, such as Doncaster, Finsbury Park and Peterborough, which mainly service the ECML, the proportion of red zone working was around 95%. For others such as Bedford, the proportion was much lower at around 15%. The overall target for the proportion of red zone working in the LNE&EM route was 30% at the time of the accident⁸. However, the overall average proportion of red zone working for the rail testing and lubrication team, across the route, was 61%.

Figure 8: Proportion of red zone to green zone working on the Network Rail's LNE&EM route for each delivery unit

89 Although not linked to the cause of this accident, the RAIB observes that the SSOW planning at Doncaster Marshgate Depot was not being implemented in accordance with the hierarchy of risk set out in Network Rail standard NR/L2/OHS/019. The intention of the standard is that the planner should choose the safest practicable system of work. However, in the case of the rail testing and lubrication teams, this was being disregarded in favour of the most flexible and convenient system of work for the availability of staff and equipment or one that fitted with custom and practice. The amount of red zone working undertaken by the rail testing and lubrication teams based in the Doncaster delivery unit was significantly higher than the target for the LNE&EM route (**paragraph 84, Recommendation 2**).

- 2 *The intent of this recommendation is to improve the implementation of Network Rail's procedures for planning safe systems of work, so that the hierarchy of risk is used in the intended way.*
