Millennium Diamond

Contact with Tower Bridge

River Thames

4 June 2014

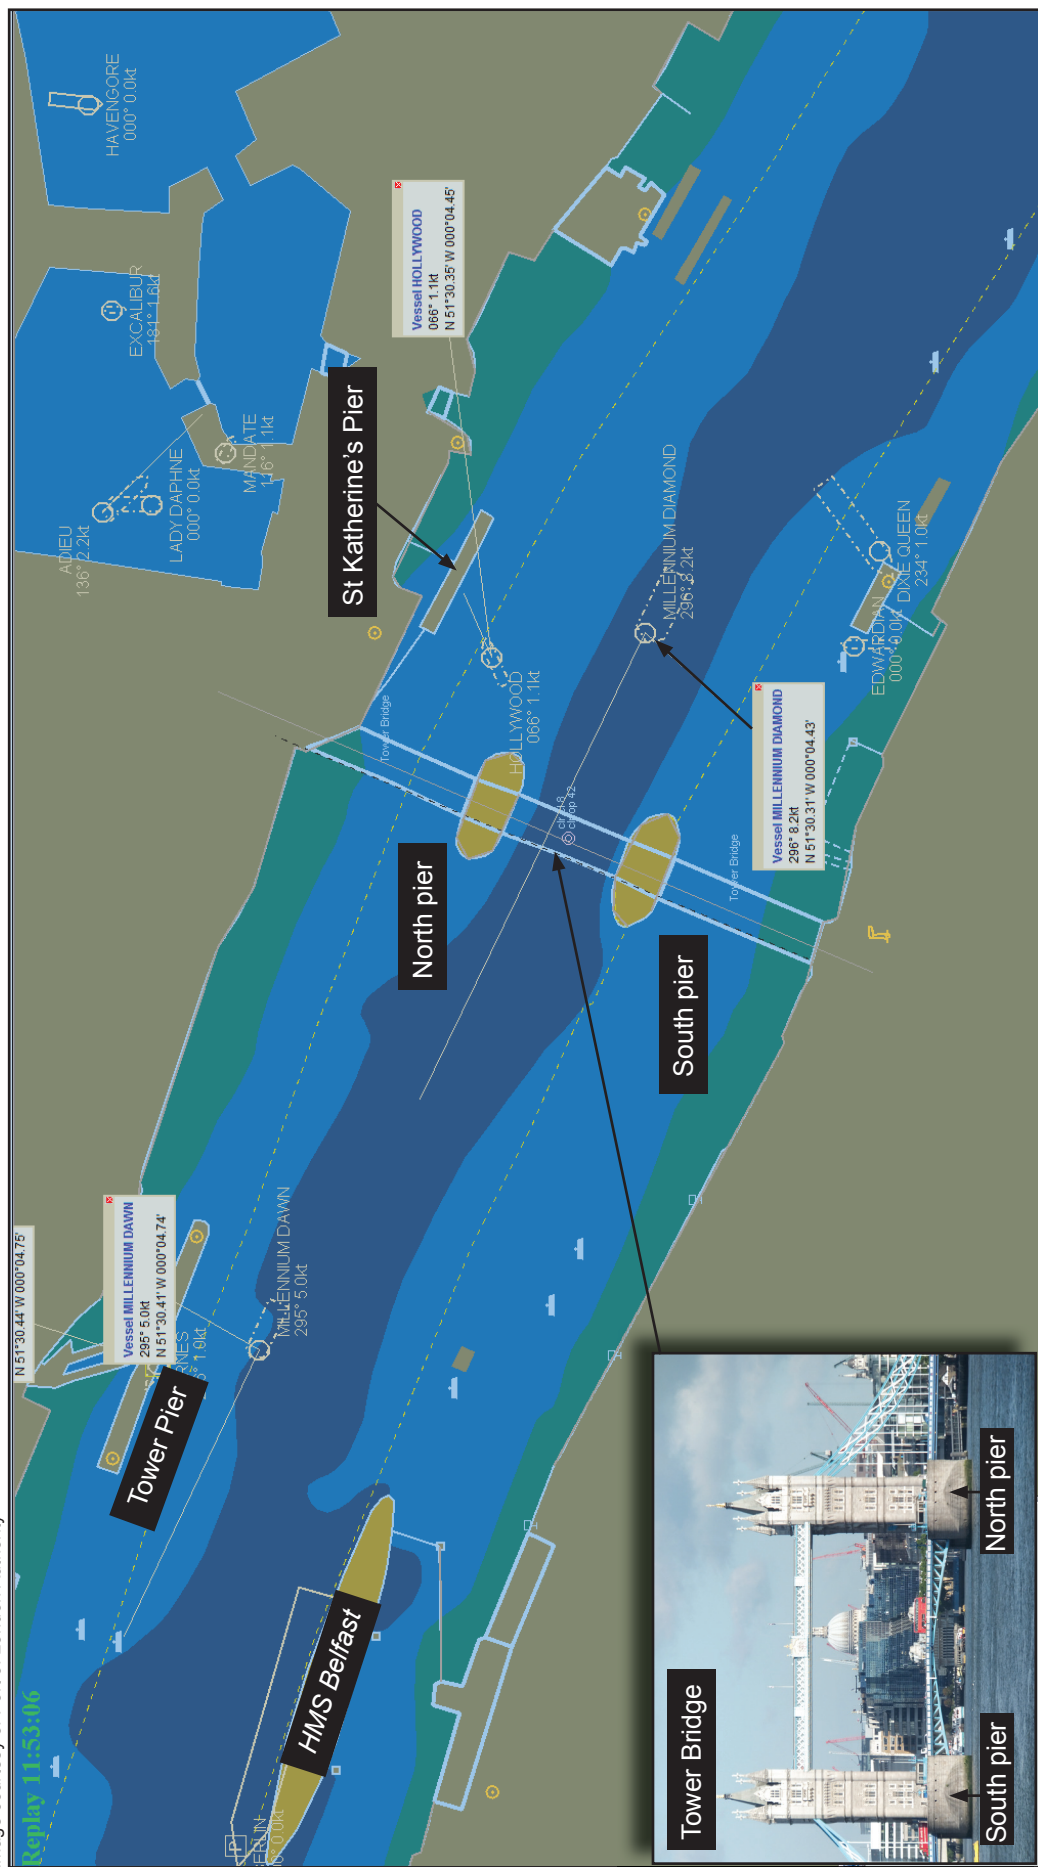
At 1152:52 the vessel was approaching Tower Bridge at a speed of 8.2knots (**Figure 2**). The mate was at the helm and London VTS made a VHF broadcast informing vessels that Tower Pier had been temporarily closed as a gun salute was due to be fired at the Tower of London at 1200. The PLA had previously issued a local notice to mariners, which stated that the gun salute would take place at 1300.

The VTS broadcast lasted 14 seconds. Immediately it had finished, the mate used the replay facility on the vessel's VHF radio to verify the time Tower Pier would be closed. As he reached across to activate the VHF replay switch, he also moved the steering joystick to port (**Figure 3**), intending to move the vessel towards the south side of the river, away from Tower Pier. The vessel was about 50m from the south pier of the bridge at this time.

The mate listened to the replay and did not notice that the vessel had veered to port and was heading towards the south pier of Tower Bridge. When he looked up, he realised that the vessel was about to make contact with the bridge, and put the starboard engine astern and the helm to starboard.

Figure 2: *Millennium Diamond* approaching Tower Bridge at 1152:22 (Automatic Identification System image)

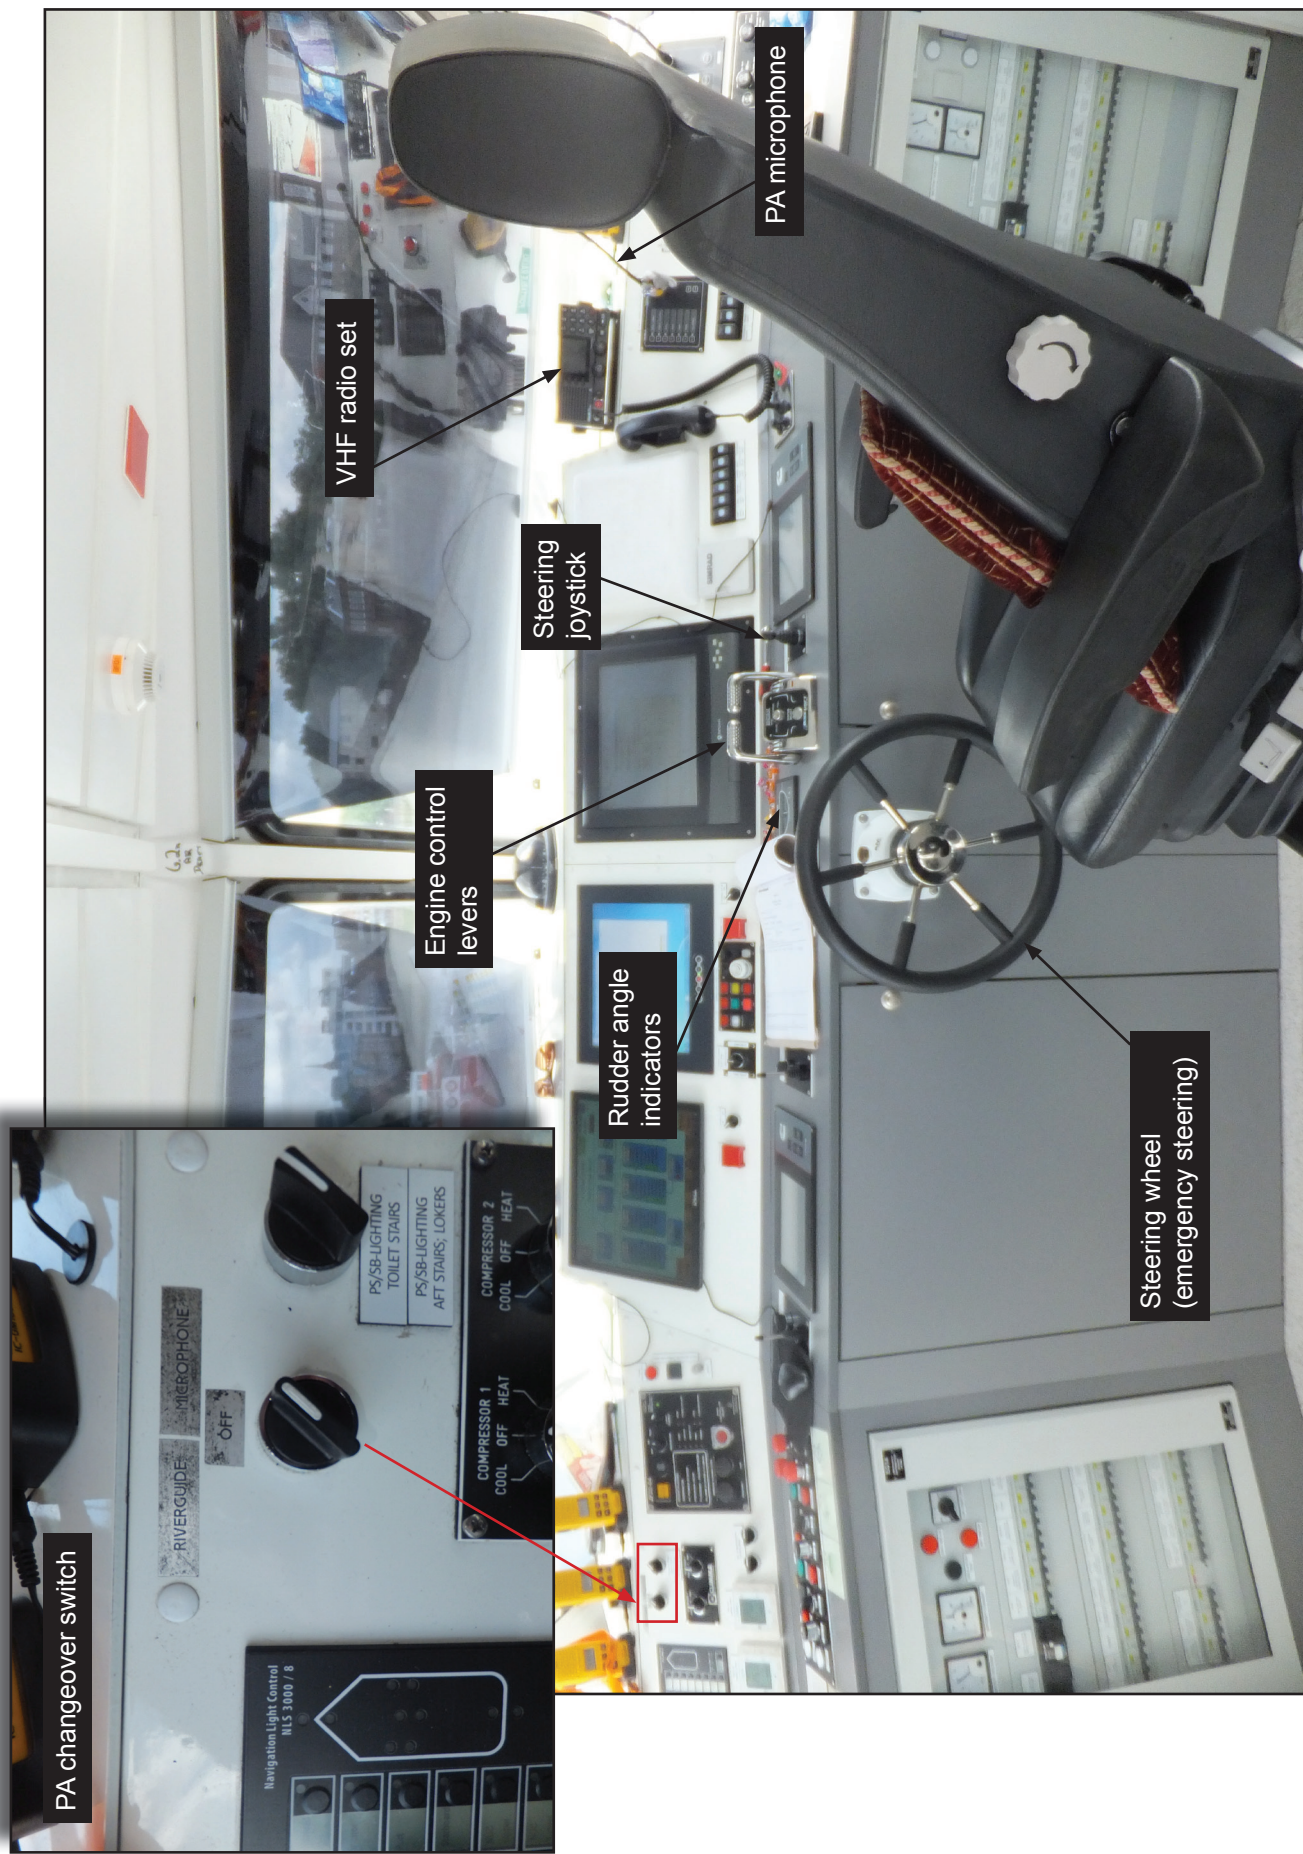
Figure 3: Wheelhouse equipment – looking forward

The master attempted to use the PA to warn passengers to brace themselves just before *Millennium Diamond* struck the pier. Unfortunately, with the PA system set to the *riverguide* mode the microphone was not active and the master's warning was not heard.

The master was very familiar with the vessel but, with contact imminent, he forgot that the selector switch on the port side had to be changed to enable the microphone, located on the starboard side, to become active.

This arrangement was ergonomically poor, as the selector switch could not be reached by a person standing at the microphone and the activation of the microphone did not automatically take priority over all other PA transmissions.

- Ensure the Public Address microphone is able to override all other transmissions.
- Ensure bar equipment is appropriately secured on all its vessels.
- Consider the relocation of the wheelhouse VHF set.
- Investigate the relocation of the rudder angle indicators to a more central position.
- Include in its vessels' generic passage plans the provision of suitable holding areas in the event of unexpected pier closures.

- Complete the intended actions listed in its investigation report in a timely manner.
- Undertake a thorough review of the wheelhouse equipment layout on *Millennium Diamond* to ensure its use does not create distraction and prevent its officers from conning the vessel safely.

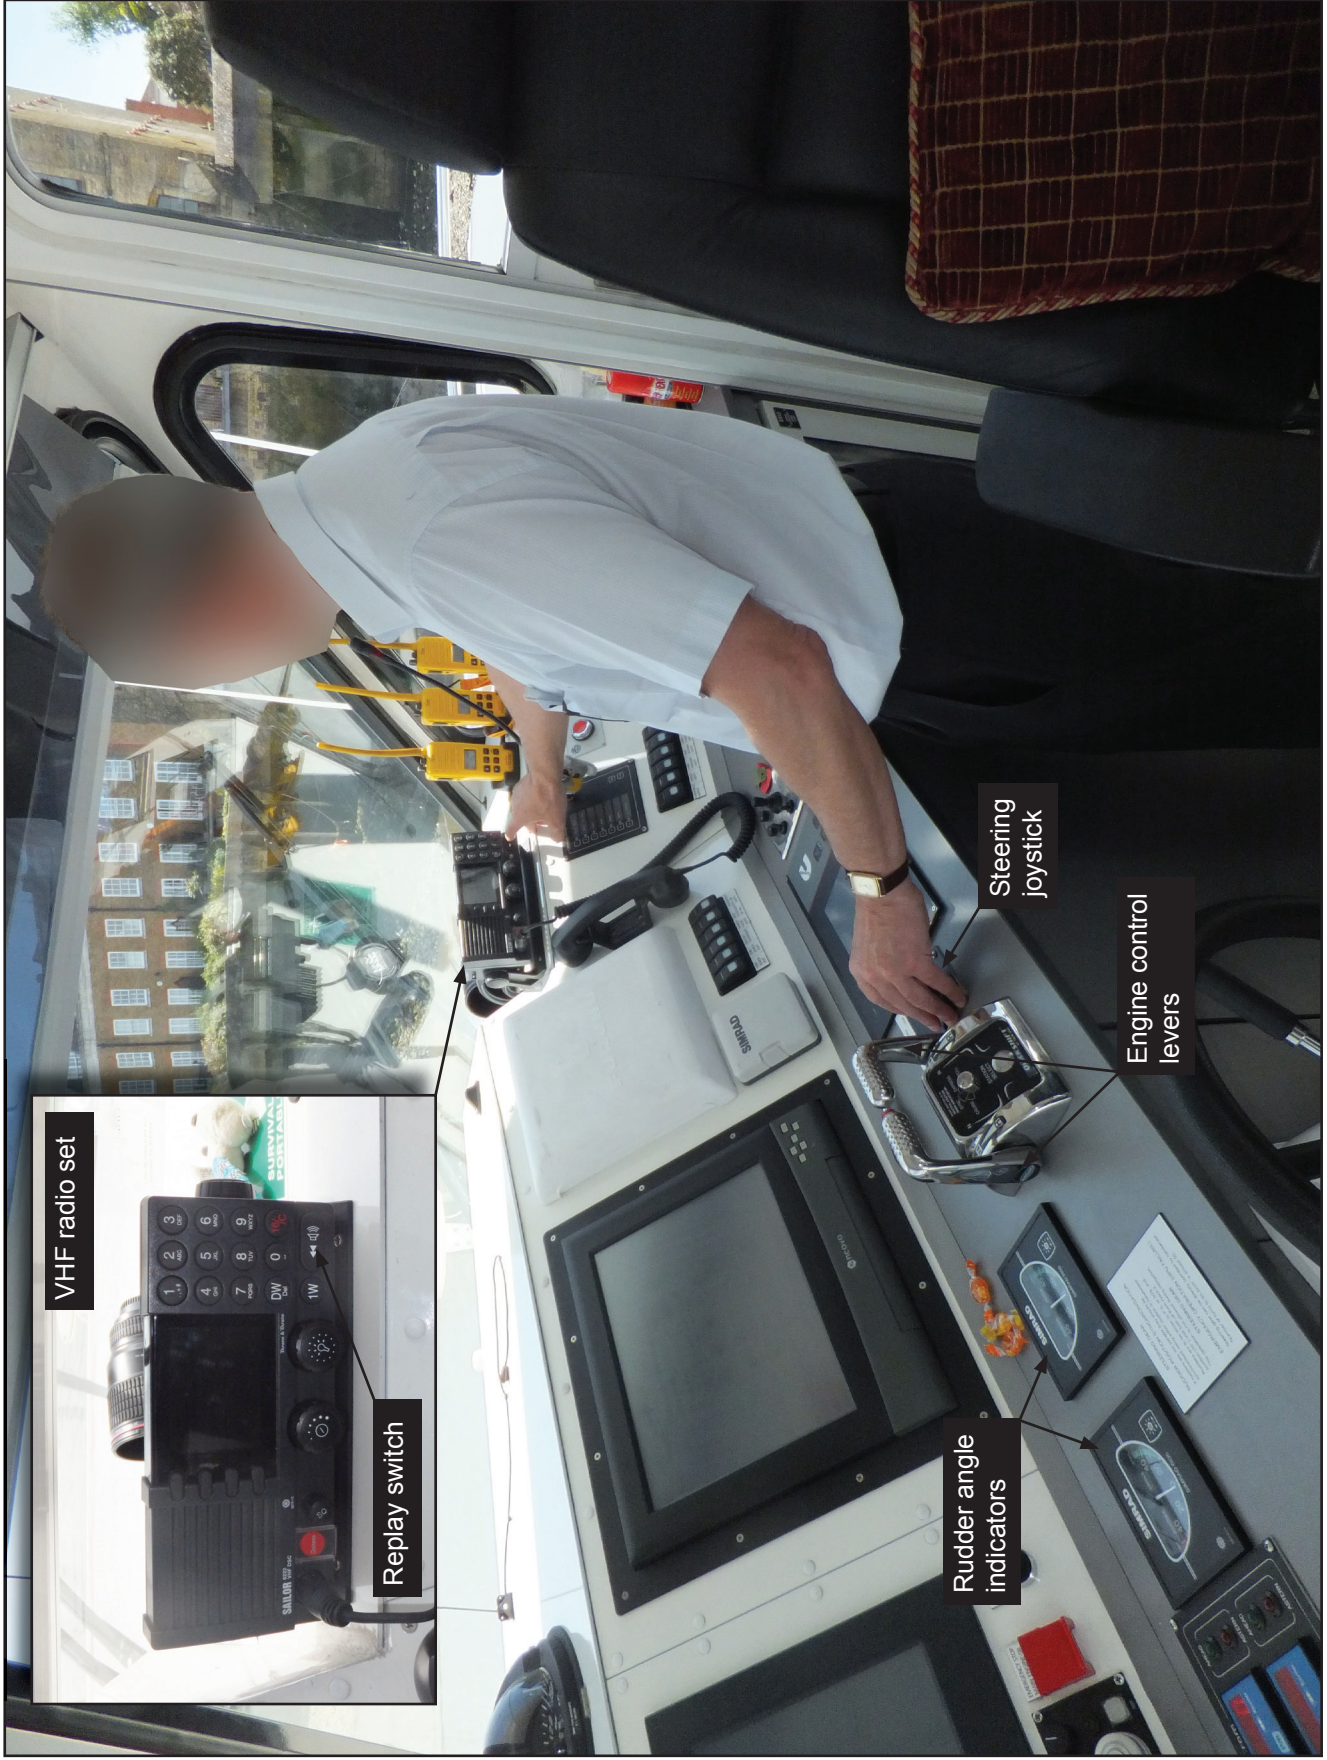
Millennium Diamond was about 50m from Tower Bridge when the mate replayed the VHF message regarding the closure of Tower Pier, which was the vessel's destination. When he pressed the VHF replay switch he also applied port helm as his intention was to manoeuvre the vessel to the south side of the river to await the re-opening of Tower Pier. The vessel turned quickly to port; analysis based on the steering trials conducted by the PLA suggests that the mate applied about 20° of helm during the replay of the VHF message.

The action of reaching to press the VHF replay switch, which was at arm's reach on his right hand side, and then concentrating on the content of the message he needed to check, was sufficient distraction to ensure that the mate did not monitor the rudder angle indicators or notice that *Millennium Diamond* had turned towards the south pier of Tower Bridge.

The location of the VHF radio did not enable the mate to operate the set while maintaining a lookout ahead and monitoring the rudder angle indicators at the same time (**Figure 5**).

Figure 5: Operation of VHF radio replay switch while also moving steering joystick
