# Rail Accident Report

**Derailment of a freight train at Stoke Lane Level  
Crossing, near Nottingham  
27 August 2013**

Report 02/2015  
April 2015

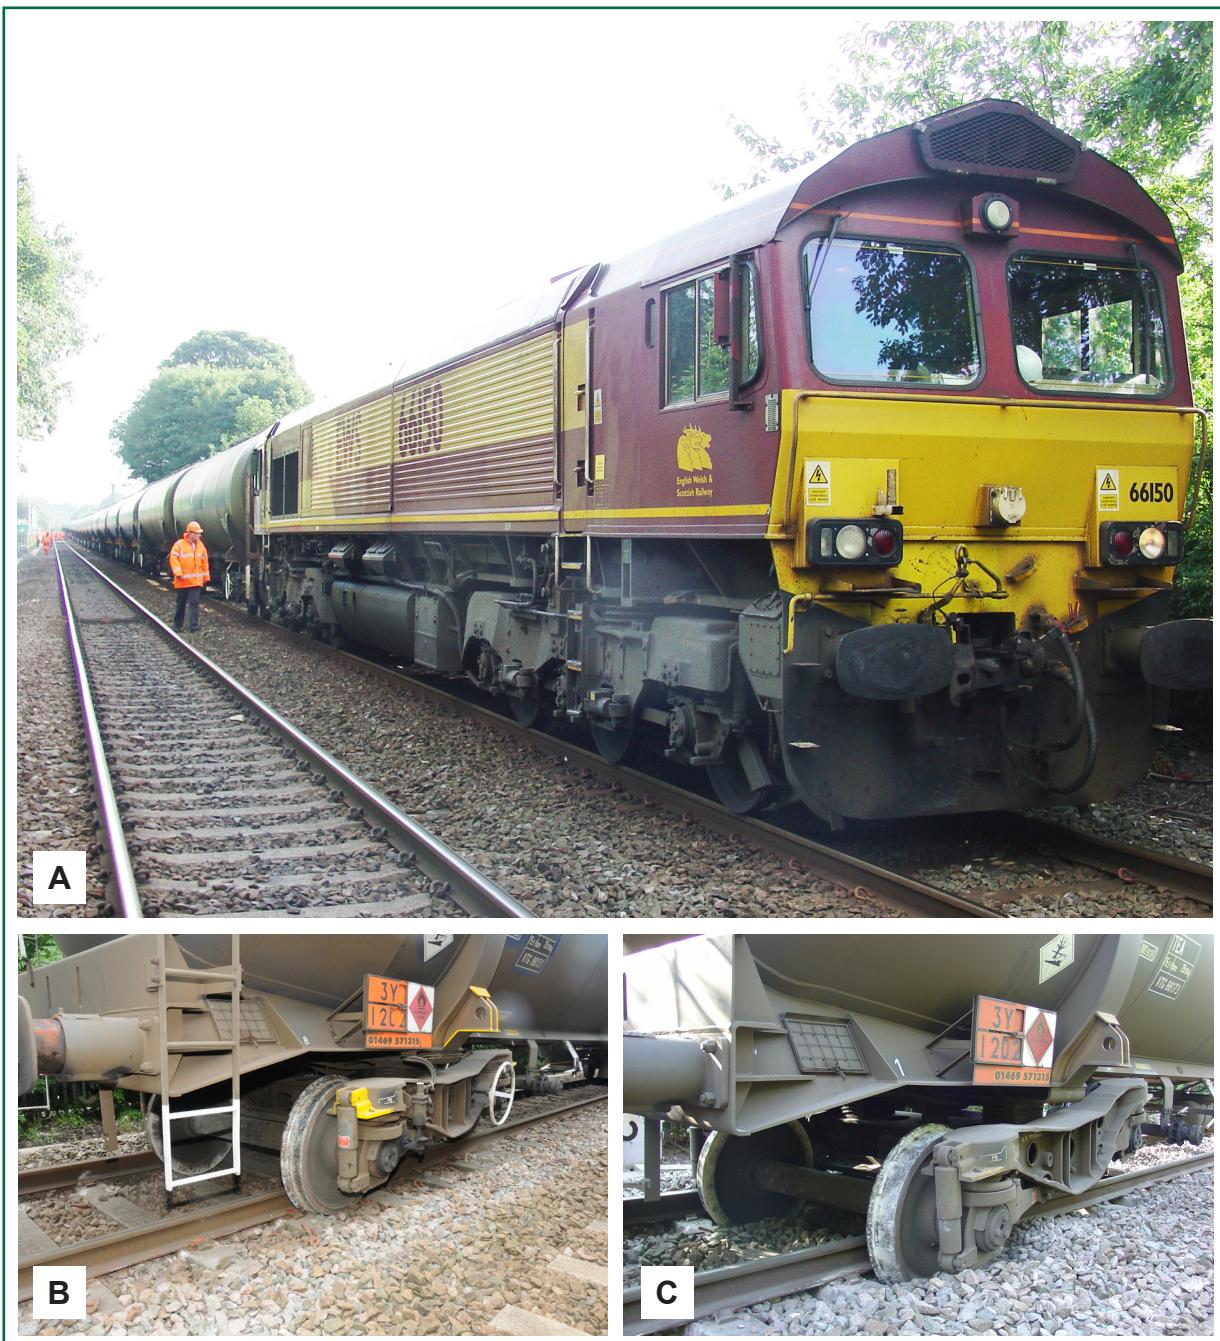
- 8 After informing the signaller of the automatic brake application, the driver went to investigate. He found the trailing axles of the 26<sup>th</sup> and 28<sup>th</sup> wagons had derailed toward the six foot (figure 2). The wagons had remained upright and in line and had not fouled the adjacent running line. There was no leakage of diesel fuel from any of the tank wagons, but the buffers on some had been damaged. The track was damaged by the derailed wheelsets for a distance of around 800 metres. The driver was not injured.

Figure 2: Train 6M35 (a) and its derailed wheelsets on 26th wagon (b) and 28th wagon (c)

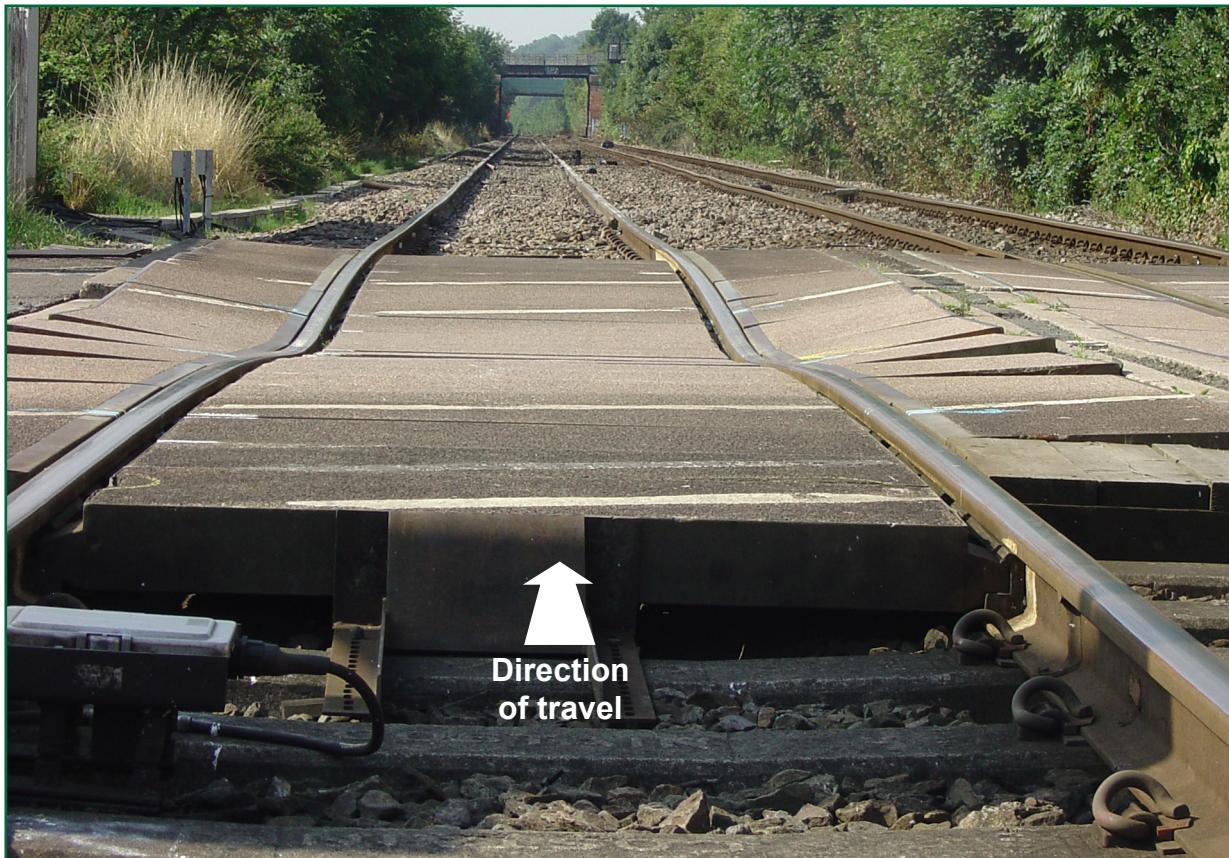
- 9 Examination of the site revealed severe dips of about 100 mm in both rails of the up line at Stoke Lane level crossing (figure 3). The rails had deformed over a void in the ground. Because of this void the track was not supported over a length of around 3 metres (figure 4). The railway remained closed for repairs until 15:30 hrs on 8 September 2013.

Figure 3: The dip in the rails at the point of derailment

- 48 The immediate cause of the derailment was a severe dip in the track which had developed rapidly under the leading portion of train 6M35 and caused the 26<sup>th</sup> and 28<sup>th</sup> wagons to derail.
- 49 After the derailment the maximum track dip was measured at 98 mm on the cess rail and 97 mm on the six foot rail. The actual amount of track dip that the last eight wagons of train 6M35 experienced would have been greater, due to additional deformation caused by elastic bending of rails under the weight of the wagons.

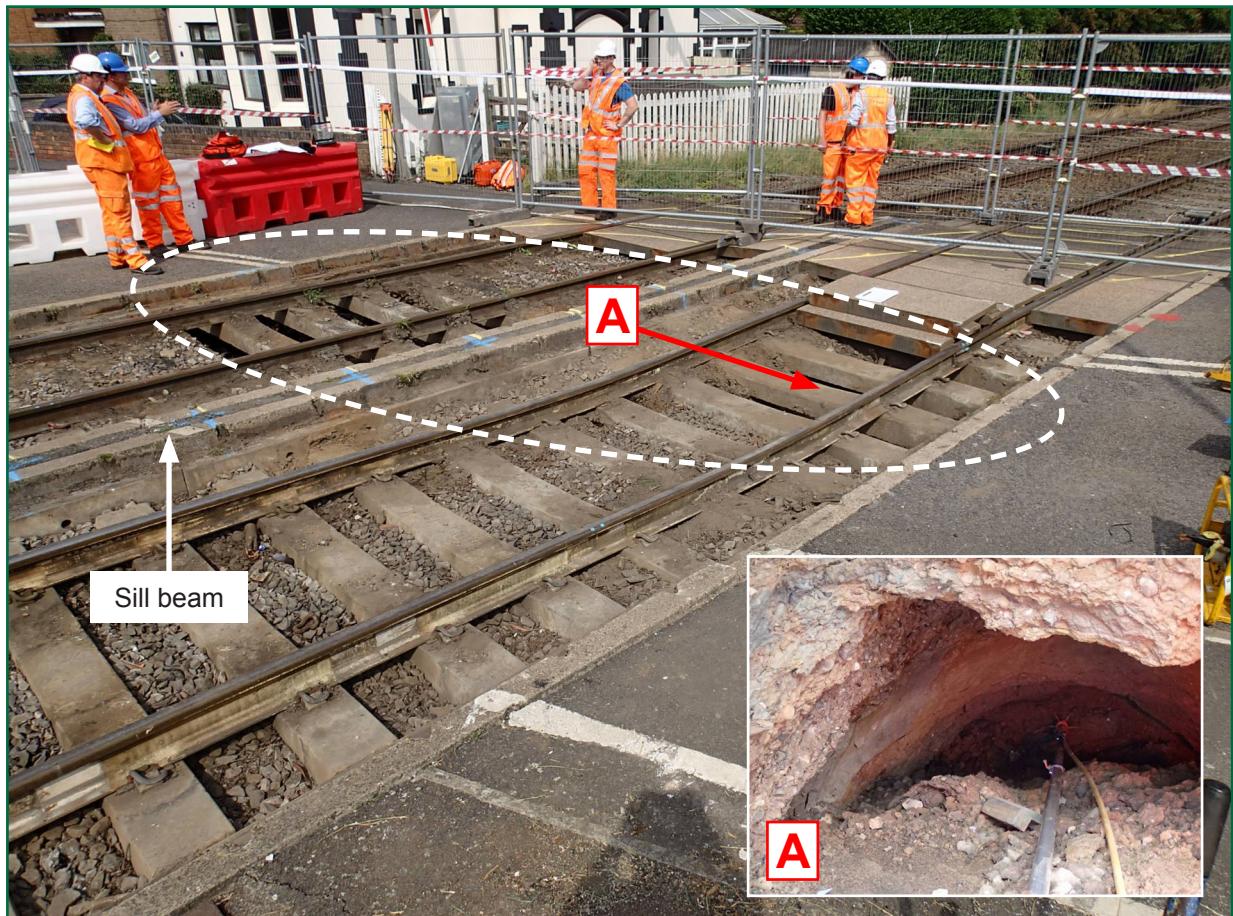
Figure 4: Extent of voiding below the track at the crossing

- 45 The severe distortion in the rails of the up line (figure 3) was found at around 06:00 hrs. Later that day, the *level crossing panels* were removed and this revealed the large voids below both railway lines around the centre of the road (figure 4). In the following days, a significant amount of ground investigation and repair work was carried out by Network Rail and Morgan Sindall Underground Professional Services, in consultation with the RAIB, to document the voids and repair the track before the line was reopened to traffic on 8 September 2013.

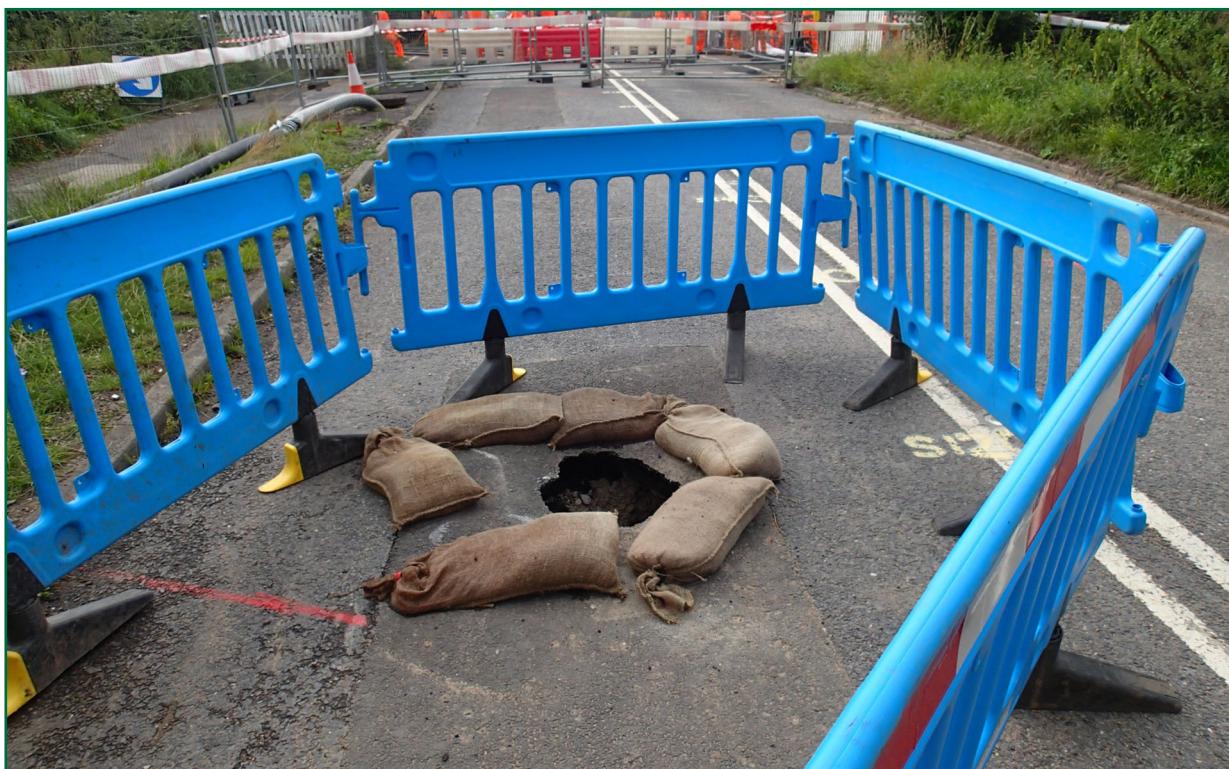
- 37 On 8 August, Bridgeway Consulting staff found a hole in the road located at one end of the trial excavation (paragraph 29) over the twin siphon closest to the launch shaft (figure 8). The position of the hole in relation to the siphons is shown in figure 5. On closer examination, the Bridgeway Consulting staff found the hole had loose material inside it which appeared to come from the reinstated road sub-base material and that there was a void below the surface which sloped downwards and toward the centre line of the road. Bridgeway Consulting called a site meeting the same day with representatives from Morgan Sindall Utilities and Nottinghamshire County Council, to examine the hole and determine the likely cause of the defect. The opinion of the two contractors' representatives at the meeting was that the hole had originated at the trial excavation due to inadequate reinstatement of the excavation and that both the hole and the void were not linked to the tunnelling activity. Nottinghamshire County Council's representative was uncertain as to the cause of the hole and subsequently sought further views from the involved parties. However no party accepted responsibility and the matter was unresolved when the derailment occurred. Severn Trent Water and F&B Tunnelling Solutions were informed of the hole. Network Rail was not informed and remained unaware of the hole until after the derailment.

Figure 8: Hole in the road found on 8 August 2013 (photograph taken on day of accident)

- 71 There were two other factors which affected the decisions made by the involved parties about the severity of the settlement problem:
- a) The hole that was discovered in the road on 8 August (paragraph 37) was not reported to Network Rail by either Morgan Sindall Utilities or Bridgeway Consulting, despite the joint meeting on 1 August to discuss Network Rail's concerns about the settlement. Interview evidence indicates that the reason it was not communicated to Network Rail was because it was considered by the parties at the site meeting of 8 August, that the hole had been caused by poor reinstatement of the trial excavation carried out prior to the tunnelling work and because it was quite far from the crossing. Examination of the hole after the derailment revealed that the trajectory of the void was steeply downward towards the centre of the road and the tunnel and not into the remainder of the trial excavation. Had more rigorous consideration been given to the cause of the void, a possible link to the tunnelling operation should have been apparent. This was a missed opportunity to provide potentially valuable information to Network Rail about what was happening at Stoke Lane almost three weeks before the derailment. Had Network Rail been informed about the hole in the road, and the trajectory of the void below, it may have led to lifting the level crossing panels sooner than the planned 9 September possession.

- f) Where there is an unexpected event such as the appearance of a surface hole in the vicinity of a tunnel, this should be investigated immediately and thoroughly, to identify the cause and any associated risks.

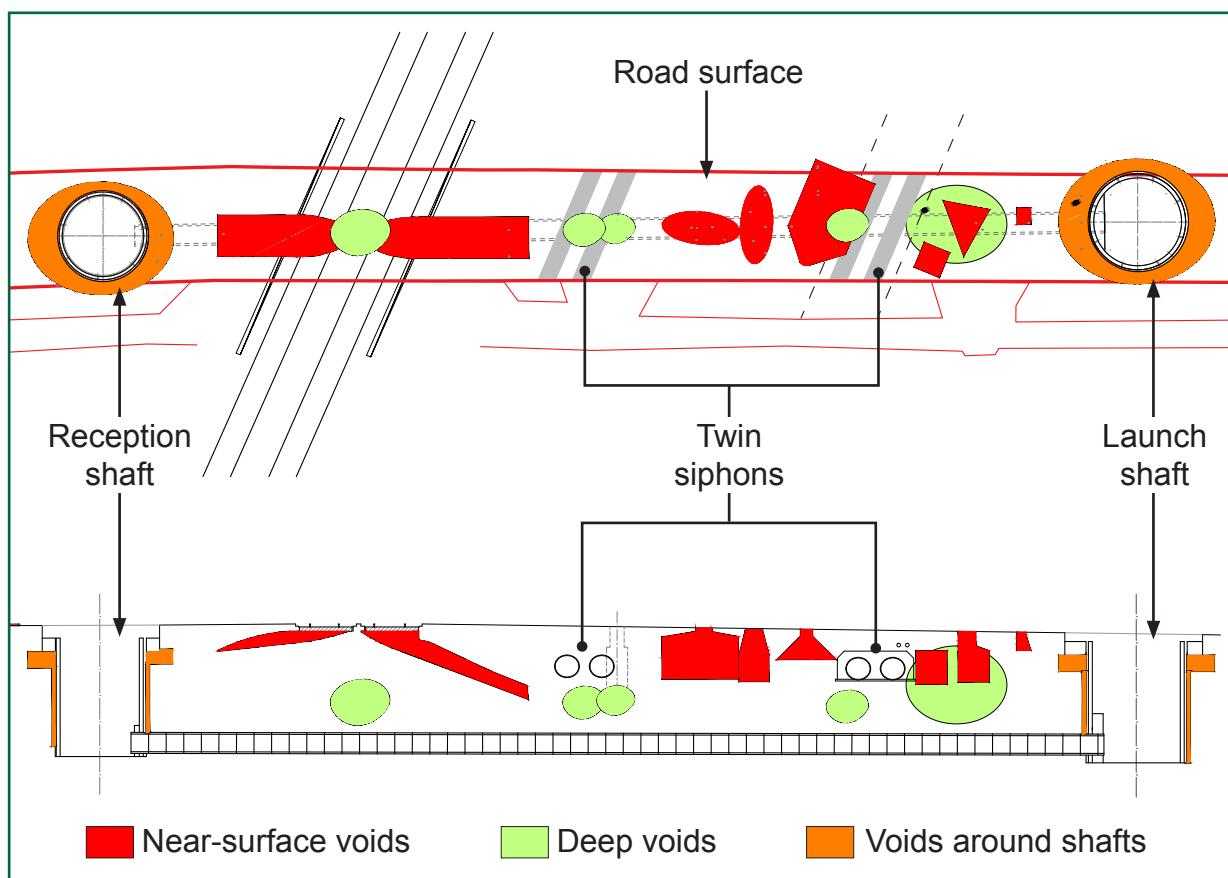
- 53 Ground investigations carried out following the derailment revealed that the voids under the railway were not isolated but were part of a series of voids which ran between the launch and reception shafts of the UTX, generally along the centre line of the road as shown in figure 9. Most of the voids were just below the road surface, but there were also voids found under the railway and the twin siphons and around the shafts. The volume of each void was estimated by Morgan Sindall Underground Professional Services from the amount of grout that had to be pumped into them during the remedial work. The combined total volume of the voids was estimated at around 63 m<sup>3</sup> comprising:

Figure 9: Map of voiding found during ground investigations undertaken by Morgan Sindall

- 58 The positioning of the voids above the path of the microtunnel (figure 9) is the strongest indication that the voids had been caused by overmining of the ground during the tunnelling activity. Most of the voids along the road and across the railway between the launch and reception shafts had migrated from the depth of the tunnel to a level just below ground level. Normally such voids would be expected to break through the surface soon after the tunnelling had been completed but the road and its foundations effectively bridged the voids, except for one hole which appeared in the road on 8 August (paragraph 37). The deep voids found below the railway and each of the twin siphons do not appear to have risen higher because they were bridged by those structures.

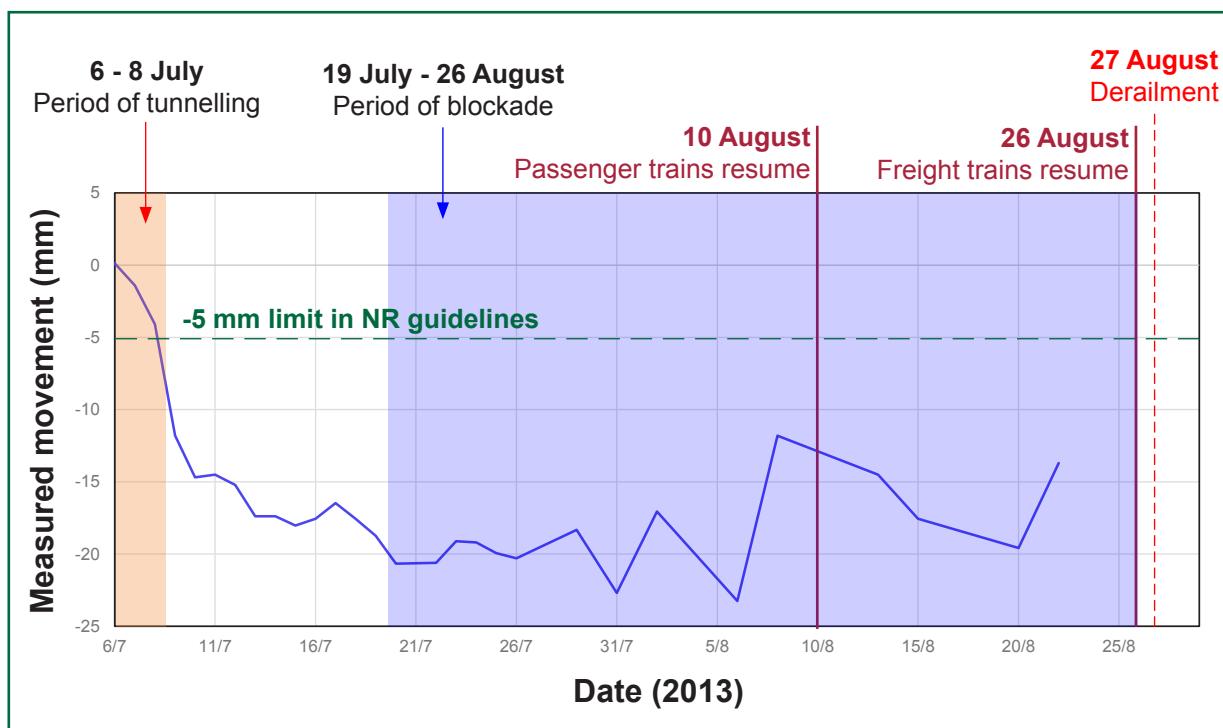
- 67 **Normal train services had been allowed to resume following the tunnelling work, despite evidence of abnormal ground behaviour.**
- 68 As detailed at paragraphs 34 to 38, monitoring of the railway showed a trend of increasing track settlement from 9.5 mm on 8 July when the tunnelling operations finished, to around 23 mm on 31 July. A graph of settlement against time from the start of tunnelling (6 July) for the six foot rail of the up line at the road centre line (which generally showed the greatest amount of settlement) is shown in figure 11. After 31 July, this measurement position and some others around it indicated some fluctuation<sup>7</sup> between 23 mm and 12 mm. The last measurements taken before the derailment were on Thursday 22 August when the settlement recorded for position LX5 was 14 mm and those at other rail measurement positions at the centre of the level crossing were similar. The next set of readings were due on the day of the derailment. By 29 July, the monitoring had been reduced in frequency to three times per week (paragraph 34). The Nottingham station blockade, which had started on 19 July and continued until 26 August, had resulted in reduced rail traffic over Stoke Lane level crossing. Despite the reduced rail traffic flows there had been a further increase in settlement up to 31 July.

Figure 11: Movement of rail during and following tunnelling (on six foot rail of up line at road centre line)

<sup>7</sup> The precise reasons for the fluctuation are not known, but the RAIB considers it is unlikely that the ground level itself fluctuated by the amount indicated in the measurements. Other factors which could have contributed are the passage of a trains around these dates, natural expansion/contraction of the rails due to temperature changes and measurement errors (estimated by the surveyors to be around +/- 3mm).
