**ACCIDENT**

<b>Aircraft Type and Registration:</b>	Boeing 737-476(SF), EI-STD	
<b>No &amp; Type of Engines:</b>	2 CFMI CFM56-3C1 turbofan engines	
<b>Year of Manufacture:</b>	1990	
<b>Date &amp; Time (UTC):</b>	29 April 2014 at 0128 hrs	
<b>Location:</b>	East Midlands Airport	
<b>Type of Flight:</b>	Commercial Air Transport (Cargo)	
<b>Persons on Board:</b>	Crew - 2	Passengers - None
<b>Injuries:</b>	Crew - None	Passengers - N/A
<b>Nature of Damage:</b>	Left main landing gear, left wing and engine	
<b>Commander's Licence:</b>	Airline Transport Pilot's Licence	
<b>Commander's Age:</b>	38 years	
<b>Commander's Flying Experience:</b>	4,279 hours (of which 377 were on type) Last 90 days - 114 hours Last 28 days - 10 hours	
<b>Information Source:</b>	AAIB Field Investigation

**Synopsis**

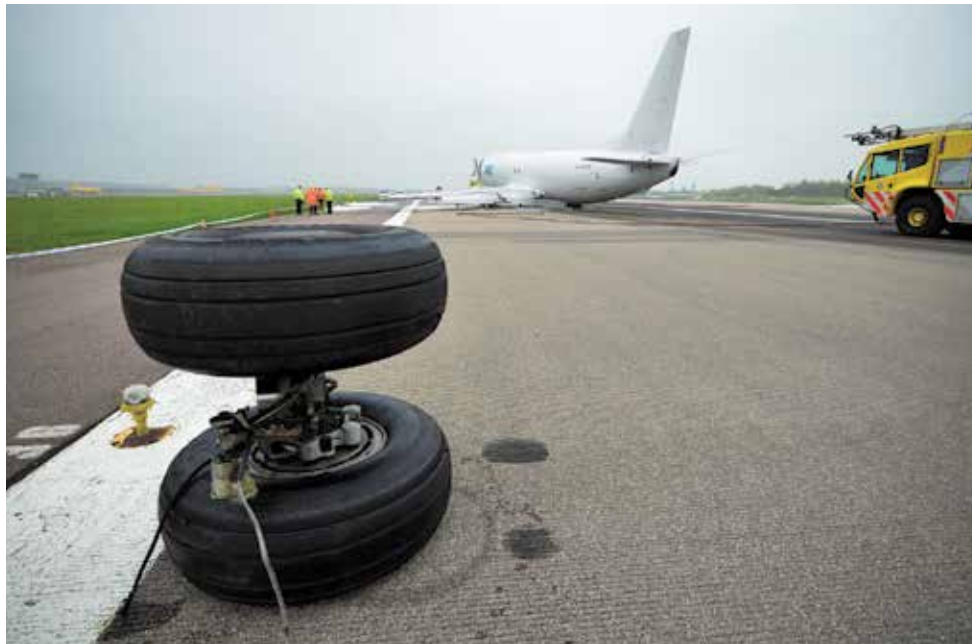
**Figure 1**

View of aircraft and detached section of lower left MLG

Marks and damage to the runway surface indicated that the aircraft had travelled 115 m with its weight on the left engine nacelle and left MLG outer cylinder, from the position where the left MLG had failed. A debris trail, consisting mainly of composite material, was deposited on the runway, along with a large oil stain where the MLG lower section had detached. The aircraft’s path described a gentle curve diverging to the left, away from the runway centreline. The aircraft had come to rest with its nosewheel off the ground and its weight borne on the right MLG, the remains of the left MLG and the underside of the left engine nacelle.

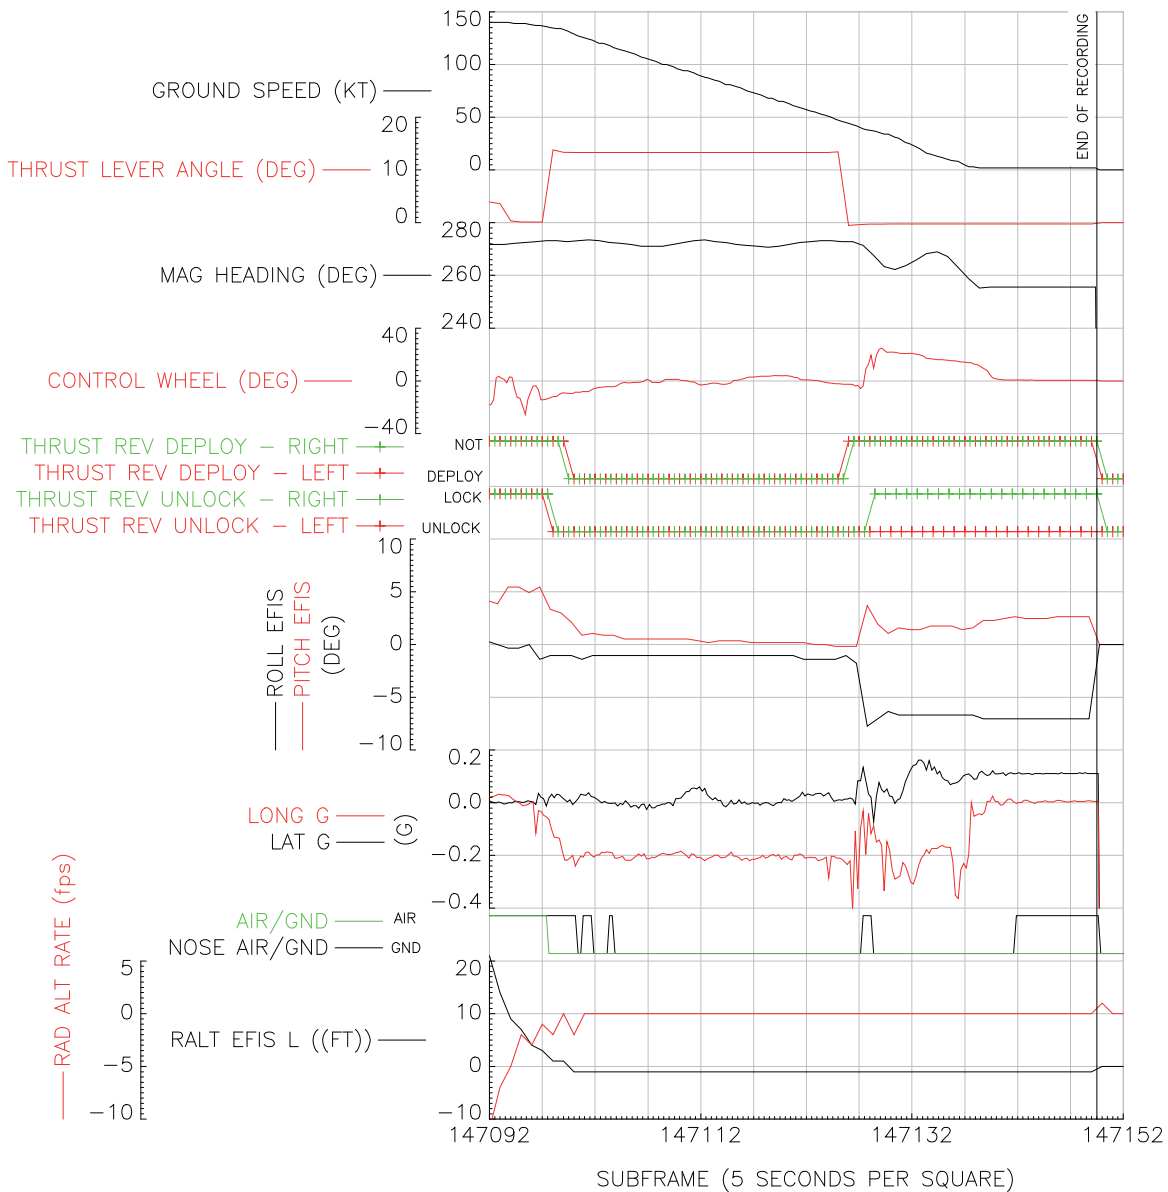
**Figure 2**  
Pertinent FDR parameters

The aircraft took off at a recorded time of 0040:46 hrs and touched down at 0128:59 hrs. Figure 2 is a plot of the pertinent recorded parameters for the landing. There was no valid normal-acceleration parameter, but the derived closure rate with the runway does not indicate a heavy landing. The thrust reversers were deployed. There were no valid recorded brake-parameters but the longitudinal acceleration during the landing roll was very uniform. A brief spike in longitudinal acceleration was recorded as the aircraft groundspeed reduced through 52 kt. This was followed 2.25 seconds later by a larger spike in longitudinal acceleration and then oscillations with a frequency too high for the parameter to follow accurately. After approximately one second of these oscillations in longitudinal acceleration, a clockwise control wheel input was recorded, associated with a change in attitude which peaked at 7.7° left-wing-down and 3.7° nose-up pitch.

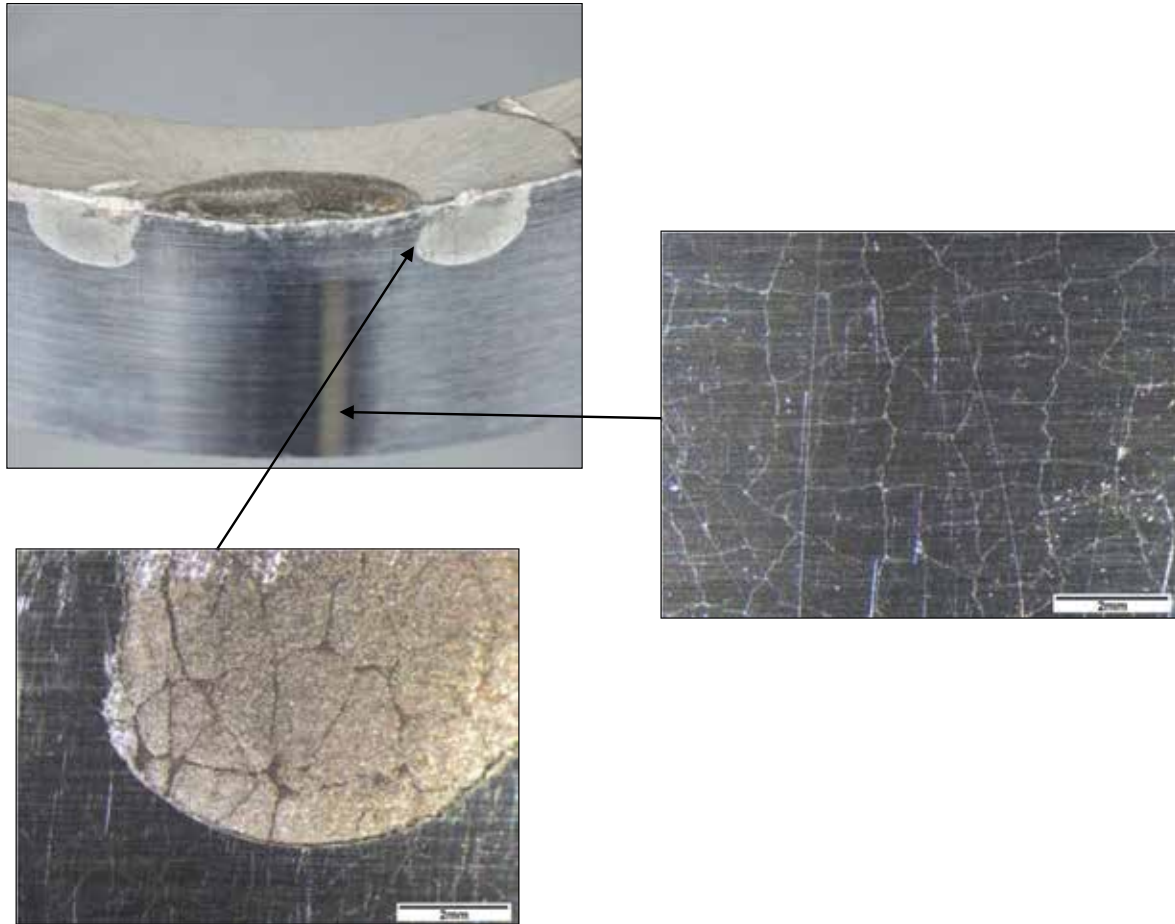
**Figure 3**

The visual examination under magnification of the outer chrome plated surfaces of the inner cylinder revealed extensive crazing of the chrome plating. This phenomenon is known as 'chicken wire' cracking and was apparent over the majority of the surface. Small flakes of the crazed chrome plating had detached from the substrate material at the edge of the fracture face, leaving an imprint of the crazing in the form of ferrous oxide tracks (Figure 3).

Chrome plate flake area and ferrous oxide tracks left by the chicken wire cracking

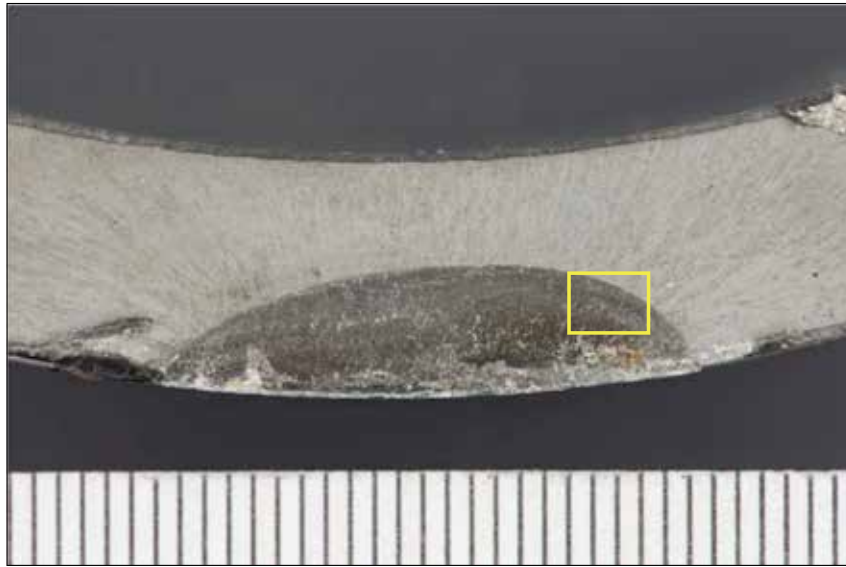
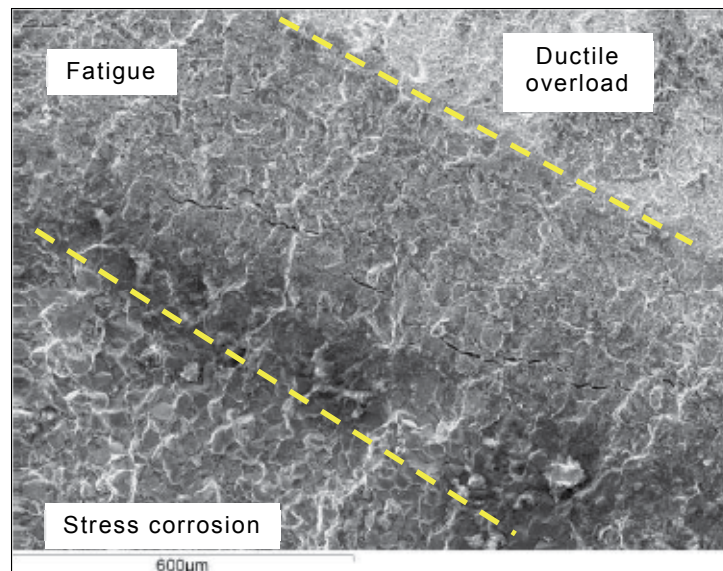
**Figure 4**  
Fracture surface map

The left MLG inner cylinder had fractured through the chrome portion approximately 75 mm above the axle. The fracture was horizontally across the full diameter of the inner cylinder and exhibited a discoloured thumbnail-shaped feature on its surface. This feature was on the forward face of the MLG, approximately in line with the level at which the inner cylinder protrudes from the outer cylinder with aircraft weight on wheels. The upper torque link arm had failed and the antiskid system wiring harness, conduit and brake pipes had parted. The left mainwheels, brake units and axle assembly came to rest approximately 27 m behind the aircraft, to the left of the centreline.

The fracture face showed three distinct failure mechanisms in the grey 'thumbnail' area of the fracture (Figure 4). The majority of this area exhibited stress corrosion. Further into the material there was evidence of fatigue and the remainder of the fracture face showed the characteristics of ductile overload.

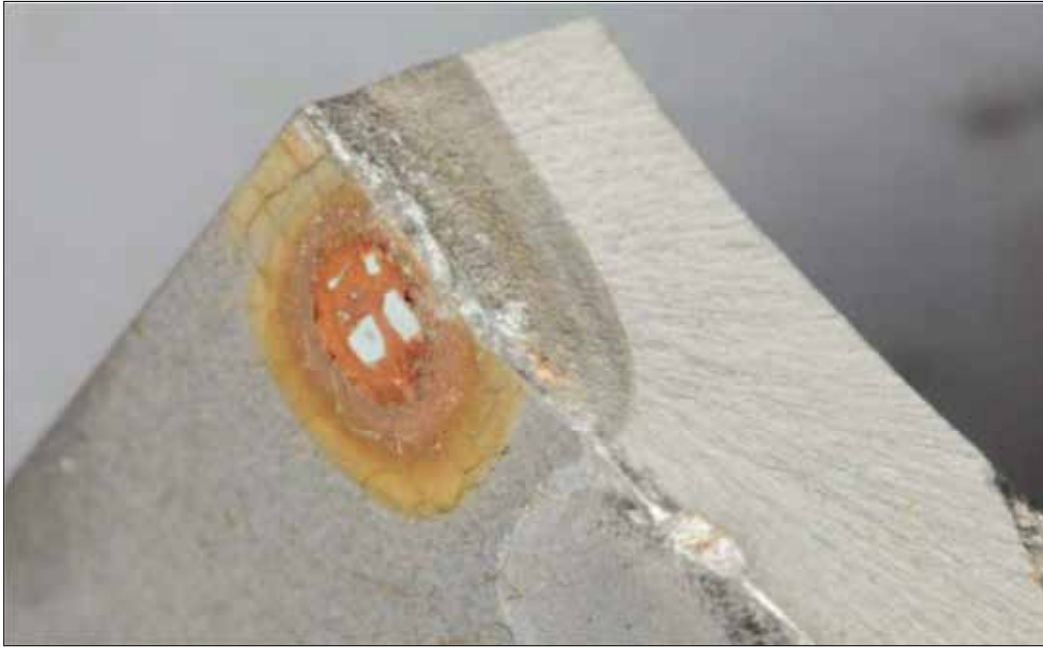
**Figure 5**

With the chrome plating removed, a very distinctive area of ferrous oxidation became apparent on the surface of the steel, just beneath the area of fatigue cracking (Figure 5). In addition, in the same area, there was also evidence of chrome combining with the steel.

Ferrous oxidation on the substrate beneath the chrome plating  
(after longitudinal microsection)

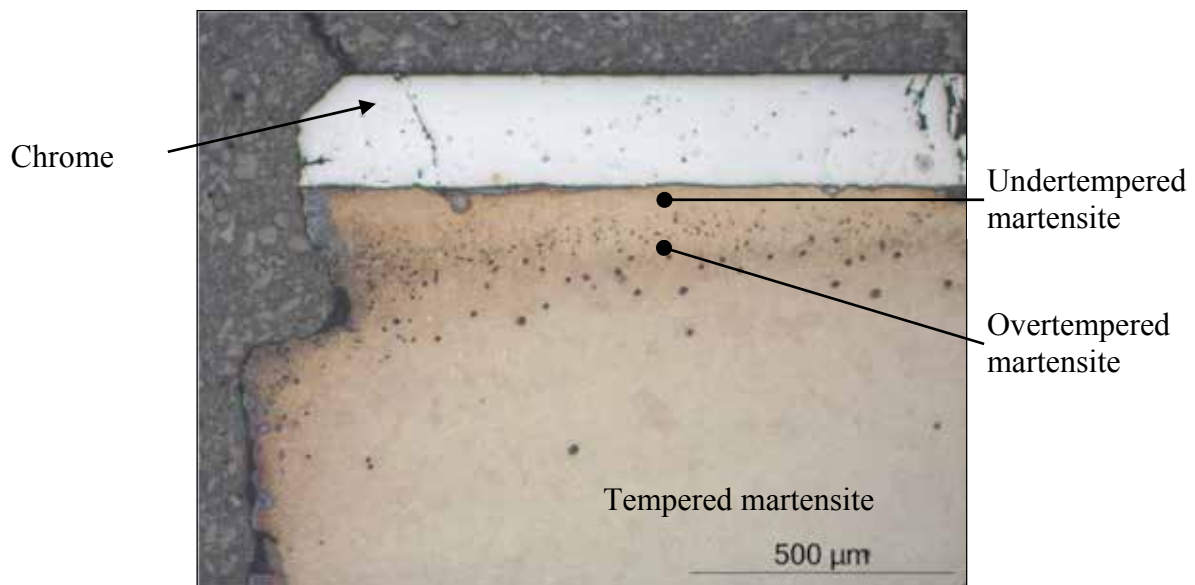
**Figure 6**

Metallurgical examination of the microsection through the fracture face showed an area in the substrate steel of over and undertempered martensite, consistent with localised heating. The hardness profile through this section also confirmed this finding. Prior to removal of the chrome, hardness checks were carried out; these showed that the chrome decreased in hardness in the vicinity of the fracture face. Figure 6 shows the disposition of the martensite.

Fracture surface metallurgy

The origin of the failure was an area of intense, but very localised heating, which damaged the chrome protection and changed the metallurgy; ie the formation of martensite within the steel substrate. This resulted in a surface corrosion pit, which, along with the metallurgical change, led to stress corrosion cracking, fatigue propagation and the eventual failure of the inner cylinder under normal loading.

Although it is not clear how or when the chrome plating damage occurred, the landing gear overhaul company has carried out a comprehensive review of their processes as a precaution.
